DRAFT
Remedial Investigation Report
93B Maple Avenue
Former MGP Site
Haverstraw, New York
Orange and Rockland Utilities, Inc.
Volume 1
Text, Tables, Figures, Plates, Appendices

**GEI Consultants, Inc.**

March 29, 2002
010820-1008

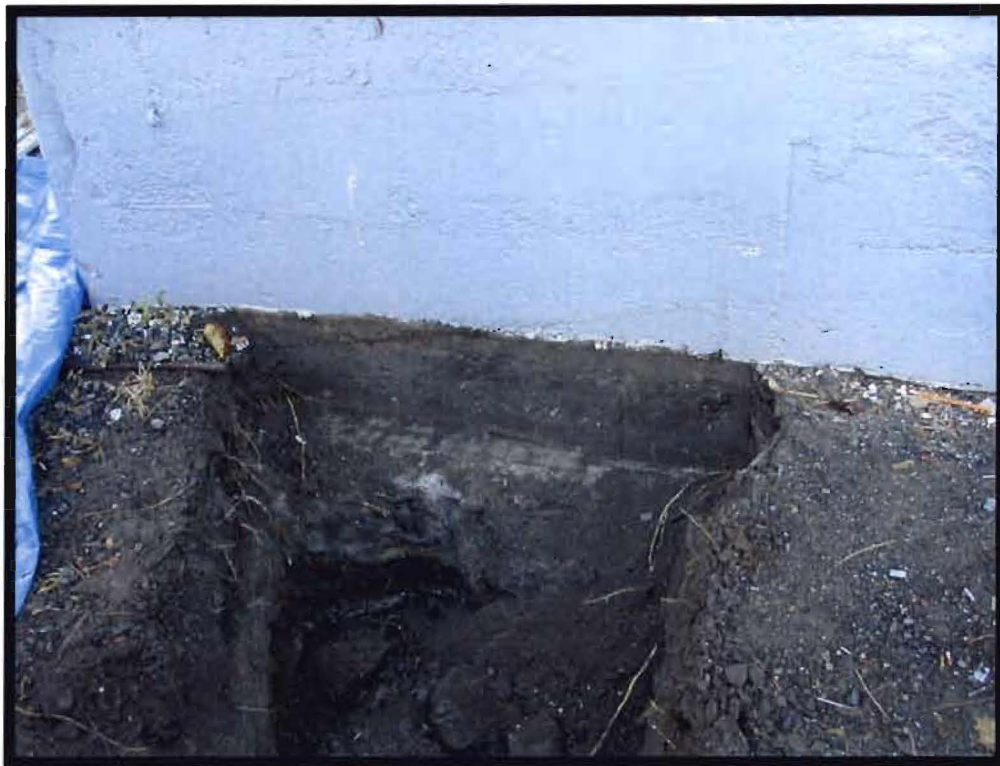
Test Pit GT-TP1, Located At Alley-end Of The Building.
Note The Small (4-inch Wide) Ledge Of Overpour From The Forms.
Fill Material Is Present Under The "footer".

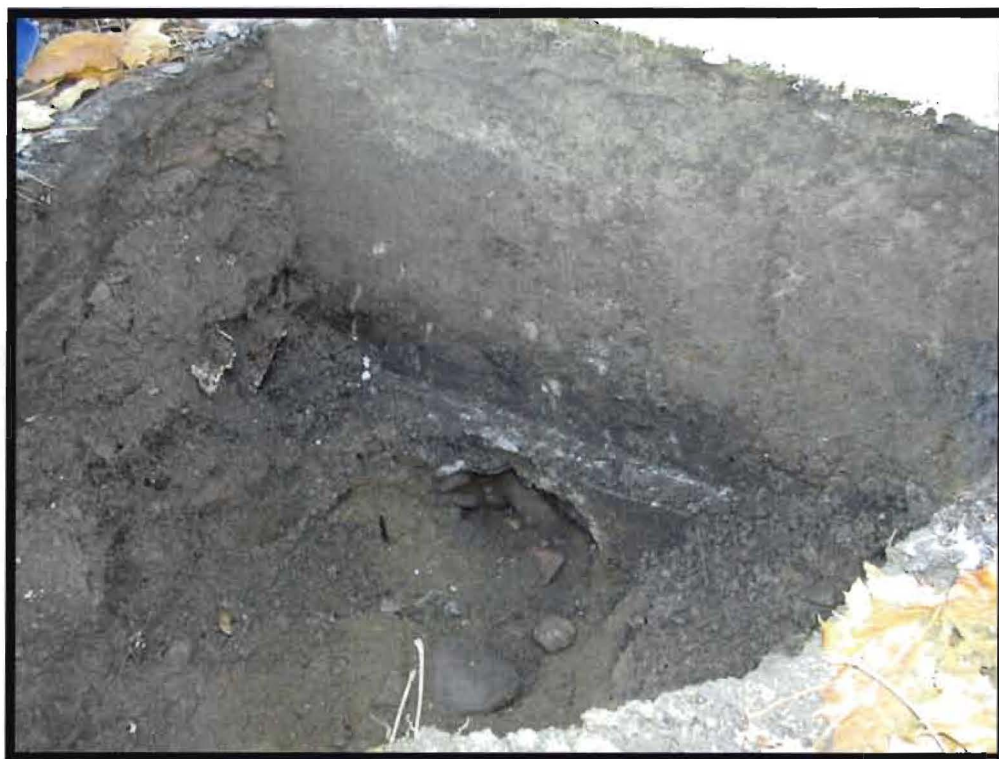
Test Pit GT-TP2, Located At Midpoint Of Building.
Note The Small Footing Underneath The Formed Wall.

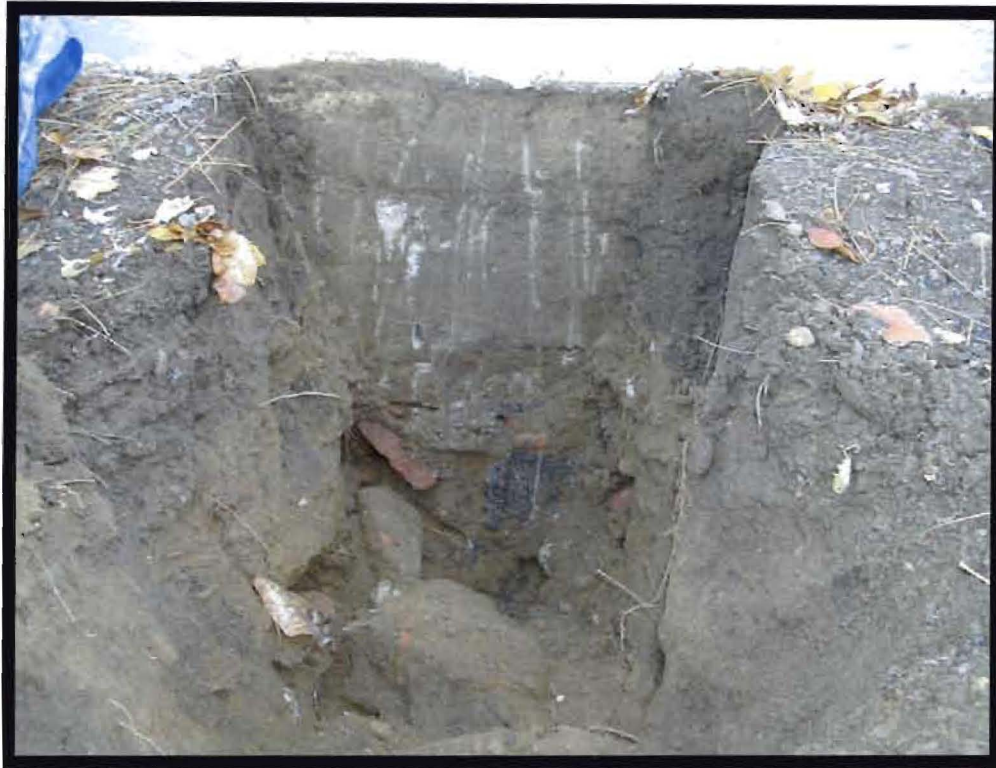
Test Pit GT-TP3, Located At Driveway End Of The Building.
Note Rubble And Fill Under The Formed Walls;
No Apparent Or Existing Footer At This Location.

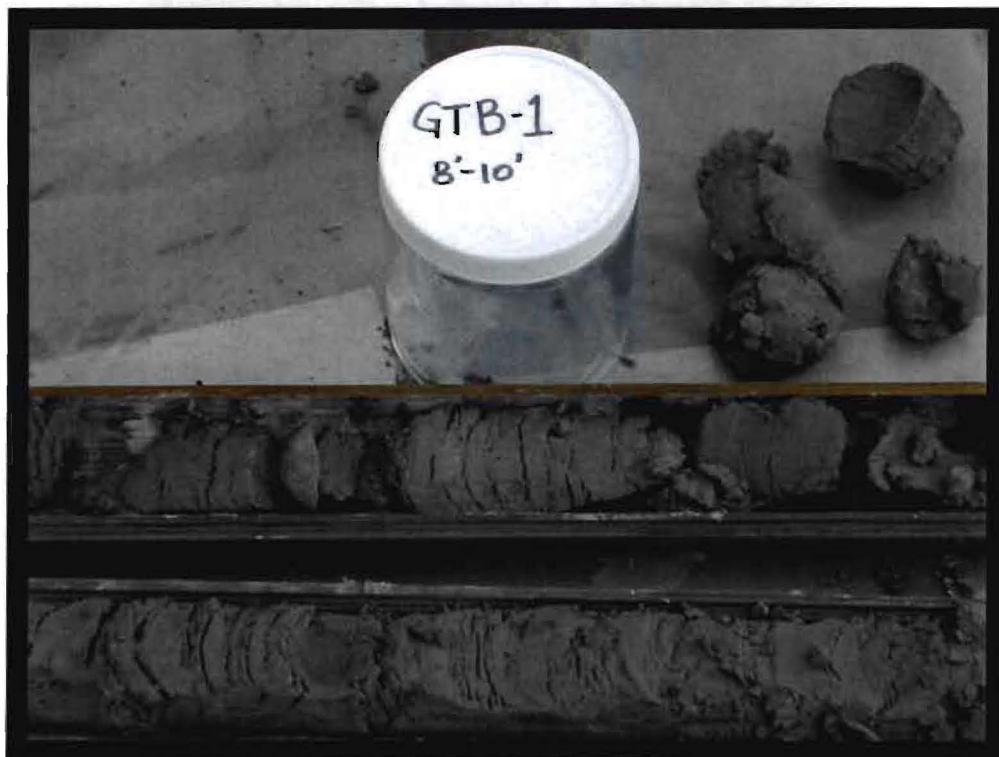
Soil Boring GTB-1, 8-10 Feet Below Ground Surface.
Grey Clay With Frequent mm Scale Silt Beds.
No Visual Impacts Noted at Water Table.

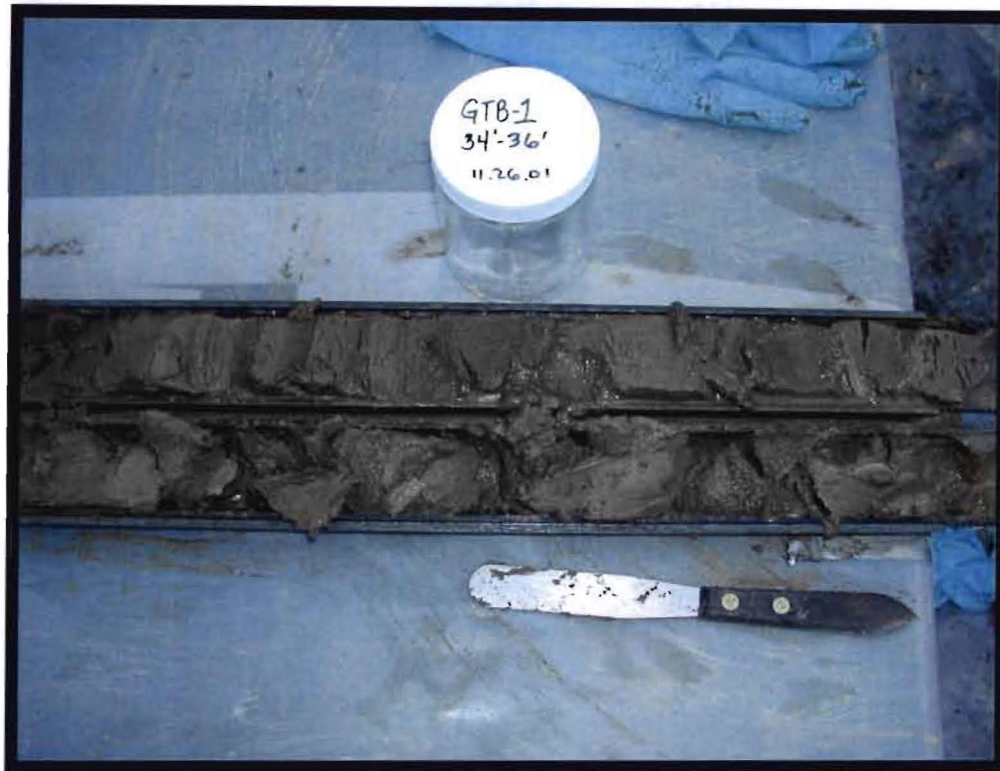
Soil Boring GTB-1, 34-36 Feet Below Ground Surface.
Brown to Light-Brown Silt and Clay.
No Visual Impacts Noted at End of Boring.
