Nyack Former Manufactured Gas Plant

Final Engineering Report

NYSDEC Site Number: 344046

Orange and Rockland Utilities, Inc.
3 Old Chester Road
Goshen, New York 10924

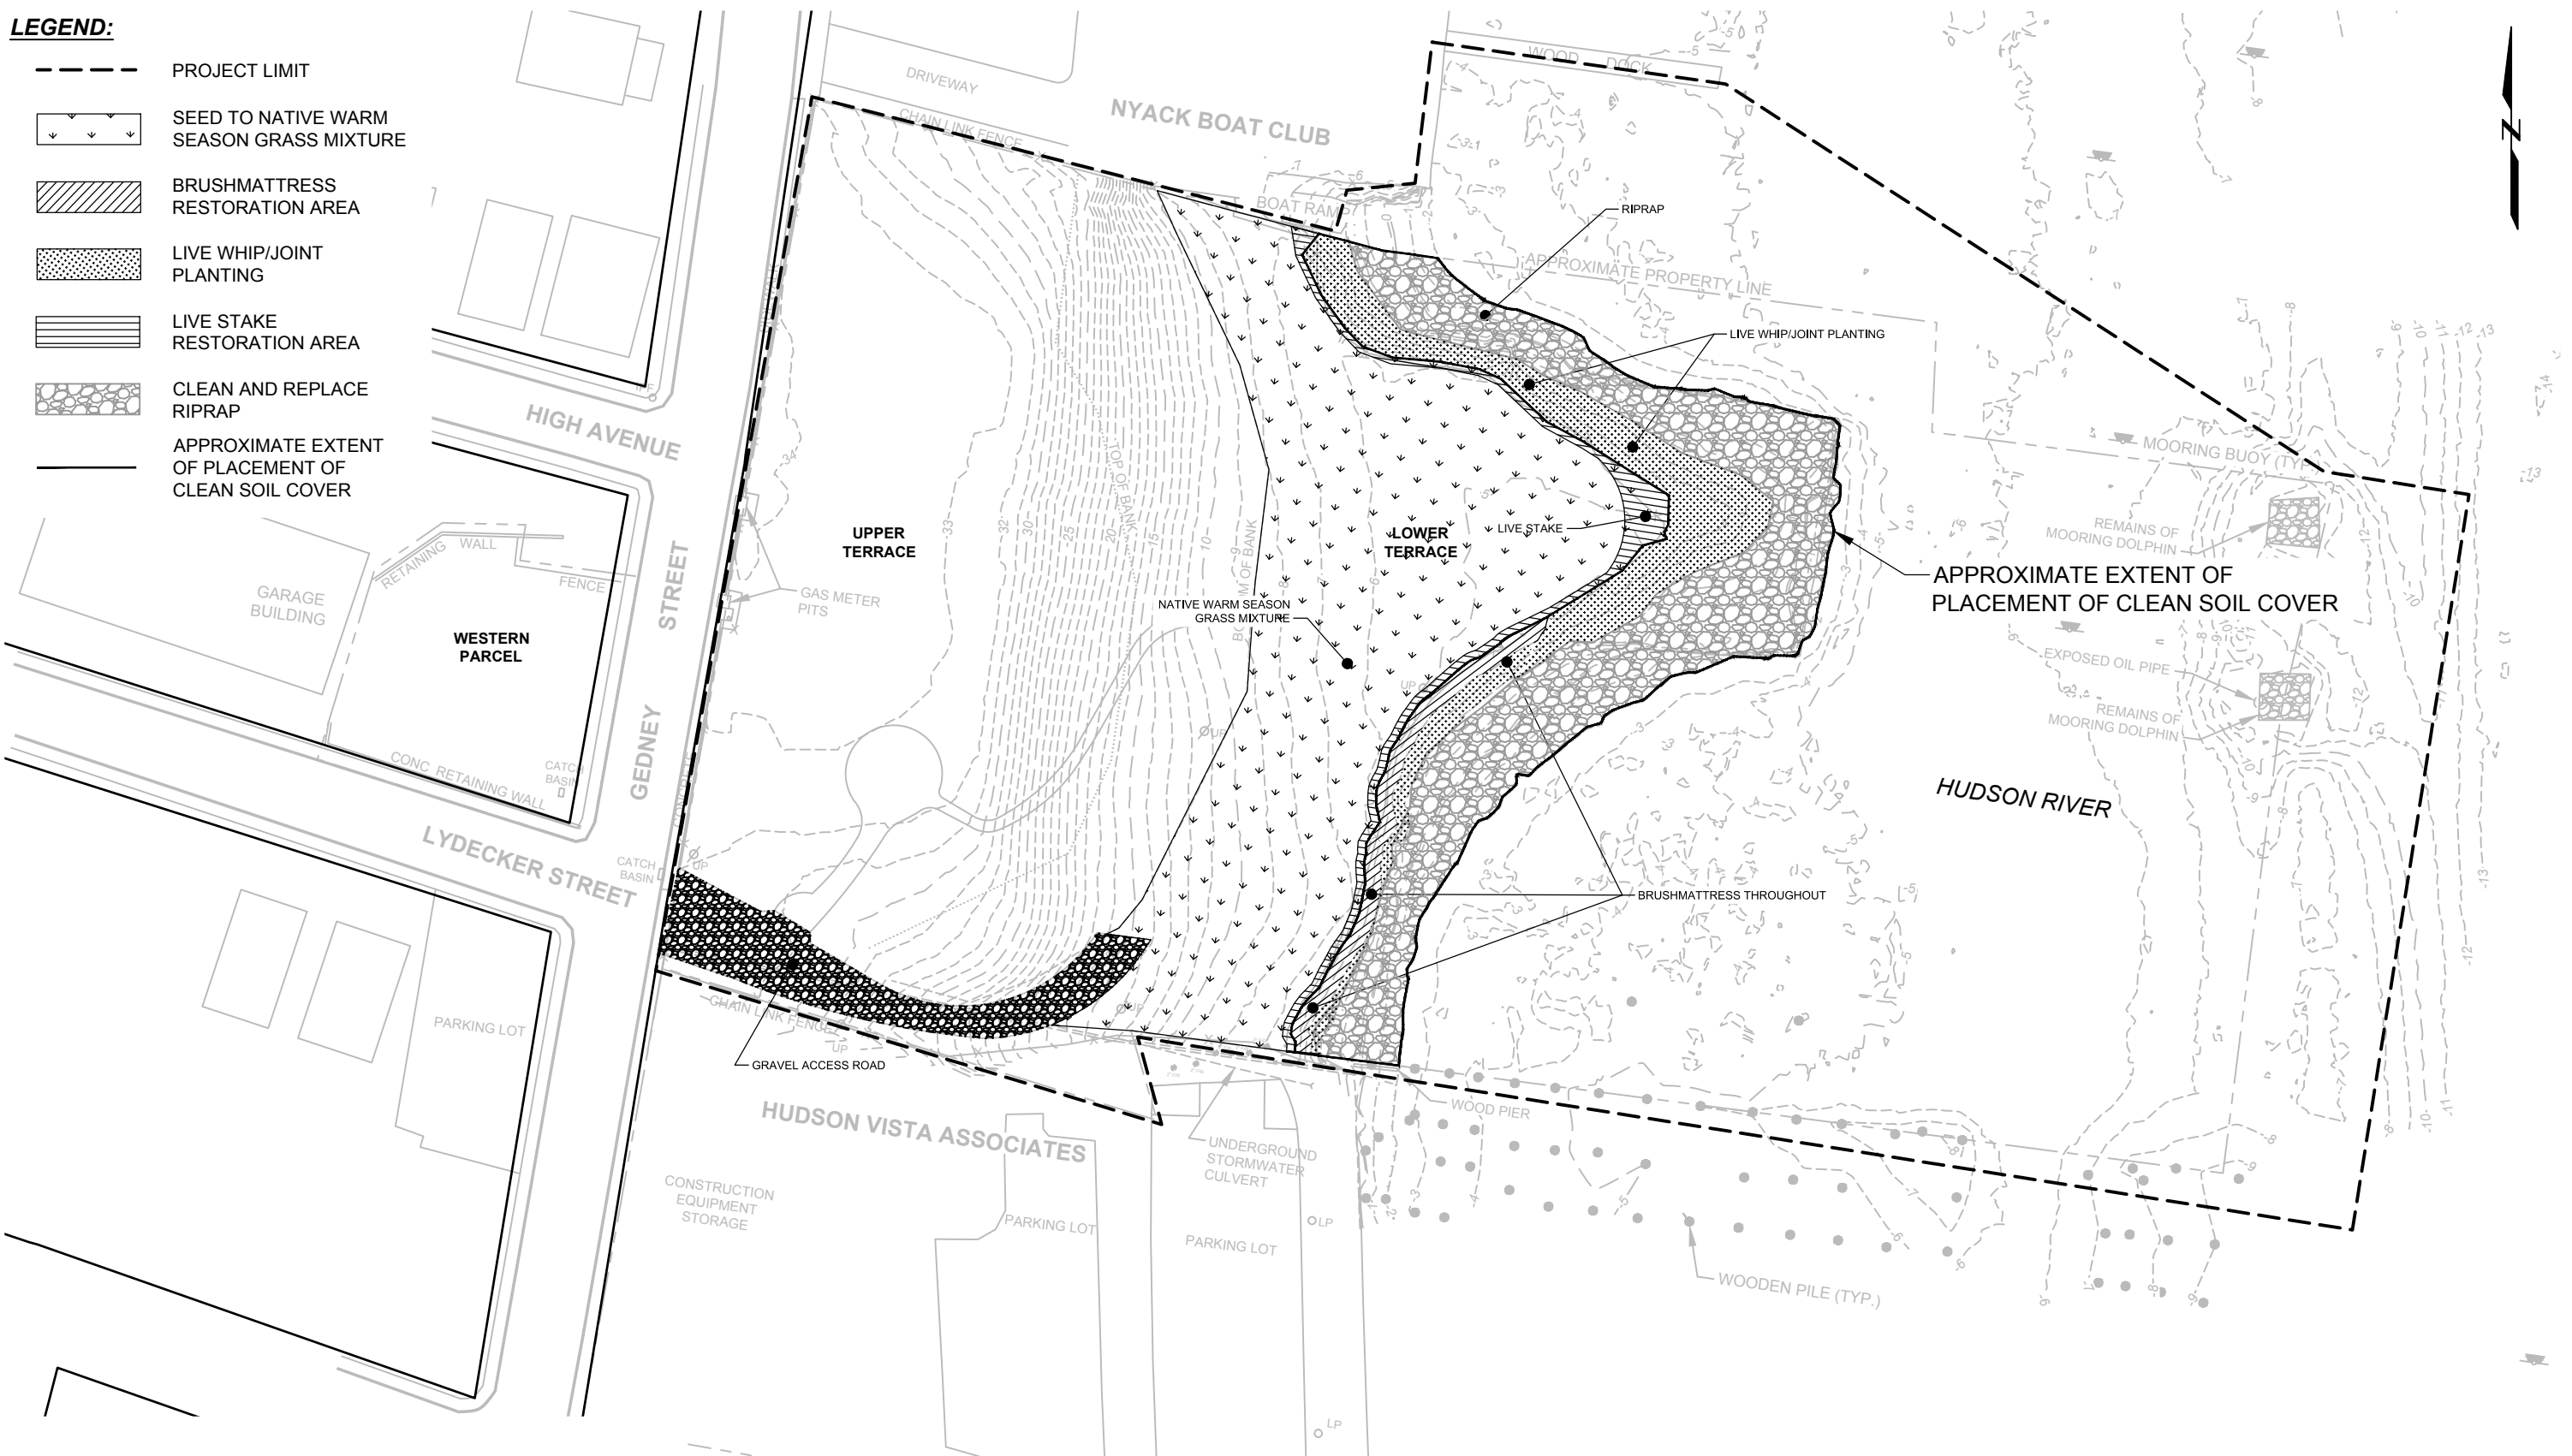
<p>Final Engineering Report Nyack Former MGP Nyack, New York</p>	<p>GEI Consultants</p>	<p>APPROXIMATE EXTENT OF CLEAN SOIL COVER</p>
<p>Orange and Rockland Utilities, Inc. Goshen, New York</p>	<p>Project 1400400</p>	<p>April 2016 Fig. 5</p>

1. A MINIMUM OF 2 FEET OF CLEAN SOIL COVER WAS PLACED OVER THE ISS, AS REQUIRED BY THE RECORD OF DECISION.

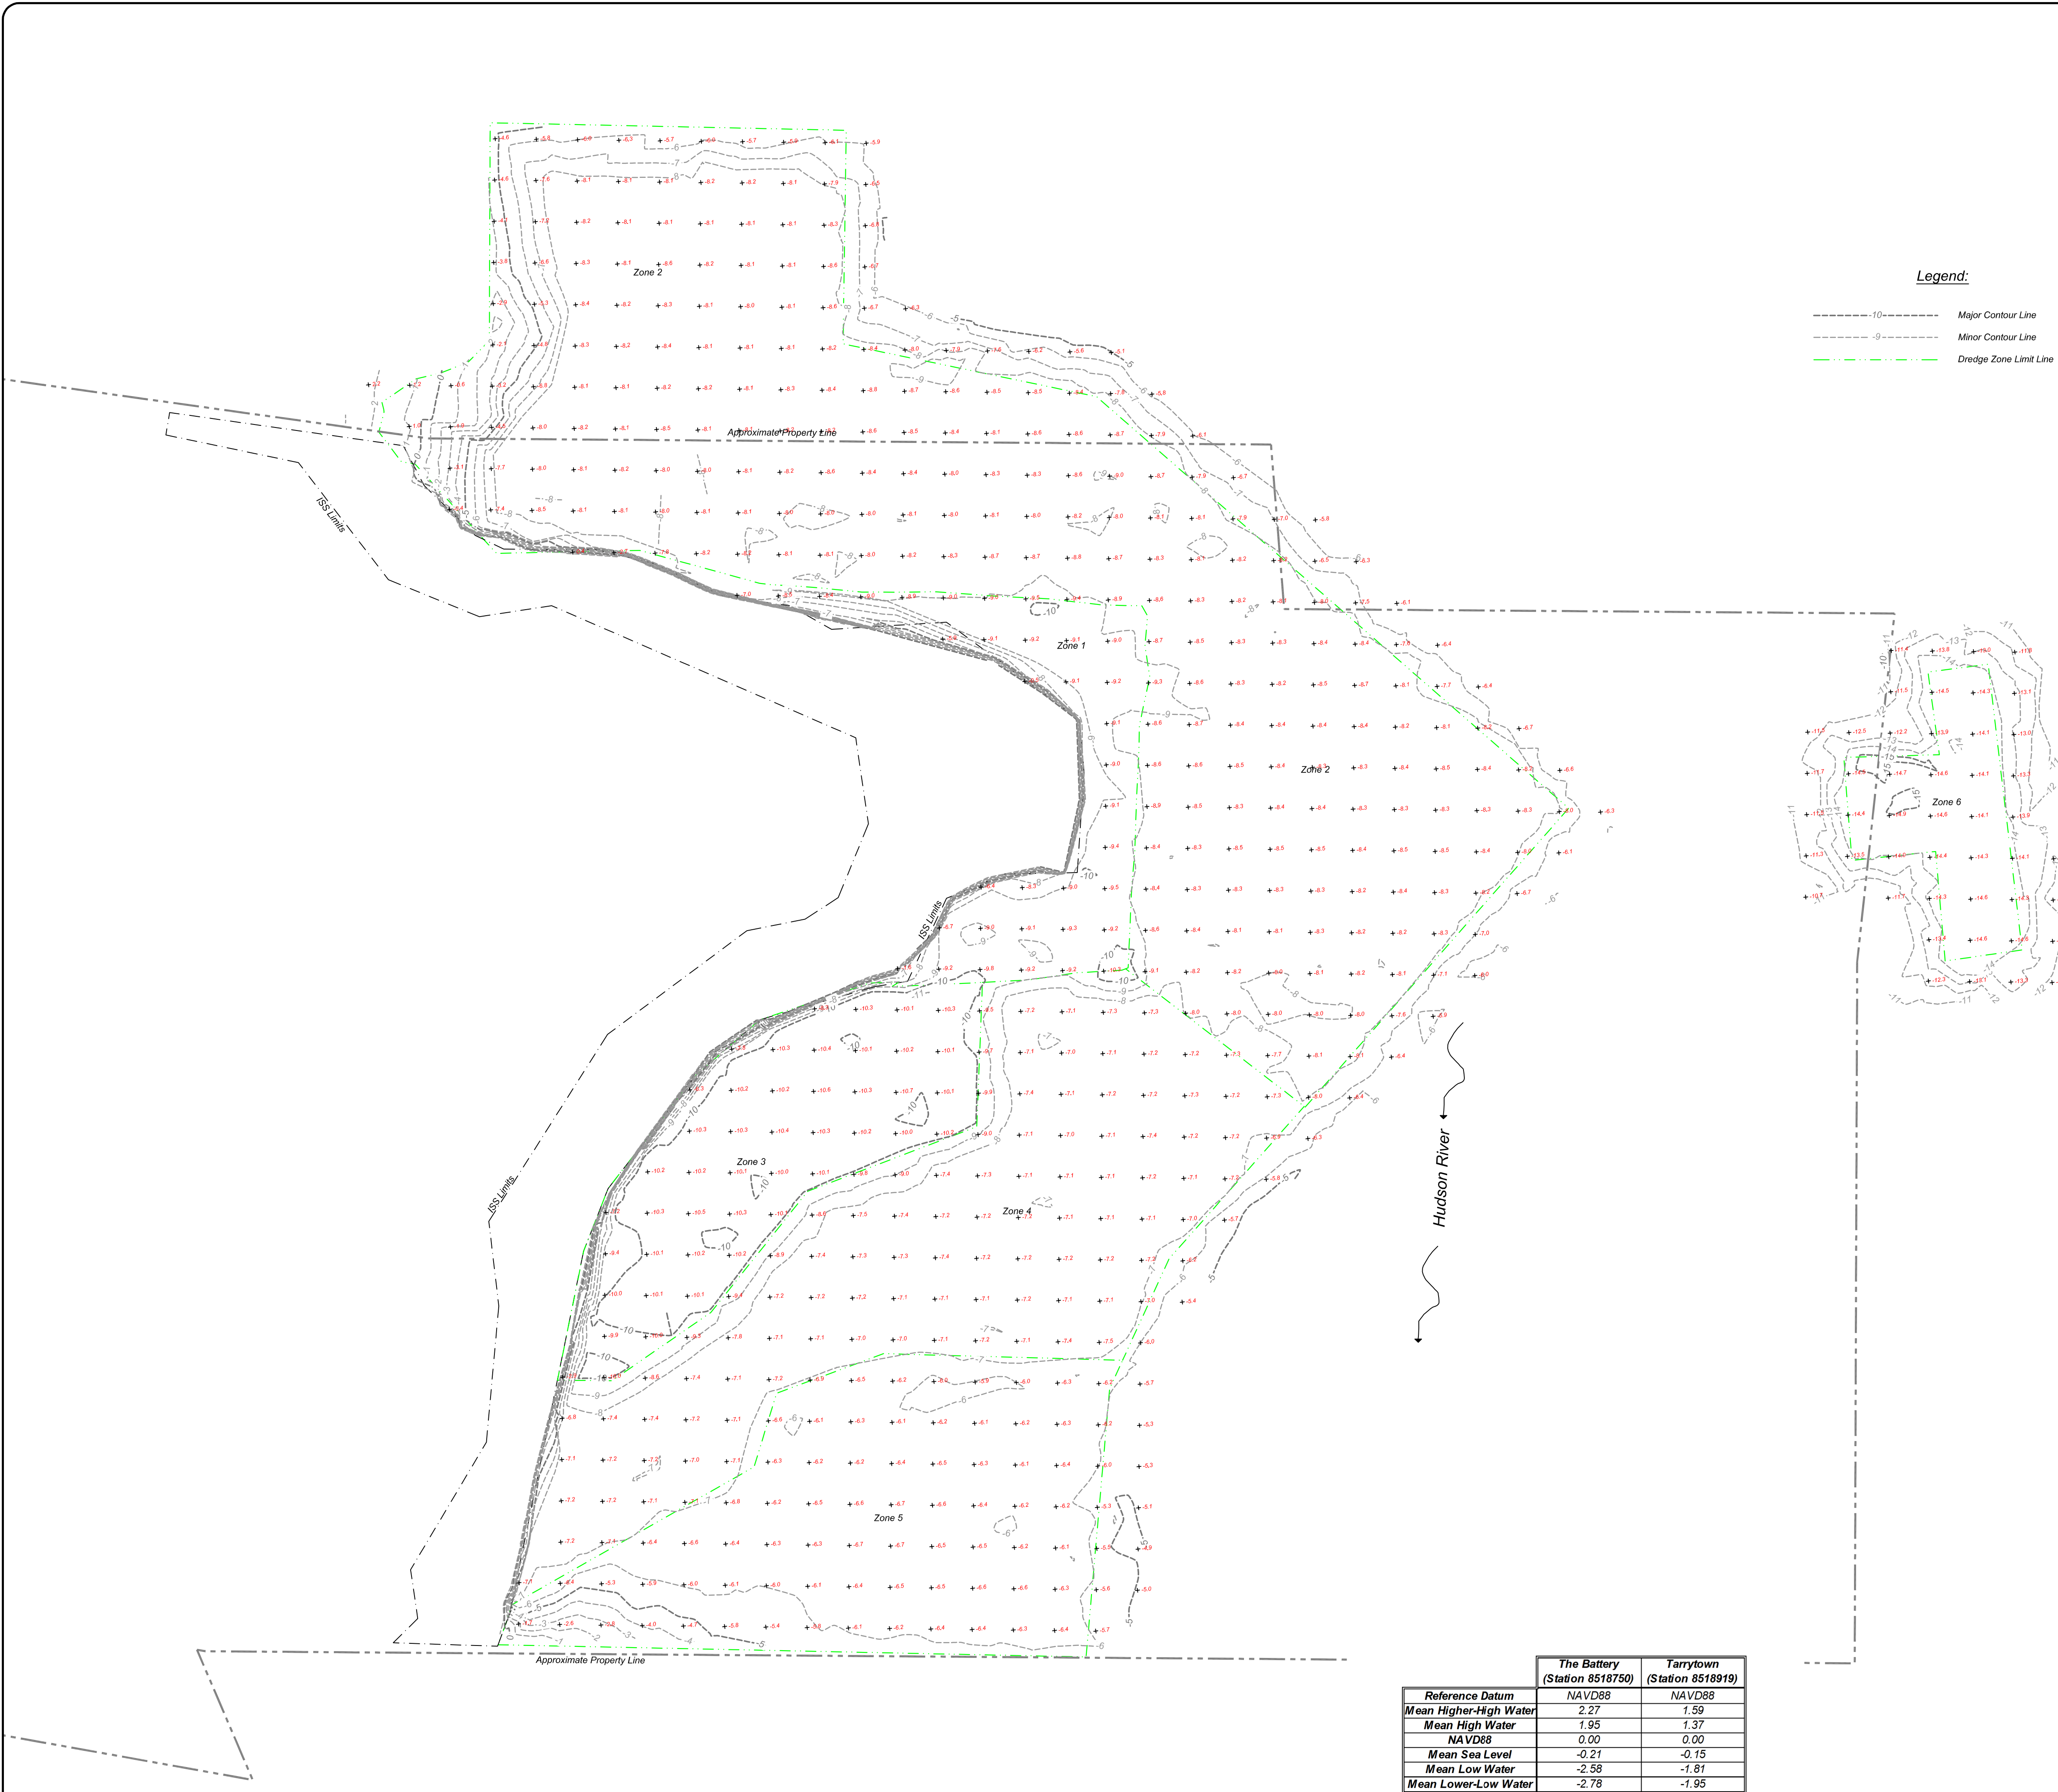
Drawing No. 1

- Contours shown hereon were generated from a Digital Terrain Model utilizing AutoCAD Civil 3D Surveying and Engineering software.
 - The bathymetric information shown hereon is based on an acoustical survey completed on December 10, 2014.

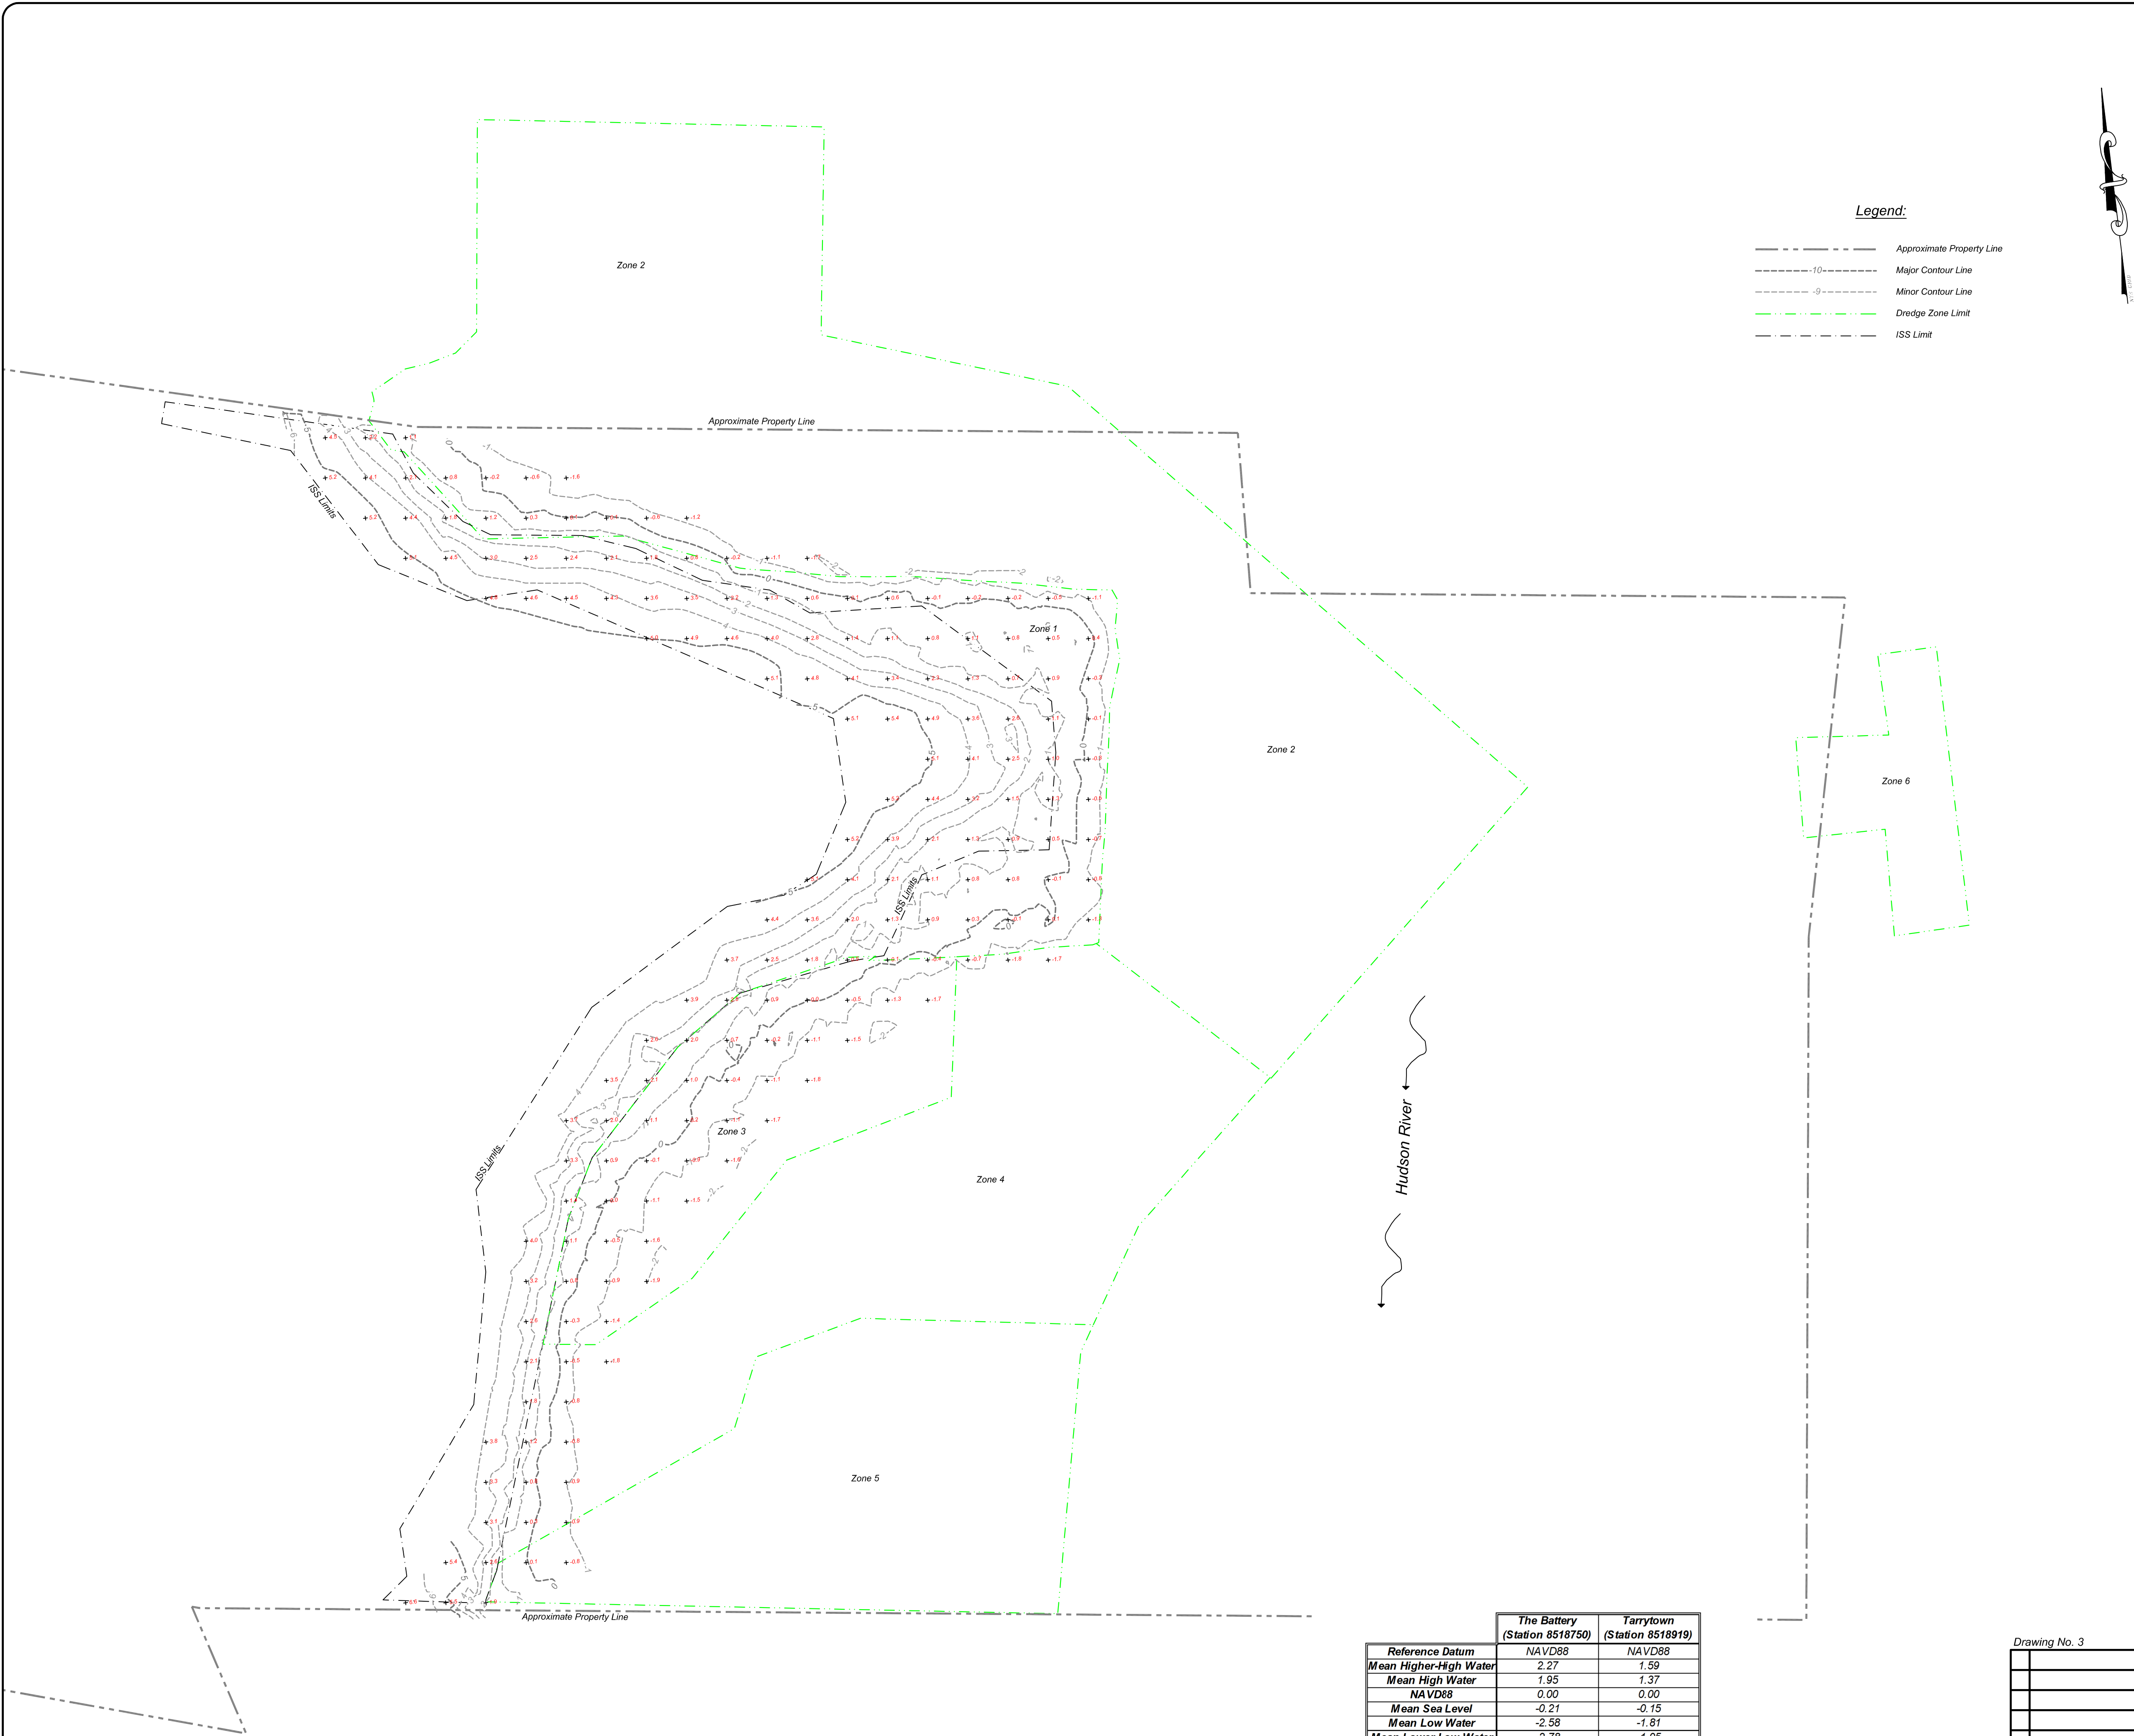
"The Battery" (Station 8518750) is the reference harmonic tide gauge station for the subordinate tide gauge station "Tarrytown" (Station 8518919). The heights at "The Battery" are multiplied by 0.70 to obtain the tide gauge elevation at "Tarrytown".
