2023 Periodic Review Report

Nyack Manufactured Gas Plant Site Village of Nyack, Rockland County, New York

NYSDEC Site Number: 344046
Index # D3-001-98-08

December 2023
Project 2202333

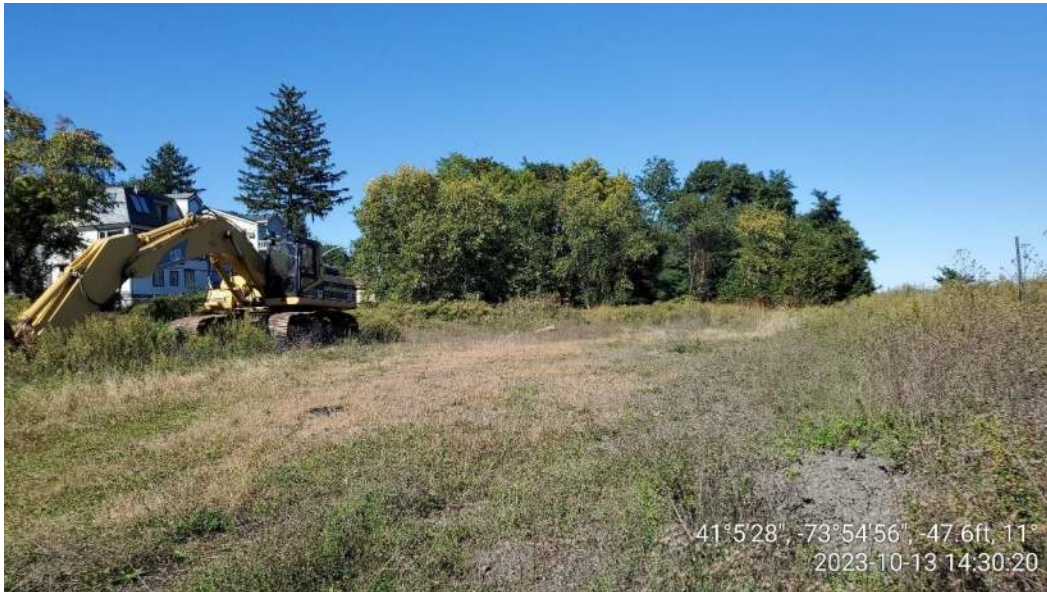
Photo No.: 1
Photographer: S. DiBartolo
Date: 10/13/2023
Direction: North

Comments:
Upper Terrace

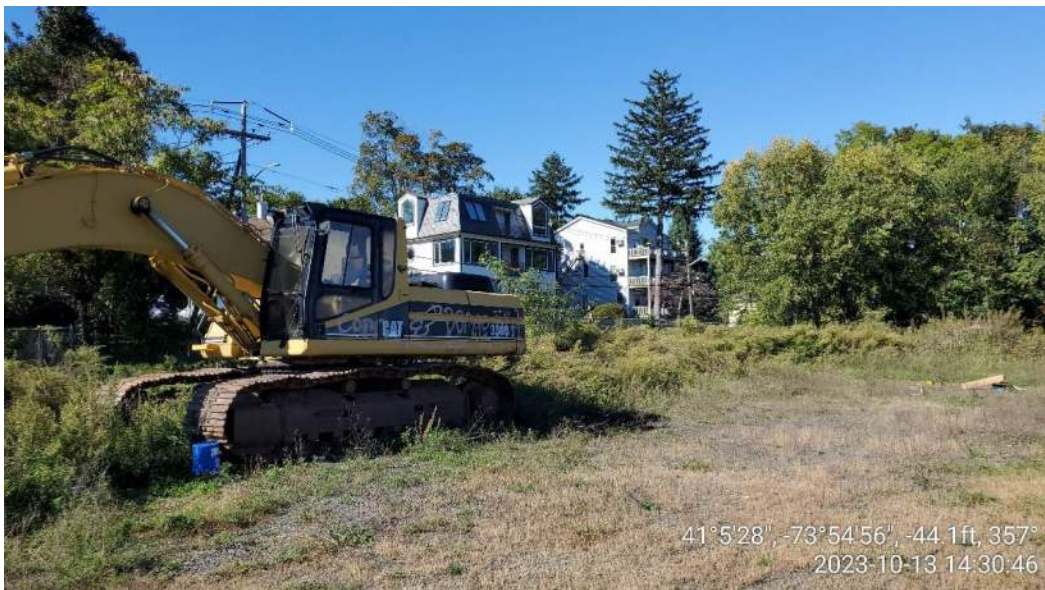
Photo No.: 2
Photographer: S. DiBartolo
Date: 10/13/2023
Direction: Northwest

Comments:
Upper Terrace

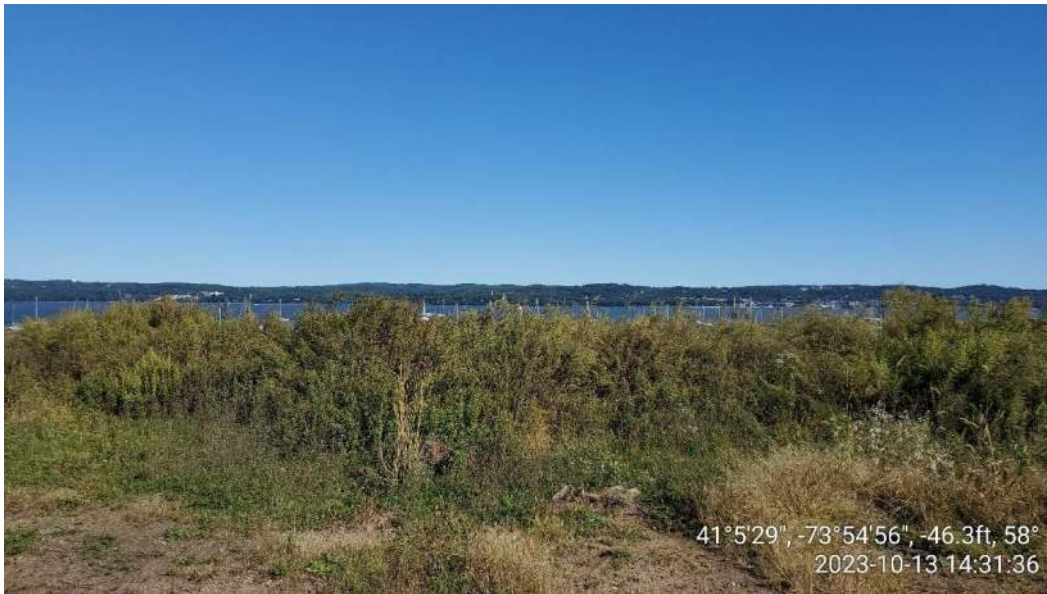
Photo No.: 3
Photographer: S. DiBartolo
Date: 10/13/2023
Direction: East
Comments:
Upper Terrace

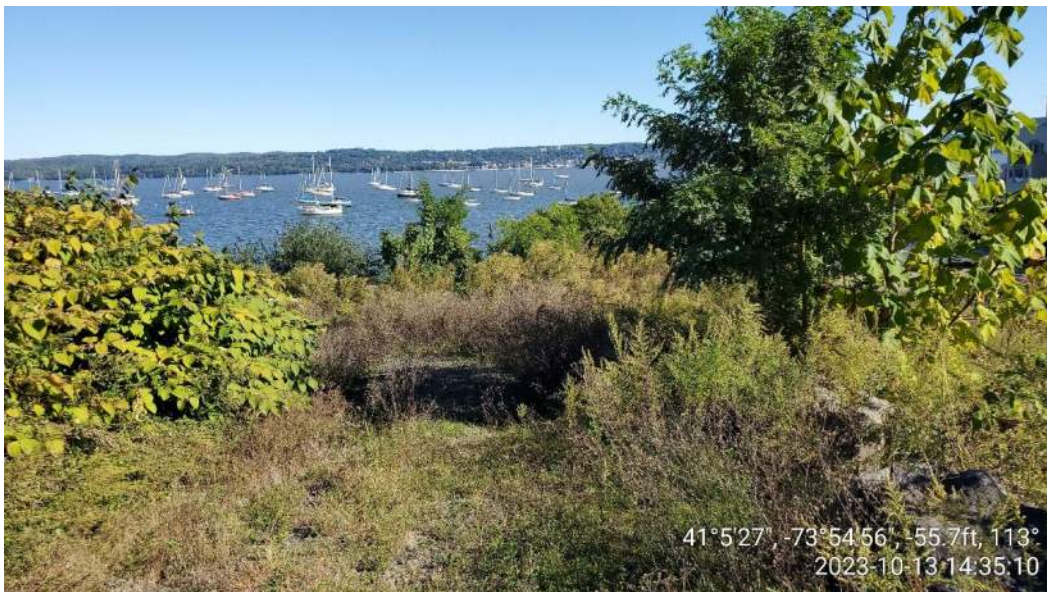
Photo No.: 4
Photographer: S. DiBartolo
Date: 10/13/2023
Direction: East
Comments:
Lower Terrace and Hudson
River Area

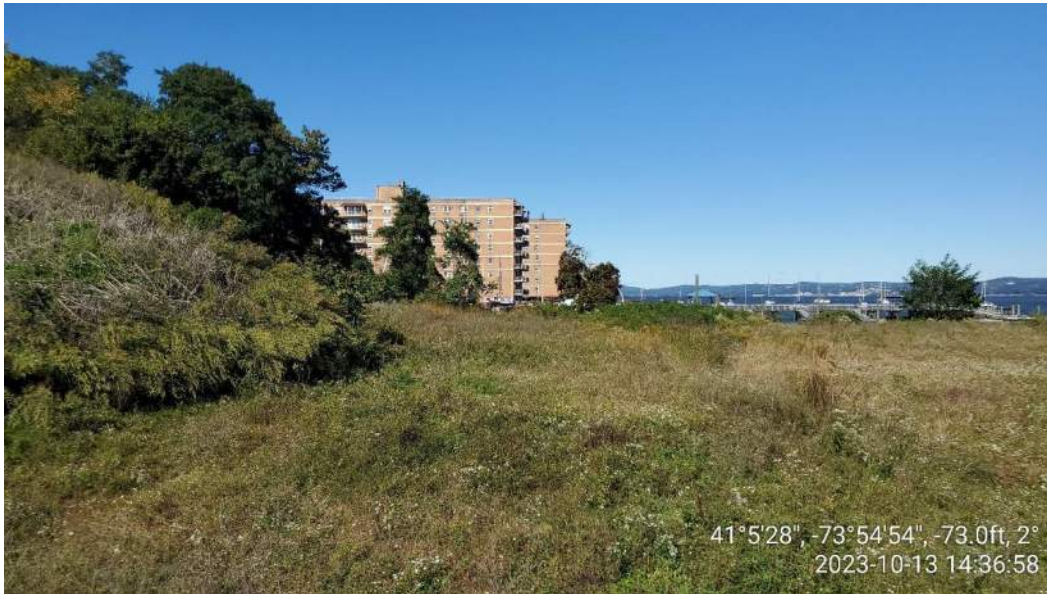
Photo No.: 5
Photographer: S. DiBartolo
Date: 10/13/2023
Direction: North

Comments:
Lower Terrace

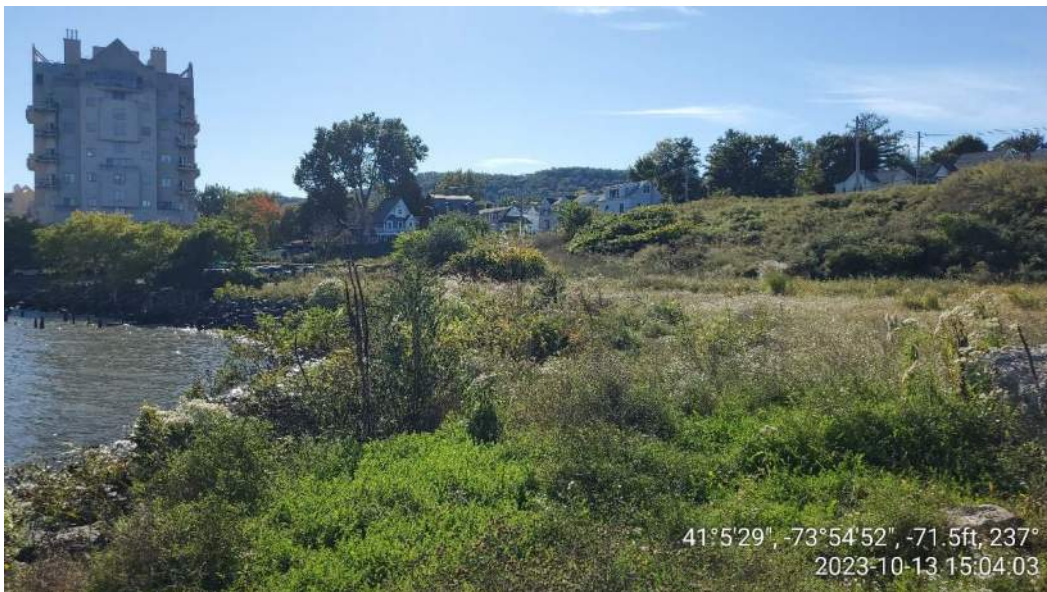
Photo No.: 6
Photographer: S. DiBartolo
Date: 10/13/2023
Direction: Southwest

Comments:
Lower Terrace

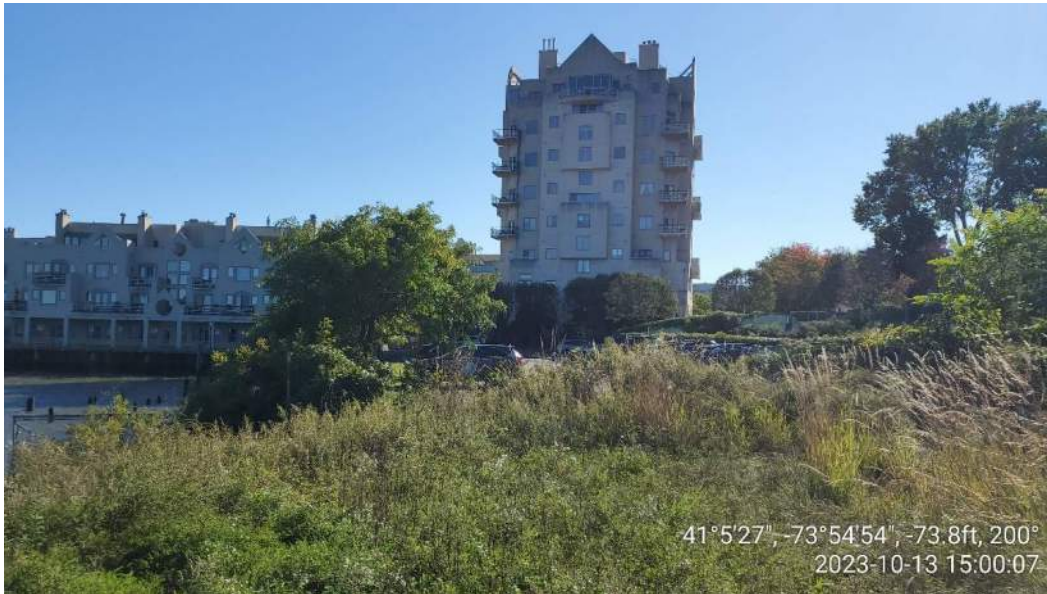
Photo No.: 7
Photographer: S. DiBartolo
Date: 10/13/2023
Direction: South

Comments:
Lower Terrace towards
Hudson Vista Parking Lot

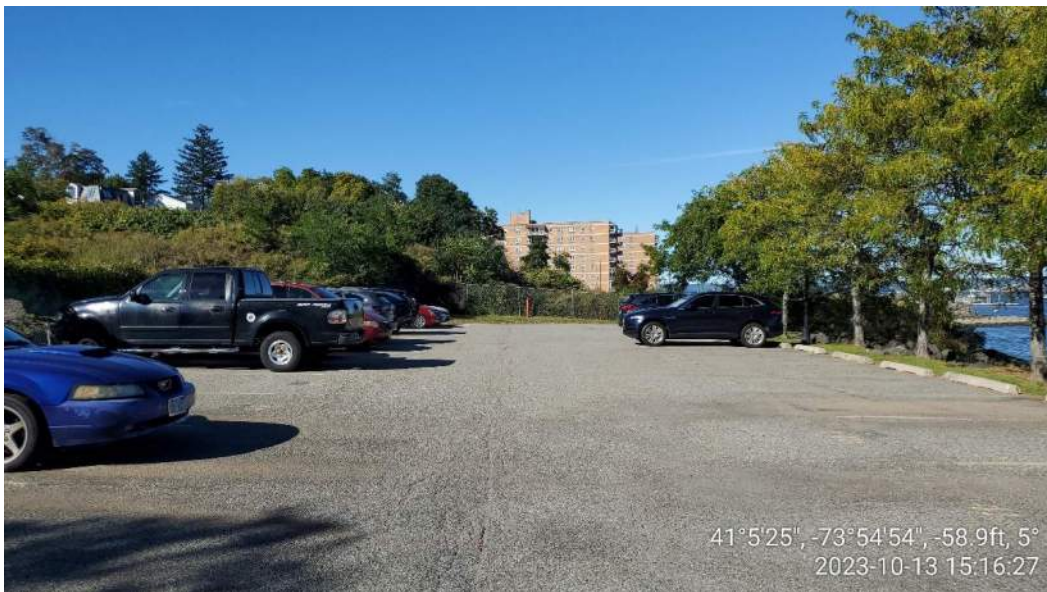
Photo No.: 8
Photographer: S. DiBartolo
Date: 10/13/2023
Direction: North

Comments:
Hudson Vista Associates
Parcel lower parking lot
portion of surface cover

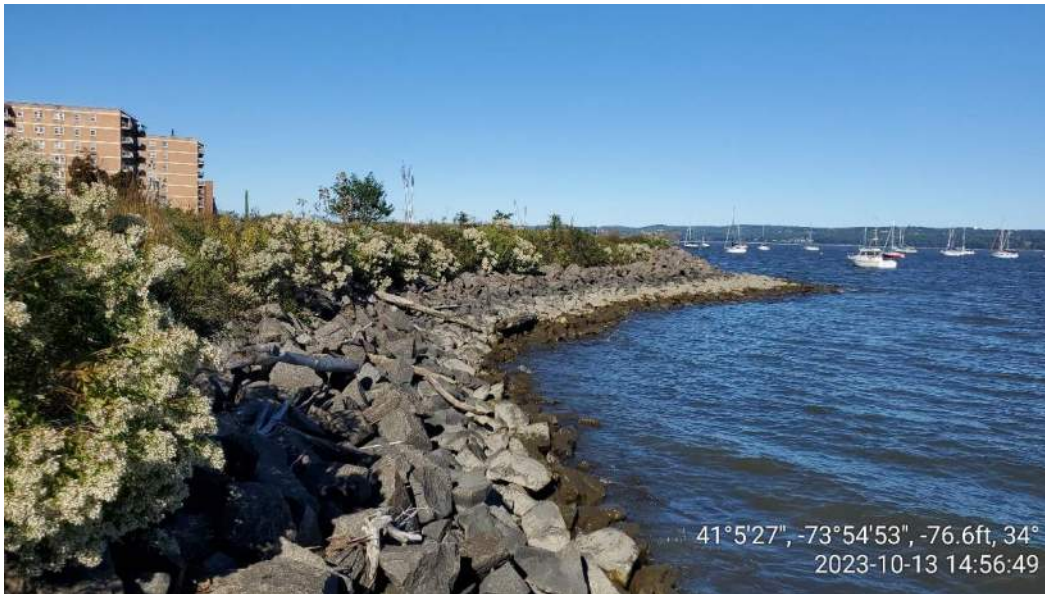
Photo No.: 9
Photographer: S. DiBartolo
Date: 10/13/2023
Direction: Northeast

Comments:
Lower Terrace and Riprap Slope

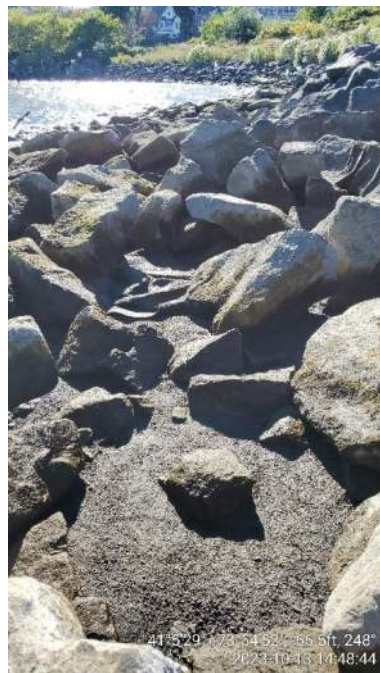
Photo No.: 10
Photographer: S. DiBartolo
Date: 10/13/2023
Direction: Southeast

Along the Lower Terrace shoreline, the ISS materials are protected from contact by site users and erosion by the installation of riprap above filter fabric during the remedial action, and by the placement of additional riprap at the shoreline by the Site Owner. Riprap areas were observed by GEI to be in good condition. Sediment has partially covered small portions of the riprap area, but evidence of movement or undermining was not observed anywhere in the riprap areas. Photographs of the shoreline are included in the Photographic Record in Appendix B.

Comments:
Riprap Slope at Hudson River at Low Tide

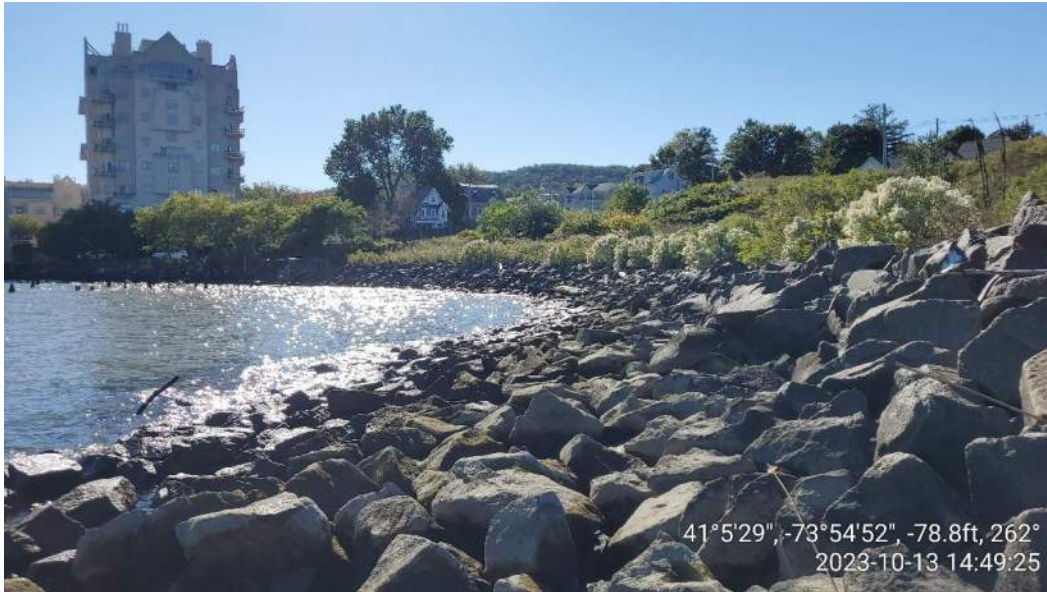
Photo No.: 11
Photographer: S. DiBartolo
Date: 10/13/2023
Direction: Southwest

Comments:
Riprap Slope at Hudson River
at Low Tide

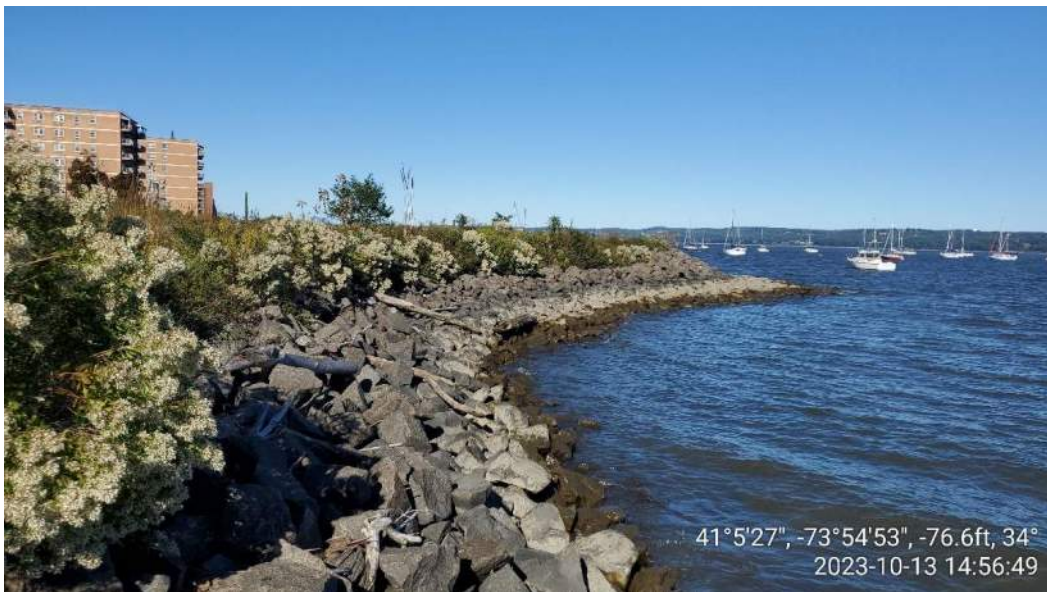
Photo No.: 12
Photographer: S. DiBartolo
Date: 10/13/2023
Direction: Northeast

Comments:
Riprap Slope at Hudson River
at Low Tide

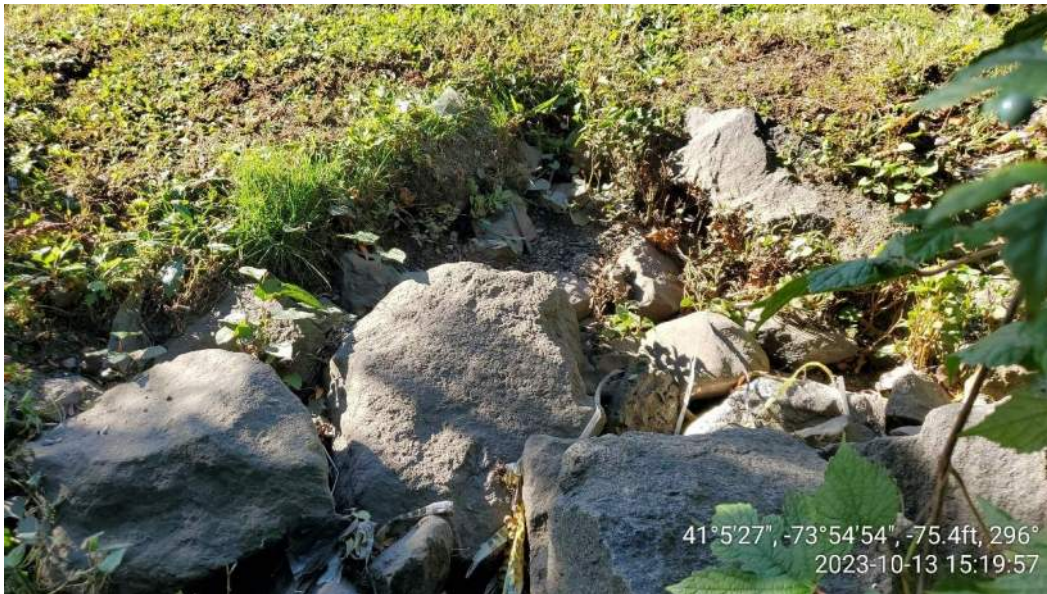
Photo No.: 13
Photographer: S. DiBartolo
Date: 10/13/2023
Direction: Northwest

These features were observed to be present, and not disturbed at the time of the October 13, 2023, site inspection. While some minor erosion continues to exist at the storm sewer outlet, it is localized and has not changed significantly from what was observed during prior events. A photograph of the storm sewer outlet is included in the Photographic Record in Appendix B.

Comments:
Stormwater CMP Outfall at
North end of Hudson Vista
Parking Lot

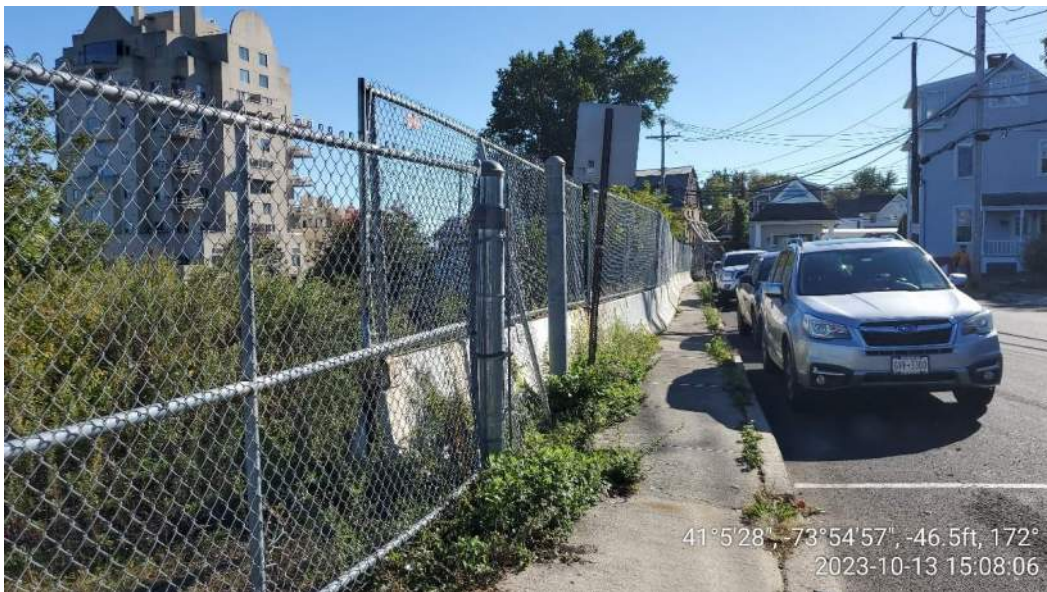
Photo No.: 14
Photographer: S. DiBartolo
Date: 10/13/2023
Direction: South

Comments:
Perimeter fence at Gedney
Street

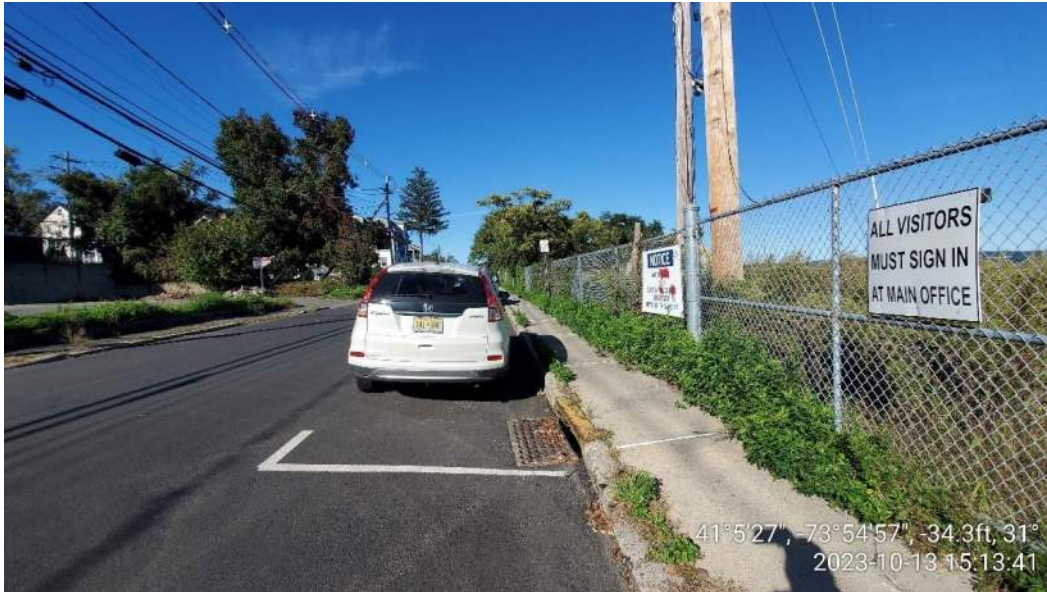
Photo No.: 15
Photographer: S. DiBartolo
Date: 10/13/2023
Direction: Northeast

Comments:
Perimeter fence at Gedney Street

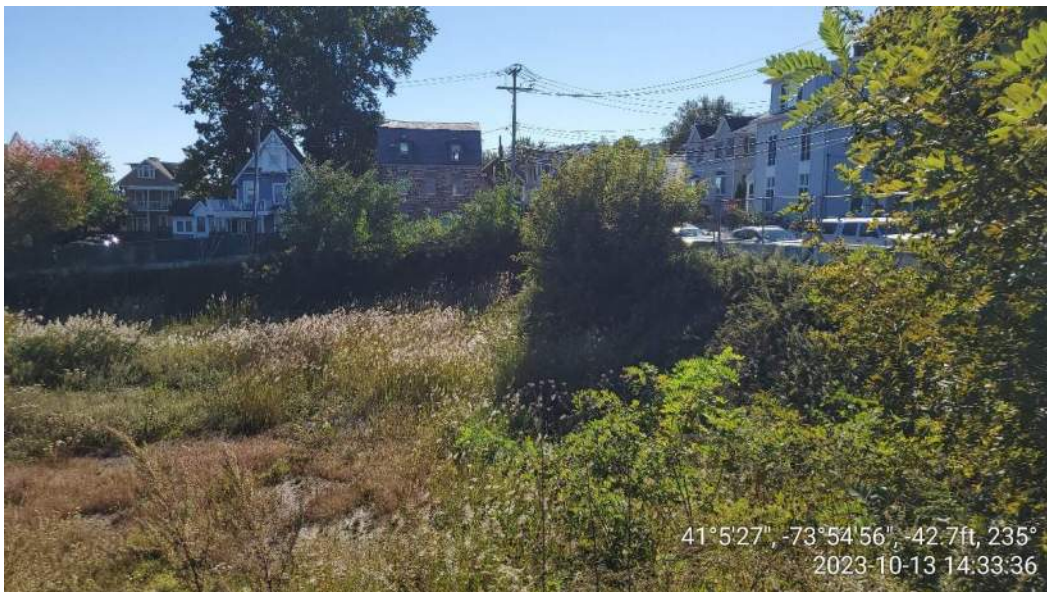
Photo No.: 16
Photographer: S. DiBartolo
Date: 10/13/2023
Direction: Southwest

Comments:
Perimeter fence at Main Street (upper left side of photo) and Gedney Street (upper right side of photo)

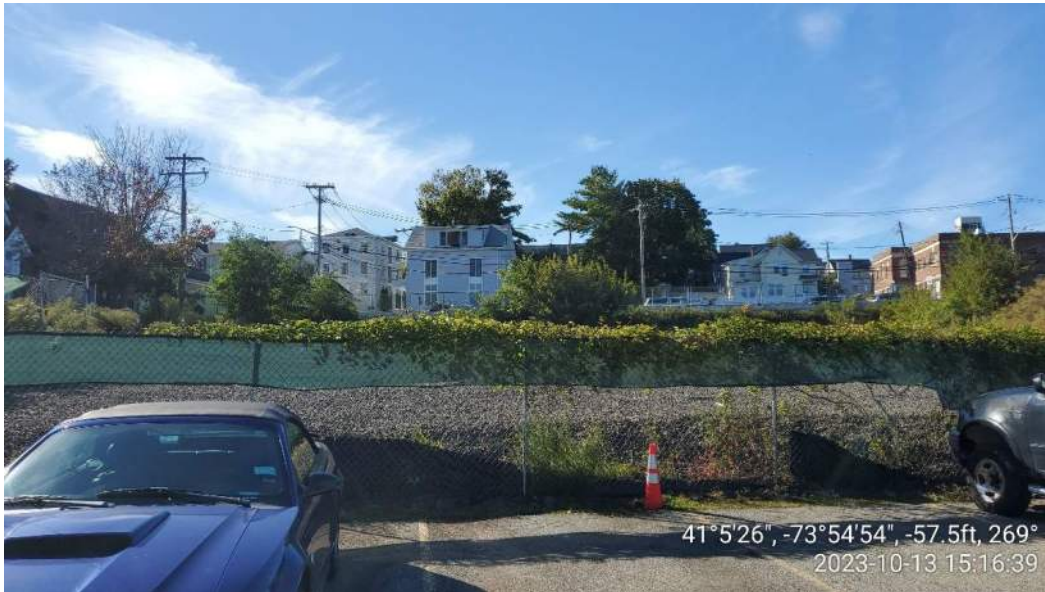
Photo No.: 17
Photographer: S. DiBartolo
Date: 10/13/2023
Direction: Southwest

Comments:
Perimeter fence at Hudson
Vista Associates Parcel lower
parking lot.

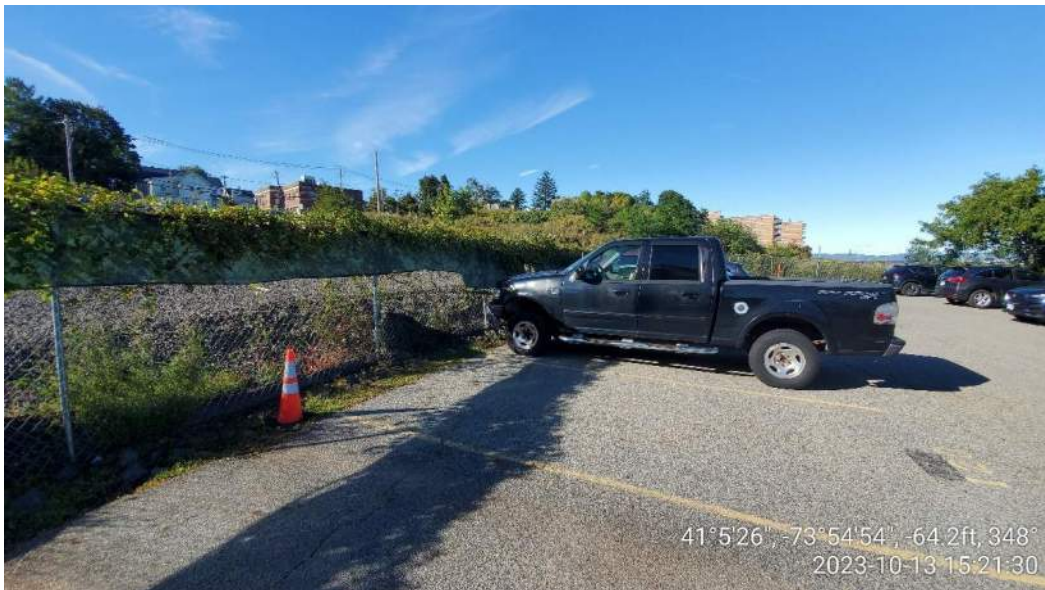
Photo No.: 18
Photographer: S. DiBartolo
Date: 10/13/2023
Direction: North

Comments:
Perimeter fence at Hudson
Vista Associates Parcel lower
parking lot.

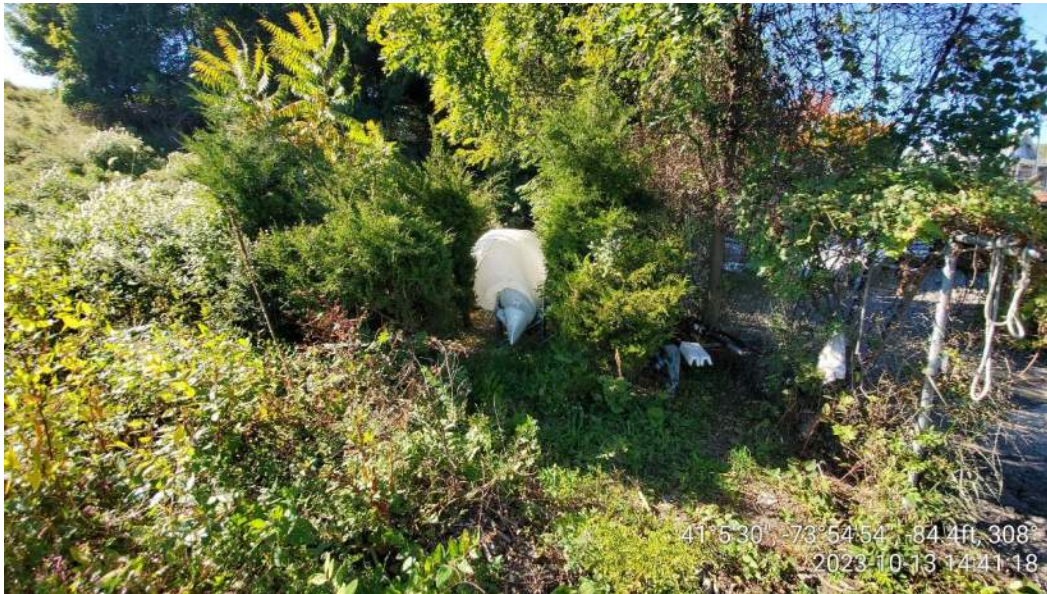
Photo No.: 19
Photographer: S. DiBartolo
Date: 10/13/2023
Direction: West

Comments:
Storage of boating equipment on Property. North perimeter fence does not extend onto the riprap slope and the site can be accessed from adjacent boat club to the north.

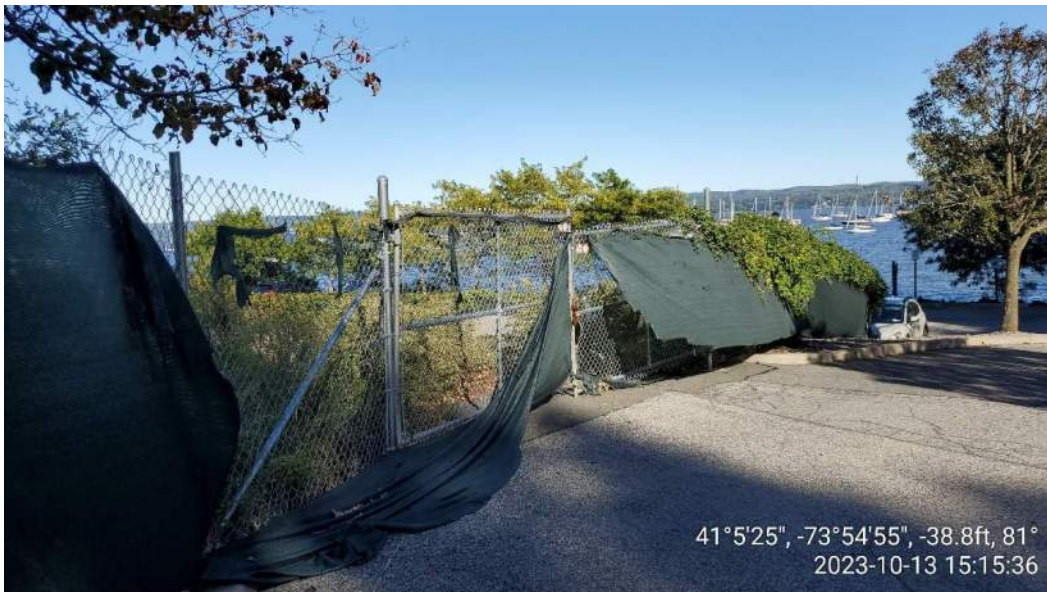
Photo No.: 20
Photographer: S. DiBartolo
Date: 10/13/2023
Direction: Northeast

Comments:
Perimeter fence at Hudson Vista Associates Parcel at east end of Main Street. Screening fabric ripped and not secured.
