Intended for  
**Orange & Rockland Utilities, Inc.**

Date  
**November 20, 2020**

**CONSTRUCTION COMPLETION REPORT**  
**OR - HAVERSTRAW CLOVE & MAPLE FORMER**  
**MGP, OPERABLE UNIT 1**  
**ROCKLAND, NEW YORK**  
**NYSDEC SITE NUMBER: 3-44-049**

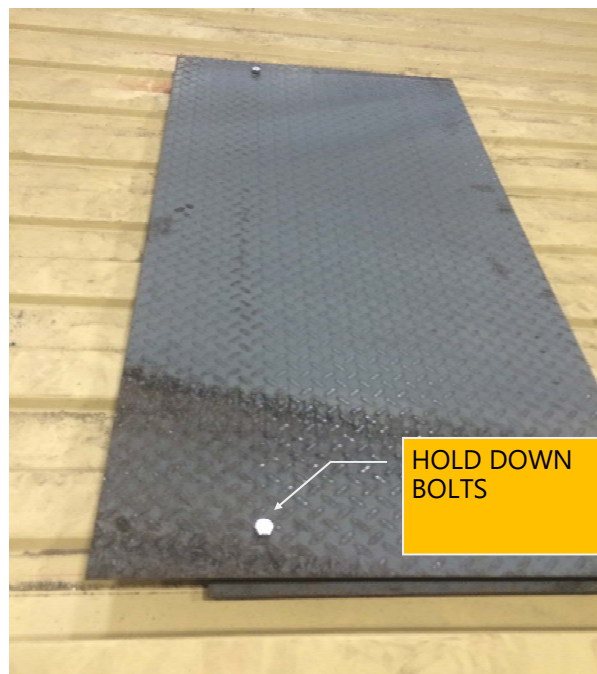
*BED ACCESS AND VENT IN TRANSPORT POSITION*

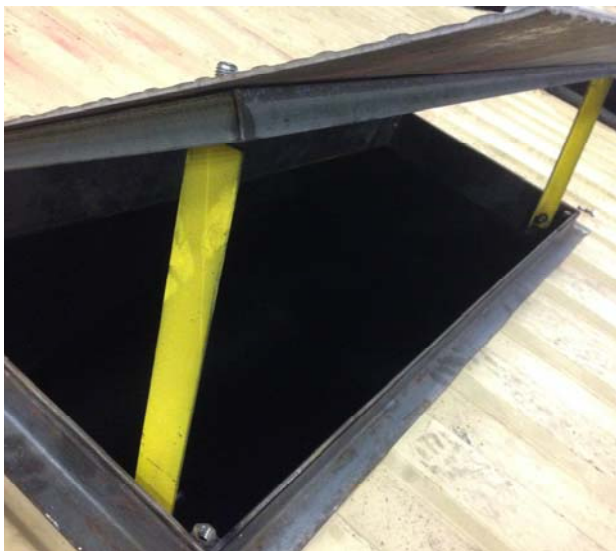
*VENT HATCH IN OPERATIONAL POSITION*

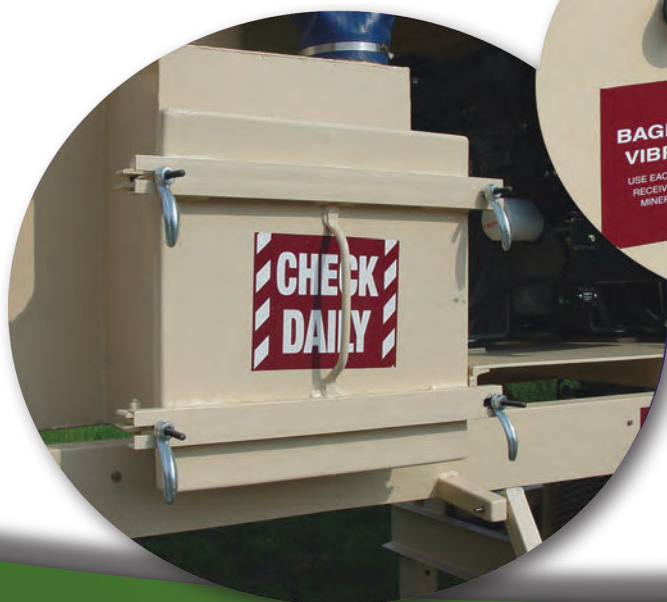
## Baghouse Vibrator

The baghouse dust collection system comes with a 12-volt vibrator which is accessible at the engine area. This vibrator is used to clean the filtration bags and is activated with the simple push of a button.

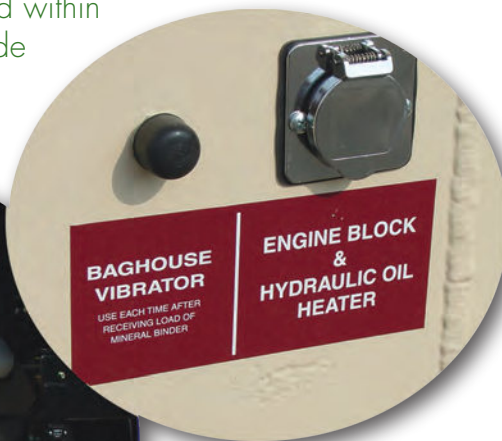
## Dust-Free System

The HS 50T includes four closure points on the baghouse dust collector and three on the product inspection hatch for dust-free transfer of product from pneumatic tankers.

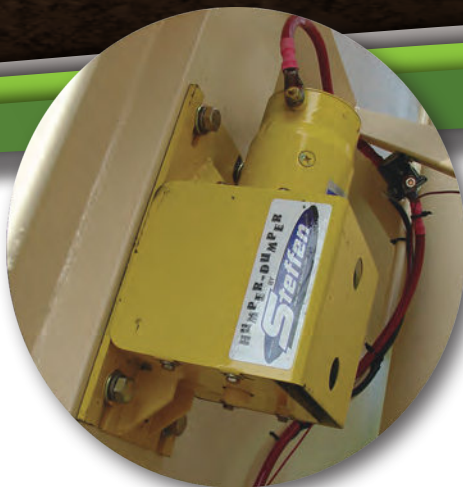
### Bin Vibrator

The HS 50T is supplied with a Bin Vibrator which is used to move product toward discharge augers when product level is low in bin. Without this vibrator, fast and efficient offloading is impossible.

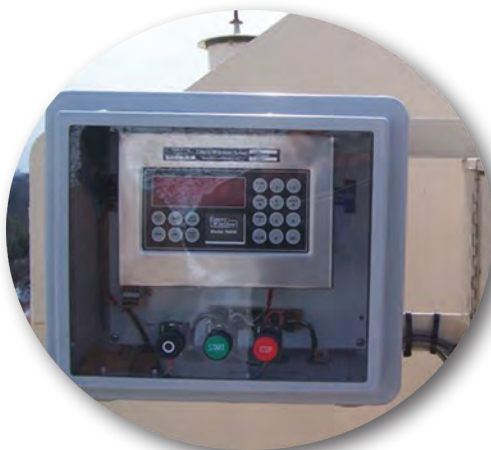
### Electronic Scale

An electronic scale with digital display is supplied with the unit. Scale is used to accurately meter bulk cement product into the slurry mixture and is also useful in determining when product is to be ordered.

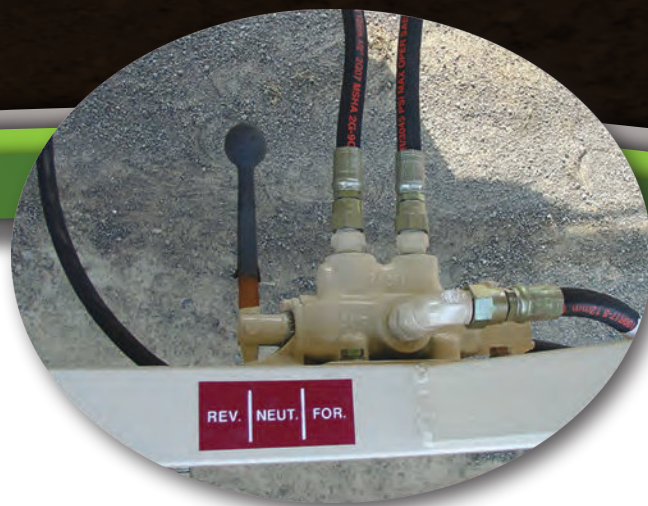
### Reversible Augers

The horizontal and diagonal augers are supplied with individual hydraulic directional control valves which allow operator to easily run in reverse when necessary.

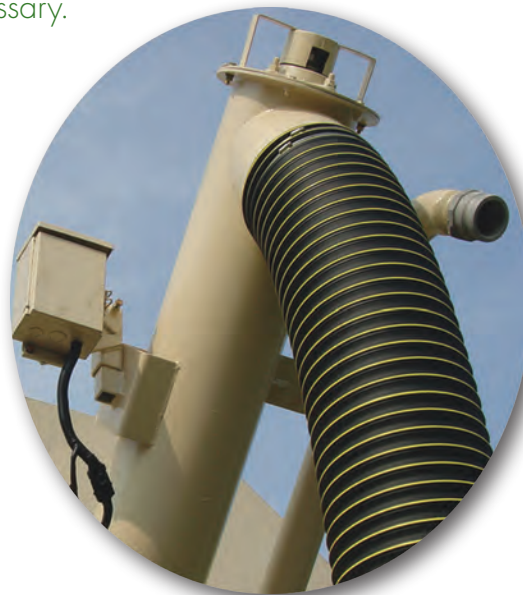
### Heavy Duty Discharge Hose

A 10" heavy duty discharge hose is provided with double clamps to ensure that it stays securely in place while dispensing product.

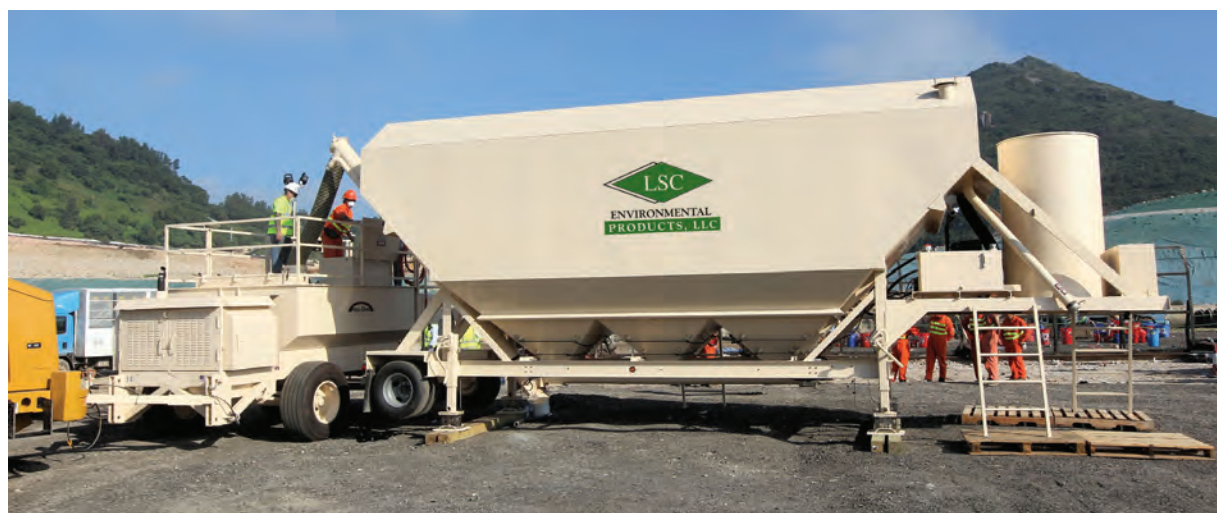
Horizontal Storage Silo  
Model # HS 50T

Horizontal silo loading powdered product into a Posi-Shell Applicator.

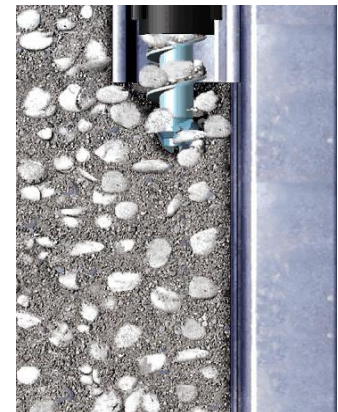
When soil conditions become too difficult or not applicable to the water cutting system, Blue Iron is capable of using the Crush System in conjunction with the Press-In Method. This system uses an integrated simultaneous auger which sits inside the pan of the sheet pile and augers at the pile is being pressed into the ground. This method is ideal when pressing sheets into soils with dense gravels, cobbles, boulders and in some cases bedrock.

The Auger is advanced at the same rate the sheet pile is pressed into the ground. This minimizes the stresses of hard driving to the pile and minimizes damages from occurring to the sheet pile as a result of the hard driving. The auger head is slightly advanced from the toe of the sheet pile and has an over-reaming head to ensure the sheet pile does not encounter an obstruction. The heads can be modified for the soil conditions and pile type. Once the sheet pile has been installed to the full depth, the auger is reversed and extracted using a special chuck attachment designed specifically for the auger. The spoils generated are typically left in place.

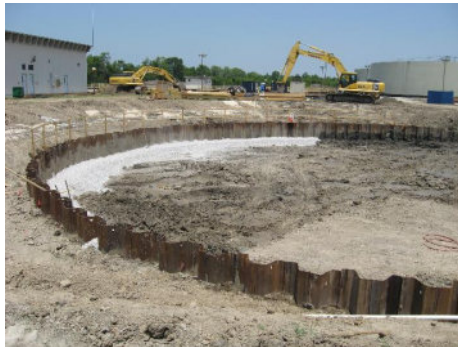
## GIKEN Pile LASER and Tolerance

The Silent Piler grips the lowest point of the sheet pile possible, and can position piles 180 degrees, Blue Iron does not need to utilize a template to maintain a very high degree of tolerance while driving the sheet piles. Blue Iron uses a

small Laser system as a reference point based on survey alignment of the pile wall. This allows the sheet piles to be installed very quickly, without false work setting and aligning a template system, while still maintaining a tolerance typically within ½ in. Actual production days are increased since the falsework is minimized. The Pile Laser is typically set up within 5 minutes and can be repositioned while piling operations are ongoing such that no downtime is experienced on site. This also allows the Silent Piler to drive piles in curves, as well as corners and angles.

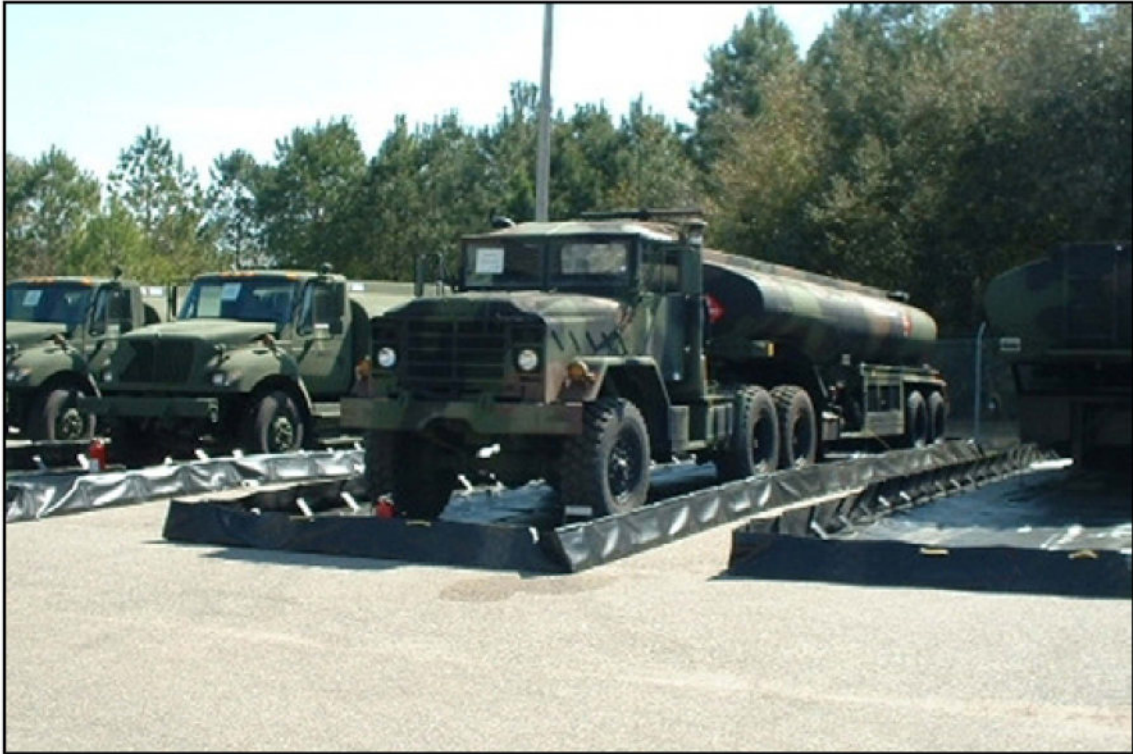
*Portable secondary containment berms*

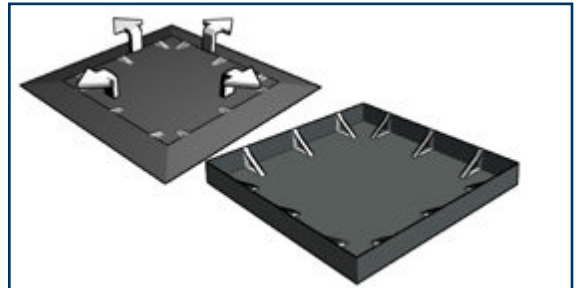
## Pop Up Berm

For the InstaBerm, pull all four sidewalls of the spill berm outward so that they are standing upright. Straighten the top angles of the wall supports inside the berm. The walls will move further outward as the berm is filled.
