PHASE I ENVIRONMENTAL SITE ASSESSMENT REPORT

STIERLEN & BRAM PROPERTIES ROUTE 9W NORTH CONGERS, NEW YORK

TEAM ENVIRONMENTAL CONSULTANTS, INC. 33 FULTON STREET MIDDLETOWN, NEW YORK (914) 344-0051

OCTOBER 29, 1998

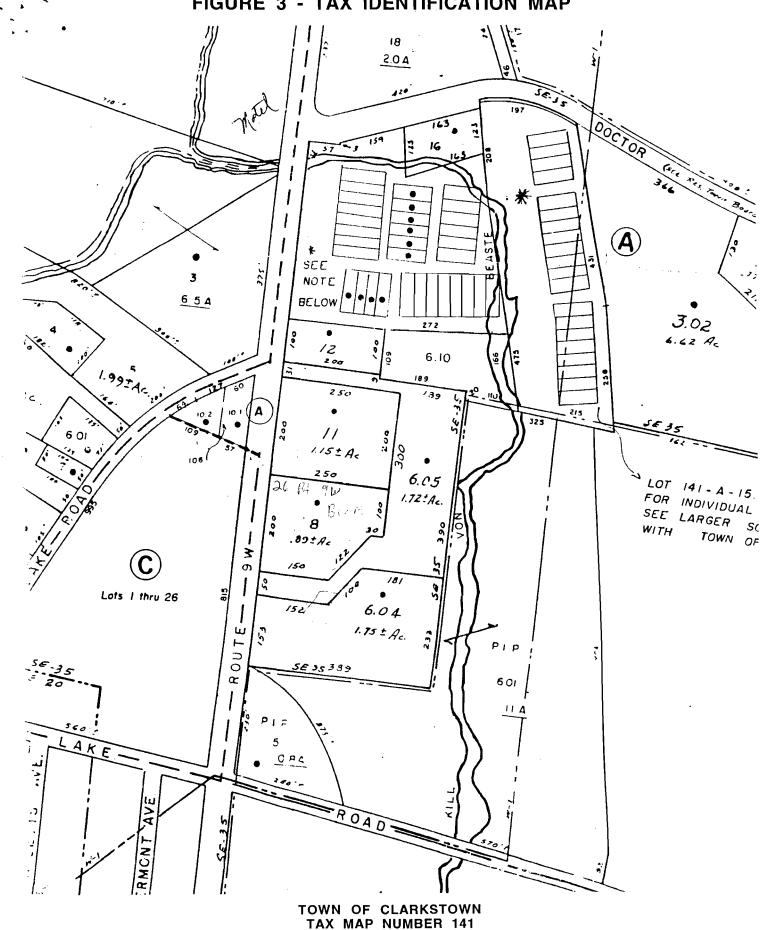
FIGURE 3 - TAX IDENTIFICATION MAP

A description of the three subject parcels is as follows. No documentation detailing date(s) of facility construction and or performance of historic site renovation efforts was available for TEAM review. A Town of Clarkstown Tax Map which identifies the subject parcel locations is presented as Figure 3.

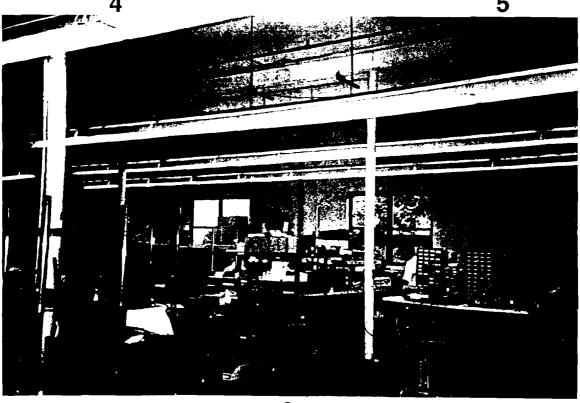
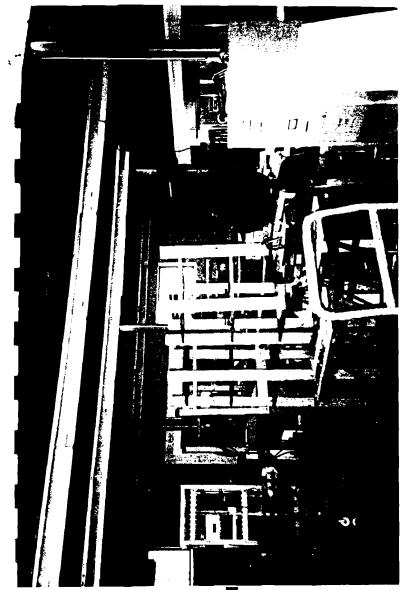
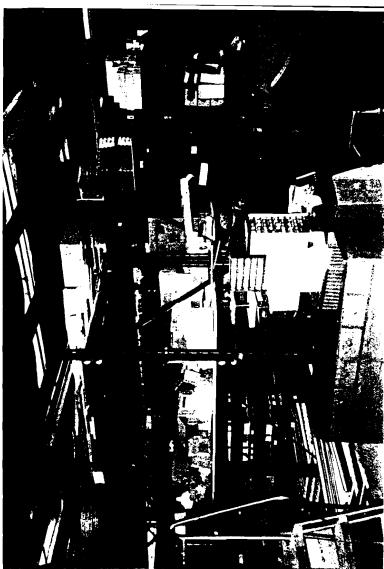
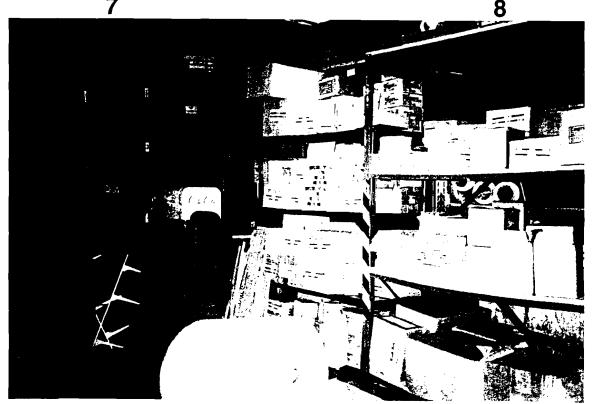
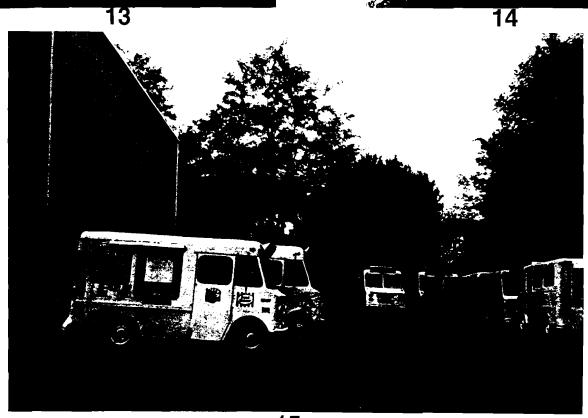
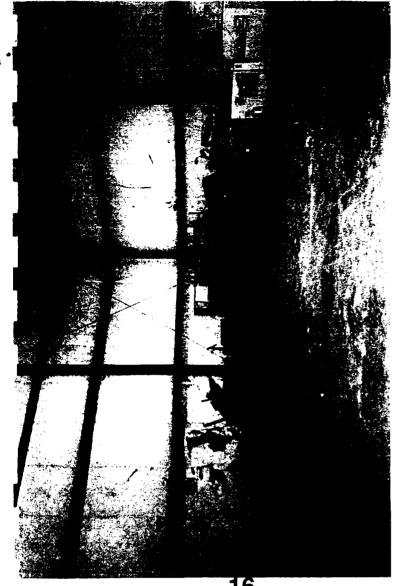
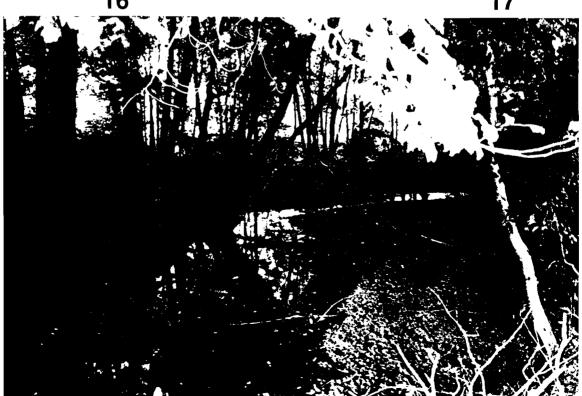
12	Eastern view along northern side of 30,000-ft ² warehouse.
13	Southern view along eastern side of 30,000-ft ² warehouse.
14	Warehouse structure (currently leased to Nyack Ice Cream) located within Lot 6.10.
15	Nyack Ice Cream vehicle parking area located along eastern side of warehouse structure.
16	Interior view within Nyack Ice Cream warehouse.
17	Fifty-five gallon drums located within Nyack Ice Cream warehouse facility.
18	Surface stream (Kill Von Beaste) located along eastern property border.
19	Eastern view towards 16 Route 9W building as seen from across Route 9W.
20	Former water supply well located within stairway along southern side of 26 Route 9W North structure.
21	Former underground storage tank location along southern side of 16 Route 9W facility.
