Prepared for:
Superfund Standby Program
New York State
Department of Environmental Conservation
625 Broadway
Albany, NY 12233

Prepared by:
AECOM
Latham, NY
60302031
January 2018

Beaver Smelting Site
Fallsburg, NY
Periodic Review Report
December 31, 2014 to December 31, 2017
NYSDEC Site Number: 3-53-005

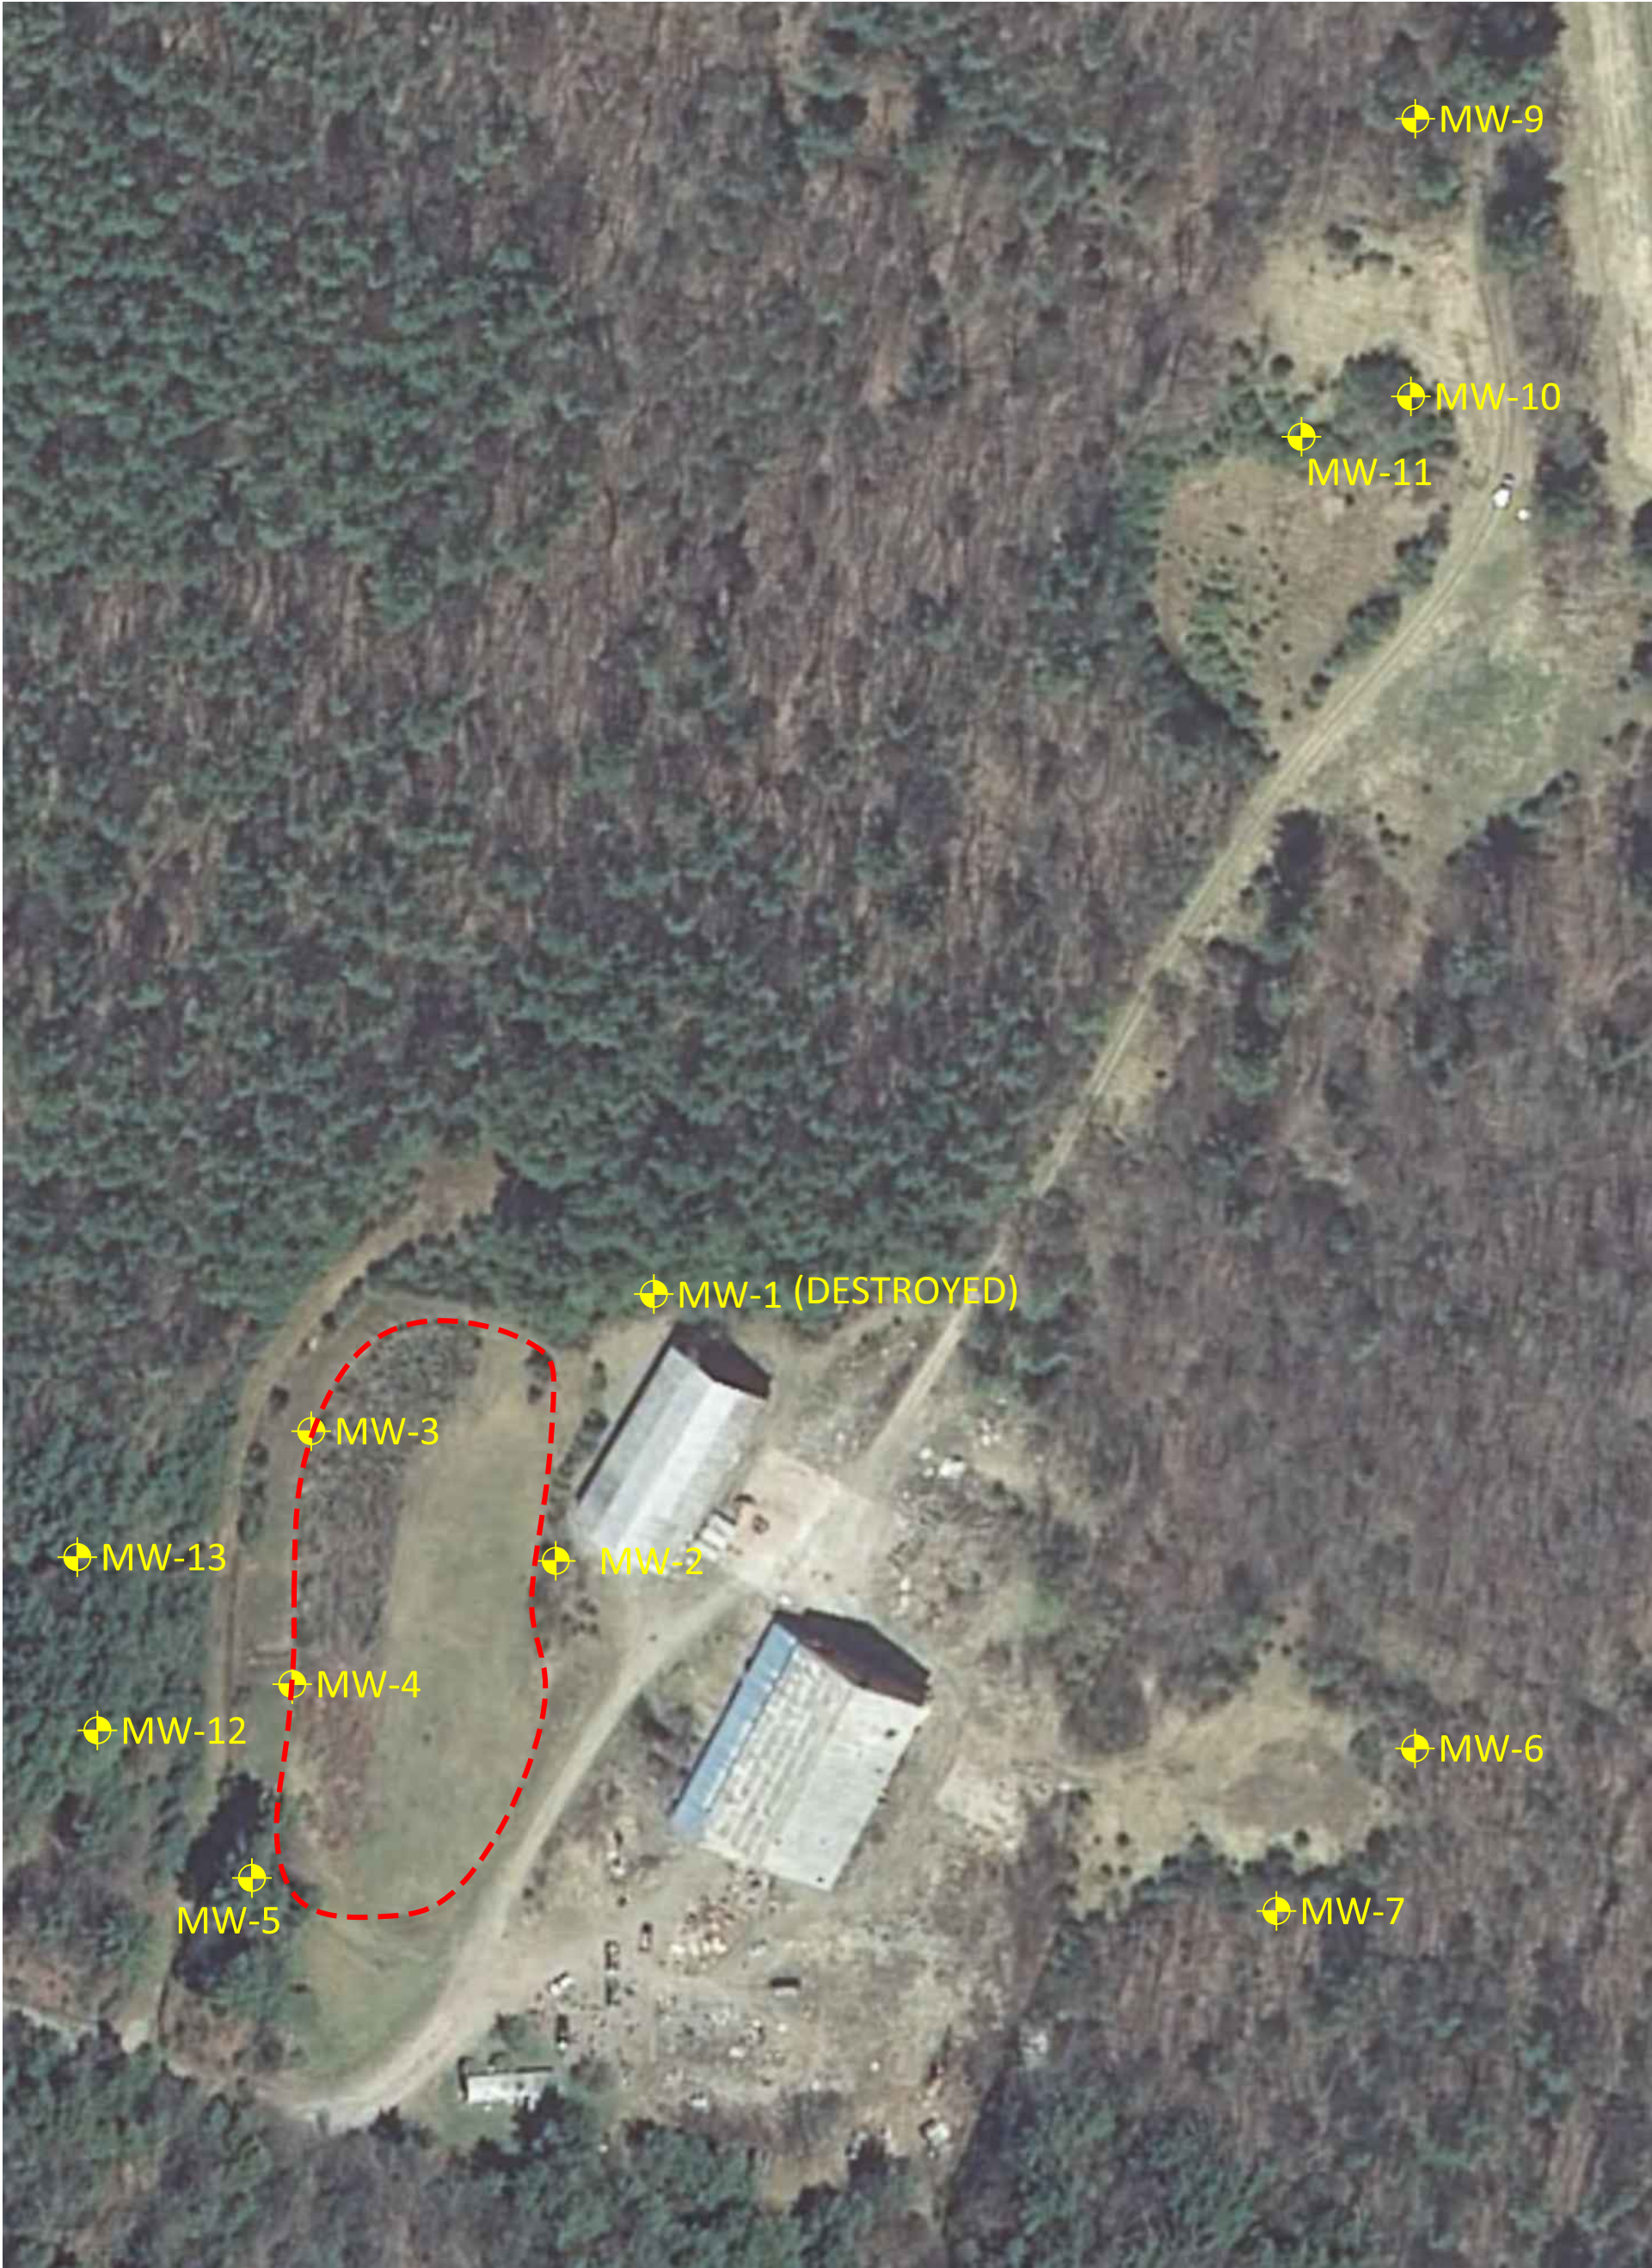
FILE NAME:	DRN	PROJECT NO.	DATE	FIGURE NO.
2016 Beaver.dwg	RNB	60302031.2	11/2016	2

Figure 2: Location of Monitoring Wells

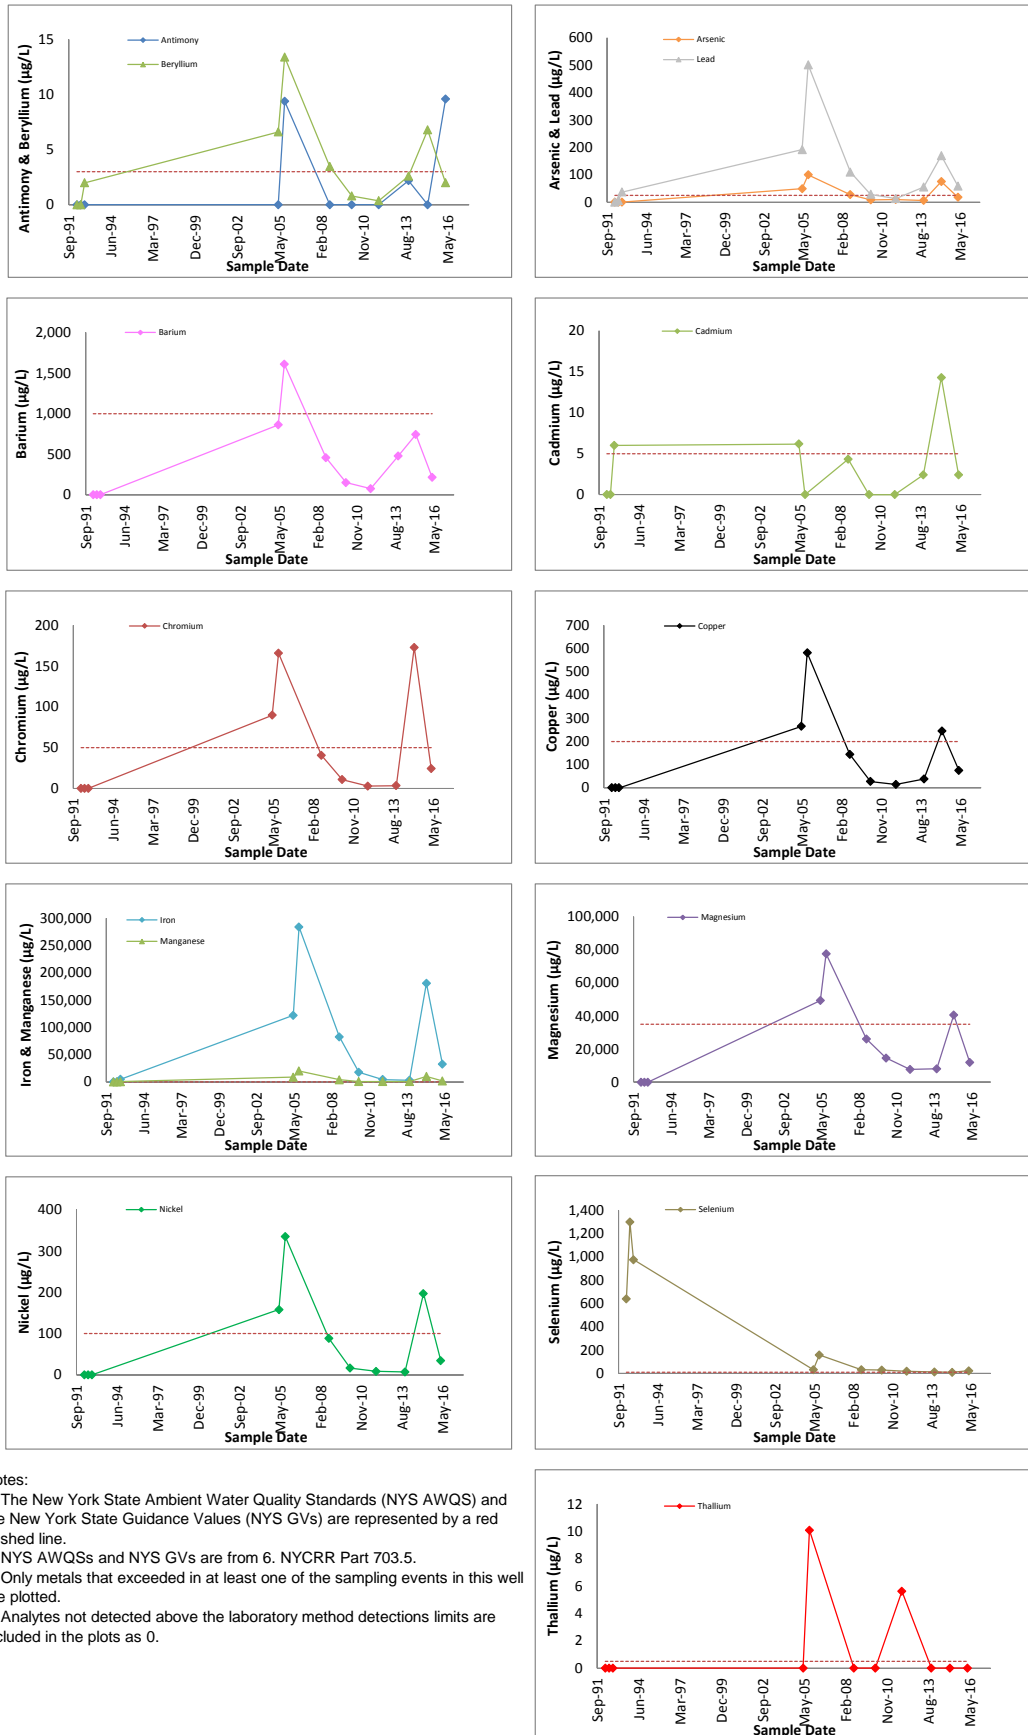
- Antimony was detected in site groundwater at an estimated concentration of 9.6 µg/L, exceeding the AWQS Guidance Value of 3 µg/L at one monitoring well (MW-10). Antimony was below the method detection limit for all other Site wells; however, it should be noted that the laboratory limits exceeded the Guidance Value.

Figure 10
Analytical Results for Total (Unfiltered) Metals Exceeding NYS AWQS or Guidance Values in Monitoring Well MW-10
Beaver Smelting Site
Fallsburg, New York

1. The New York State Ambient Water Quality Standards (NYS AWQS) and the New York State Guidance Values (NYS GVs) are represented by a red dashed line.
2. NYS AWQSs and NYS GVs are from 6. NYCRR Part 703.5.
3. Only metals that exceeded in at least one of the sampling events in this well are plotted.
4. Analytes not detected above the laboratory method detections limits are included in the plots as 0.

Concentrations of metals are generally consistent with previous sample results (see Figures 3 through 13 and Table 1); however, for several analytes in some of the monitoring wells, a peak is observed from the 2015 sampling event. These peaks are likely attributed to higher turbidity of the samples collected in 2015. Iron, lead, and manganese are found widely distributed in the monitoring wells at concentrations exceeding the respective New York State AWQS (TOGS 1.1.1). Detections of iron ranged from 20 to 559,000 µg/L in 2015 and 100 to 32,600 µg/L in 2016. The AWQS of 300 µg/L was exceeded at all sampled wells with the exception of MW-13 in 2015 and MW-2, MW-5, and MW-13 in 2016. Detections of lead ranged from 2.4 to 1,280 µg/L in 2015 and from 1.9 to 224 µg/L in 2016. In 2015, the AWQS for lead, 25 µg/L, was exceeded in all wells with the exception of MW-3, MW-5, MW-

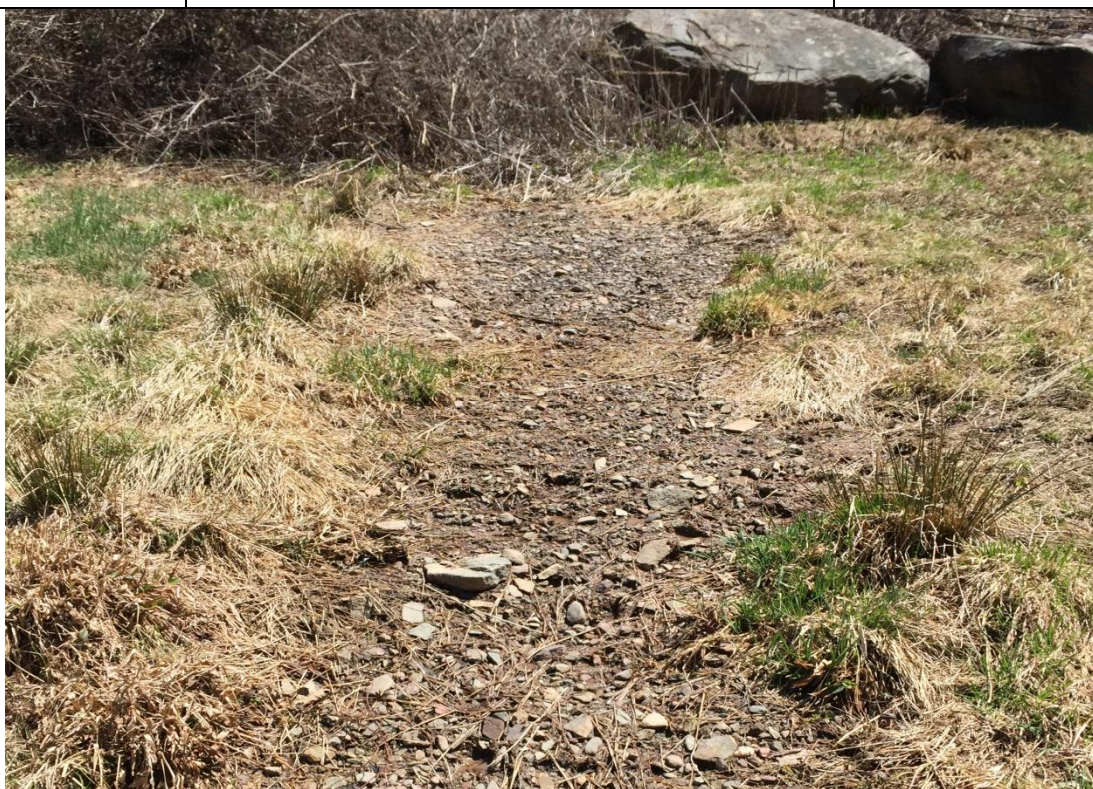
No issues were found with the monitoring well network. All wells were found to be in good condition. A previously identified seep was observed to still be active on the west side of the landfill, although the cover is remaining stable in the area of the seep, and it has not changed since prior site inspections.

Description: Location of seep along western slope of landfill

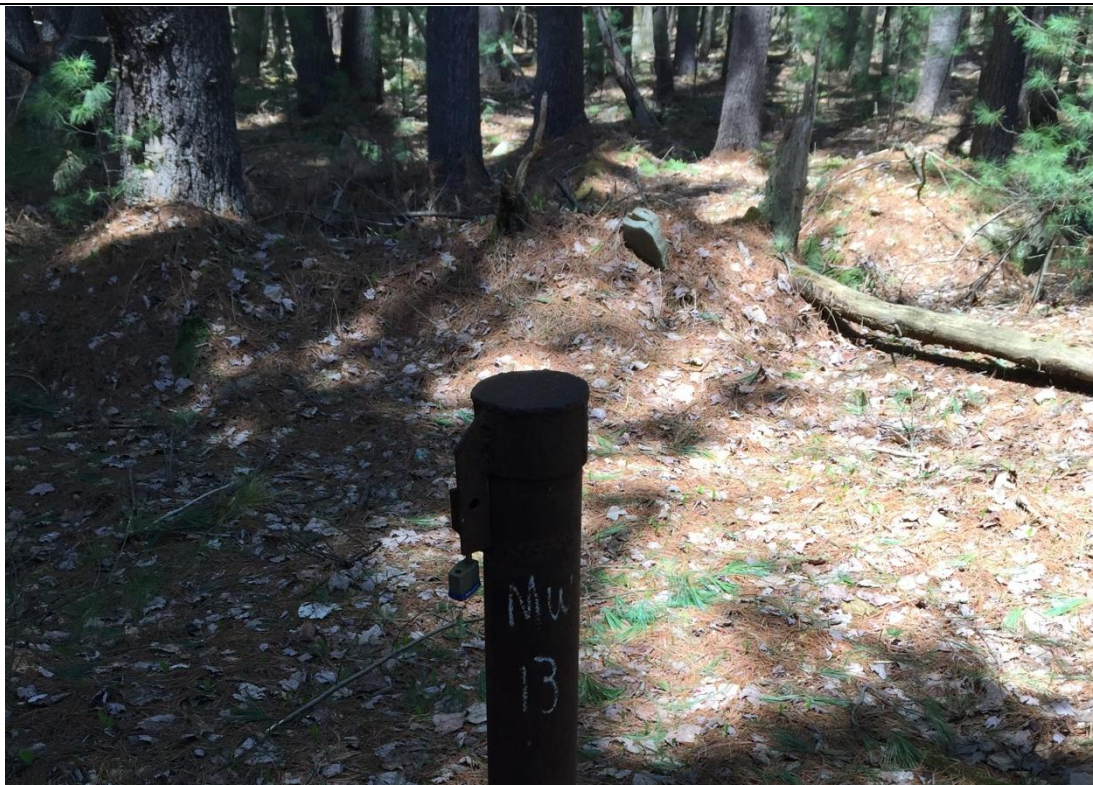
Monitoring well MW-13

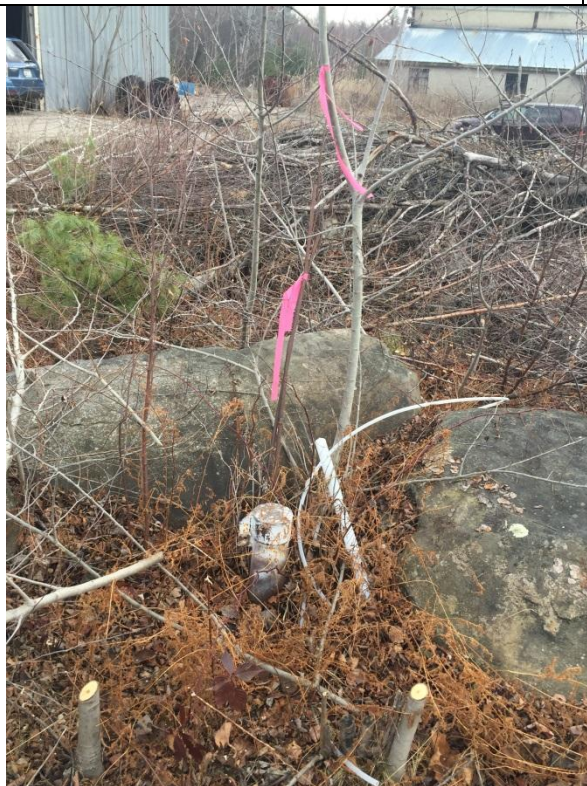
Monitoring Well MW-2

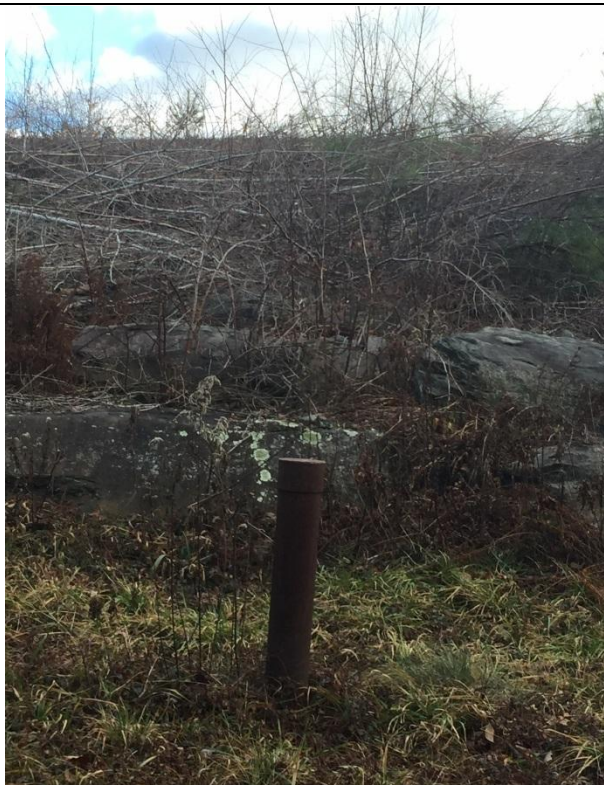
Monitoring Well MW-4

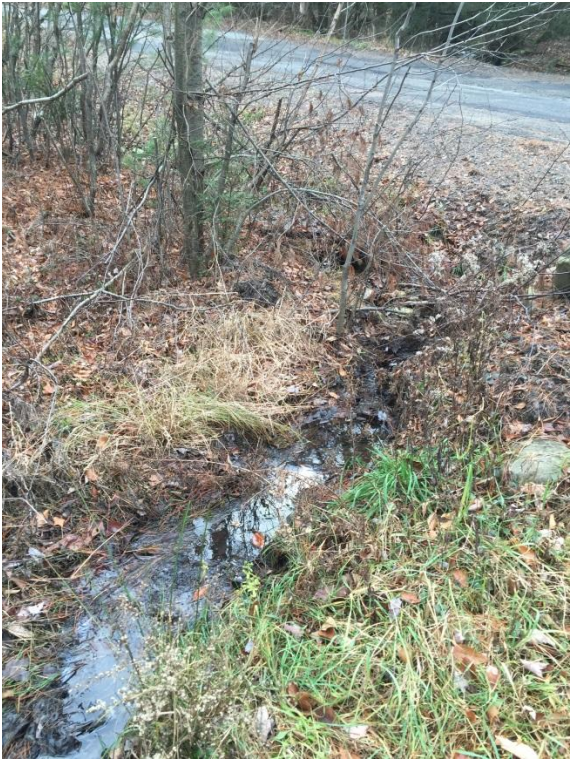
Direction Photo Taken: Facing south			
Description: Ponded area south of the landfill, adjacent to Beaver Lane

- Monitoring sediment and surface water in ponded areas, drainage ditch, and seep on a five-quarter basis, through sampling and estimating water flow. Note that no sediment or surface water samples were collected during the reporting period of this PRR due to the lack of sufficient standing water at the times personnel were on the site. Per the site PRR for the previous reporting period, the dissolved fraction will be analyzed for all surface water samples. It is recommended that this sampling be completed during the next site inspection planned for spring 2018.

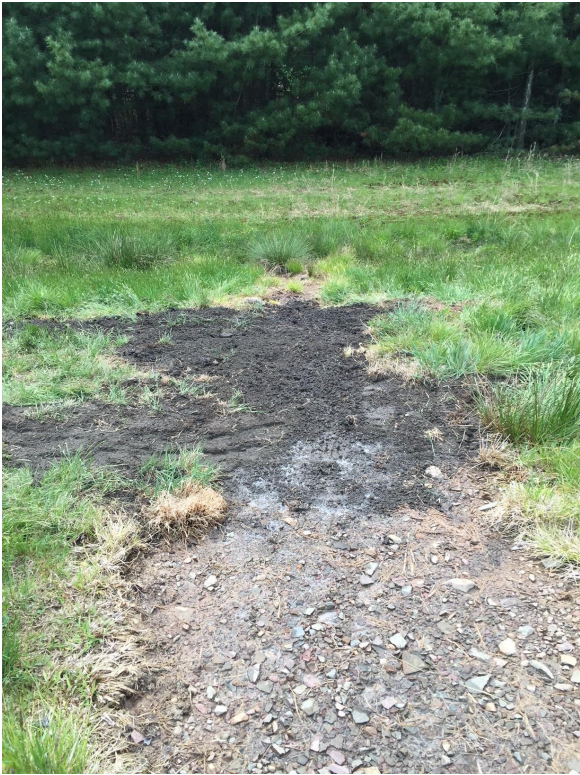
Direction Photo Taken: Facing west				
Description: Toe of west slope of landfill, in the area of the seep. Photo shows area of tire ruts lefts during the sampling the previous month after filling in.
