Dyno Nobel Site Port Ewen, New York

Prepared for: Hercules Incorporated and Dyno Nobel, Inc.

June 2017

Historical Soil Investigation Summary Report Prepared by: EHS Support, LLC

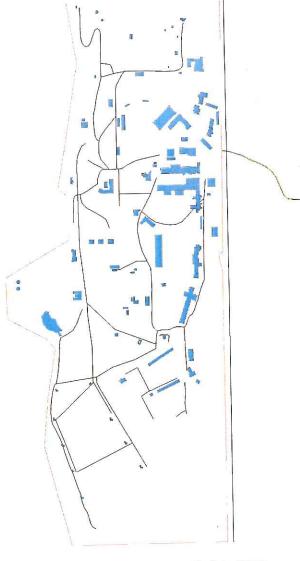
Figure 4-6 **Timeline** 1970-1980

SITE DEVELOPMENT CA 1970

SITE DEVELOPMENT CA 1980

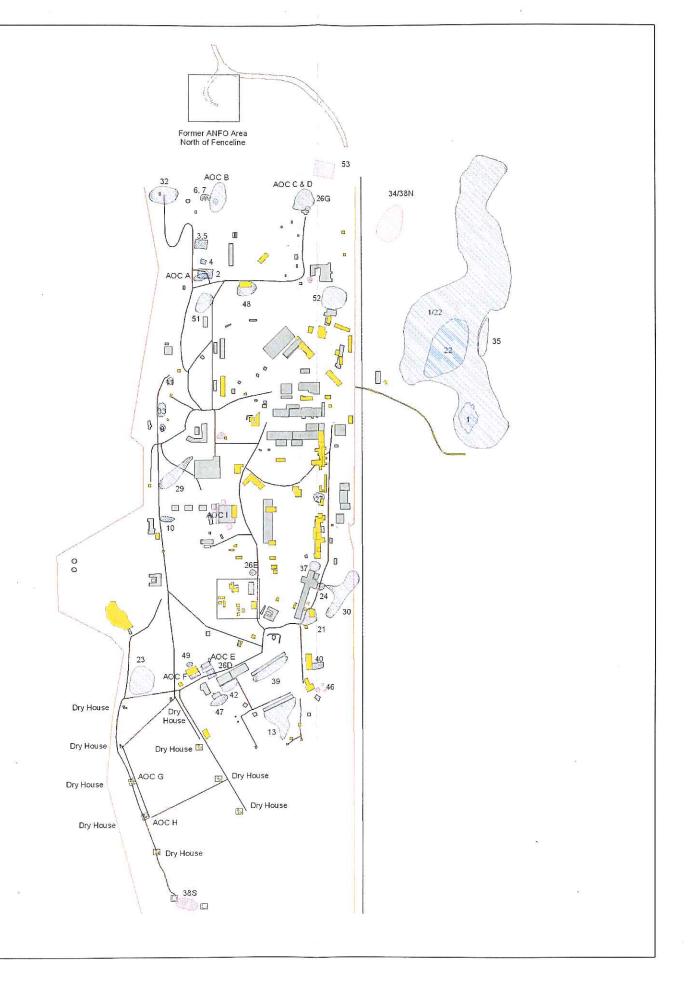
Figure 4-10 Historical Site Summary Map

WMU N	<u>o.</u>	SWMU Name		
	1	Shooting Pond		
	2	Burning Cage/Incinerator		
	3	Copper Wire Burning Area		
	4	Iron Wire Burning Area		
	5	Wire Burning Area III		
	6-7	Open Burning Pads		
	8	Former Burning Area		
	9	Waste Powder Catch Basins - Building 2037		
	10	Waste Powder Catch Basins - Building 2048		
	11	Waste Powder Catch Basins - Building 2049		
	13	Former Waste Powder Catch Basins – Lead Azide Building		
	21	Lead Recycling Unit Area		
	22	Former Landfill		
	23	Former Dump		
	24	Former Wastewater Treatment Facility		
260	D,E & G	Burnable Waste Satellite Accumulation Areas (3 locations)		
	29	Drainage ditch (Downgrade of Building 2049)		
	30	Drainage ditch (Downgrade of Building 2036)		
	32	Old Dump (near water tower)		
	33	Mercury Fulminate Tanks Area		
	35	Stone Fence Dump		
	37	Former Shell Plant Drum Storage Area		
	39	Former Wastewater Discharge Area – Building 2009		
	40	Pilot Line Condensate Collection Sump

42	SAC Building Steam Collection Containers		
	46	Vacuum Line Condensate Collection Sump – Building 2059		
	47	Building 2058 Fuse Room		
	48	Mercury Fulminate Area		
	49	Building 2073 Sump		
	50	Building 2075 Sump		
	51	Construction Stockpiles		
	52 53	Former Commercial Lab Shooting Area Package Test Burn Area		
		, asiago 160, sum nos		
<u>oc</u>		AOC Name		
	Α	Kerosene Tank Leak	F Burn Waste Sat. Acc Area	
	В	Open Burning Pads Area	G Former Drying House	
	С	Open Detonation Pit	H Former Drying House	
	D	Detonation Test Building	I Deto Products Building	
	E	Former Building 2073
