Re: IBM Kingston Facility, Part 373 Permit No. 3-5154-00067/00090  
Inactive West Demolition Debris Fill Area, SWMU AF

The purpose of this letter is to transmit the results of the investigation at the Inactive West Debris Fill Area Solid Waste Management Unit (SWMU) AF, located at the referenced facility. This investigation was conducted at Mr. Gary Casper's request based on his meeting with Mr. Dean Chartrand and Ms. Michele West of IBM on March 16, 2000. This report presents a brief review of the identification of the unit, a description of the unit, a brief discussion of the regulatory history of the unit, and results of the investigative field activities.

**SWMU Assessment Report  
Inactive West Demolition Debris Fill Area**

**Attachment B**  
**Site Photographs**

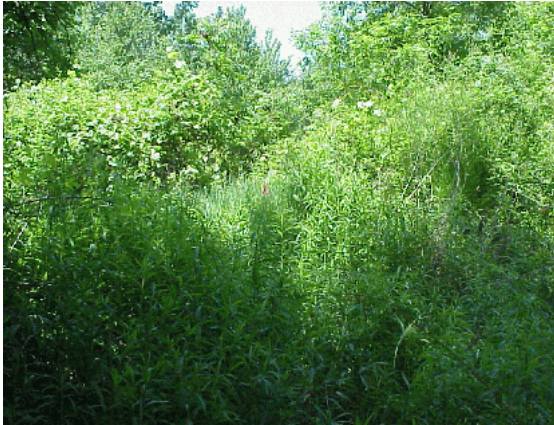
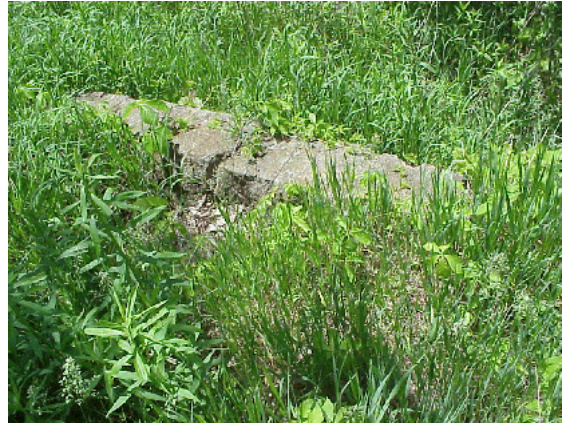
## *Soil Pile 1*

*Pre Excavation conditions at Soil Pile 1, May 26, 2000. Photo on right shows concrete blocks which lie to the west of the soil piles.*

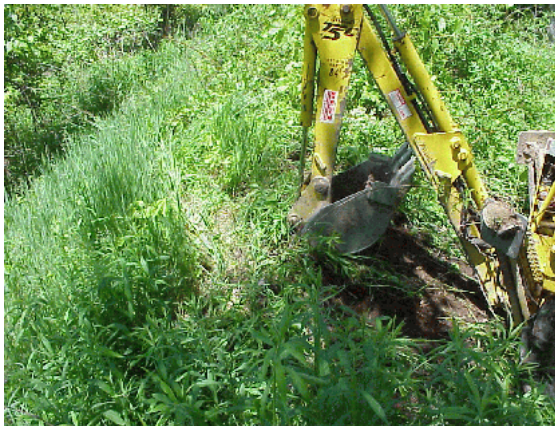
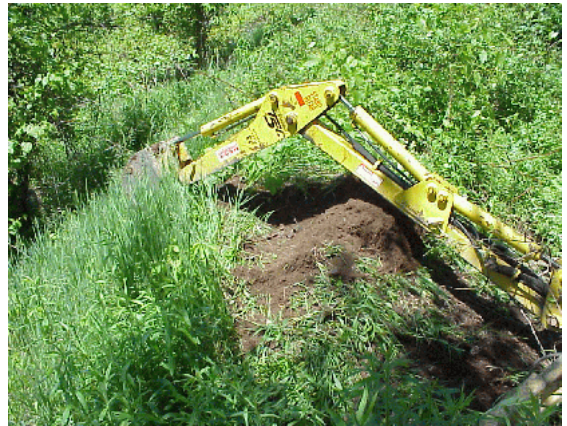
*Excavation activities at Soil Pile 1.*

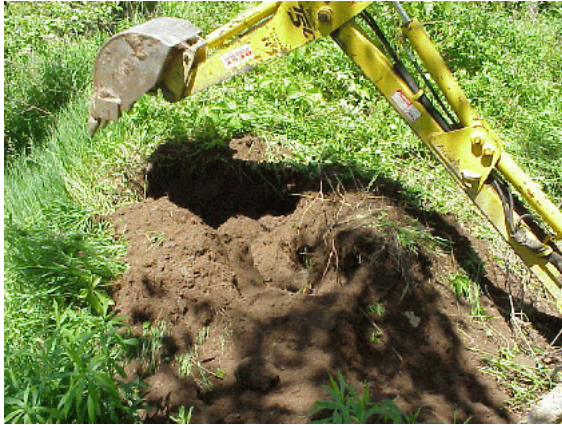
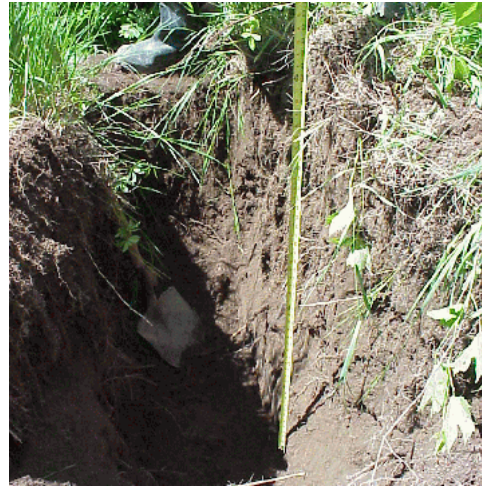
***Soil Pile 1*** (continued)

*Excavation activities. Photo on right shows limits of excavation, native soil at 5 feet below ground surface.*

| <u>Depth</u> | <u>Jar Headspace</u> | <u>Description</u> |
|---|---|---|
| 5 - 6.5 ft. | 0 ppm | Yellow-brown fine sandy silt and silty fine sand (native soil at 5 feet). |

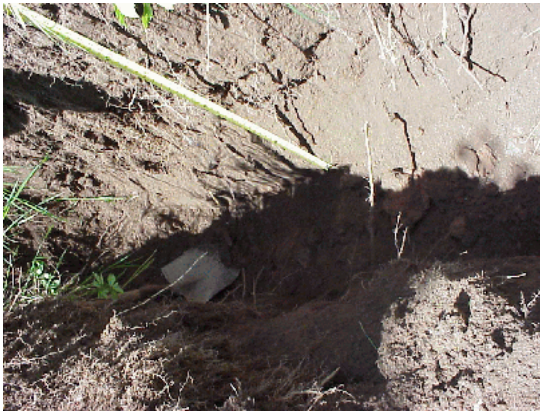
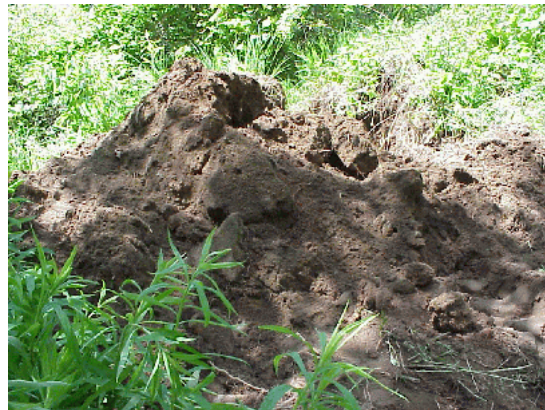
*Limits of excavation (left photo). The photo on the right shows the soil pile 1 contents.*

| <u>Depth</u> | <u>Jar Headspace</u> | <u>Description</u> |
|---|---|---|
| 0 - 2.5 ft. | 0 ppm | Dark brown f-m sand, somewhat compact. |
| 2.5- 4.5 ft | 0 ppm | same as above, slightly moist at 4.5 feet. |

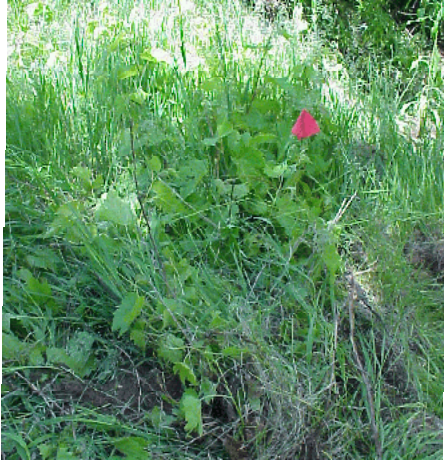
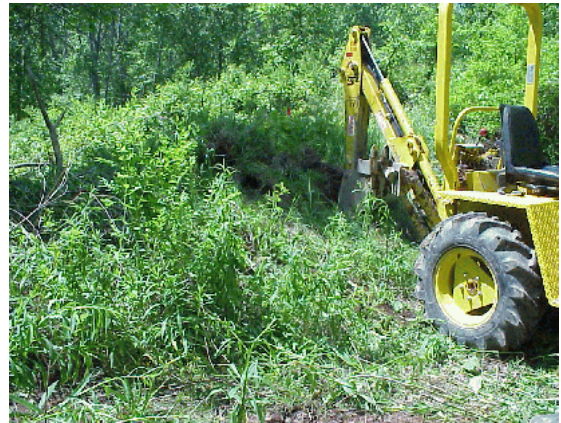
## *Soil Pile 2*

*Pre excavation (left photo) Soil Pile 2. Excavation preparations (right photo).*

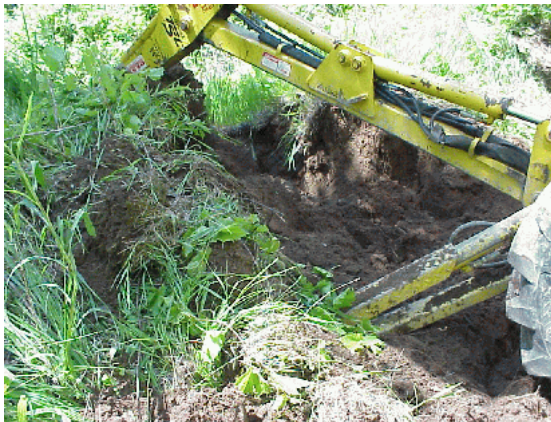
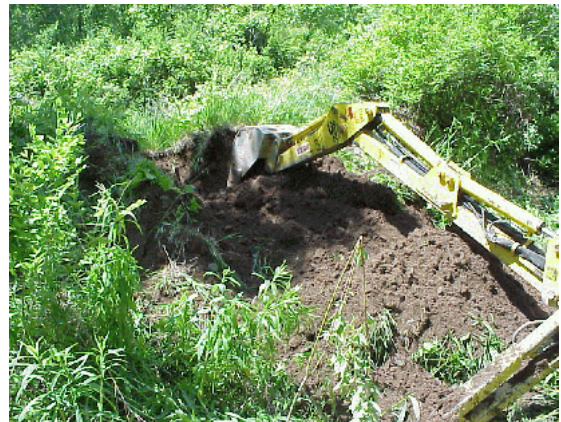
*Excavation activities at Soil Pile 2.*

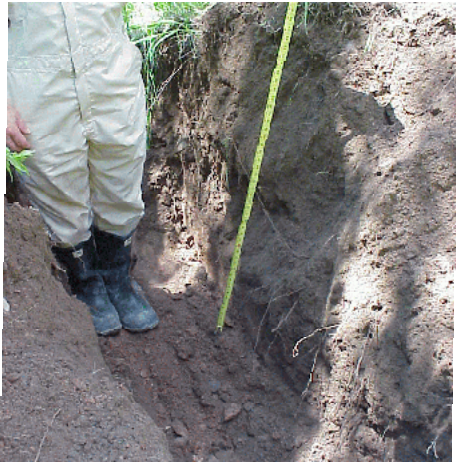
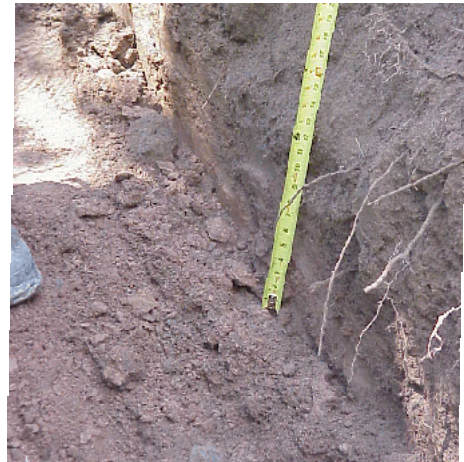
***Soil Pile 2*** (continued)

*Photos shows limits of excavation at Soil Pile 2, native soil at 3.5 feet below ground surface.*

| <u>Depth</u> | <u>Jar Headspace</u> | <u>Description</u> |
|---|---|---|
| 3.5 - 5 ft. | 0 ppm | Yellow-brown fine sandy silt and silty fine sand (native soil at 3.5 feet). |

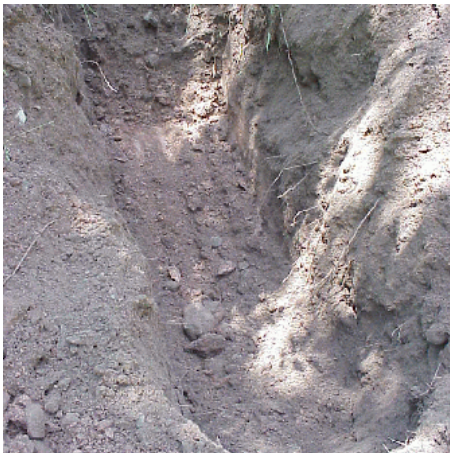
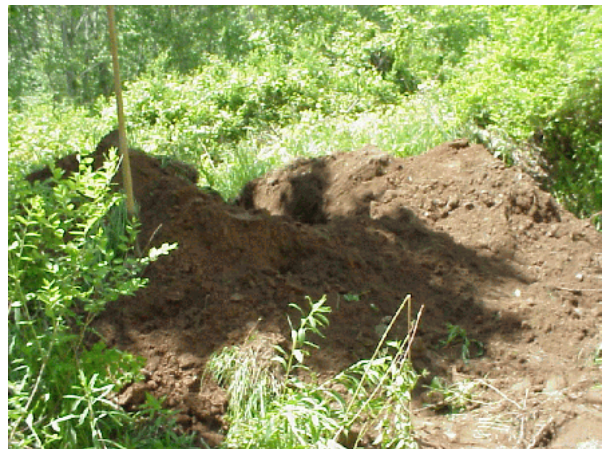
*Limits of excavation - native soil (left photo). Soil pile 2 contents (right photo).*

| <u>Depth</u> | <u>Jar Headspace</u> | <u>Description</u> |
|---|---|---|
| 0 - 2 ft. | 0 ppm | Dark brown f-m sand. |
| 2 - 3.5 ft. | 0 ppm | Dark brown f-m sand, slightly damp. |

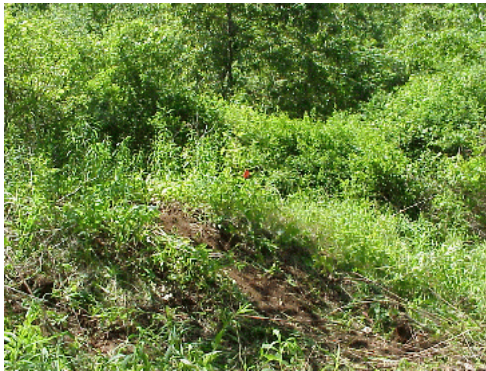
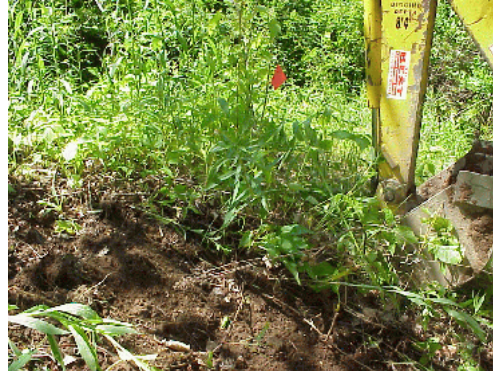
### *Soil Pile 3*

*Pre excavation activities Soil Pile 3 (photo left). Excavation of Soil Pit 3 (photo right).*

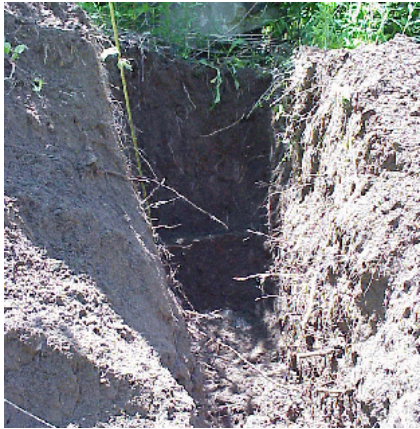
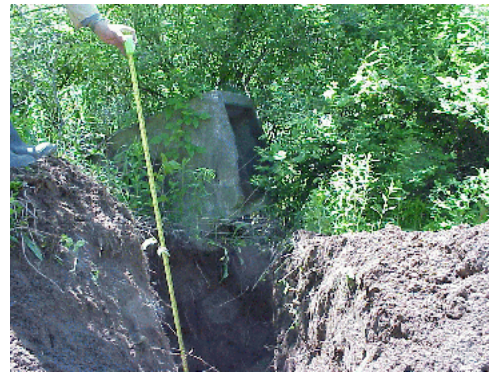
*Photos shows limits of excavation Soil Pile 3, native soil at 7 feet below ground surface.*

| <u>Depth</u> | <u>Jar Headspace</u> | <u>Description</u> |
|---|---|---|
| 7 -7.5 ft. | 0 ppm | Yellow-brown to tan fine sandy silt and silty fine sand, wet (native soil at 7 feet). |

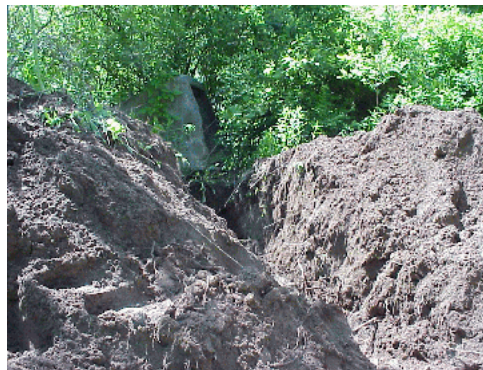
*Soil Pile 3 contents.*

| <u>Depth</u> | <u>Jar Headspace</u> | <u>Description</u> |
|---|---|---|
| 0 - 2.5 ft. | 0 ppm | Dark brown f-m sand. |
| 2.5 - 7 ft. | 0 ppm | Dark brown f-m sand, damp at 5.5 feet. |
