FISH AND WILDLIFE IMPACT ANALYSIS

ELTINGS CORNERS FACILITY CENTRAL HUDSON OAS & ELECTRIC CORPORATION TOWN OF LLOYD, NEW YORK

JULY 24, 2014

**FISH AND WILDLIFE IMPACT ANALYSIS
CHGE ELTINGS CORNERS FACILITY
INTERSECTION OF STATE ROUTE 299 AND SOUTH STREET
TOWN OF LLOYD, ULSTER COUNTY, NEW YORK**

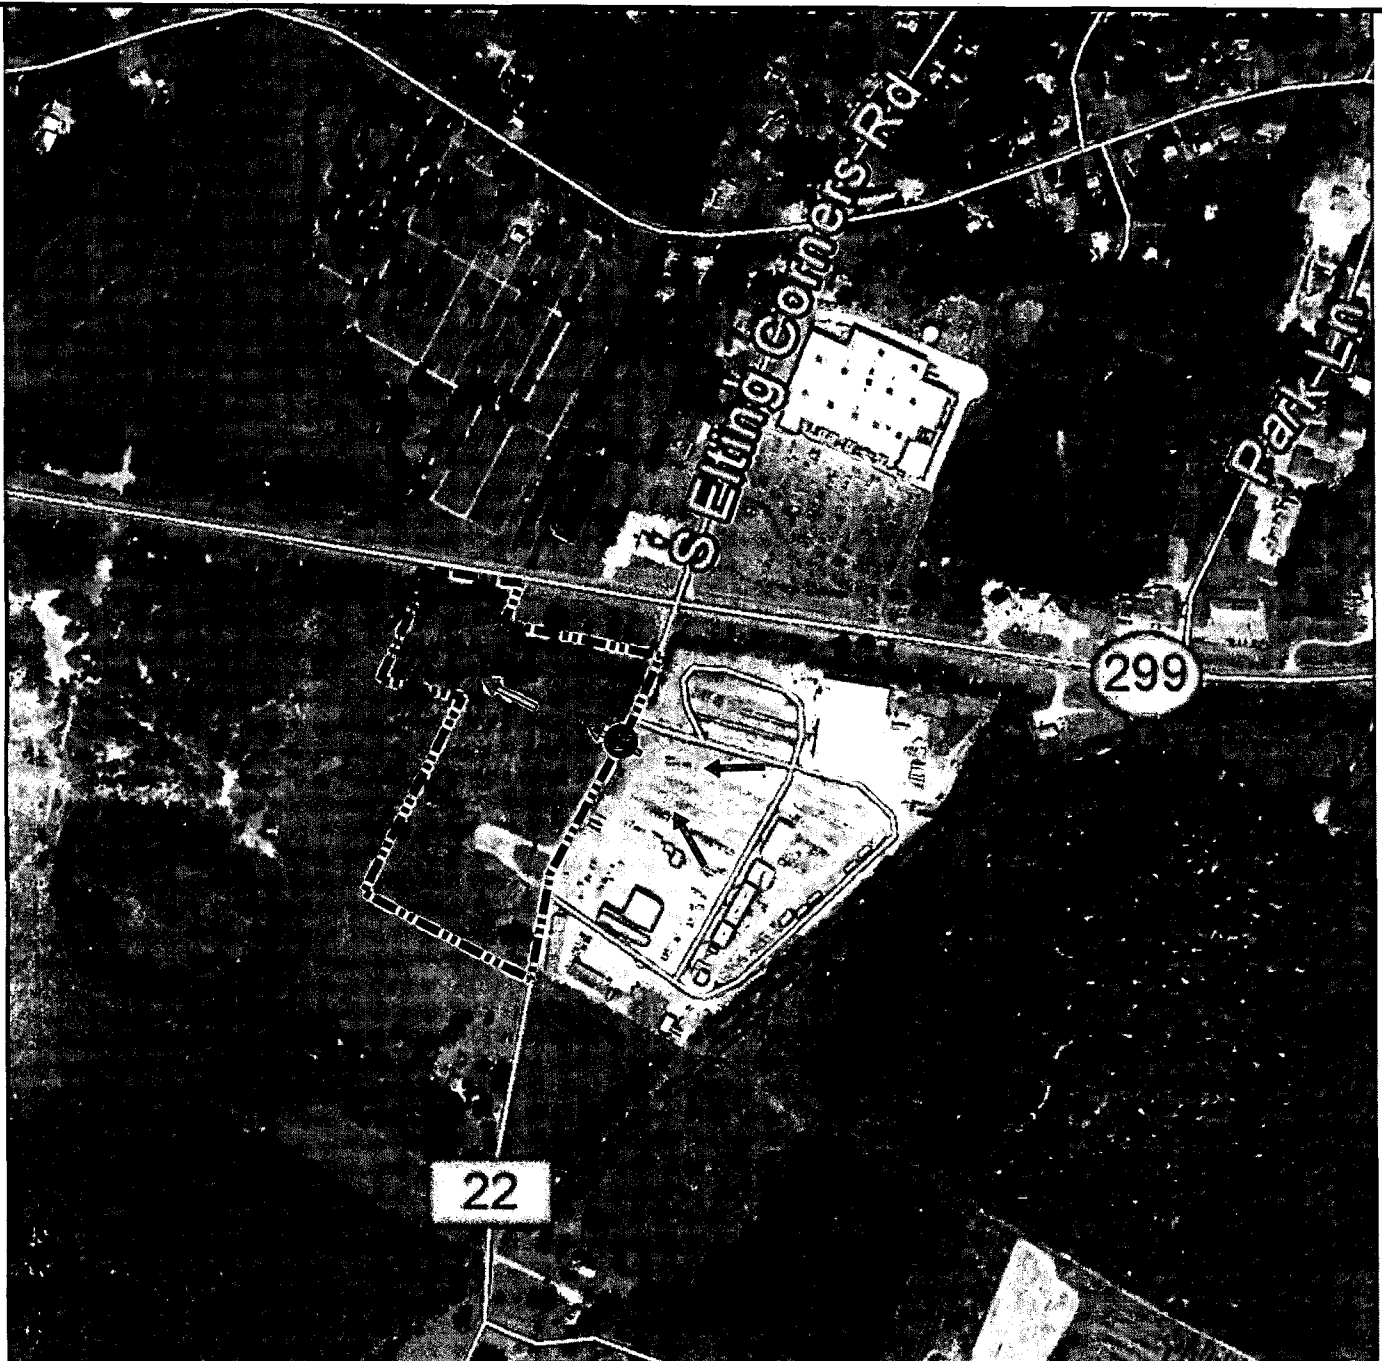
SITE PLAN

- SITE BOUNDARY
- ← DRAINAGE FLOW
- OUTFALL

Black Creek, a NYSDEC Class A trout stream in its lower branches, partially flows through the CHGE Eltings Corners Facility stormwater drainage system. This flow enters a culvert under the former rail bed (on the eastern perimeter of the active CHGE facility), flows into a fire pond, and subsequently into the onsite facility stormwater drainage system. The drainage system discharges stormwater runoff and some flow from Black Creek into wetland CD-6. Surface water flow during hydrological events is depicted on **Figure 2**.
