FISH AND WILDLIFE IMPACT ANALYSIS
CENTRAL HUDSON GAS & ELECTRIC CORPORATION
ELTINGS CORNERS FACILITY
TOWN OF LLOYD
ULSTER COUNTY, NEW YORK

JULY 24, 2014
REVISED NOVEMBER 4, 2014

**FISH AND WILDLIFE IMPACT ANALYSIS
CHGE ELTINGS CORNERS FACILITY
INTERSECTION OF STATE ROUTE 299 AND SOUTH STREET
TOWN OF LLOYD, ULSTER COUNTY, NEW YORK**

Kleinfelder Project Number: 20143521.001A

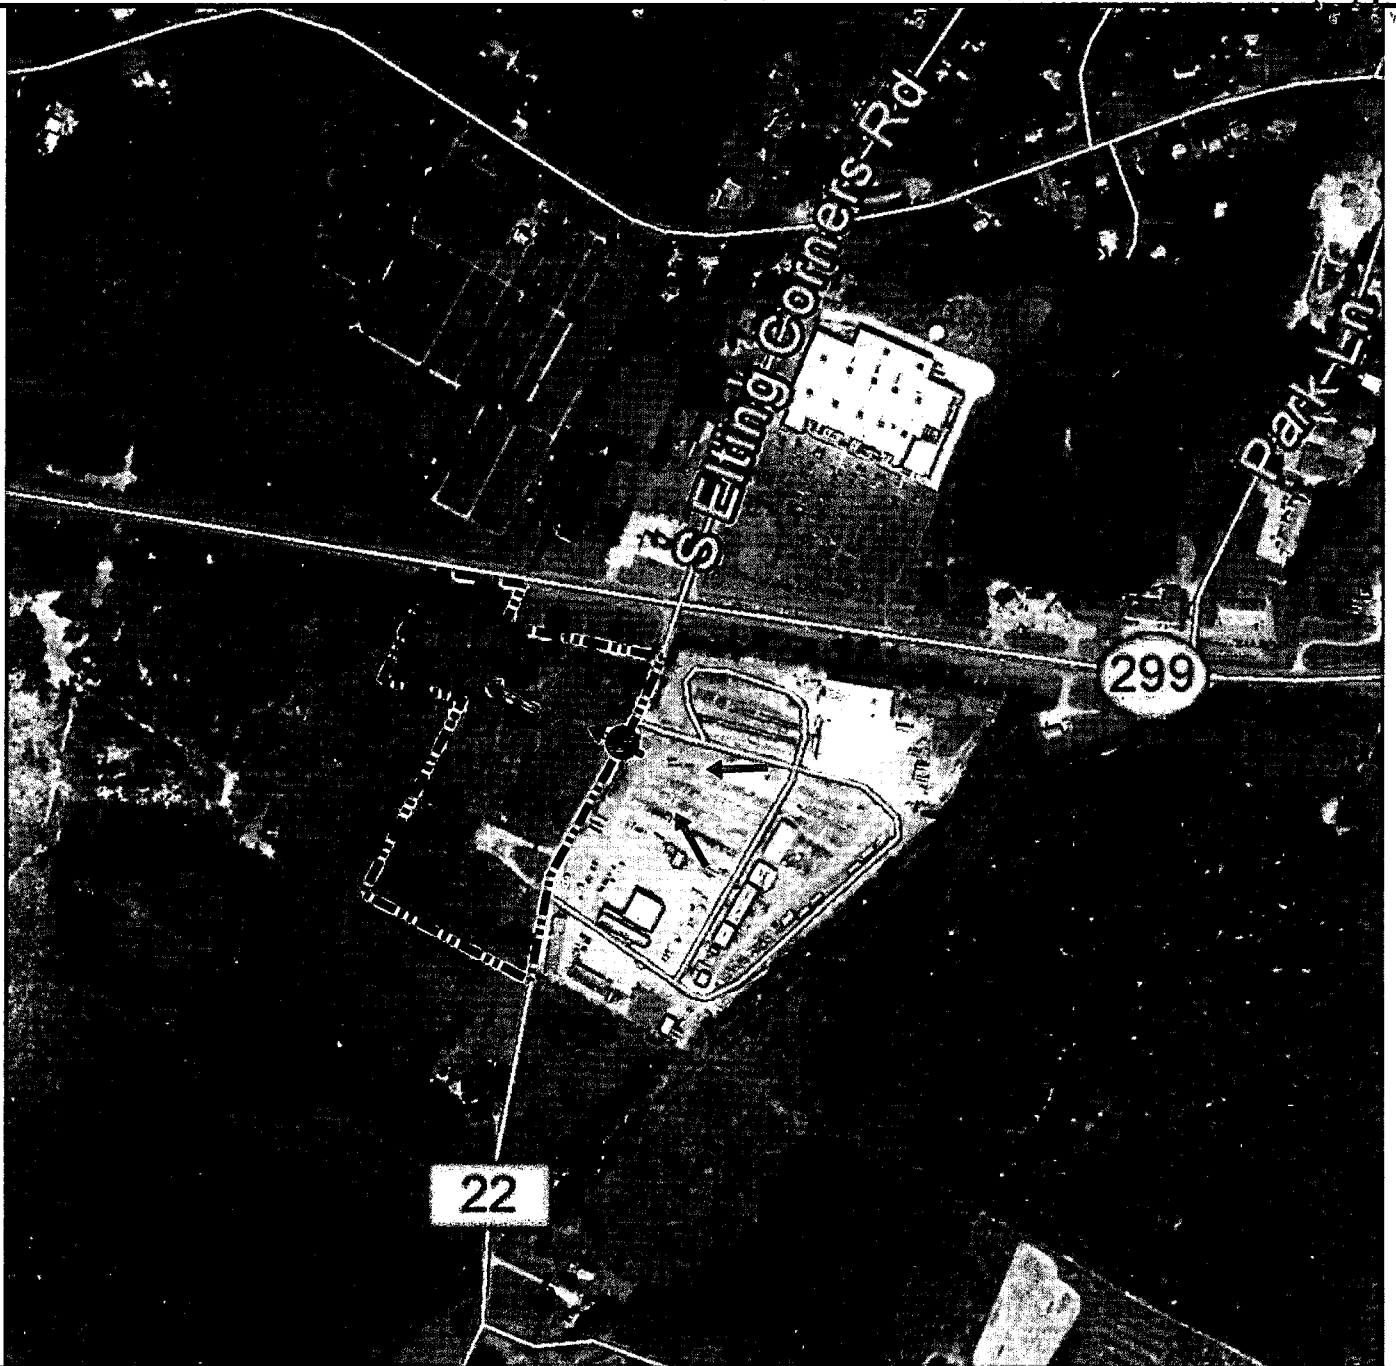
2

Black Creek, a NYSDEC Class A trout stream in its lower branches, partially flows through the CHGE Eltings Corners Facility stormwater drainage system. This flow enters a culvert under the former rail bed (on the eastern perimeter of the active CHGE facility), flows into a fire pond, and subsequently into the onsite facility stormwater drainage system. The drainage system discharges stormwater runoff and some flow from Black Creek into wetland CD-6. Surface water flow during hydrological events is depicted on **Figure 2**.

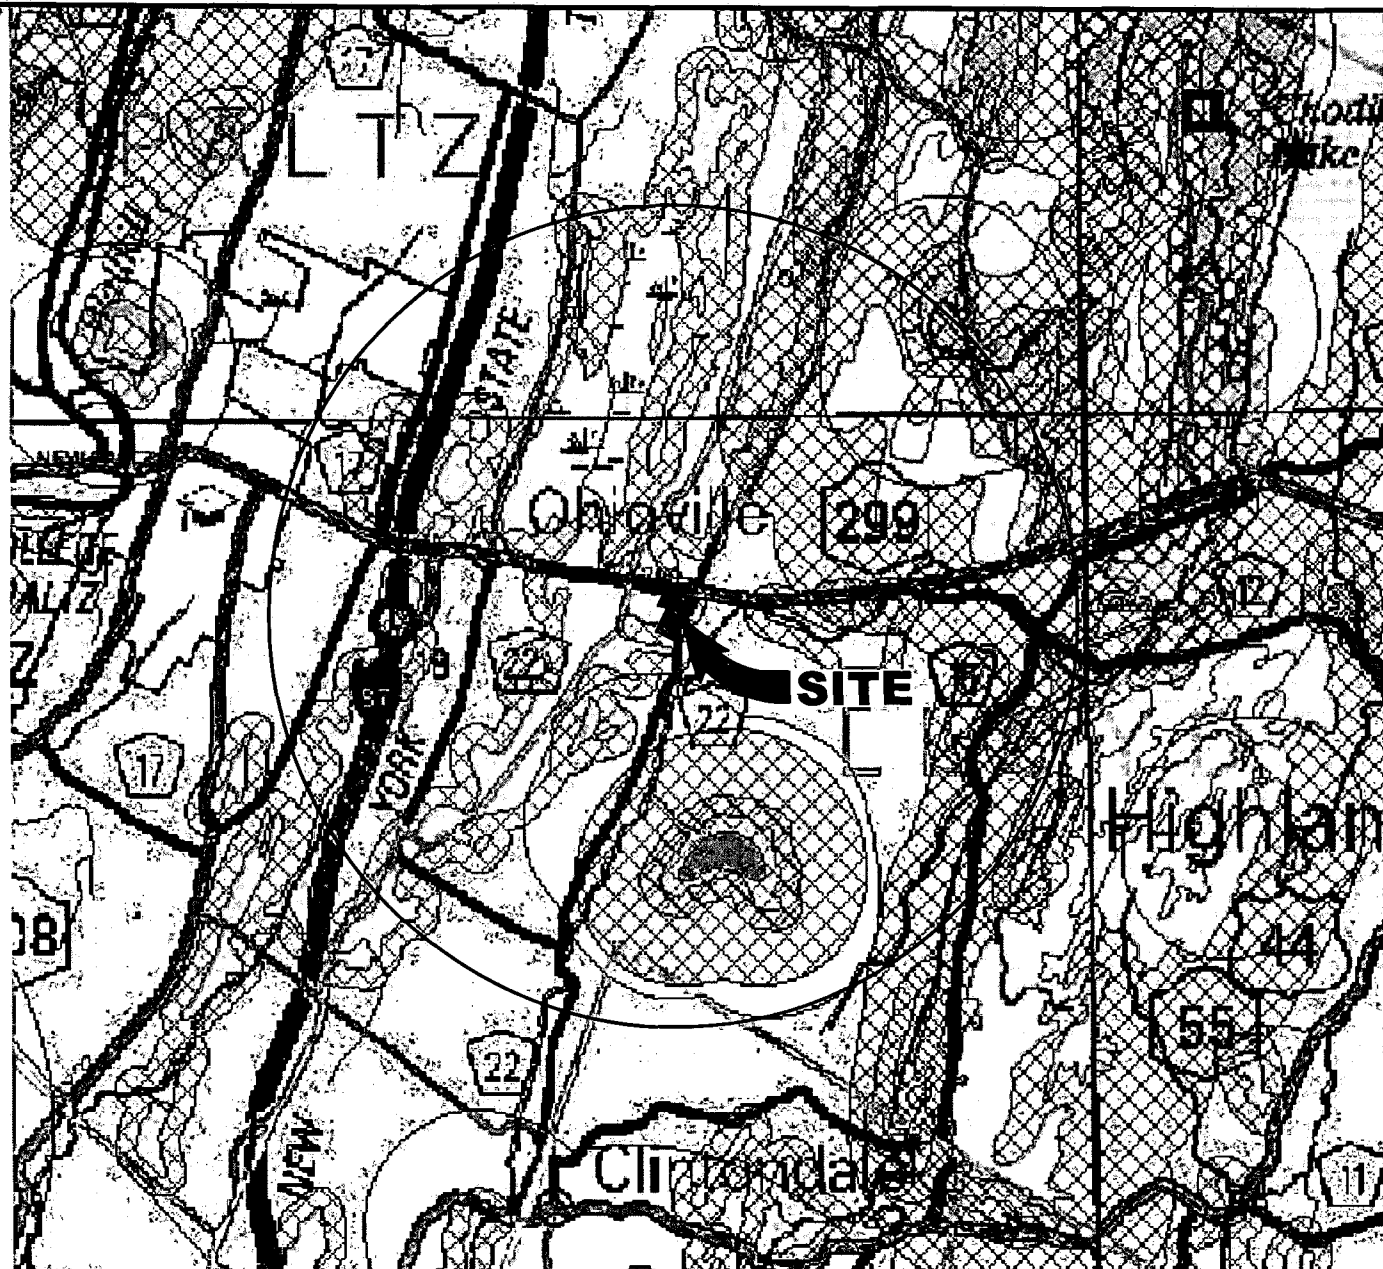
3

Several significant natural resource features are located within two miles of the Site perimeter. These ecological features are depicted on **Figure 3**. Several NYSDEC-regulated freshwater wetlands and Class A and B streams exist in this area. One NYSDEC Significant Habitat, a dwarf shrub bog, is located approximately 1.1 miles south of the Site.

SIGNIFICANT ECOLOGICAL COMMUNITIES

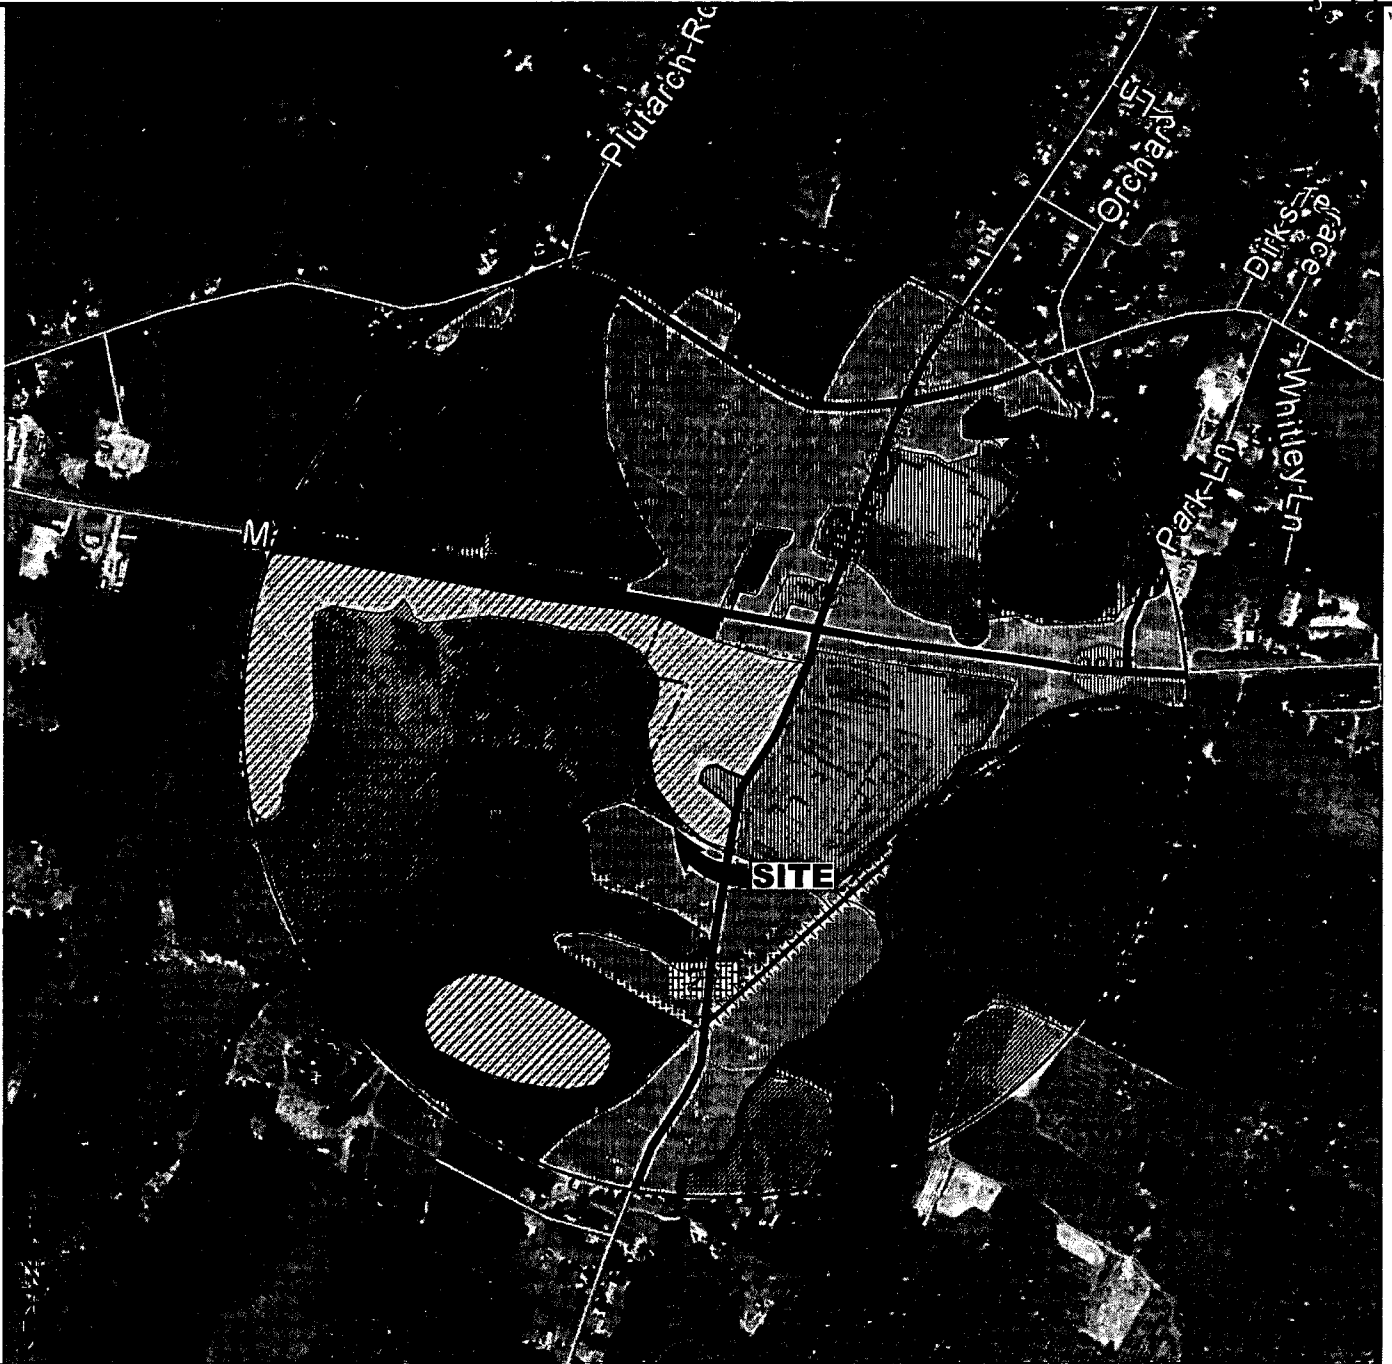
Section 2.2 describes the fish and wildlife resources found within the Site and surrounding habitats within one-half mile of the Site in accordance with the NYSDEC FWIA guidance document. The coertype assessment was conducted via a desktop analysis and was verified in the field by Kleinfelder biologist, David B. Tompkins. Coertypes were classified and described using *Ecological Communities of New York State: Second Edition* (Edinger et al., 2002). The locations of these coertypes are depicted on **Figure 4** and are described below.

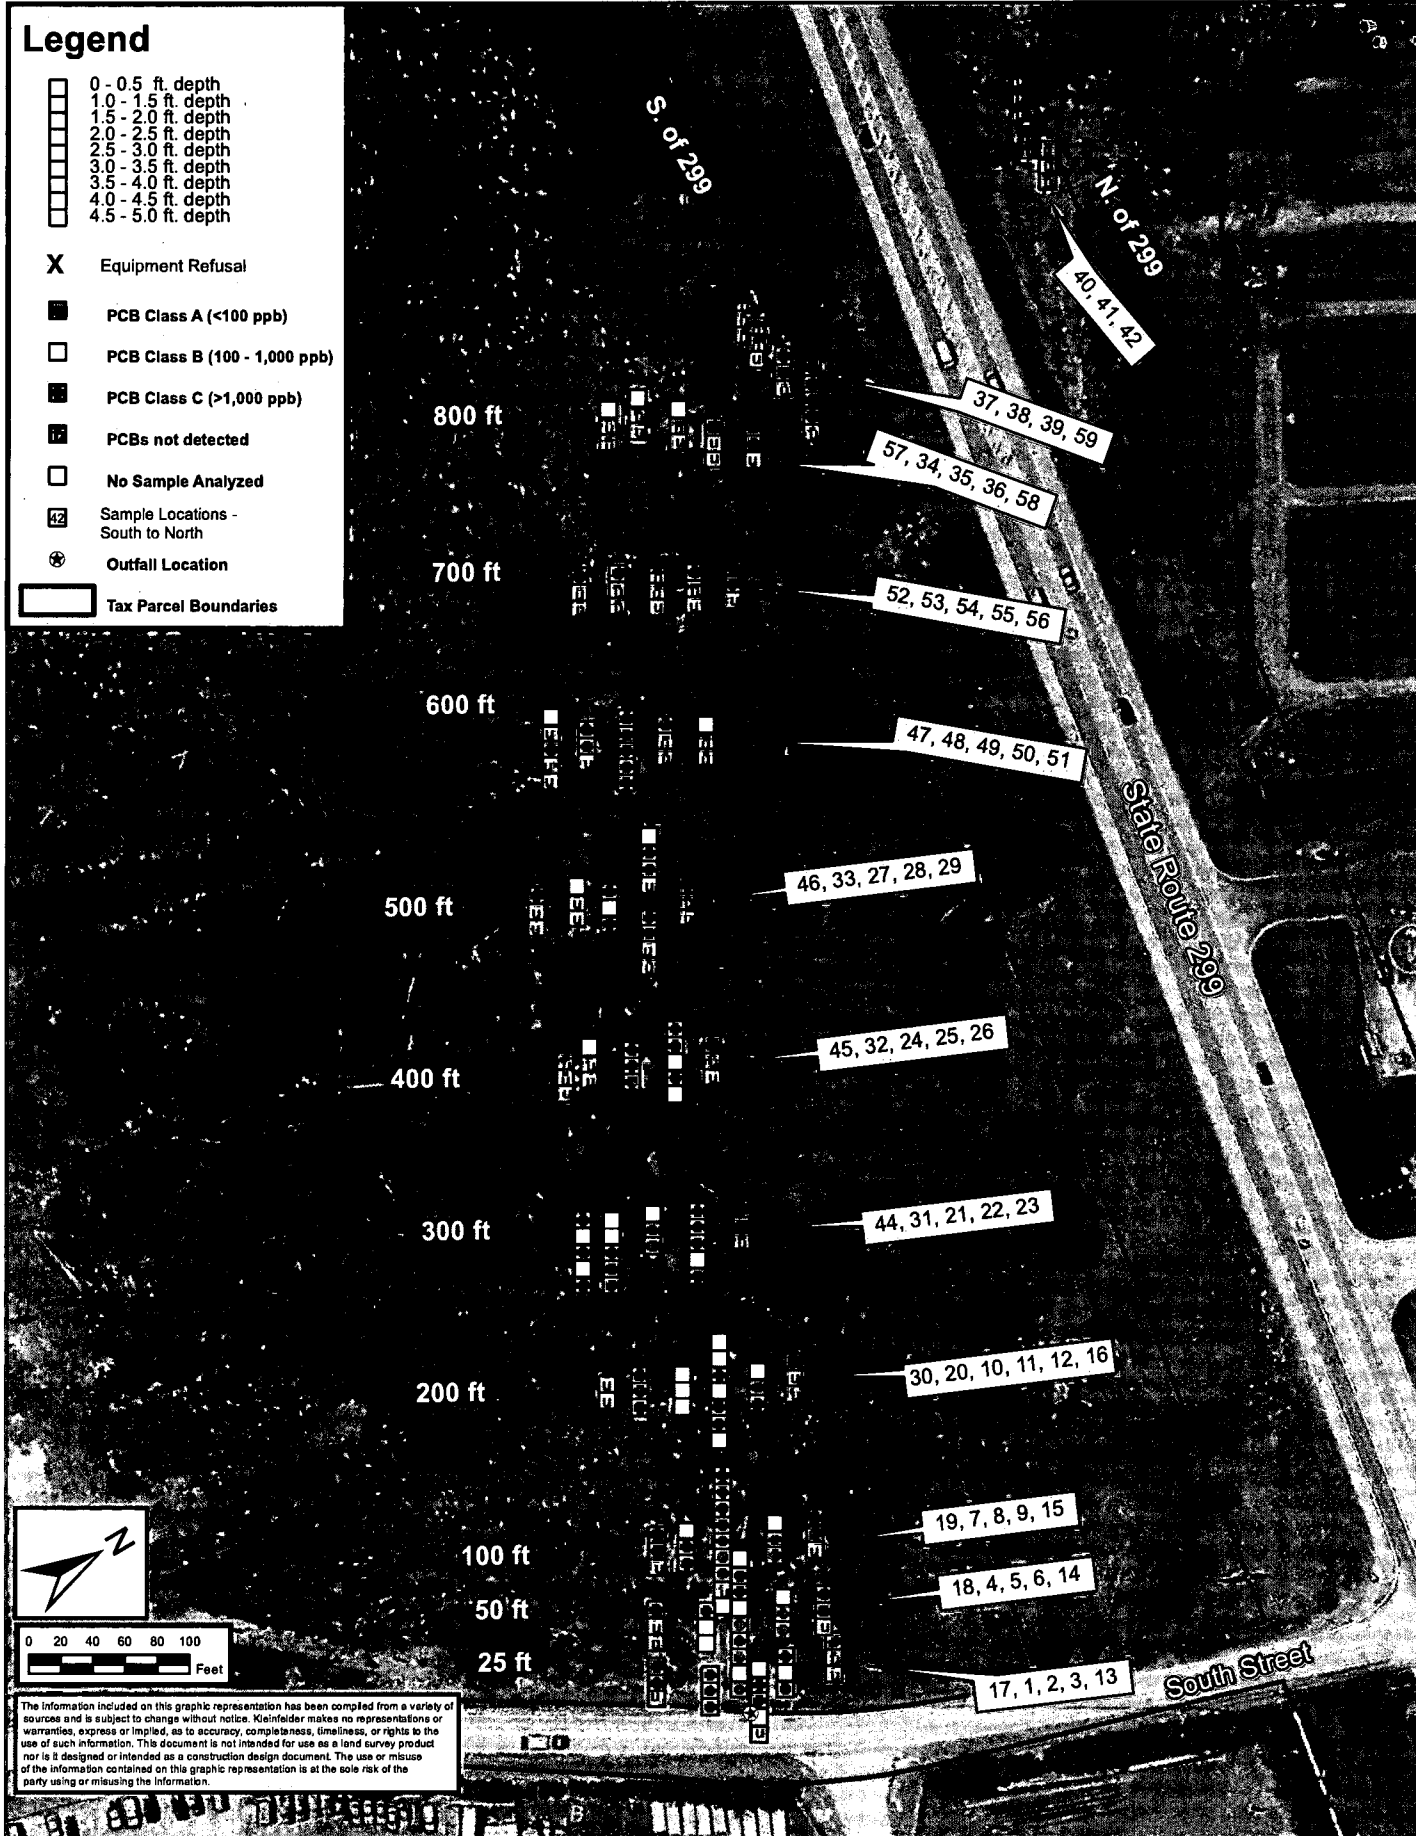
Total PCB Results
 Source: NYS GIS Clearinghouse 2004 ORTHOPHOTO
 C.H.G.E.
 ELTINGS CORNERS PROPERTY
 SOUTH STREET
 TOWN OF LLOYD, ULSTER COUNTY, NEW YORK
