# **CONTINENTAL PLACER INC.**

## **SPILL #0505154 CLOSURE REPORT**

**81 Broadway  
Kingston, New York**

September 10, 2010

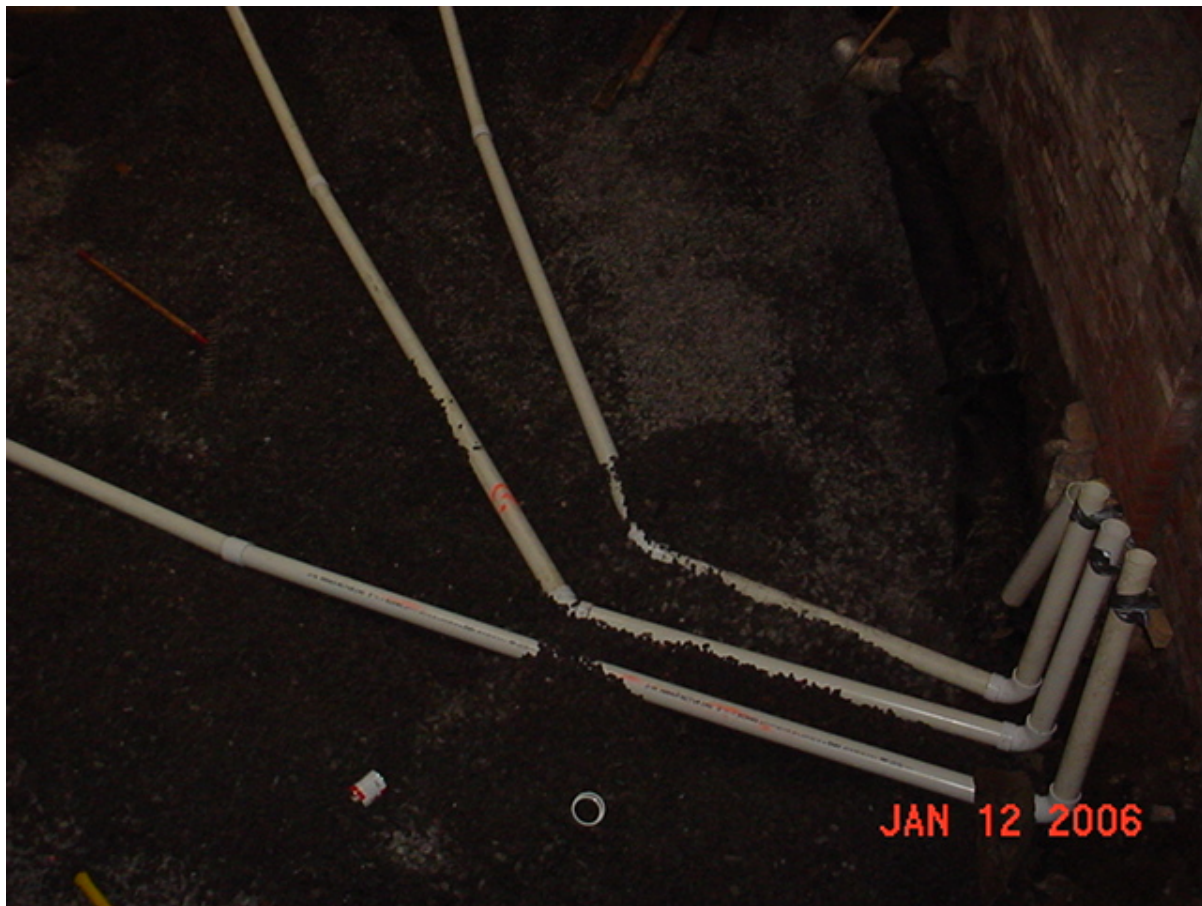
Sub slab piping with risers to valve bank.

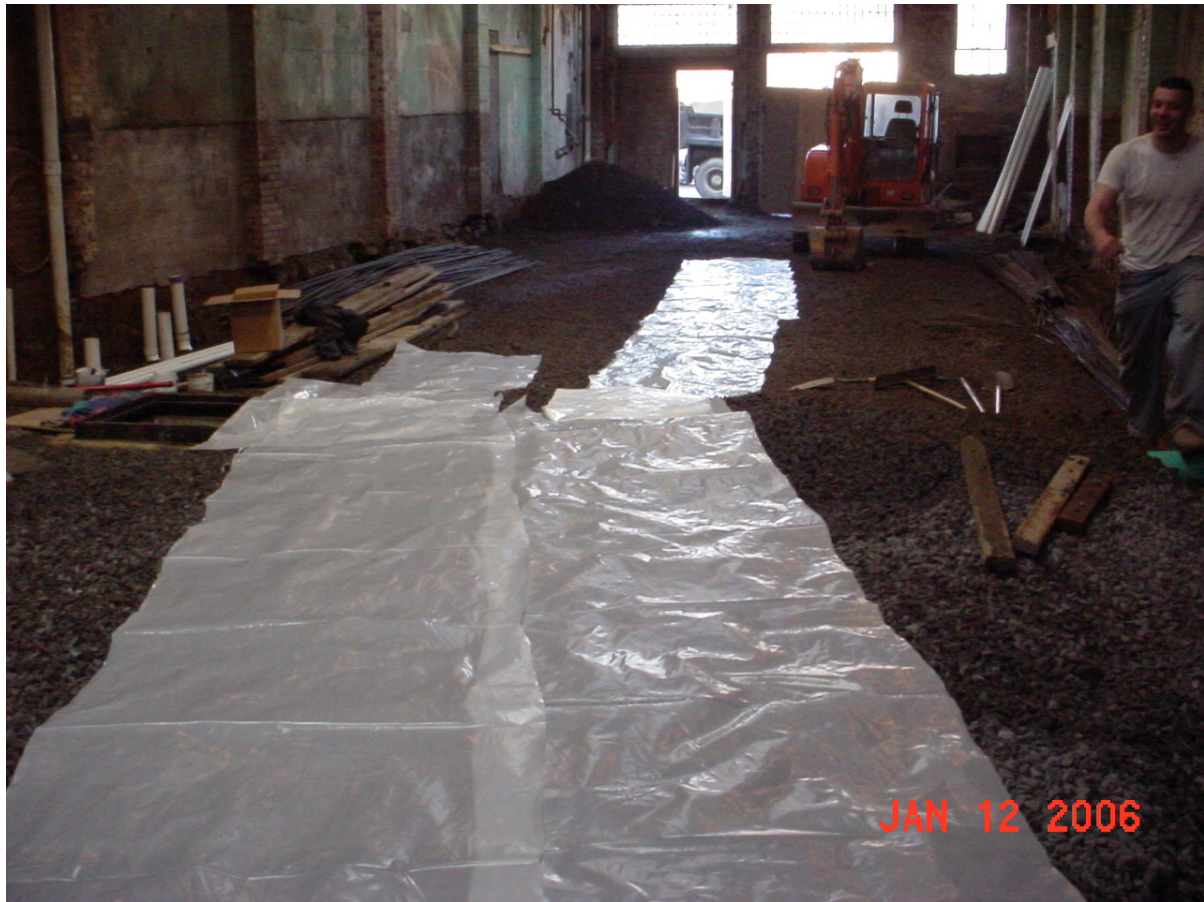
Plastic sheeting being installed over sub slab aggregate.

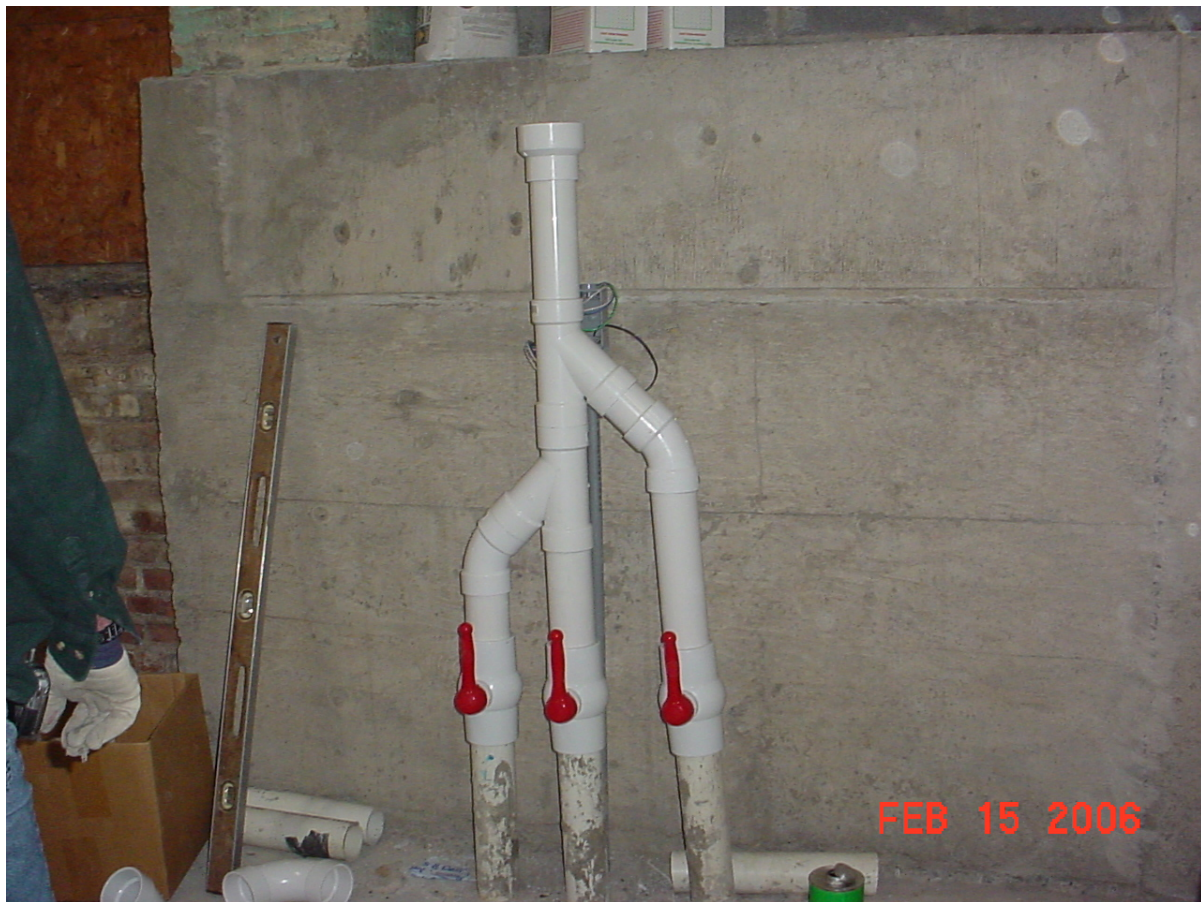
System valve bank.

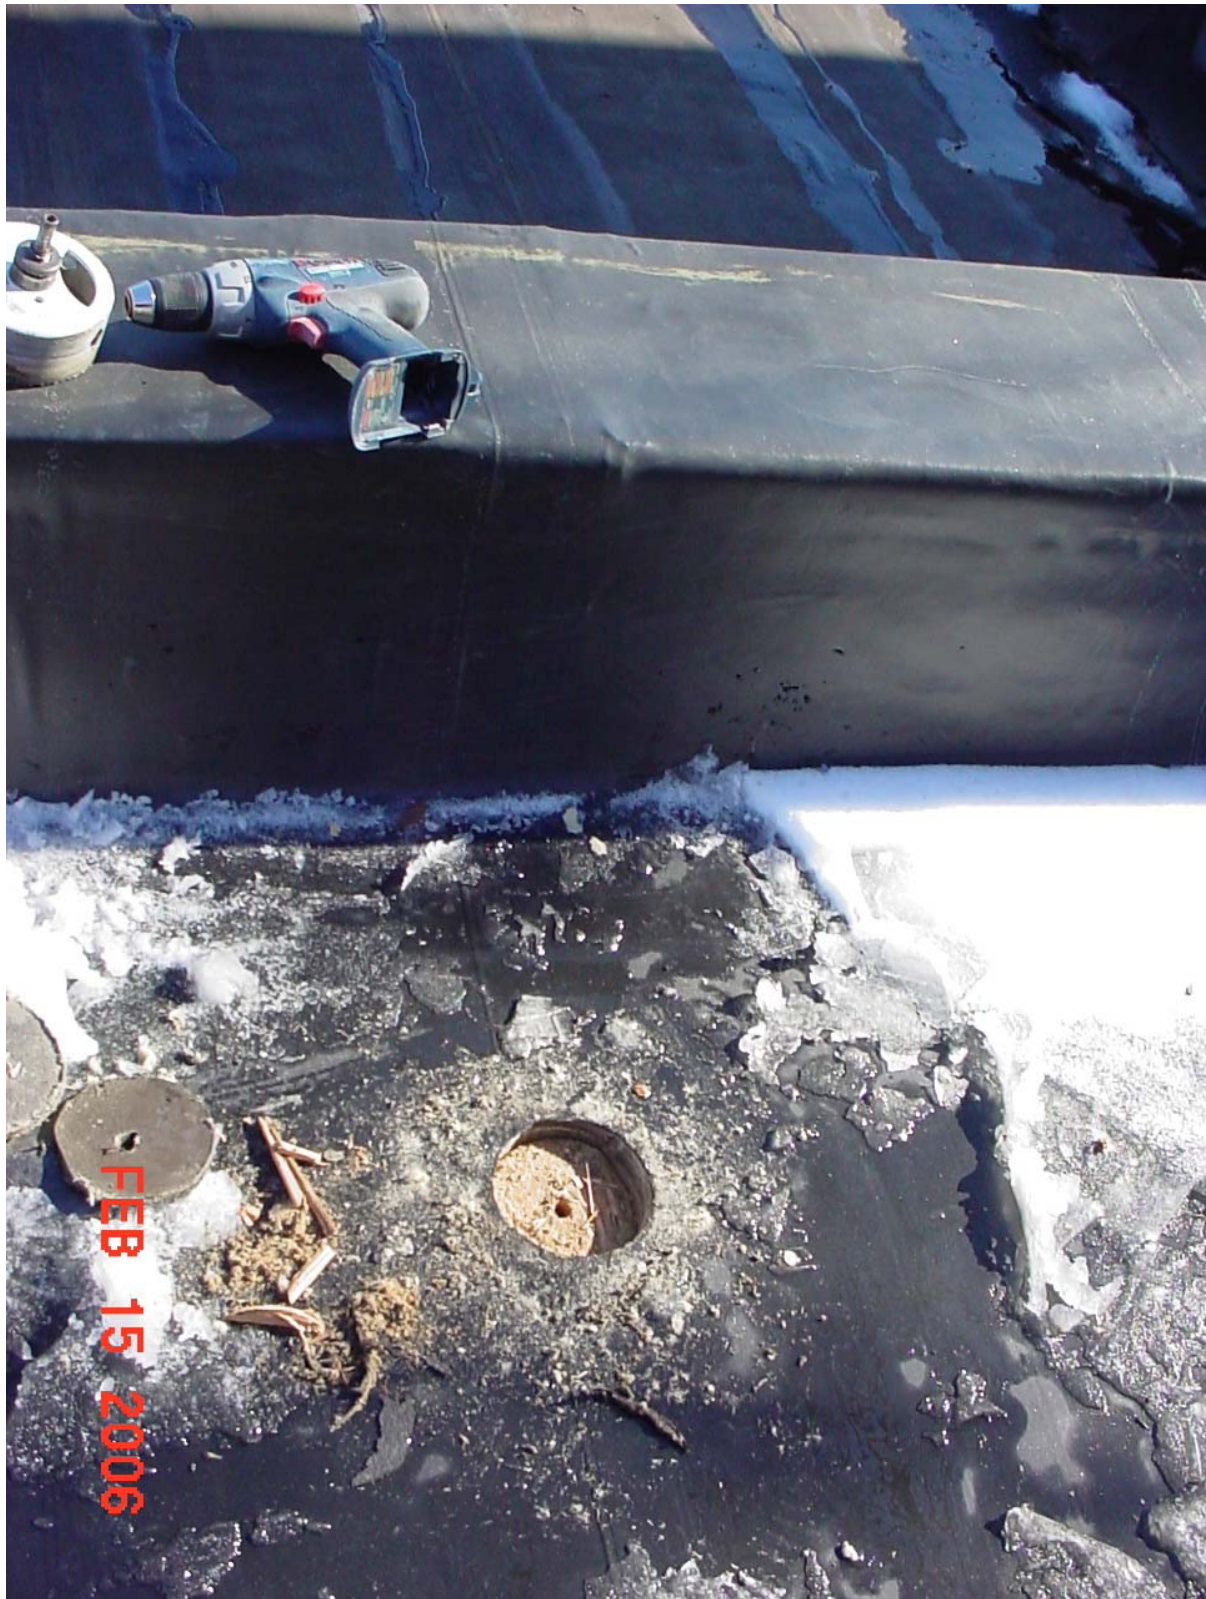
Roof penetration for manifolded exhaust stack.

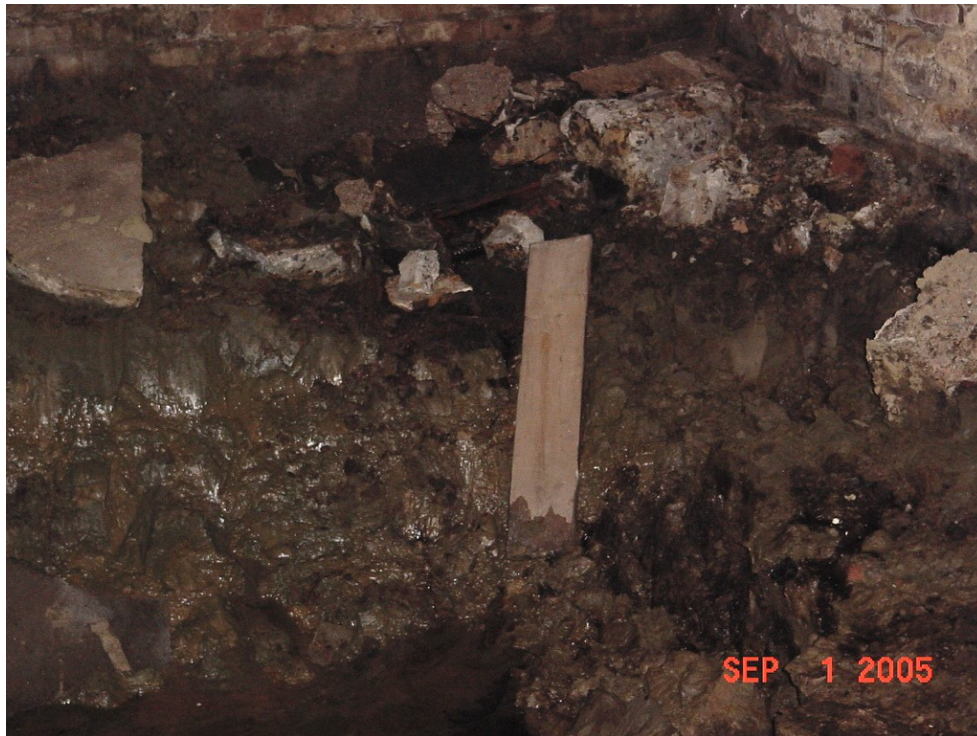
During the site inspection, it was noted that the oil appeared to be coming out from under the foundation of the southern wall of the building. CPI and NYSDEC went behind 81 Broadway to 38 Post Street and observed puddled oil in the basement of 38 Post Street. Oil was not puddled on the floor during CPI's February 2005 Phase I site inspections however an oily stain and 'speedy dry' absorbent was observed on the concrete floor at the former boiler location. NYSDEC indicated that the owner of 38 Post Street needed to be contacted to have the situation addressed. NYSDEC subsequently contacted Kingston Trio, L.L.C., owner of 38 Post Street and former owner of 81 Broadway, and requested action be taken to clean-up the oil spill. Kingston Trio, L.L.C. contacted CPI and oil spill clean-up activities were initiated.

Photo 1 - Oily water seeping into 81 Broadway along southern wall foundation discovered after concrete floor was removed.

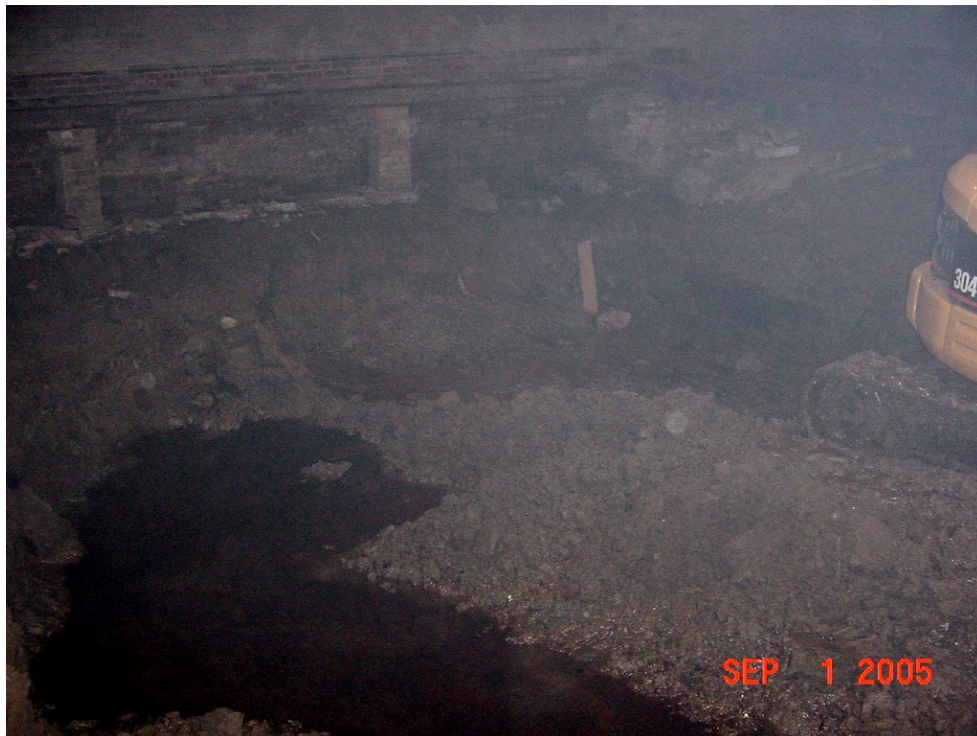
As part of the 2005 renovation of the 81 Broadway (purchased from Kingston Trio, L.L.C. by James Milne of Milne, Inc.), the concrete flooring inside the building was removed and oil-impacted soil was discovered. The construction manager for the 81 Broadway renovation contacted CPI on July 22, 2005 to request a site inspection and to assess a course of action for handling the oil-impacted soil. CPI inspected the site on July 28, 2005, and recommended that a spill be called in to New York State Department of Environmental Conservation (NYSDEC). CPI called in the spill at approximately 3:30 PM on July 28, 2005 and was provided with the spill number 0505154 for 81 Broadway. CPI then called the NYSDEC Region 3 Petroleum Spills group to discuss the spill, and subsequently arranged a site inspection for the afternoon of July 29, 2005.

Photo 2 - Accumulated water and oil impacted soil inside 81 Broadway after concrete floor was removed.

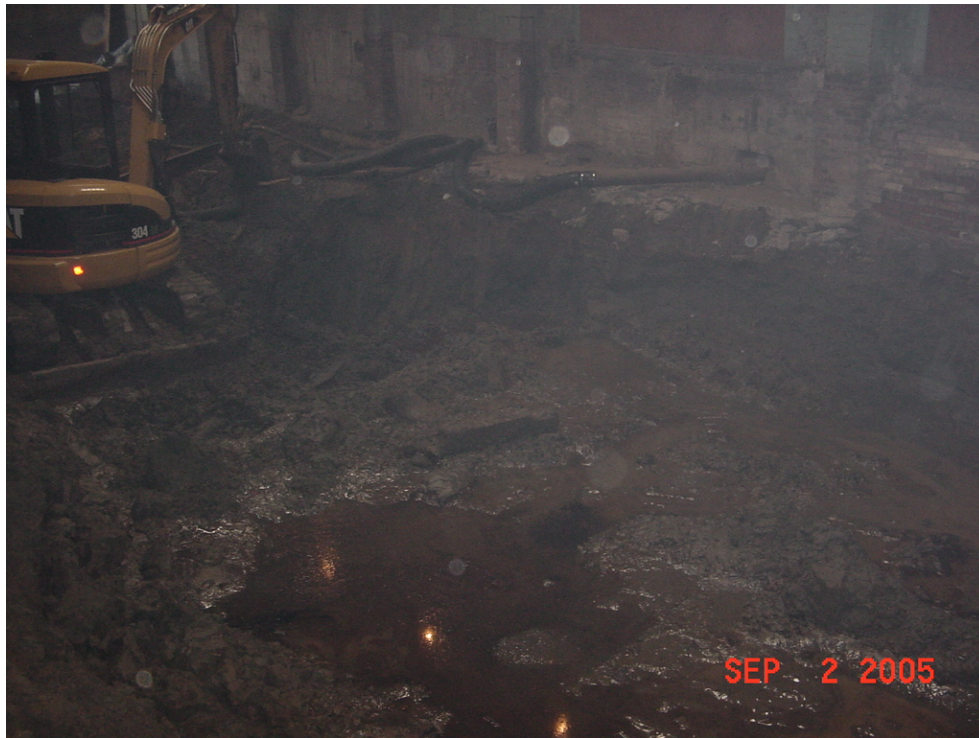
Photo 3 – Primary area in southern portion of 81 Broadway where oil impacted soil and accumulated water were removed from 81 Broadway.

As a result of the analytical results, CPI contracted with Albany Tank Services, Inc. (a petroleum licensed waste hauler) to excavate and dispose of soils from 81 Broadway at Albany Landfill, and with Precision Industrial Maintenance, Inc. (a licensed hazardous waste hauler) to remove and dispose of the soils at 38 Post Street at a hazardous waste disposal site. Albany Tank Services, Inc. (ATS) commenced soil removal from 81 Broadway on August 29, 2005. Precision Industrial Maintenance, Inc. (PIM) commenced concrete and soil removal from 38 Post Street on September 1, 2005.

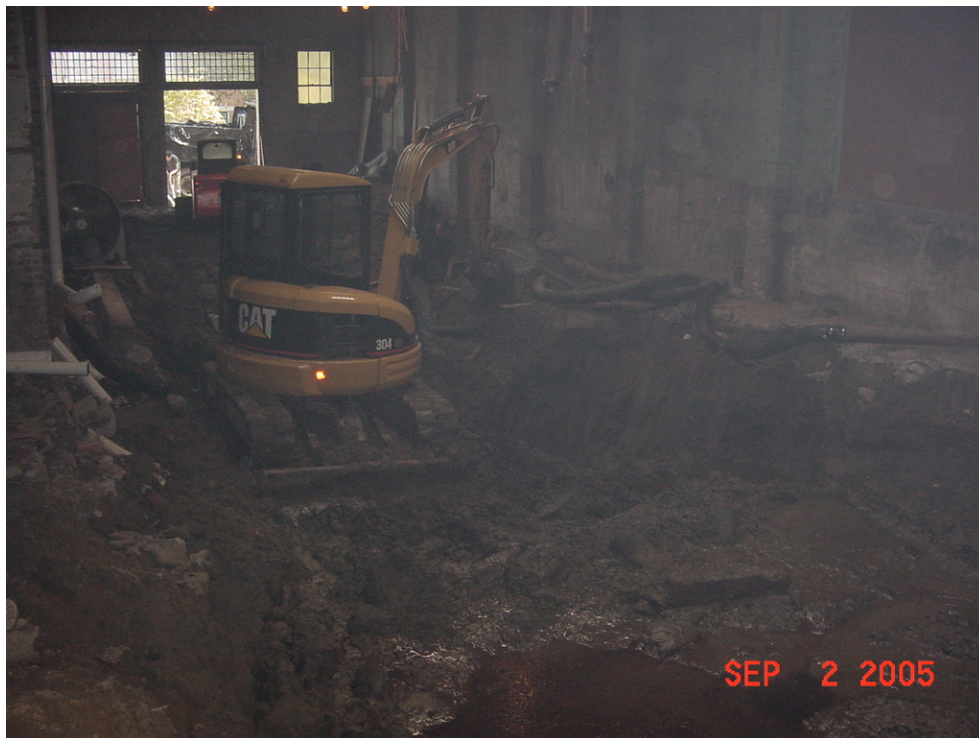
Photo 4 – Soil removal activities at 81 Broadway with dump trucks being loaded through door in background.

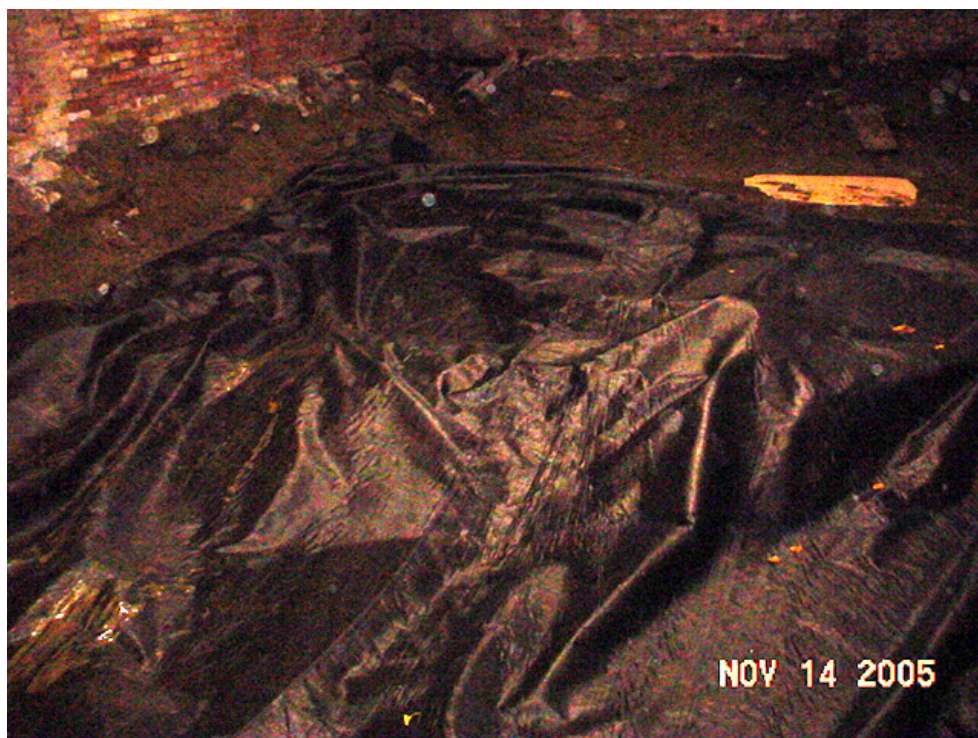
Photo 5 - Geotextile laid in base of excavation in 81 Broadway prior to backfilling with gravel.

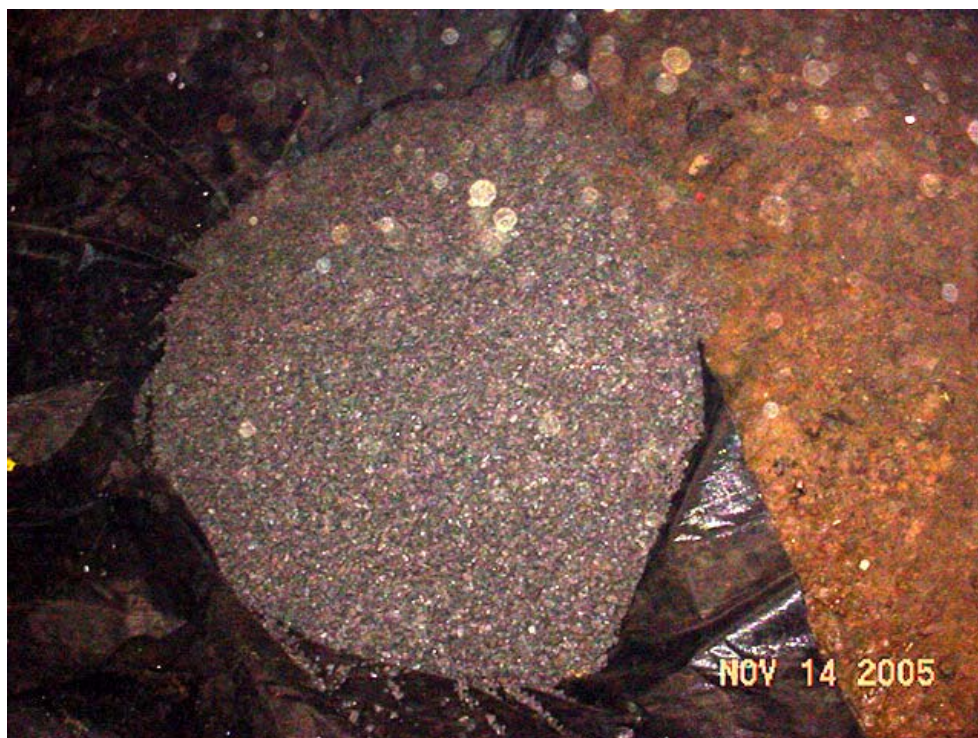
Photo 6 - Gravel being placed in excavation in 81 Broadway.

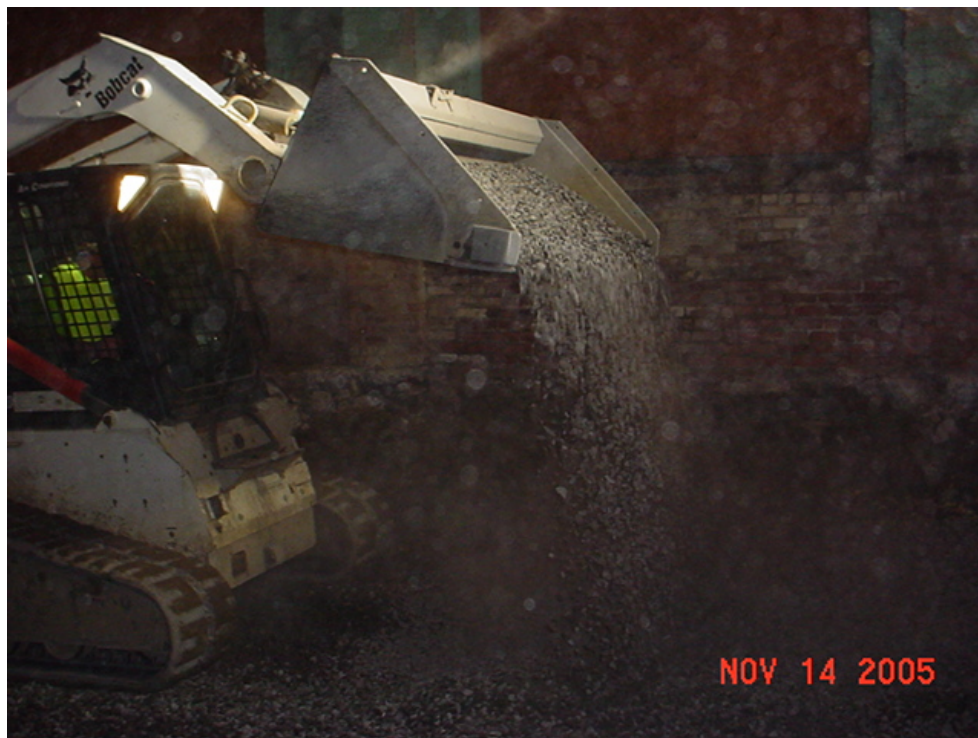
Photo 7 - Gravel being emplaced in excavation inside 81 Broadway.

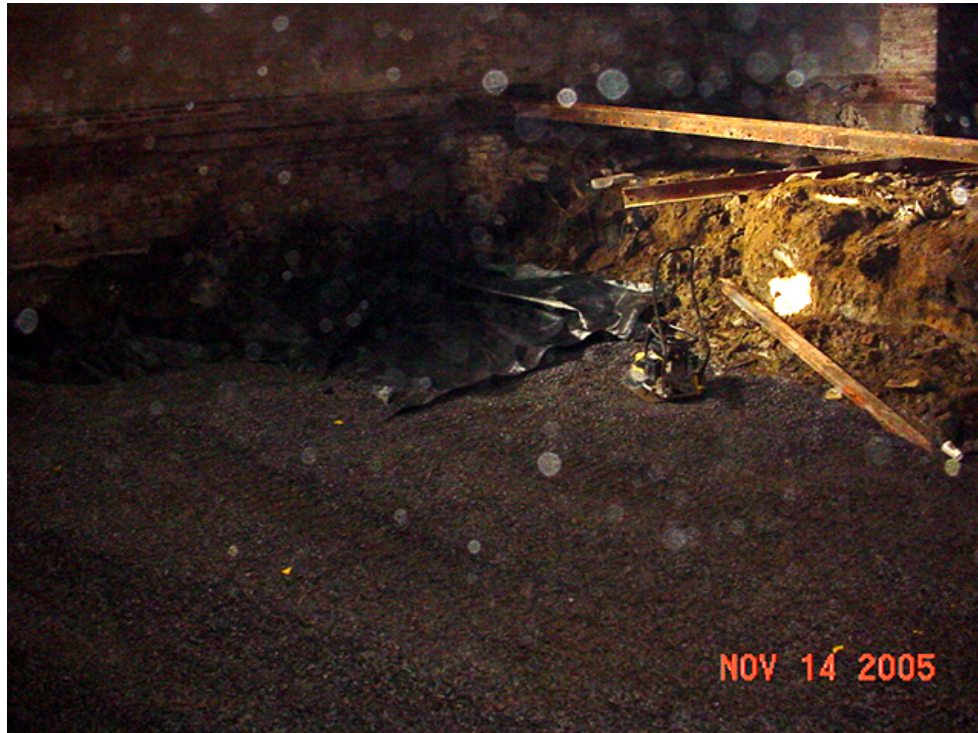
Photo 8 - Gravel layer in excavation inside 81 Broadway.

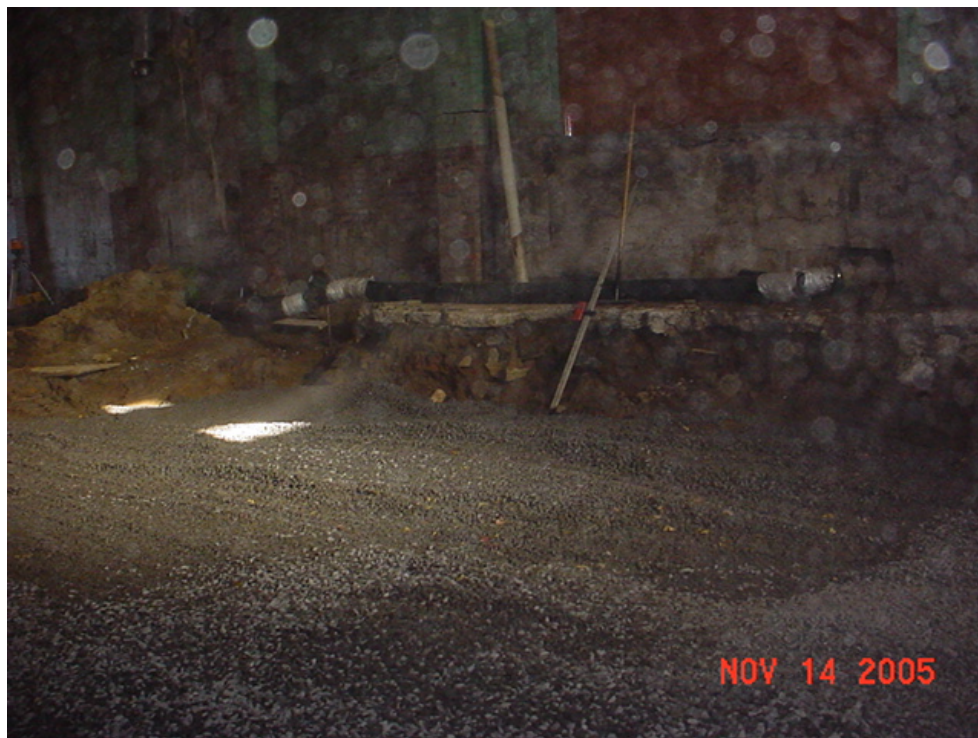
Photo 9 – Filled excavation in 81 Broadway.

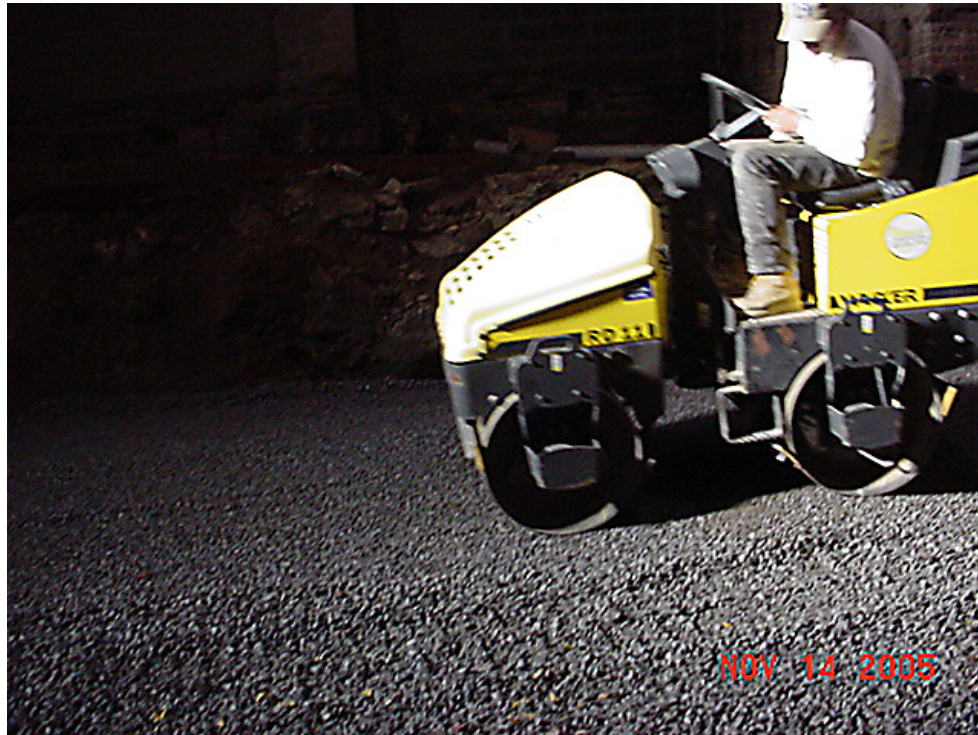
Photo 10 – Compaction of gravel inside excavation in 81 Broadway.

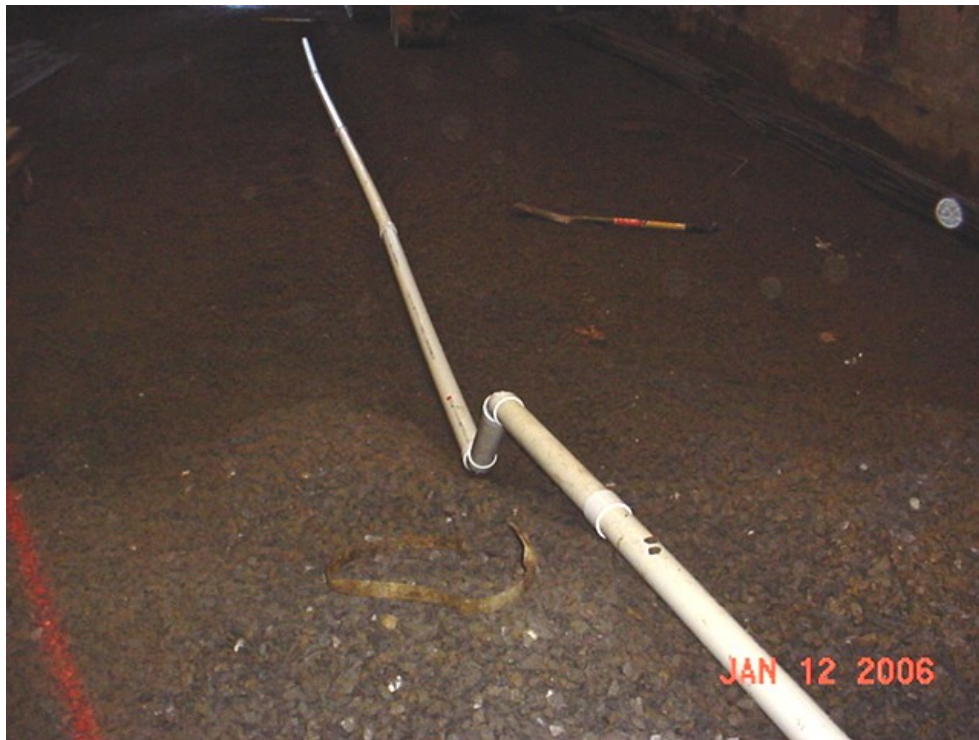
Photo 1 - Installation of 81 Broadway sub-slab depressurization system piping.

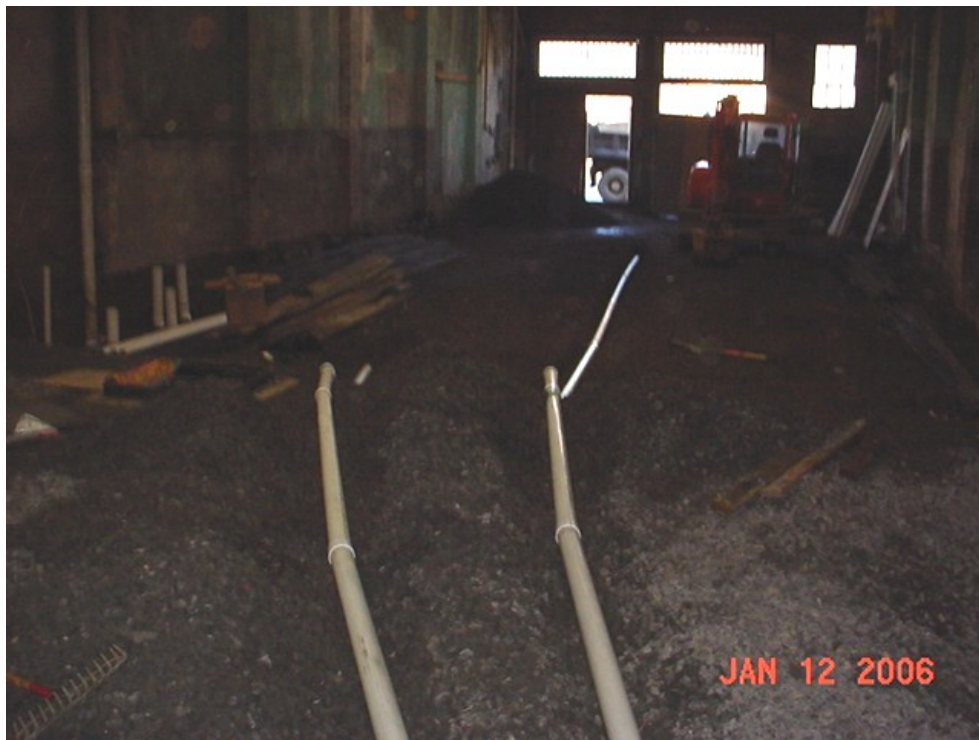
Photo2 - View northward of sub-slab depressurization system piping inside 81 Broadway.

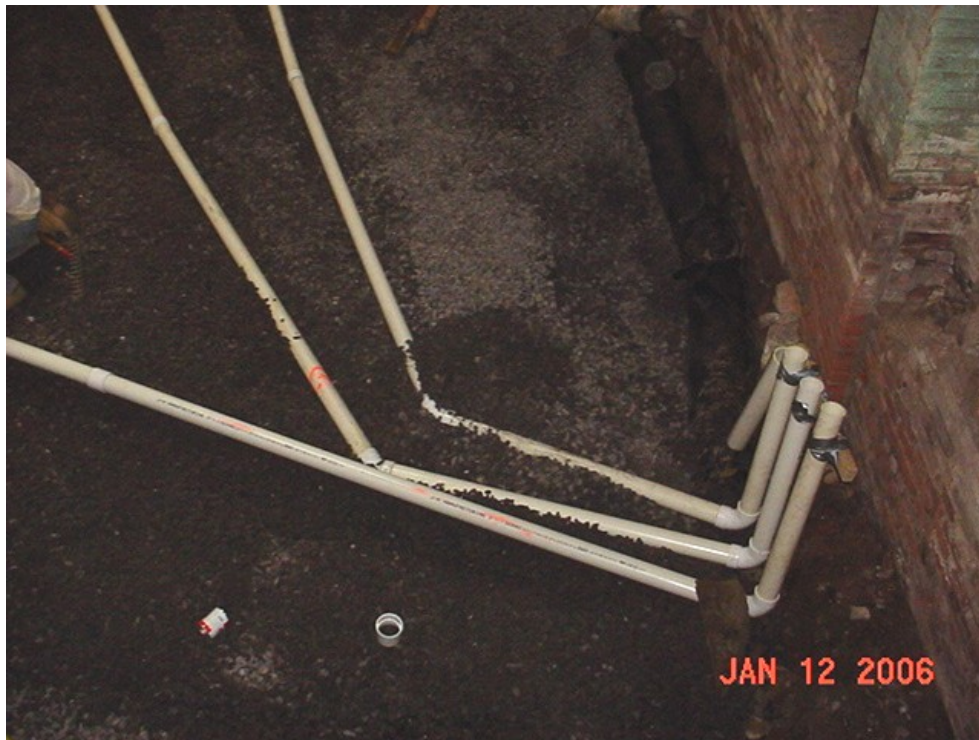
Photo 3 - Installation of 81 Broadway sub-slab depressurization system piping.

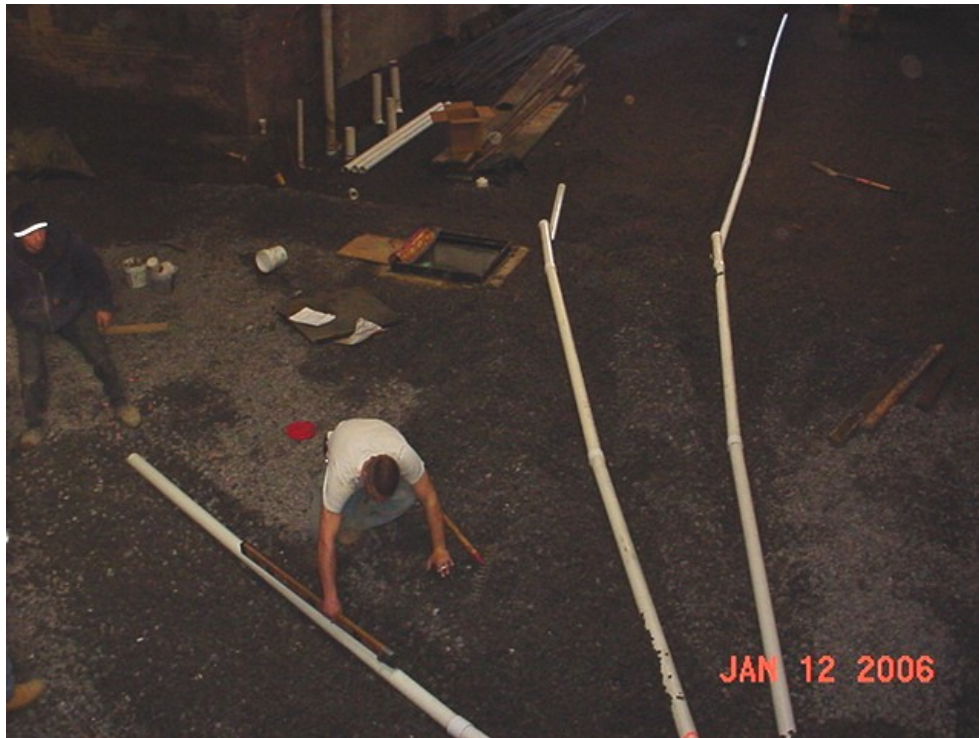
Photo 4 - Installation of 81 Broadway sub-slab depressurization system piping.

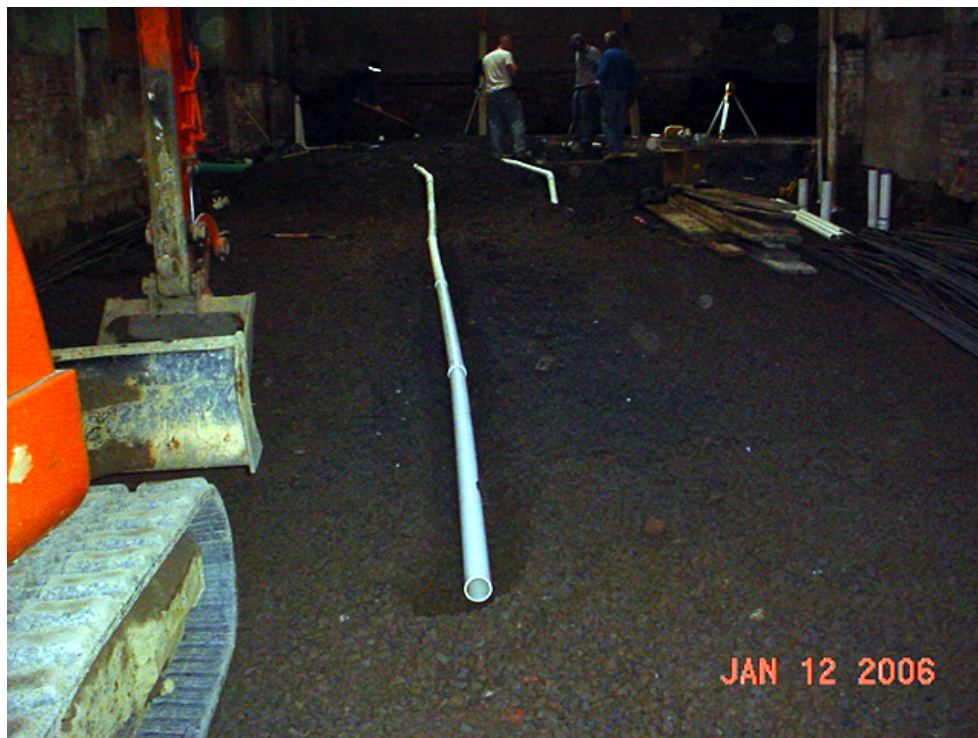
Photo 5 - Installation of 81 Broadway sub-slab depressurization system piping.

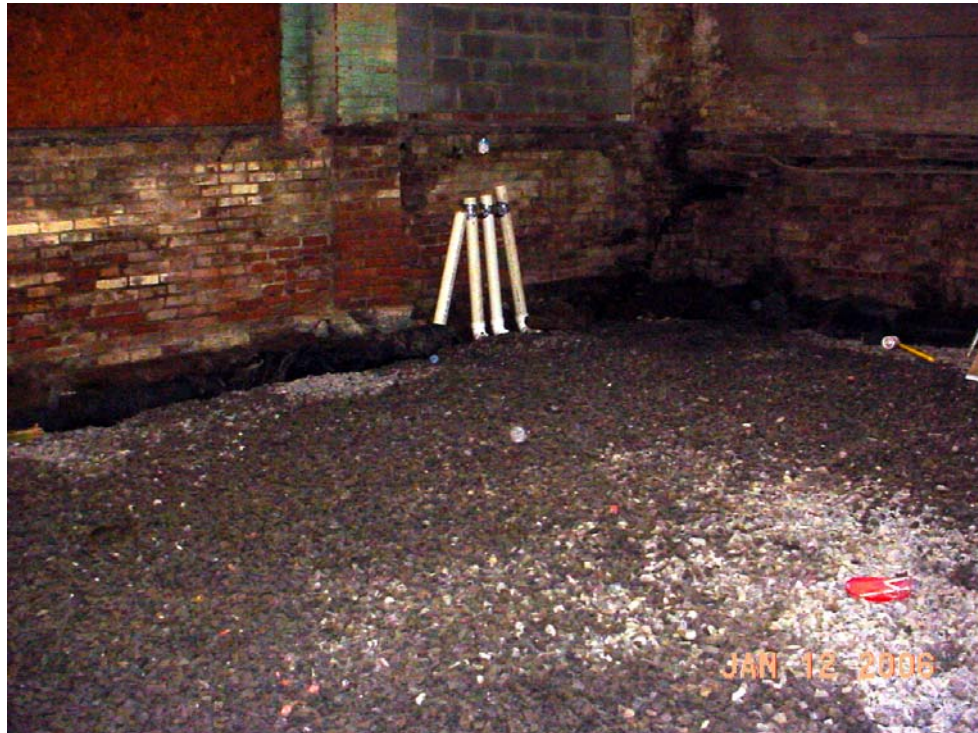
Photo 6 - Gravel placed over SSD piping.

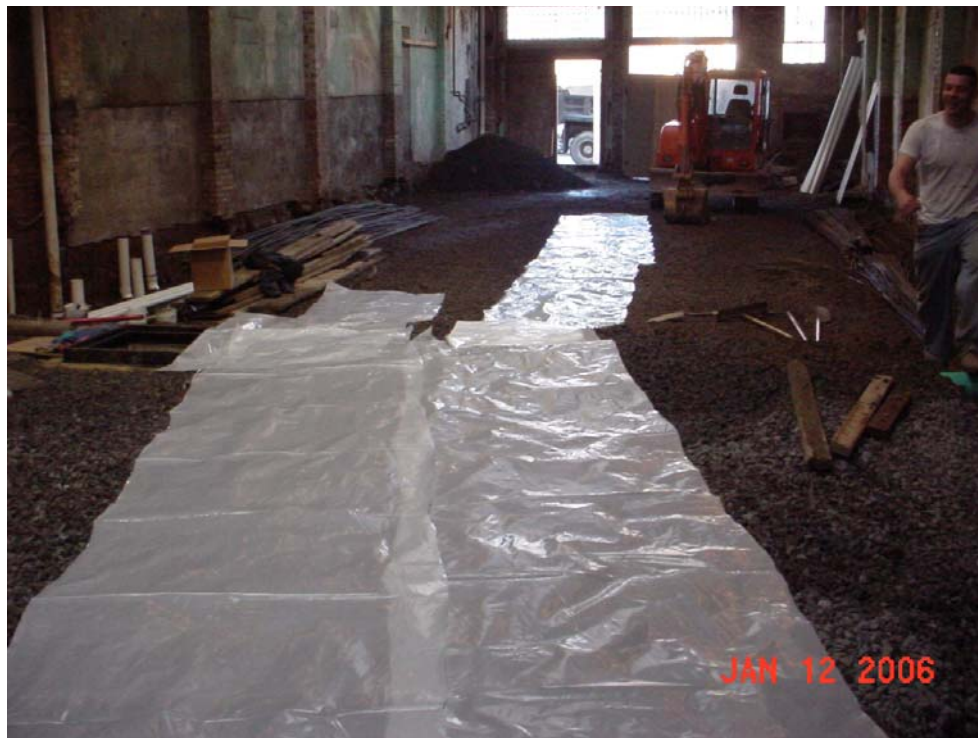
Photo 7 - Preparation for laying out polyethylene sheeting over gravel prior to pouring concrete.

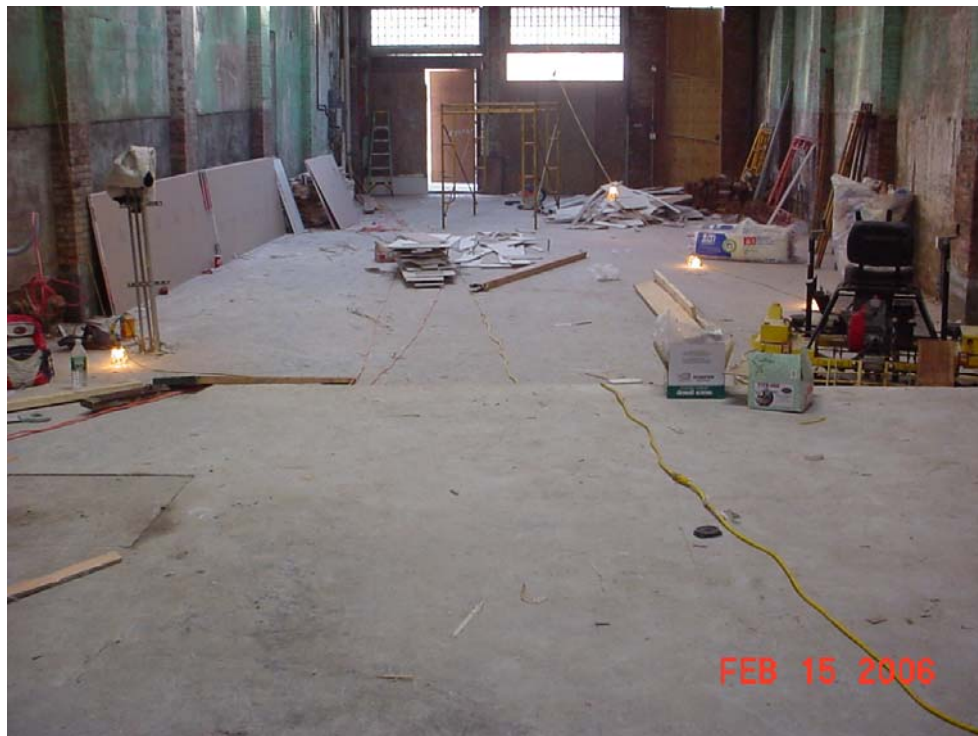
Photo 8 - Finished concrete floor over SSD piping system.

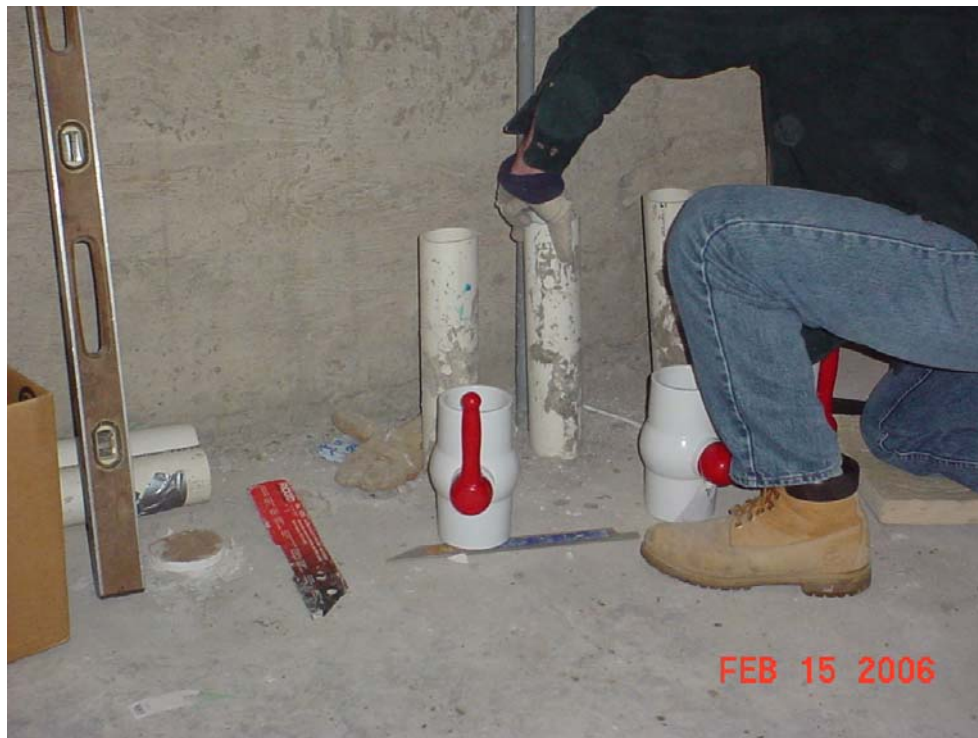
Photo 9 - SSD piping rising out of concrete floor.

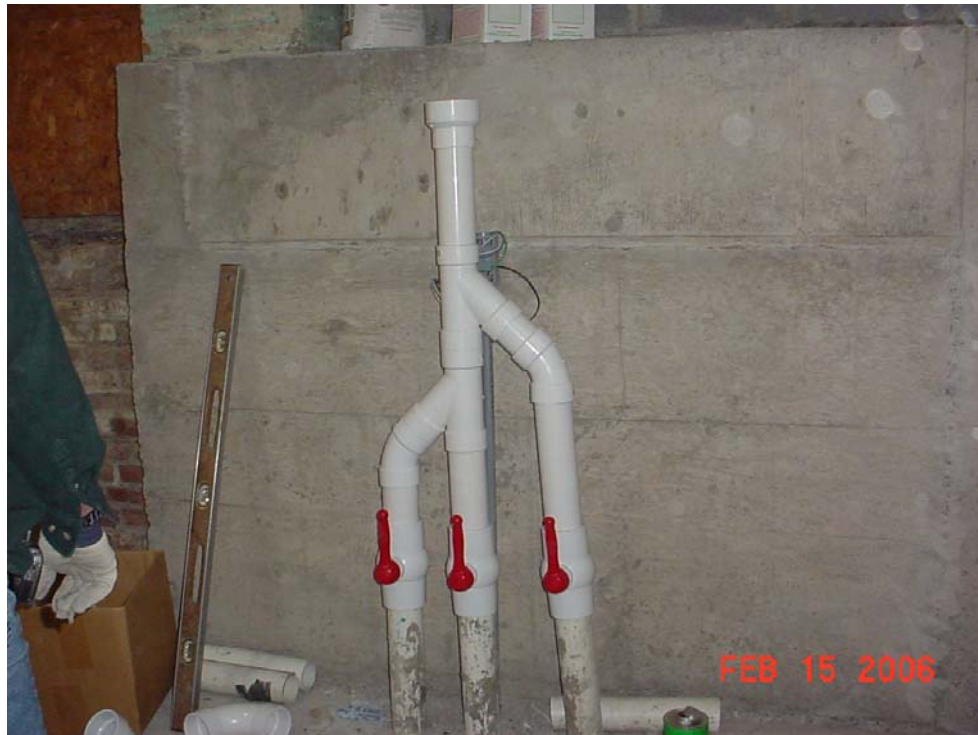
Photo 10 - SSD piping manifolded together.

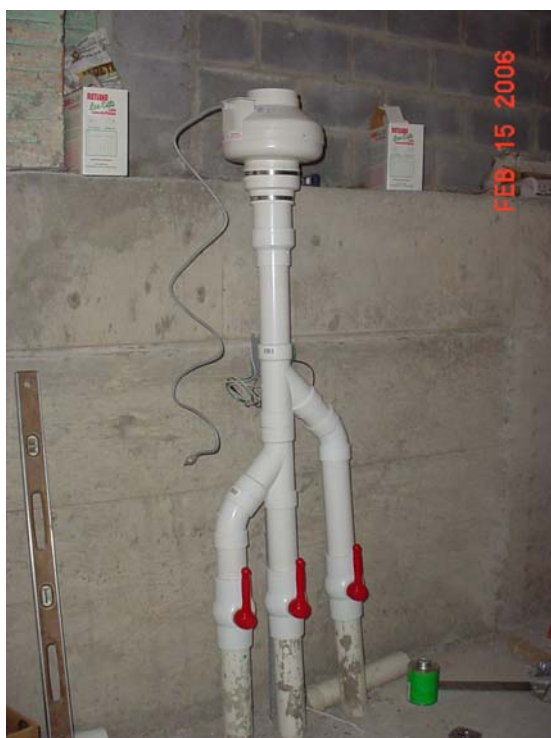
Photo 11 - SSD piping with depressurization fan.

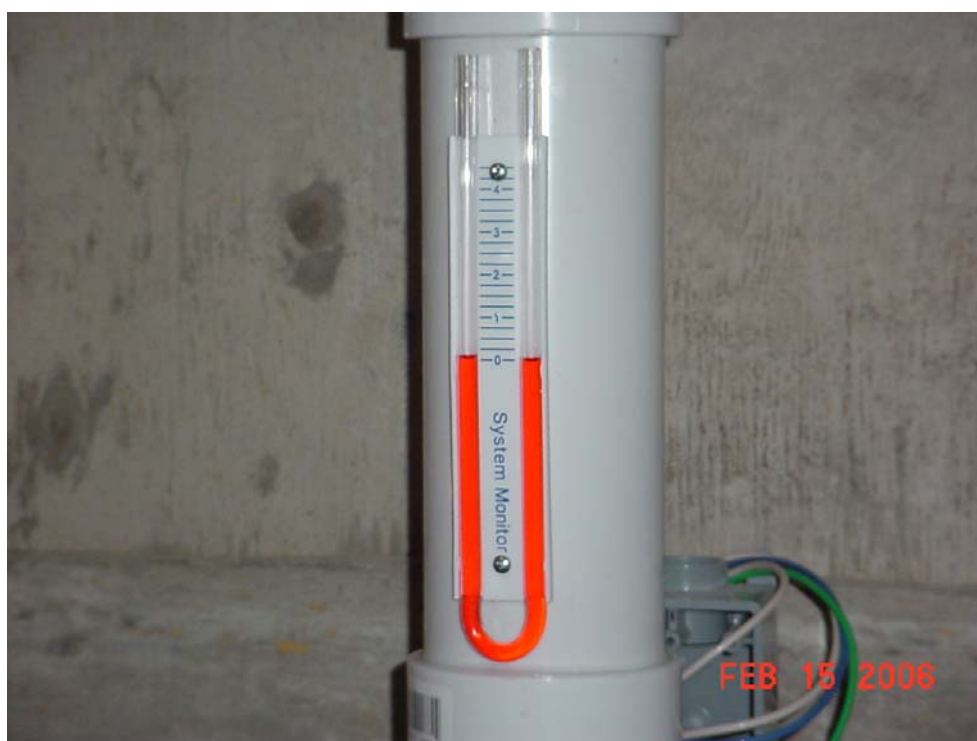
Photo 12 - Visual manometer used to demonstrate fan operation; fan is off.

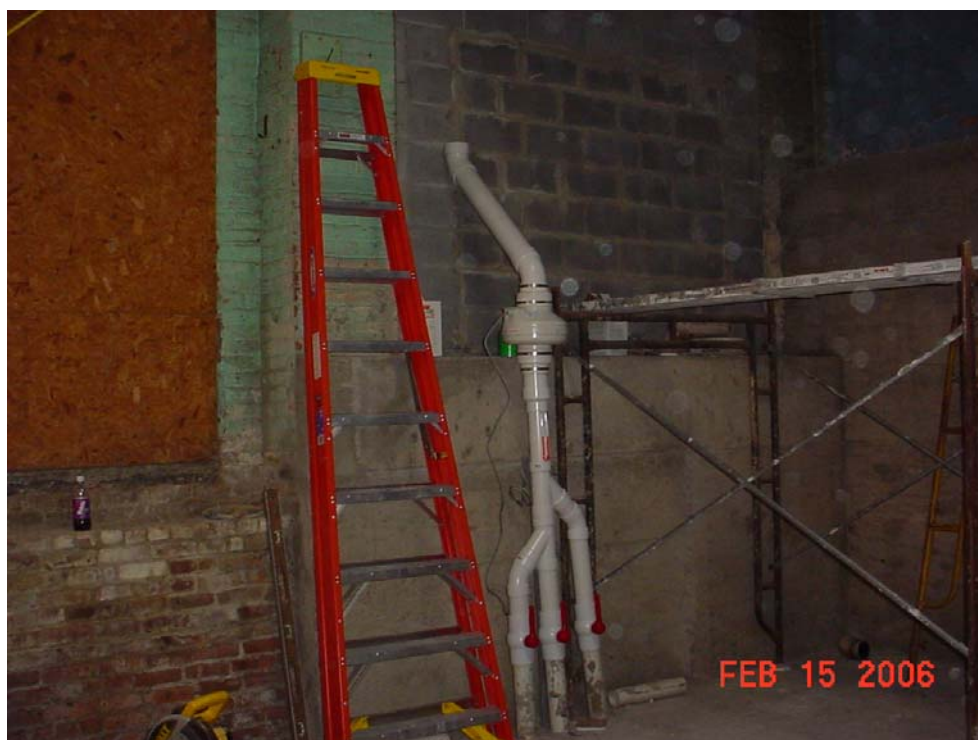
Photo 13 - Riser angled to wall for extension up through roof.

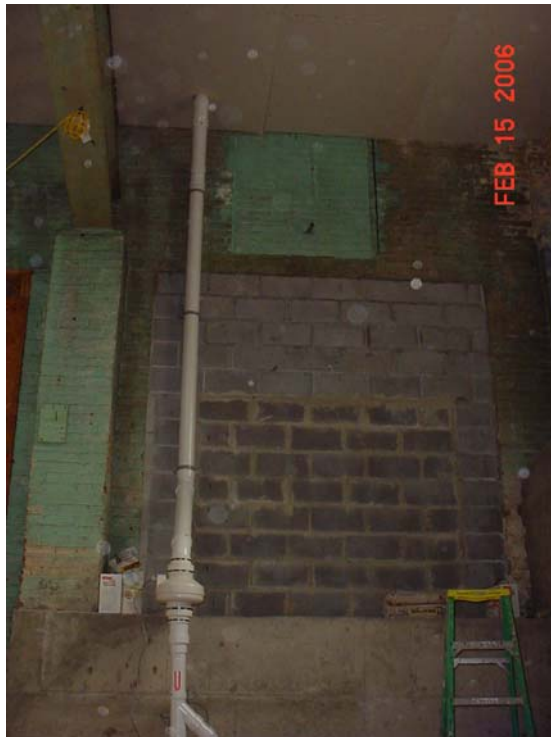
Photo 14 - Completed riser through ceiling.
