# **CONTINENTAL PLACER INC.**

## **SPILL #0505154 CLOSURE REPORT**

**81 Broadway  
Kingston, New York**

September 10, 2010

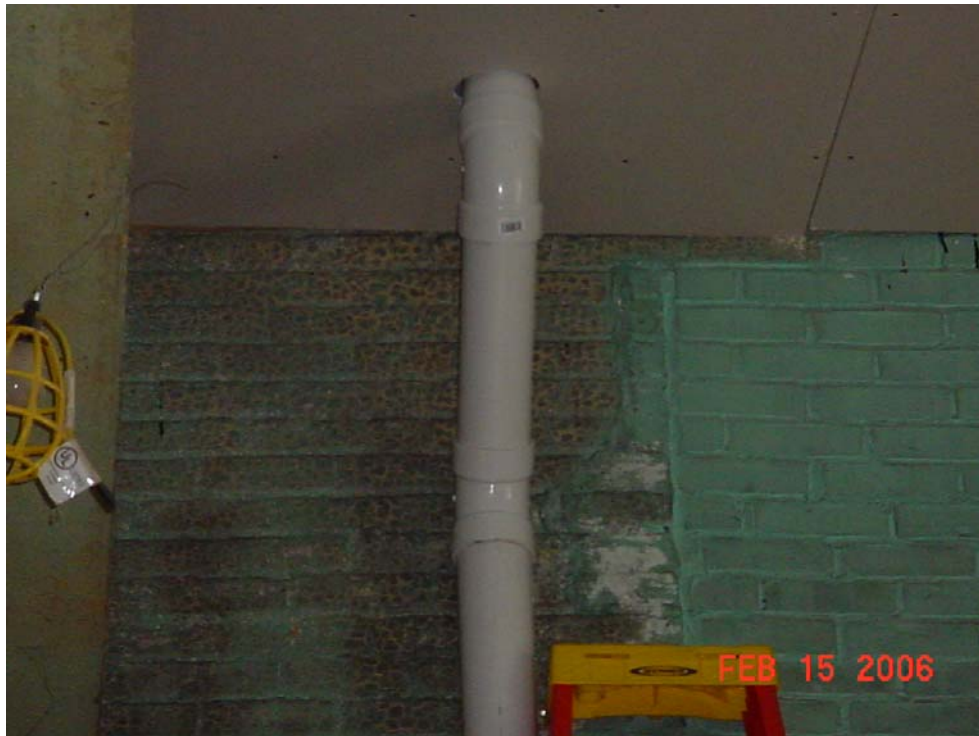
Photo 15 - SSD riser pipe exiting through roof of 81 Broadway.  
Need to insert picture of roof vent

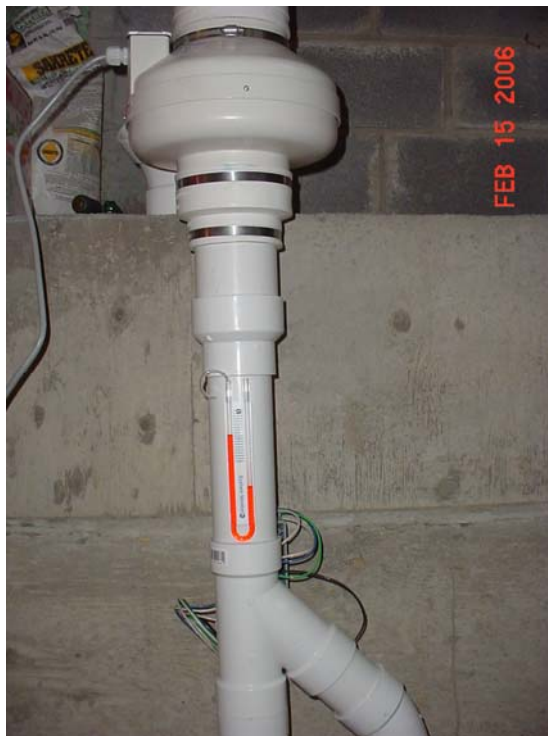
Photo 17 - Visual manometer demonstrating vacuum pressure with fan operating.

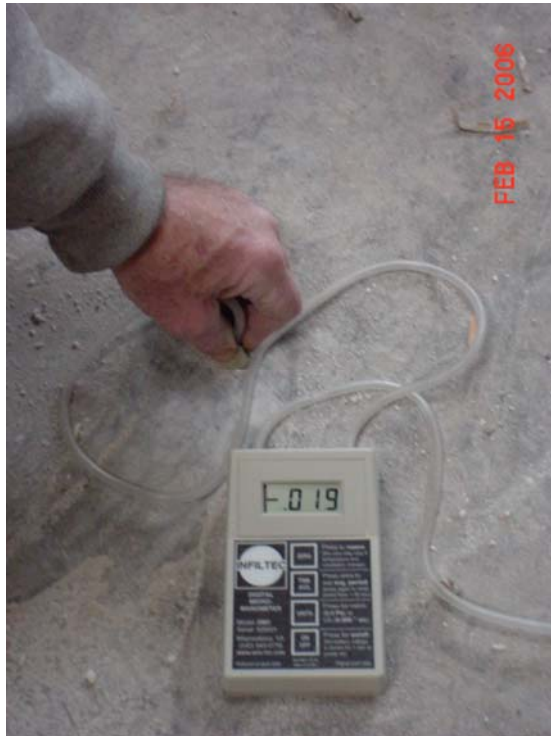
Photo 18 - Measurement of negative pressure under concrete floor using micromanometer.

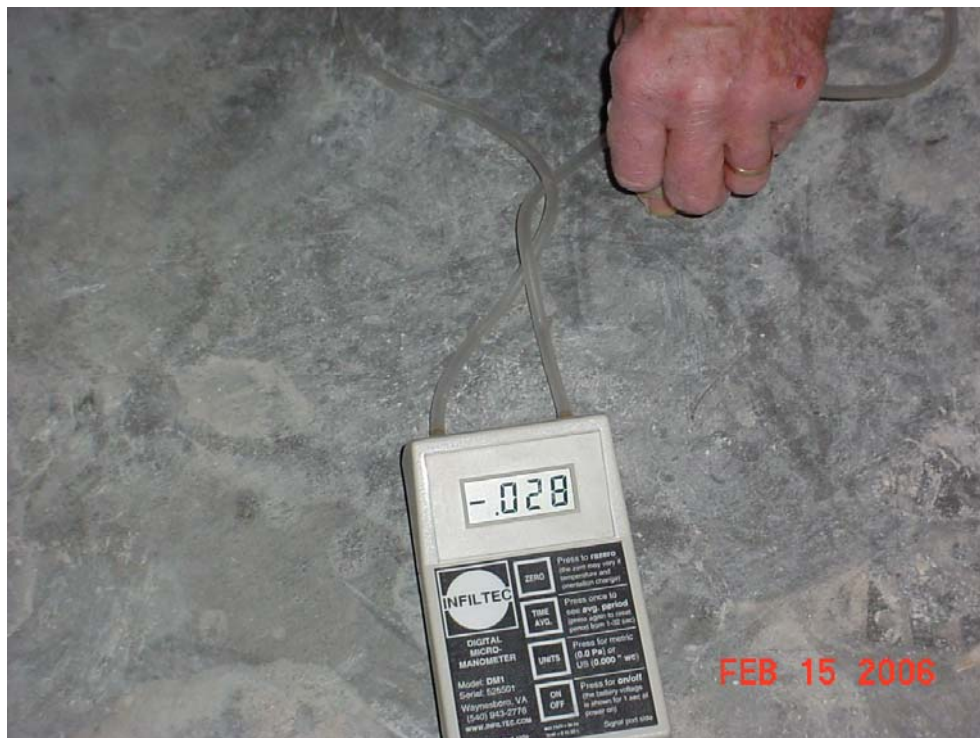
Photo 19 - Measurement of negative pressure under concrete floor using micromanometer.

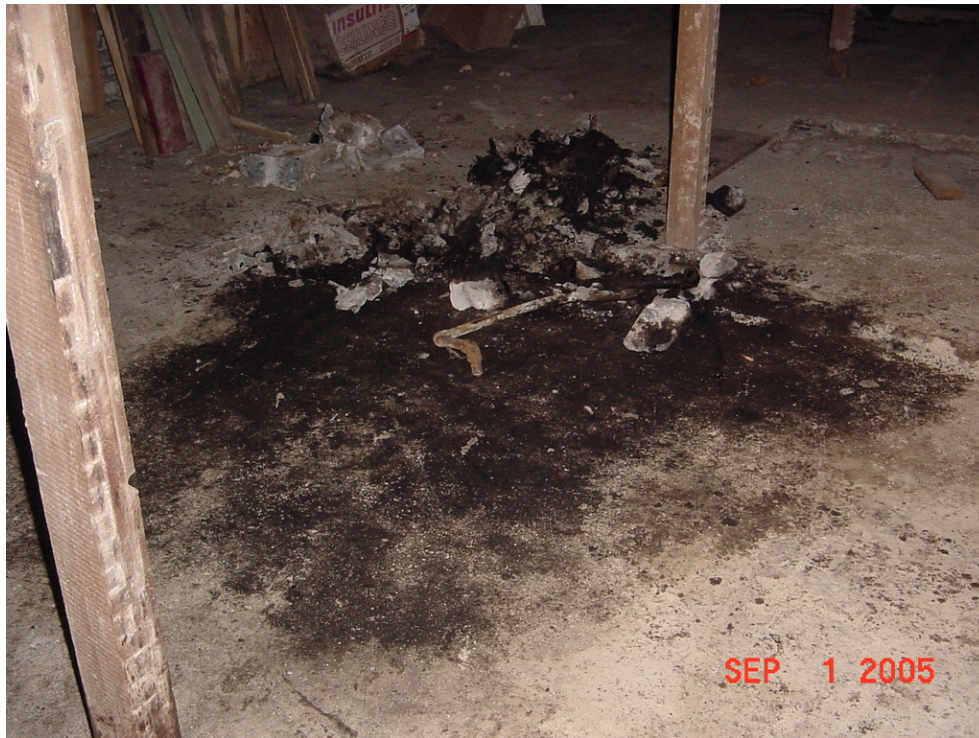
Photo 1 - Stained concrete and piping in 38 Post Street basement.

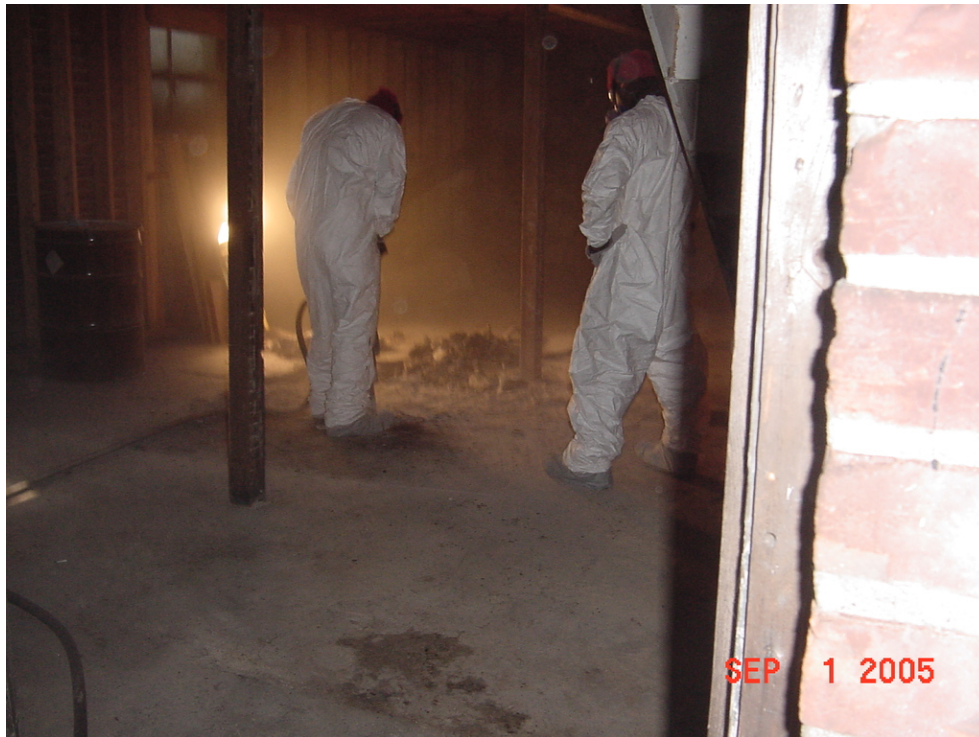
Photo 2 - Concrete and soil removal in 38 Post Street basement.

Starting on September 1, 2005, PIM cut concrete and removed soil from the basement floor of 38 Post Street along and approximately 1 foot below the piping runs leading away from the oil-stained concrete in the middle of the basement floor. Oil-impacted concrete and soil were placed in a covered, roll-off dumpster placed in the fenced-in side yard of 42 Post Street, which was also owned by Kingston Trio, L.L.C. The oil-impacted soil and concrete was subsequently disposed (March 17, 2006) at CWM Chem Services at Model City in Niagara Falls. Disposal manifests are provided in Attachment G and analysis of the waste material for disposal characterization is provided in Attachment D.

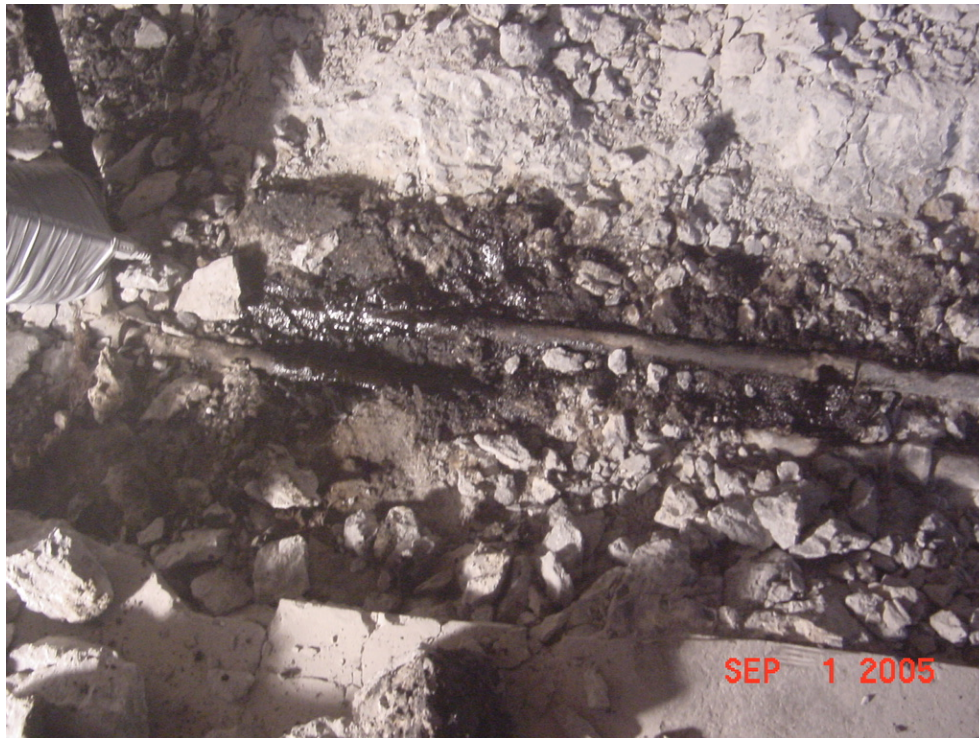
Photo 3 – Oily piping in concrete floor of 38 Post Street.

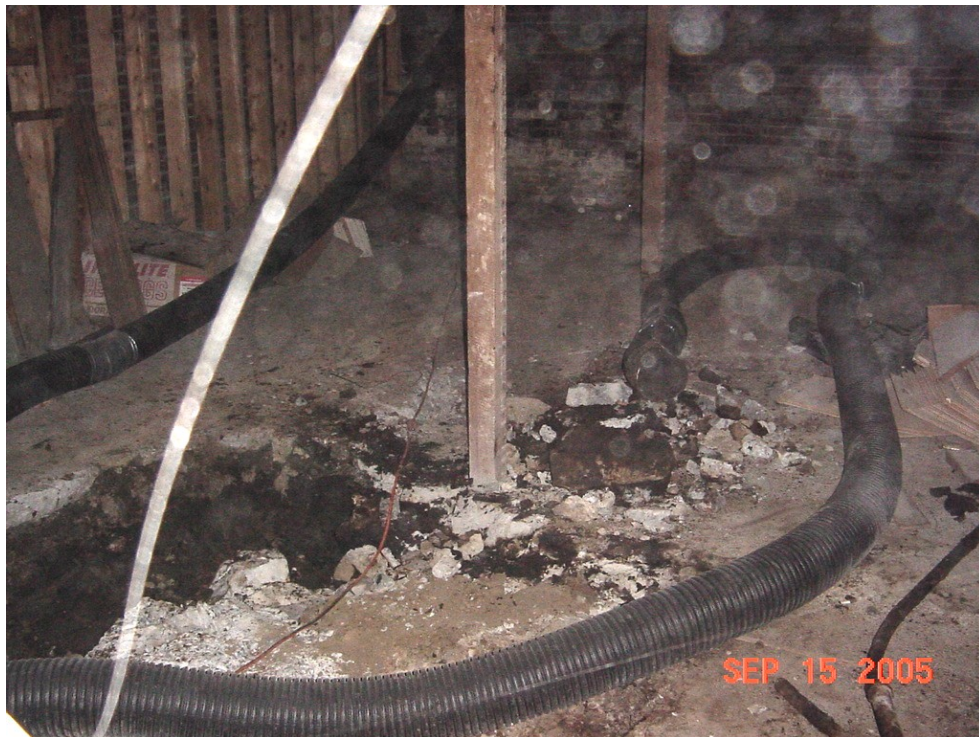
Photo 4 – Soil and concrete excavation in 38 Post Street basement.

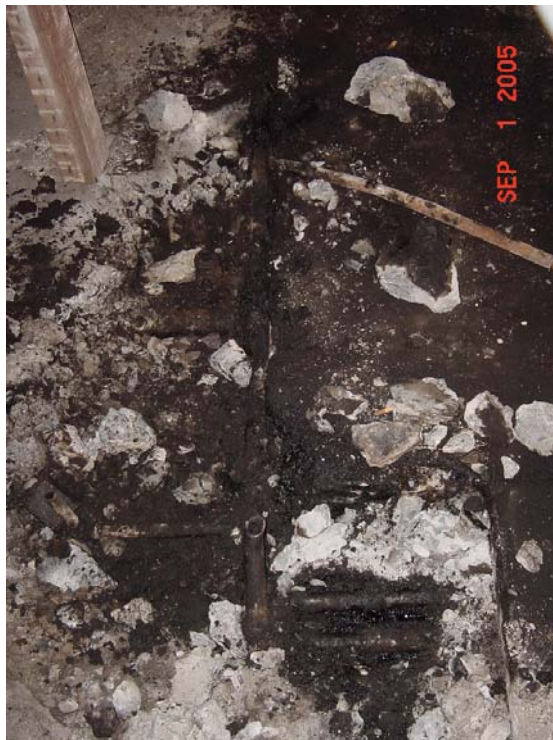
Photo 5 - Oily piping below concrete in 38 Post Street basement.

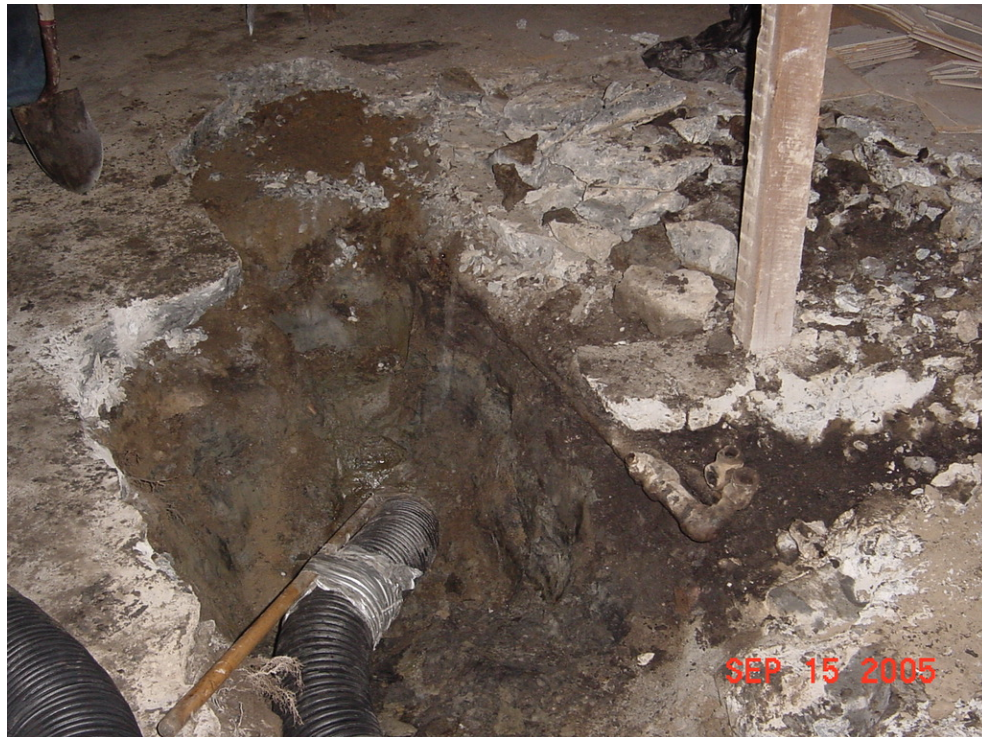
Photo 6 - Concrete and soil excavation in 38 Post Street basement.

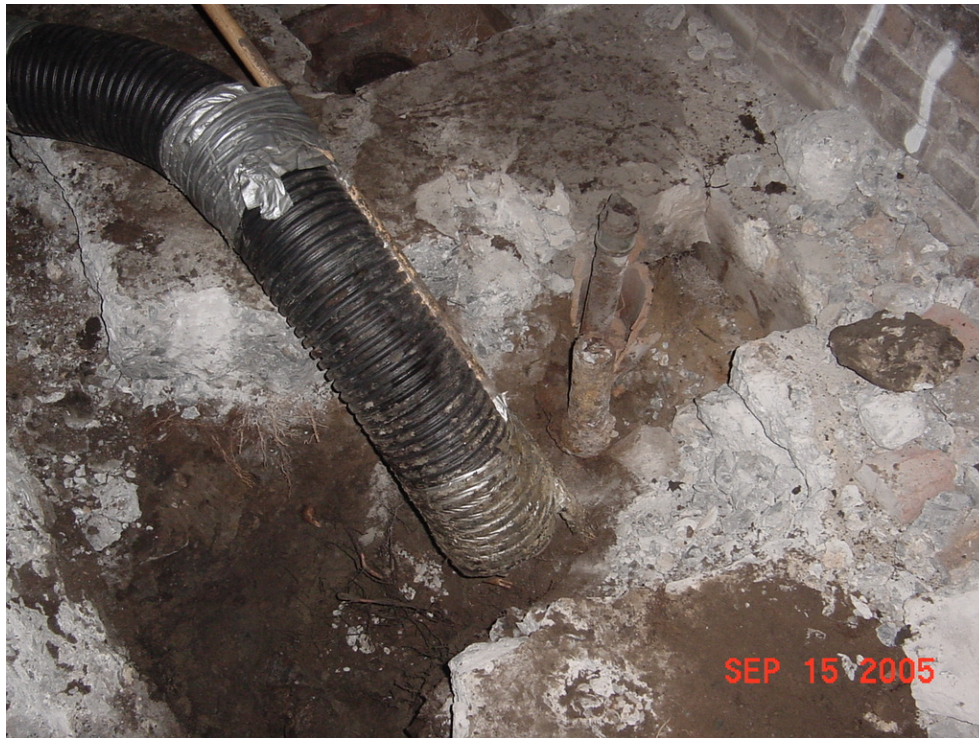
Additional piping was also identified below the basement floor concrete slab in 38 Post Street. This piping leads southeastward and elbows up through the concrete floor where it is cutoff at the floor surface along the eastern wall of the basement. The piping in the center of the basement area appeared corroded and past, historic releases of oil from this piping was apparent. There are also cutoff pipes along the northern wall of the basement, near a floor drain. The concrete was cut and removed around these pipes. One of these pipes elbows and connects with the floor drain pipe, which was determined to discharge from a clay pipe into 81 Broadway. The other one goes downward to connect to a clay tile pipe that continues downward. These pipes did not appear to be used for oil transmission.

Photo 7 - Piping cut at concrete floor surface along eastern wall of 38 Post Street basement.

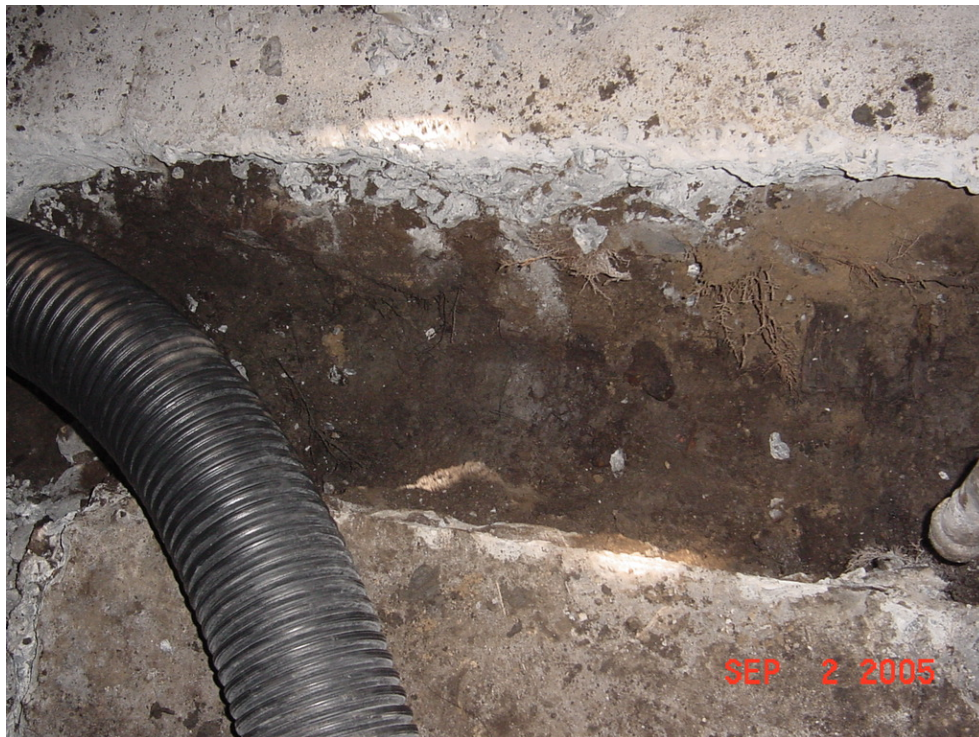
Photo 8 - Trench excavated across basement floor to pipes along eastern basement wall.

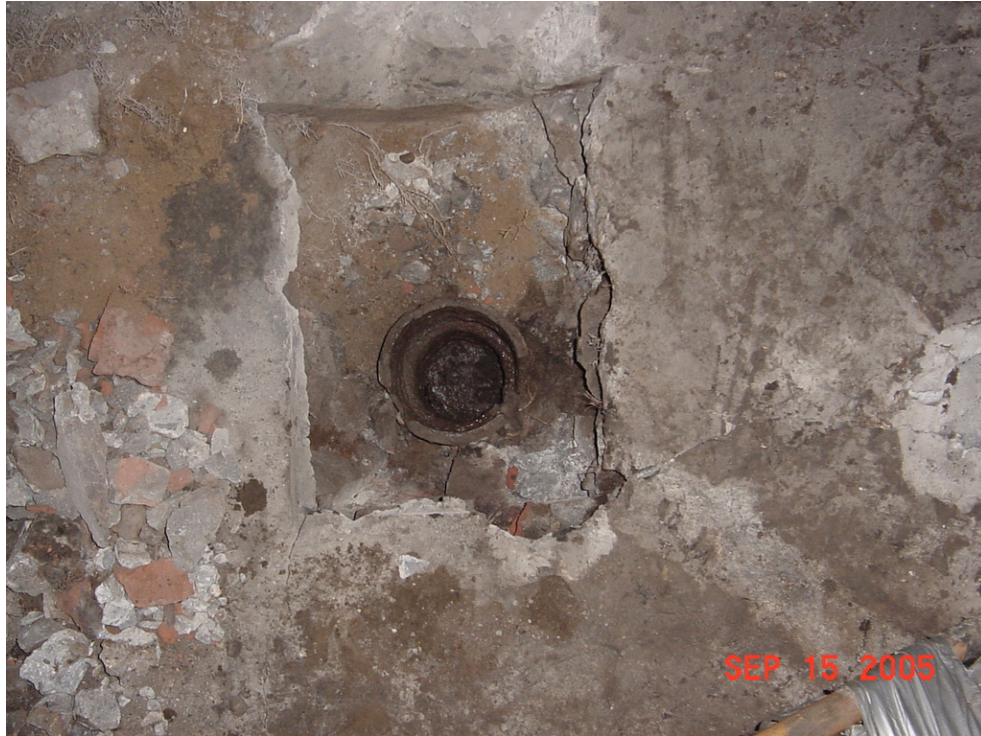
Photo 9 - Floor drain in concrete floor at 38 Post Street basement.

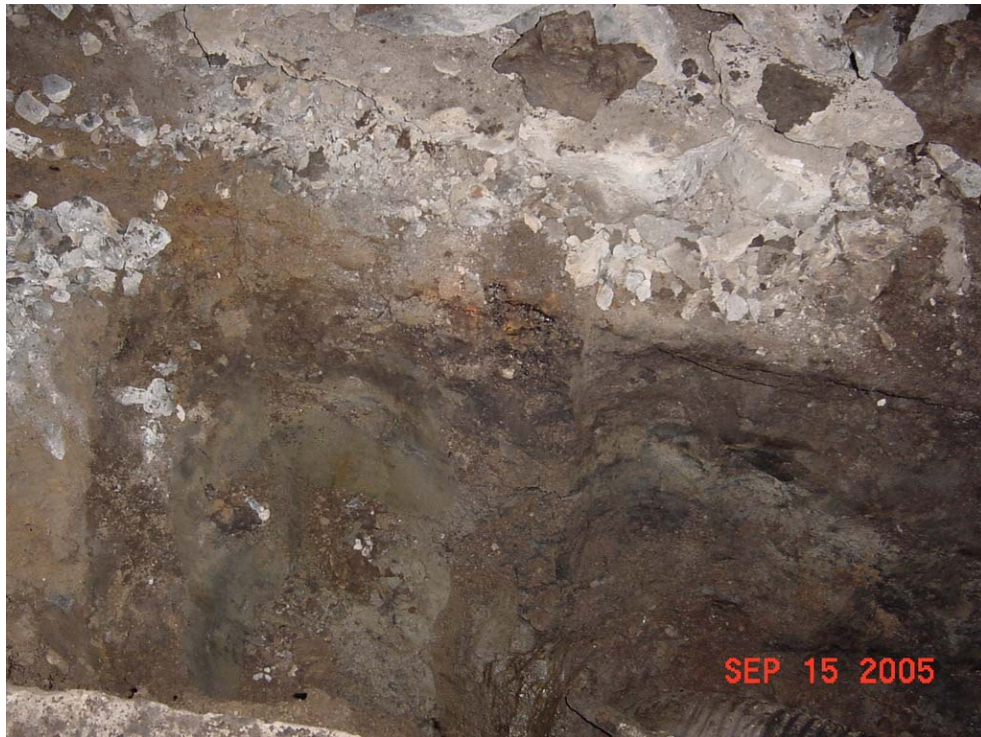
Photo 10 - Limit of excavation in 38 Post Street excavation.

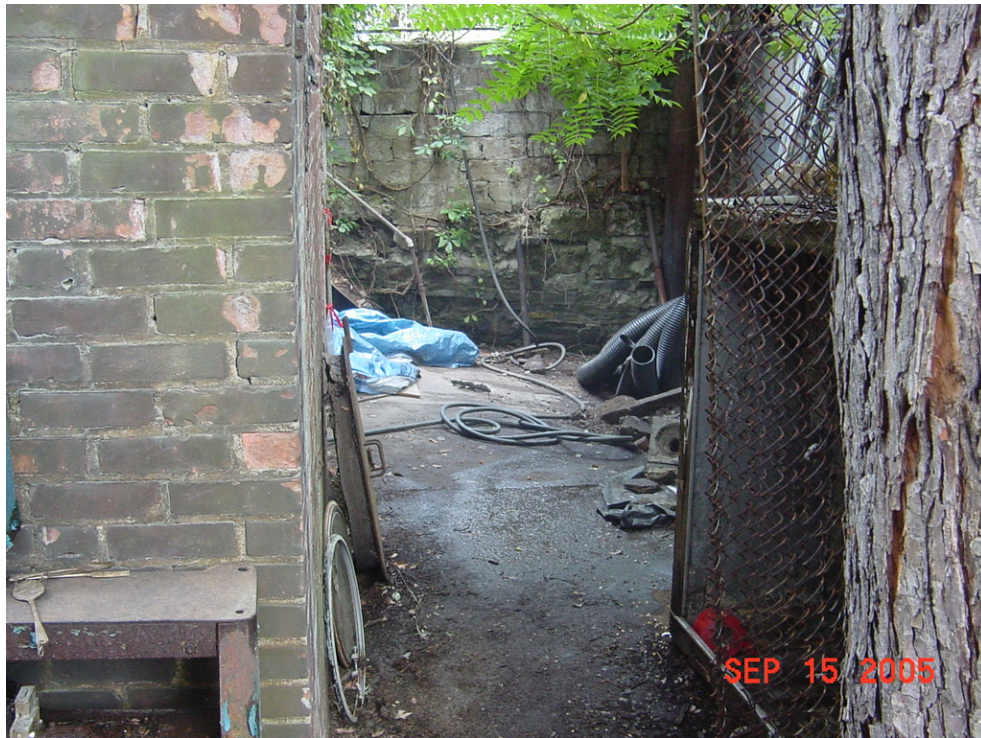
Photo 1 - Area between 38 Post Street and 81 Broadway; brick wall is 38 Post Street building.

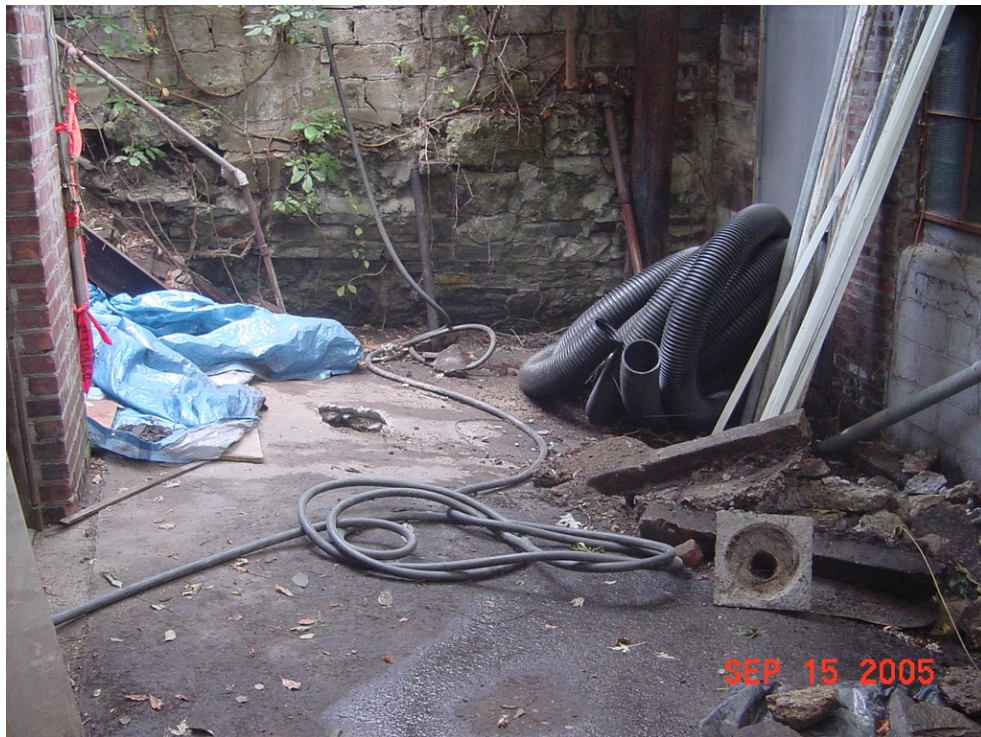
Photo 2 - Area between 38 Post Street and 81 Broadway; UST is covered by blue tarp between stair way and brick wall.

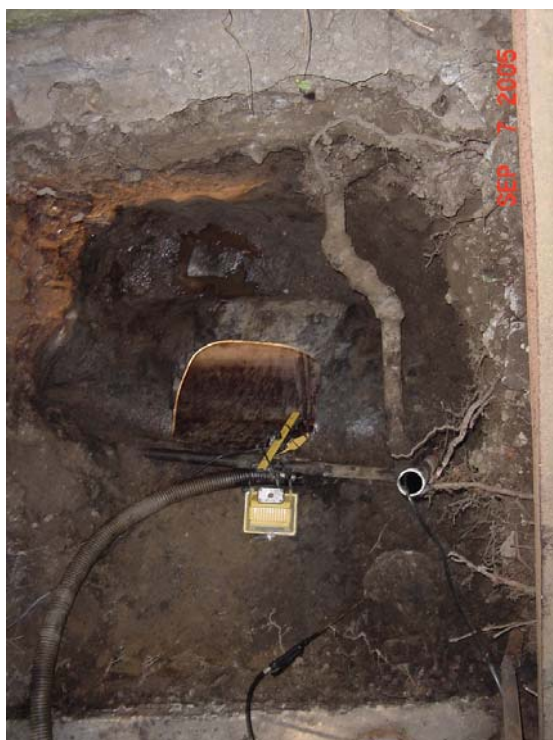
Photo 3 - Uncovered 1,500 gallon UST behind 38 Post Street.

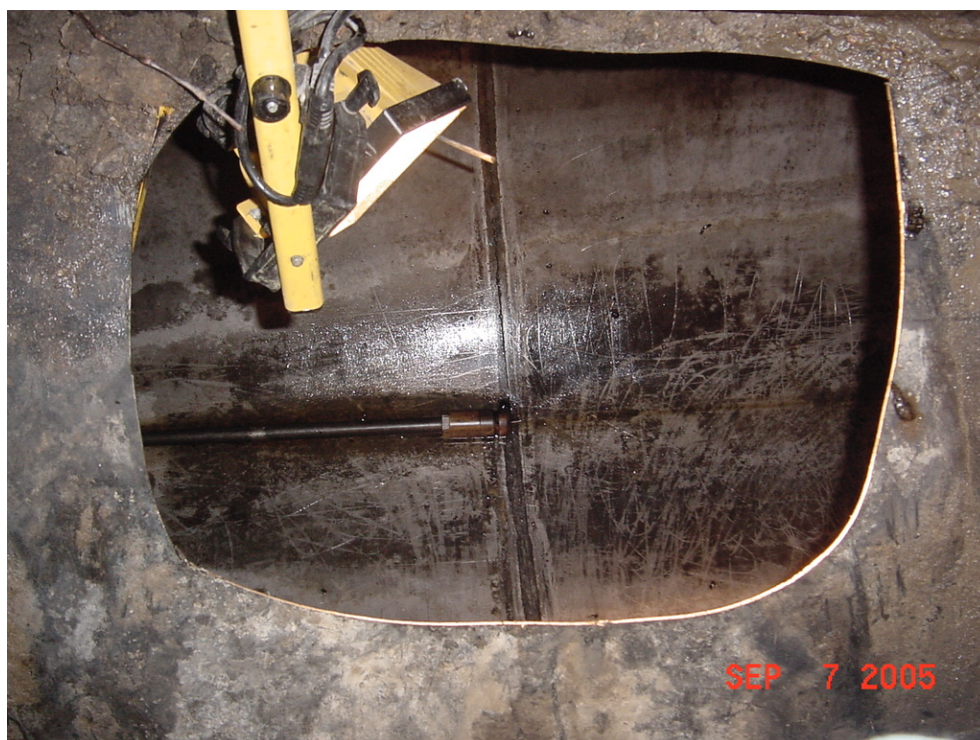
Photo 4 - 1,500 gallon UST opened and cleaned.

Further, tetrachloroethene tainted oil was removed from a leaking UST at the neighboring 38 Post Street, which removed the source of contamination affecting 81 Broadway. This UST was cleaned and closed in-place. With the removal of the oil in the leaking UST and the installation of the SSD in 81 Broadway, sufficient remedial activities have been performed to allow protection of occupants of 81 Broadway from exposure to

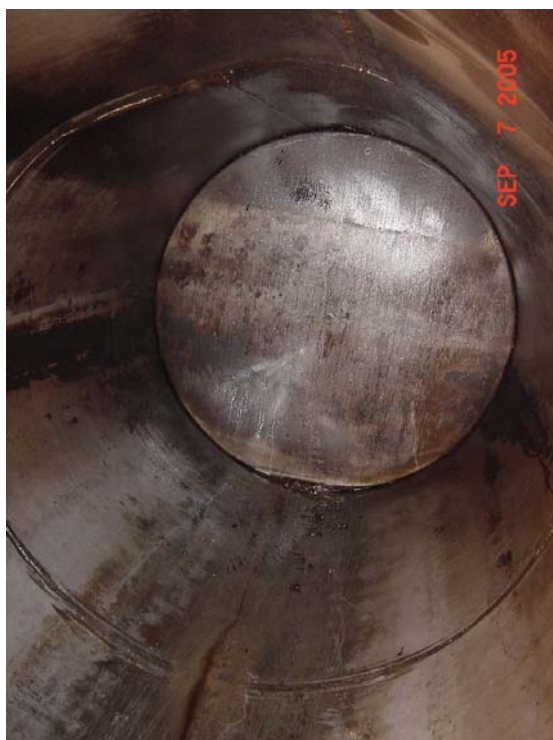
Photo 5 - Inside of cleaned 1,500 gallon UST.

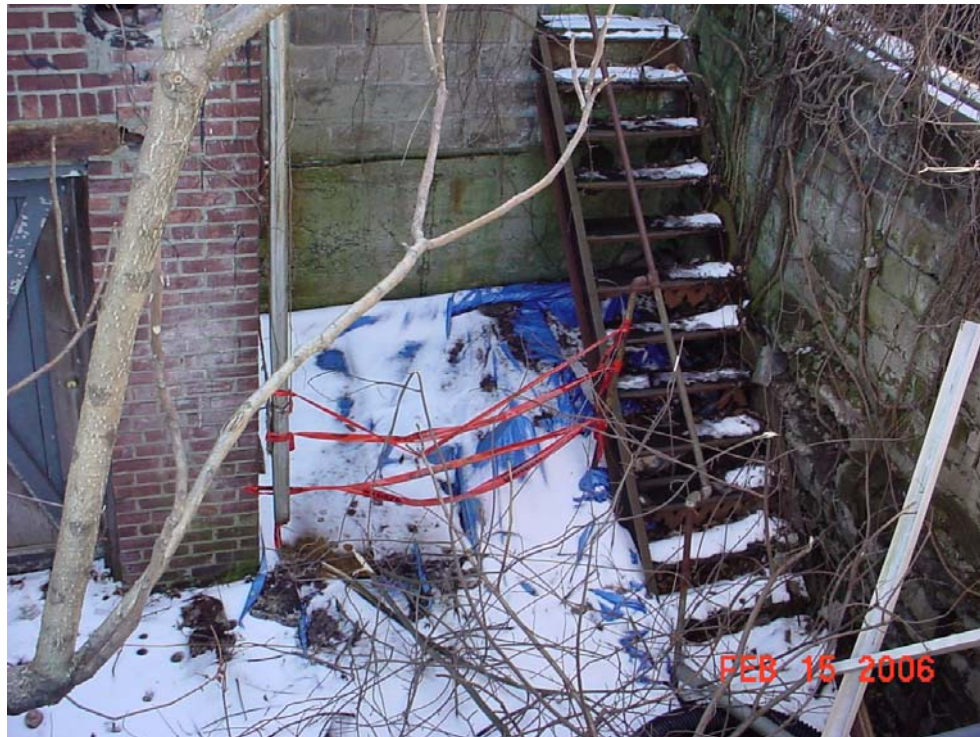
Photo 6 - 1,500 gallon UST location with cover to prevent precipitation from entering tank.

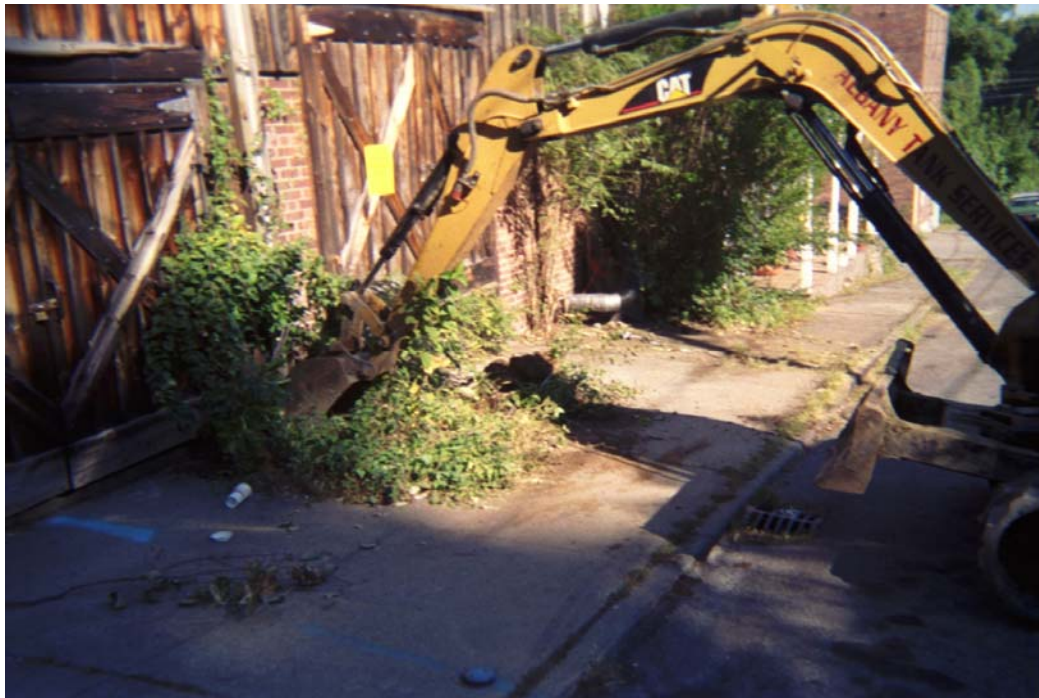
Excavation was also performed by ATS on September 6, 2005 below the sidewalk in front, south of 38 Post Street to attempt to locate the two USTs reportedly closed in-place in 1997. A single, filled-in UST, estimated to be 4,000-gallon capacity, was uncovered below the side walk in front, south of 38 Post Street. A manway had been cut into the western end of the tank. A vent pipe was still connected to the eastern end of the tank. When the vent pipe was broken off, liquid was observed in the eastern portion of the tank. The tank was dipped and approximately 1 foot of liquid appearing to be water was present. It was apparent that the fill placed in the tank from the manway on the western end of the tank had not completely filled the tank.

Photo 1 - Excavating to locate USTs below sidewalk in front of 38 Post Street.

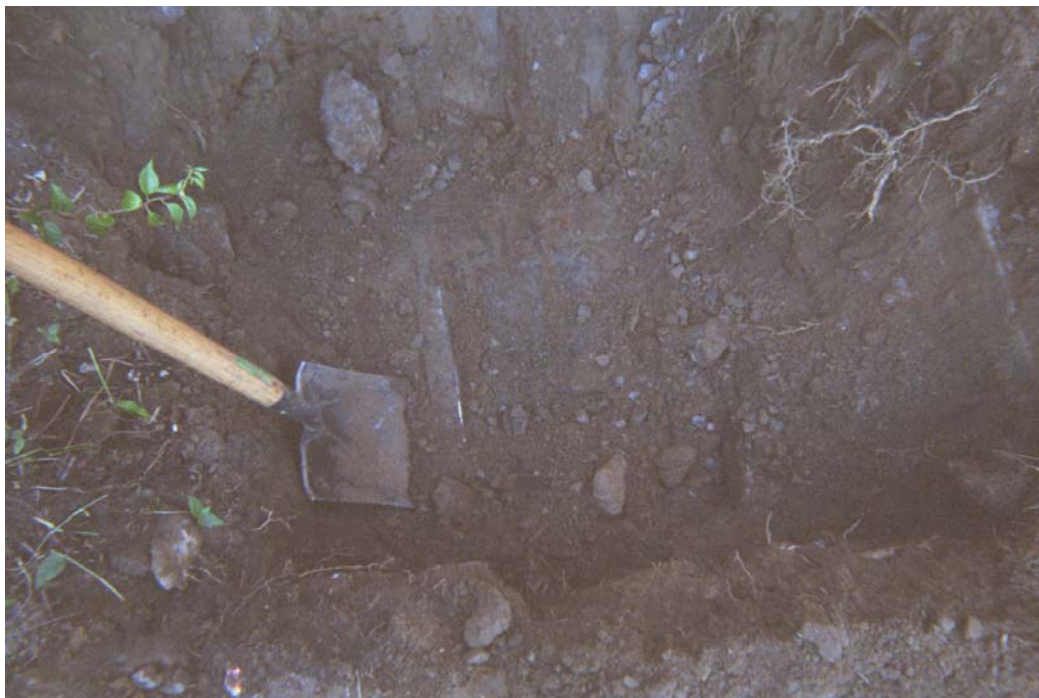
Photo 2 - Top of western portion of 4,000-gallon closed in-place UST below sidewalk in front of 38 Post Street.

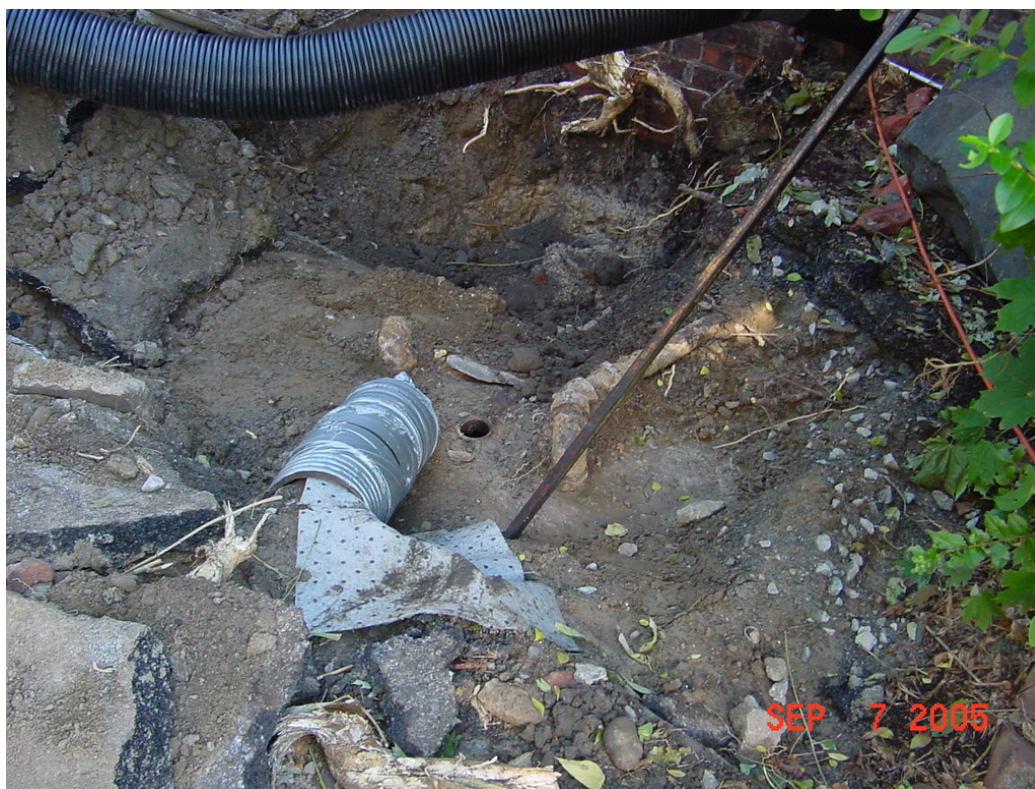
Photo 3 – Top of eastern portion of 4,000-gallon UST showing vent pipe.

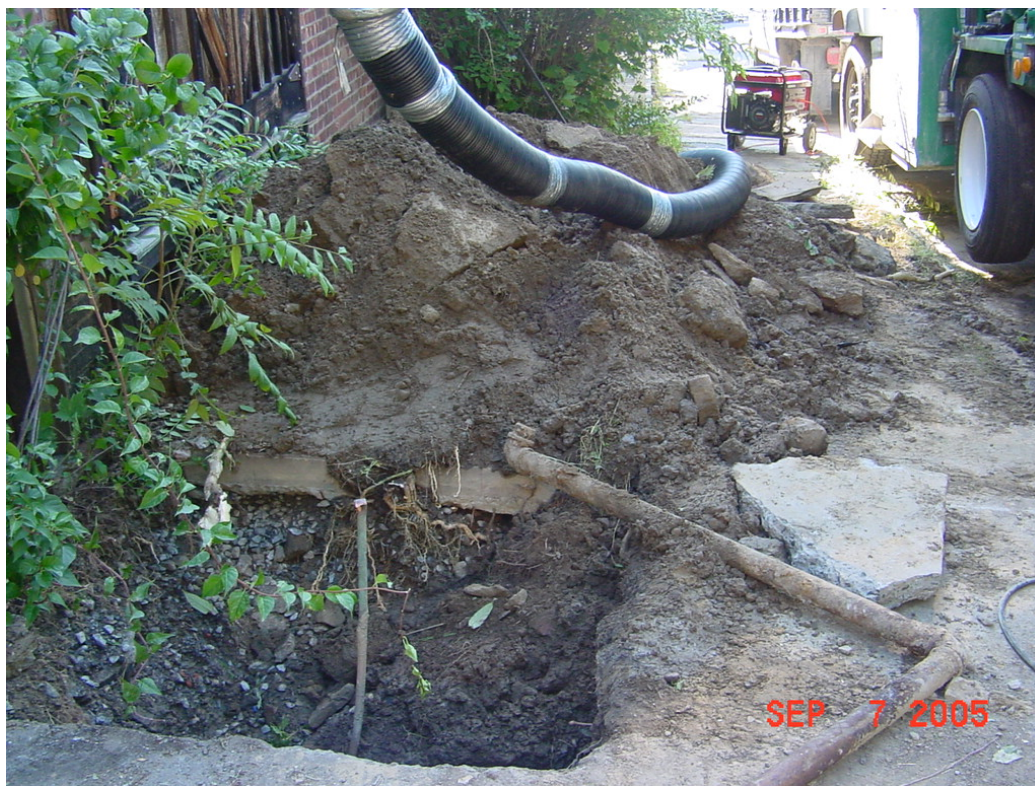
Soil sampling was also performed using a hand auger adjacent to the filled-in tank south of 38 Post Street. On September 7, 2005, a soil sample was collected from the northeast side of the tank at a depth of approximately 6 feet below the top of the tank. On September 14, 2005 another soil sample was collected using a hand auger from the northwest side of the tank at a depth of approximately 6 feet below the top of the tank. This sample was collected a week later because when excavating on the western end of the tank the 38 Post Street water line was broken, which flooded that portion of the excavation.

Photo 4 – Excavation area around 4,000-gallon UST in front of 38 Post Street showing broken water line pipe and broken UST vent pipe.
