To: Josephine Class/Tim Zengen, Orthopedic Associates
From: Emily Pereira/Dan Michaud
Date: July 16, 2009
Re: 25 Field Court Property: Supplemental Phase II Summary
Job #: 20910.00

Draft Figure - Groundwater/Vapor Sample Locations

25 Field Court
 City of Kingston
 Ulster County, New York

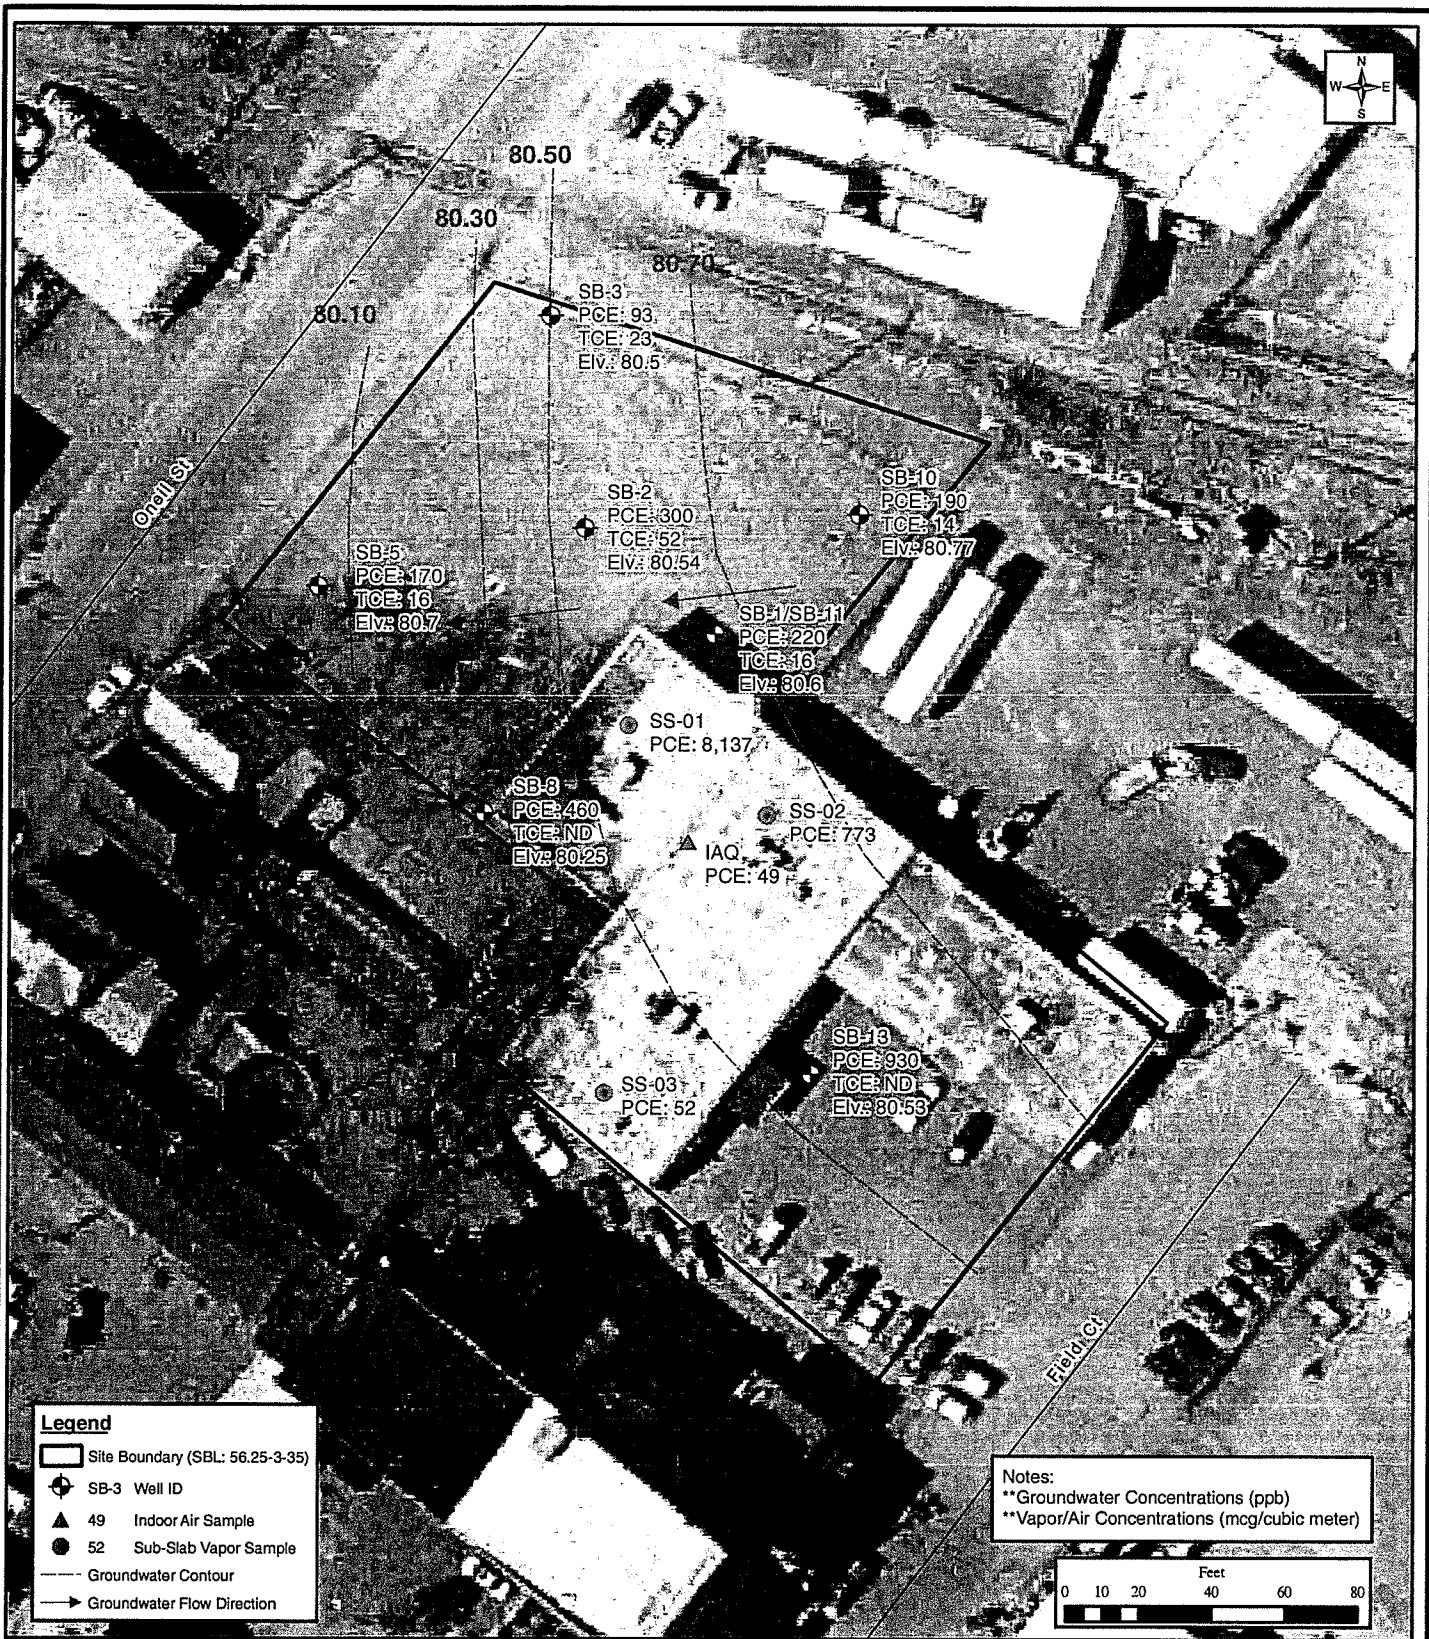
- Newly installed wells 8, 10, 11, 13 contained PCE at concentrations of 460, 190, 220 and 930, respectively (attached figure). The occurrence of PCE in all onsite wells indicate a historical spill occurred that has affected the site's groundwater aquifer.

- Groundwater flow through the site occurs in a southwesterly direction, towards the corner of Broadway and O'Neil Street.
- GC soil screening indicated potential surface spilling of PCE in the vicinity of SB-9, SB-10, SB-11 and SB-12 at shallow depths, however the concentrations of PCE in soils were low. Our soil boring locations may have been positioned marginal to the actual former spill location. Impacted soils at the surface could indicate poor housekeeping related to former temporary storage of waste oils and chemicals, and/or be related to former subsurface disposal systems such as a drywell. More sampling is needed to locate the source of subsurface contamination.

- Sub-slab air sampling revealed elevated concentrations of PCE in all three locations and the detection of various other VOCs. The highest PCE concentration (SS-01 at 8,137 ug/m³) was collected from beneath the northwestern portion of the structure. Coupled with the indoor air PCE concentration of 49 ug/m³, the NYSDOH and NYSDEC will most likely require that sub-slab depressurization system (SSDS) be installed at part or all of this structure. Several additional samples are needed to determine whether the entire building must be depressurized.

- Elevated PCE in groundwater near and just downgradient of the former auto garage corresponds well to the highest concentration of PCE detected in air samples beneath the slab of the building. The combined datasets point to a historical onsite spill near the southeast corner of the former garage; however, given the highest PCE concentration at the south end of the site, more soil and groundwater sampling would be needed to seek the origin of the spill.

We previously recommended that a spill be reported to the NYSDEC after the initial findings of PCE in groundwater. It does not appear that a spill has yet been reported for the site. Based on groundwater and air sampling data collected at the site from both stages of the investigation, we now again recommend that these findings be reported to the NYSDEC's Division of Environmental Remediation Region 3 office or by contacting the NYSDEC's general Spill Hotline. By calling the Region 3 office directly to report the spill, we can discuss with them whether your organization could qualify as a volunteer in
