PHASE II SUBSURFACE INVESTIGATION REPORT

Kingston Portfolio - The Shirt Factory
77 Cornell Street
Kingston, New York 12401

January 3, 2019
Partner Project Number: 18-228431.6

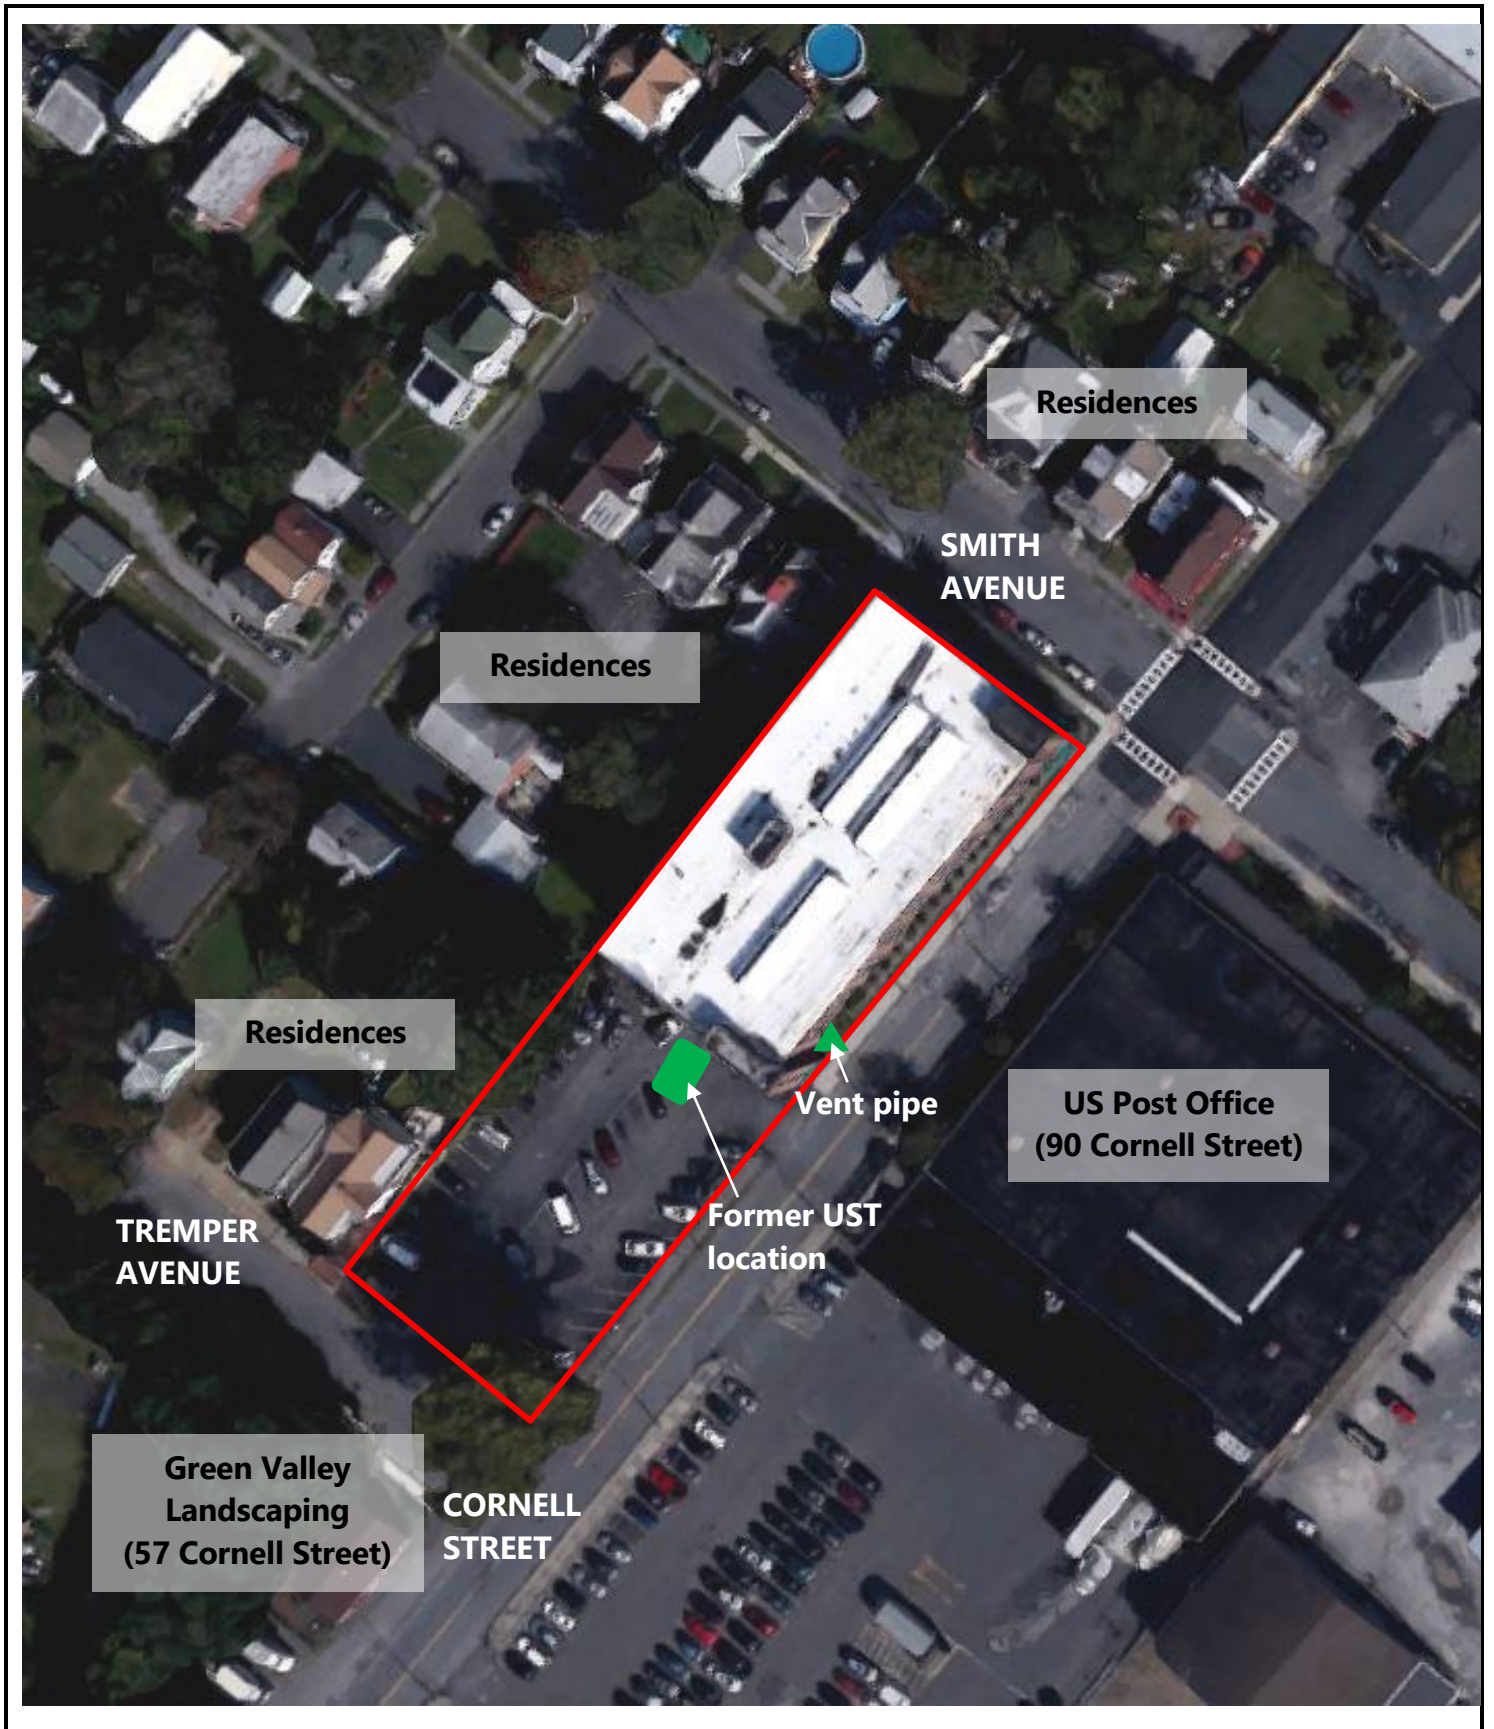
FIGURE 1: SITE PLAN
 Project No. 18-228431.6

Refer to Figure 1 for a site plan showing site features and surrounding properties.

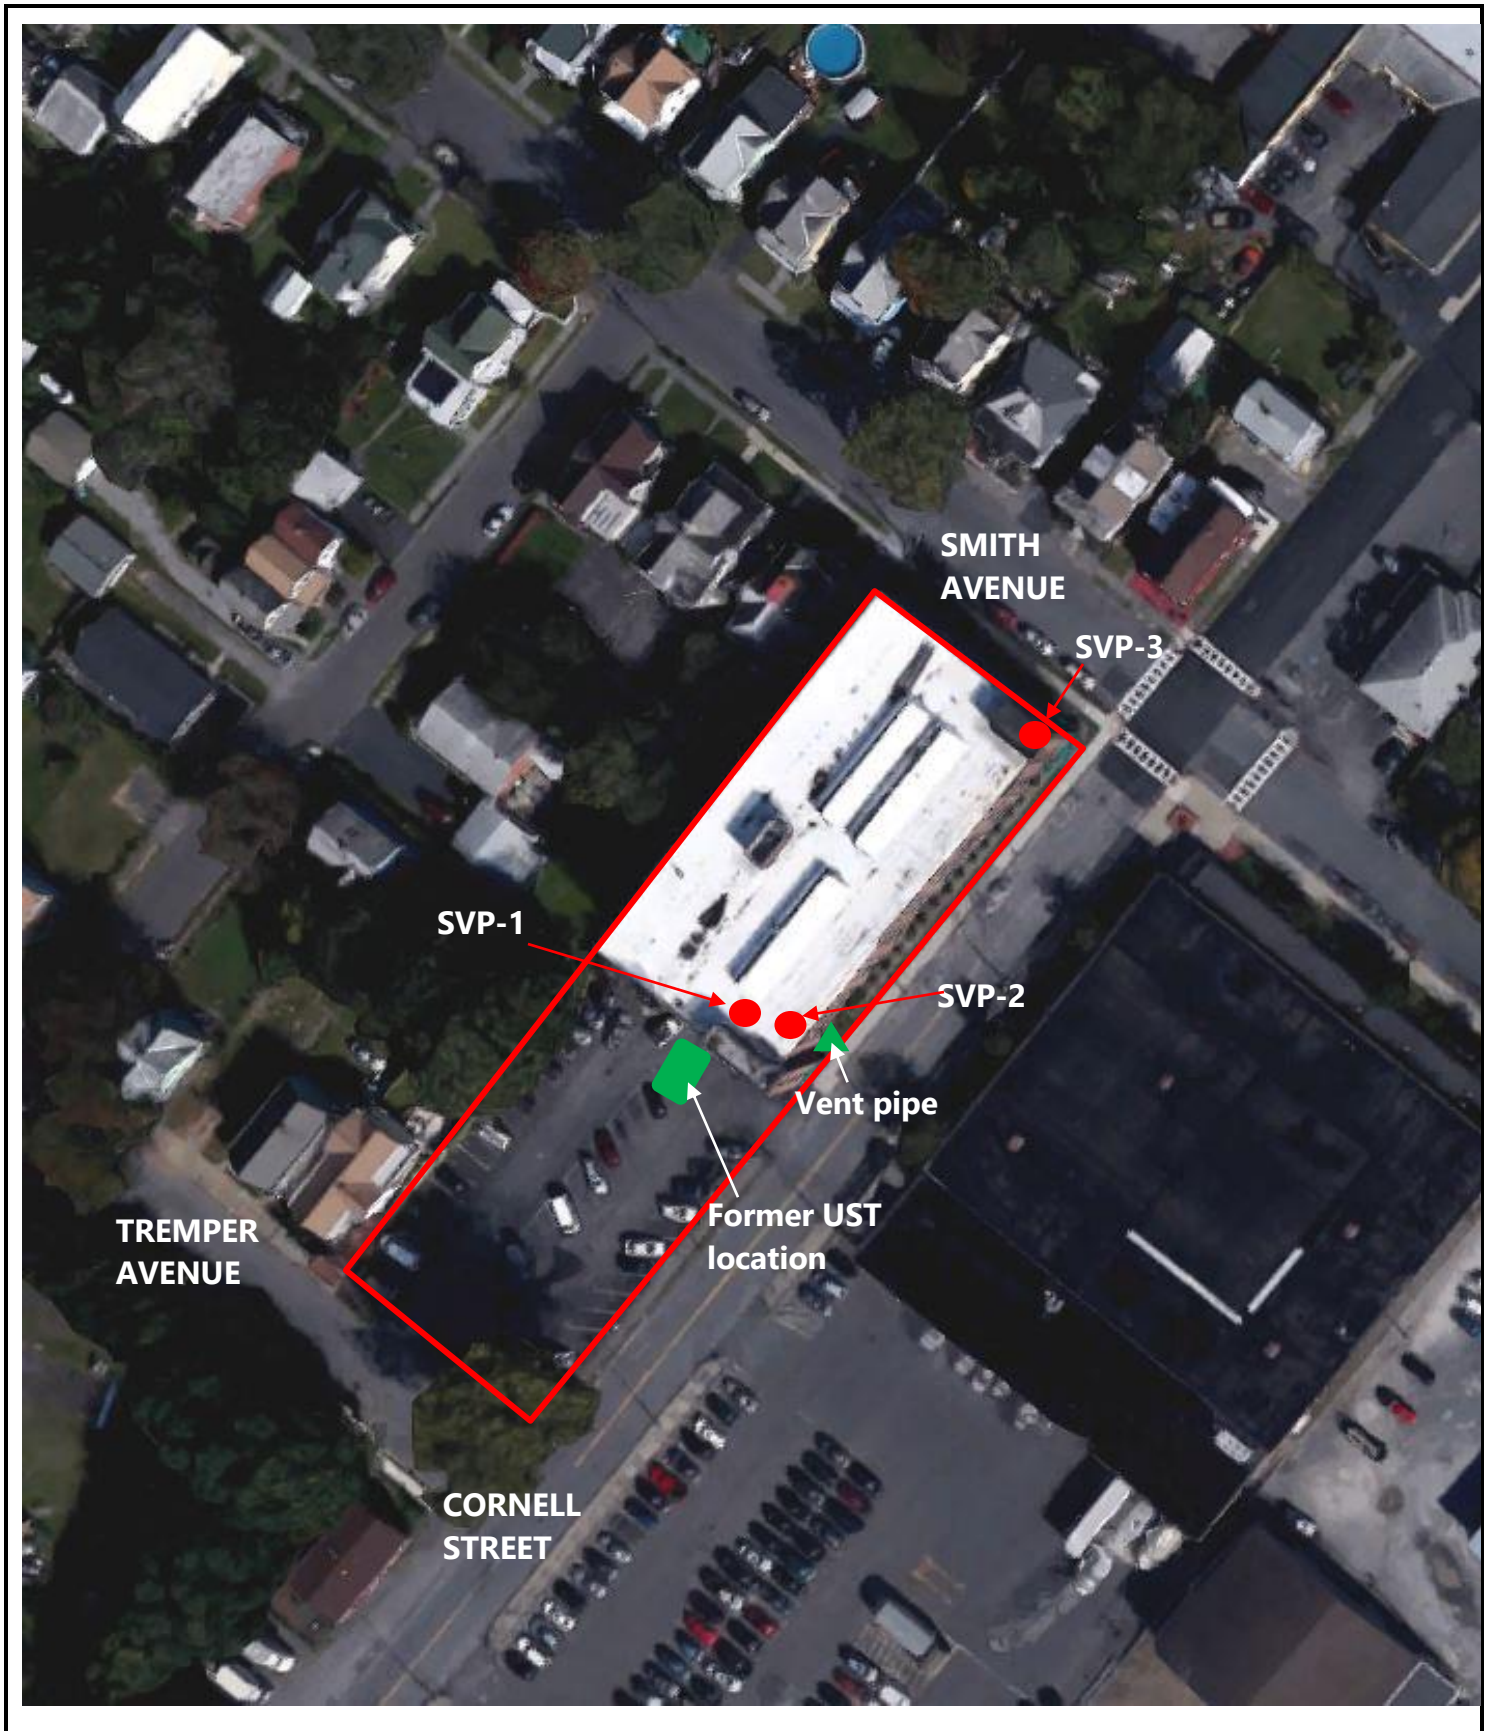
KEY:
Subject Property
