# **REMEDIAL INVESTIGATION AND FEASIBILITY STUDY**

## **REMEDIAL INVESTIGATION REPORT VOLUME NO. 1**

**Bedford Village Wells  
Shopping Arcade Site  
Westchester County, New York**

**by  
DVIRKA AND BARTILUCCI  
CONSULTING ENGINEERS  
SYOSSET, NEW YORK**

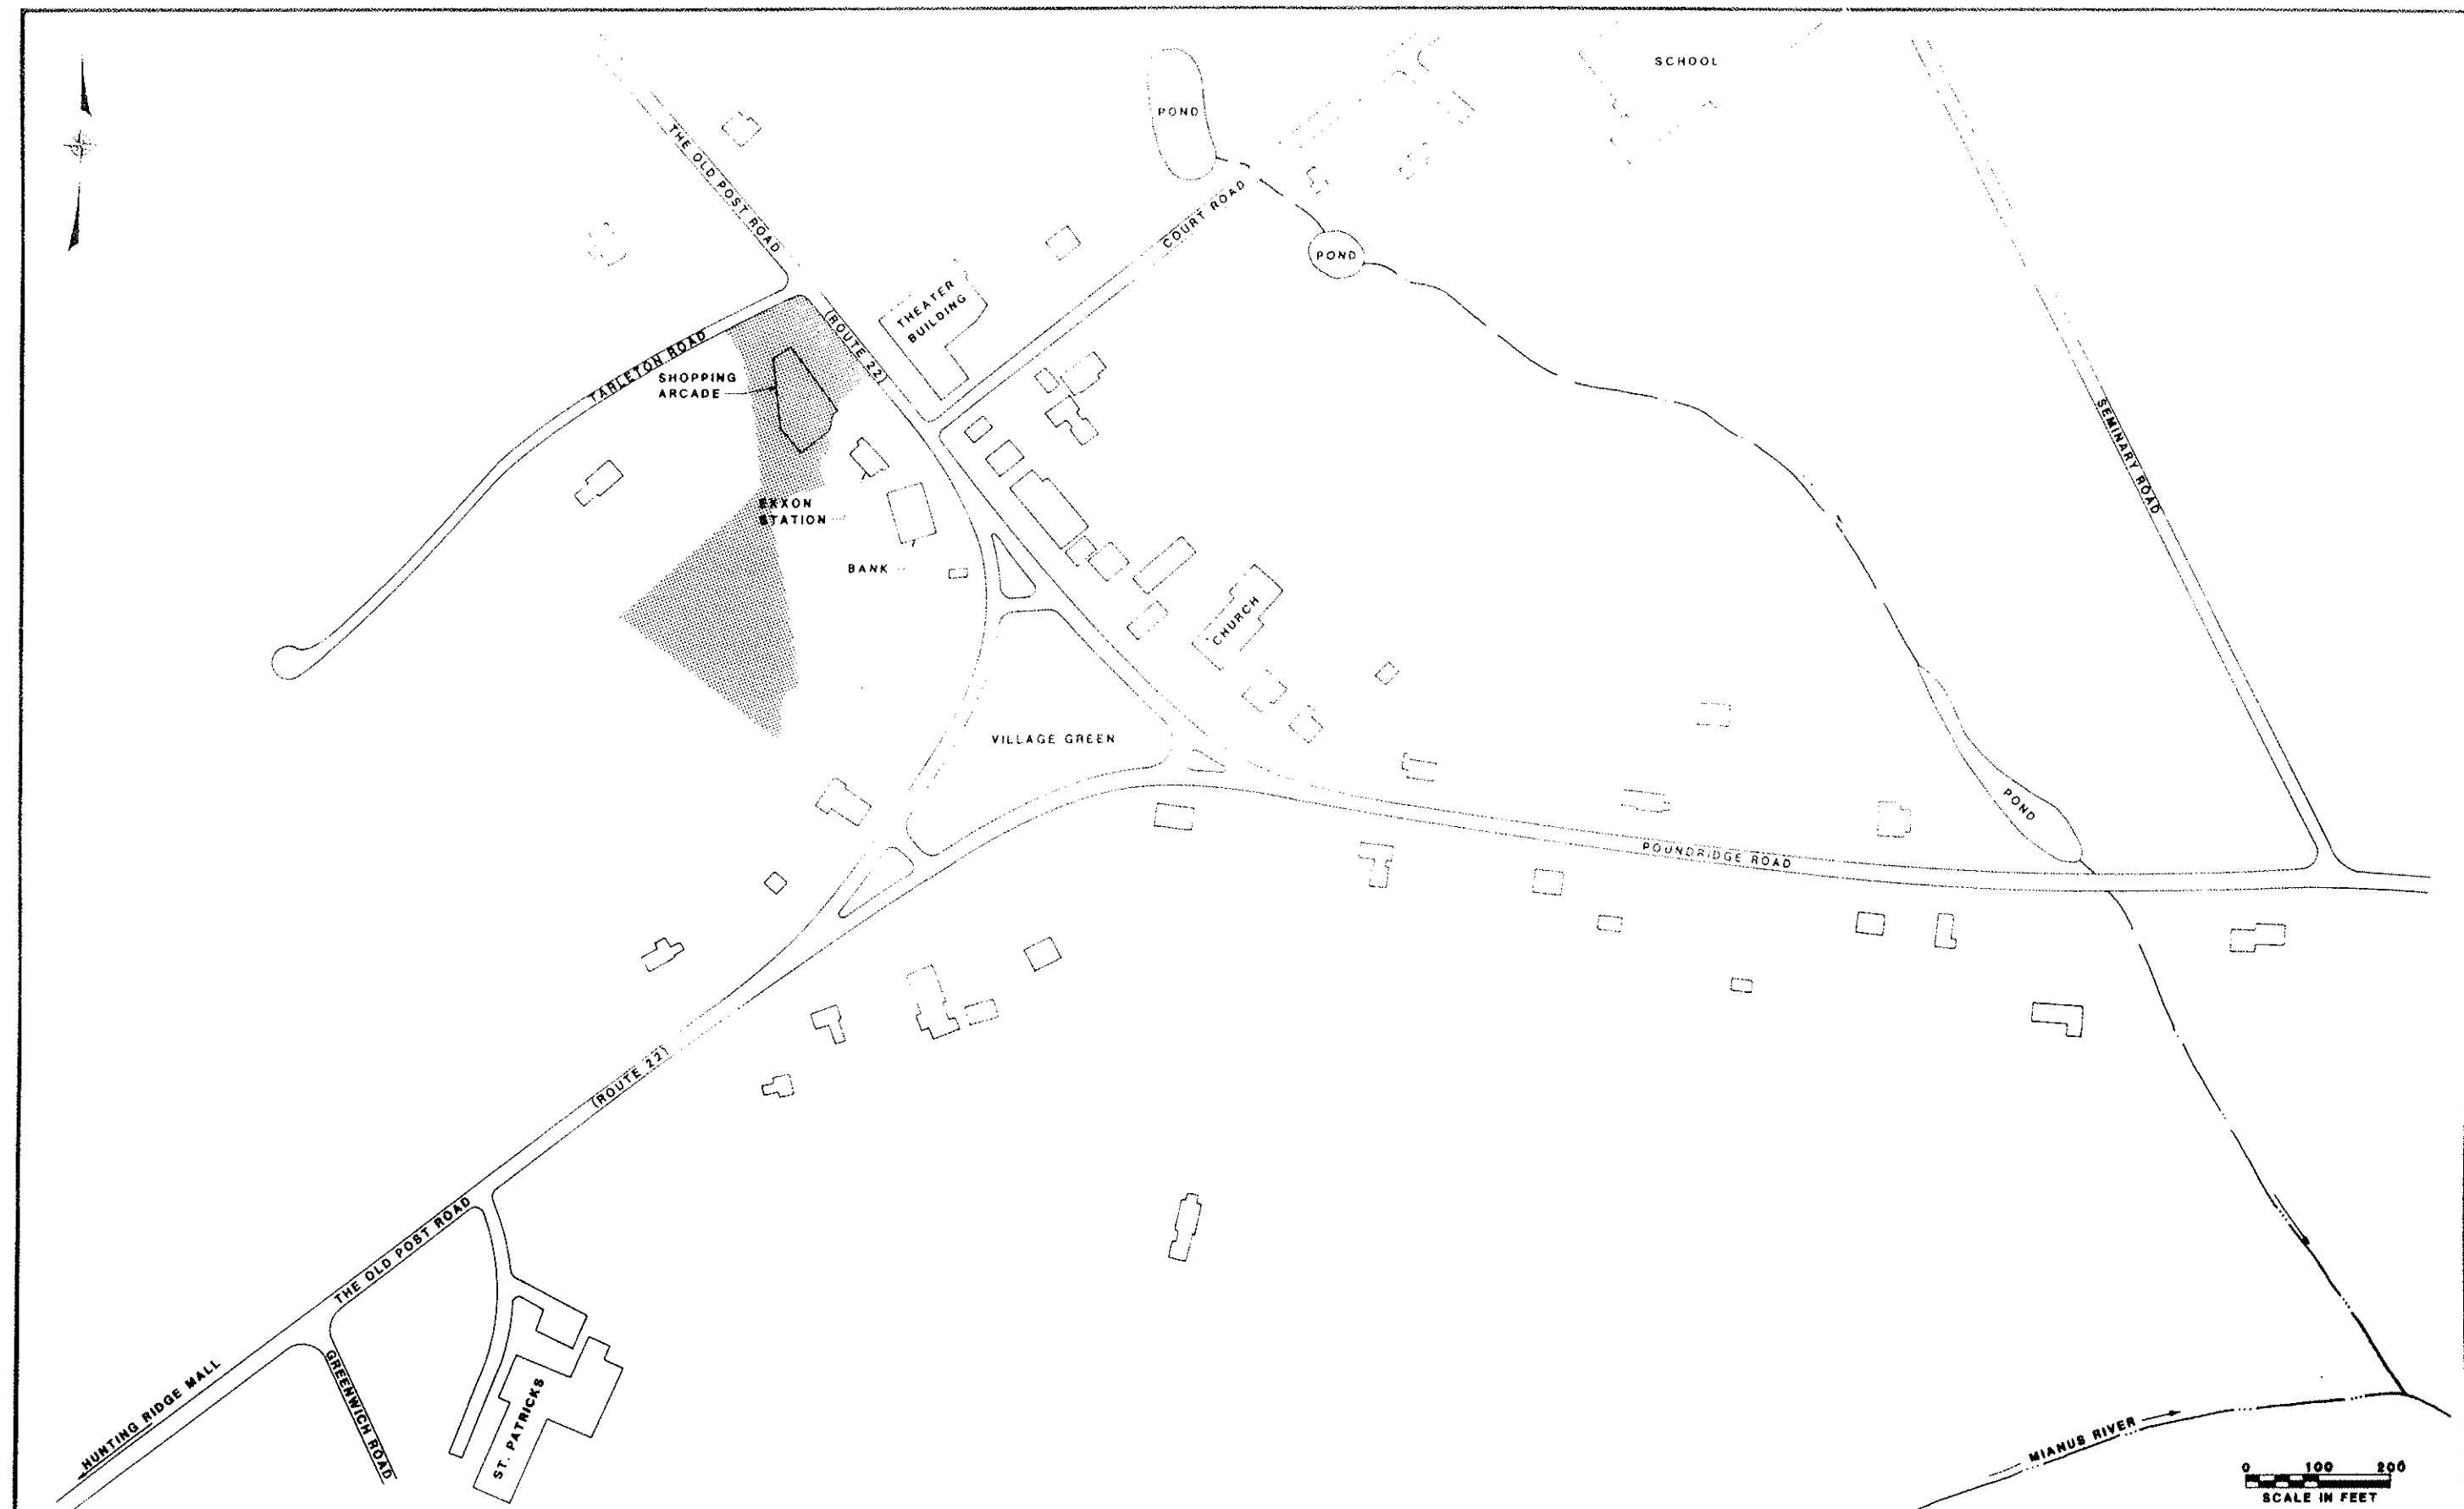
PROJECT NO. <b>642</b>	FIGURE NO. <b>1-2</b>
DATE:	
SCALE <b>AS NOTED</b>

The Bedford Village Wells – Shopping Arcade Site is located in the Village business district (see Figure No. 1-2) where a dry cleaner had operated several years ago. The results of the Westchester County Department of Health testing program first revealed (April 1979) that three wells were contaminated with varying amounts of tetrachloroethene (11 to 470 ug/l), trichloroethene (2 to 80 ug/l), as well as cis-1,2-dichloroethene (4 to 51 ug/l). These wells serve the Bedford Theatre Building, the Bedford Shopping Arcade and an Exxon gasoline station. Initially, all three wells were placed under "boil water" notices by the Department of Health; however, monitoring data obtained from the Phase I study conducted by the New York State Department of Environmental Conservation in 1983 showed only the Shopping Arcade well to have unacceptable levels (greater than 50 ug/l) of tetrachloroethene.

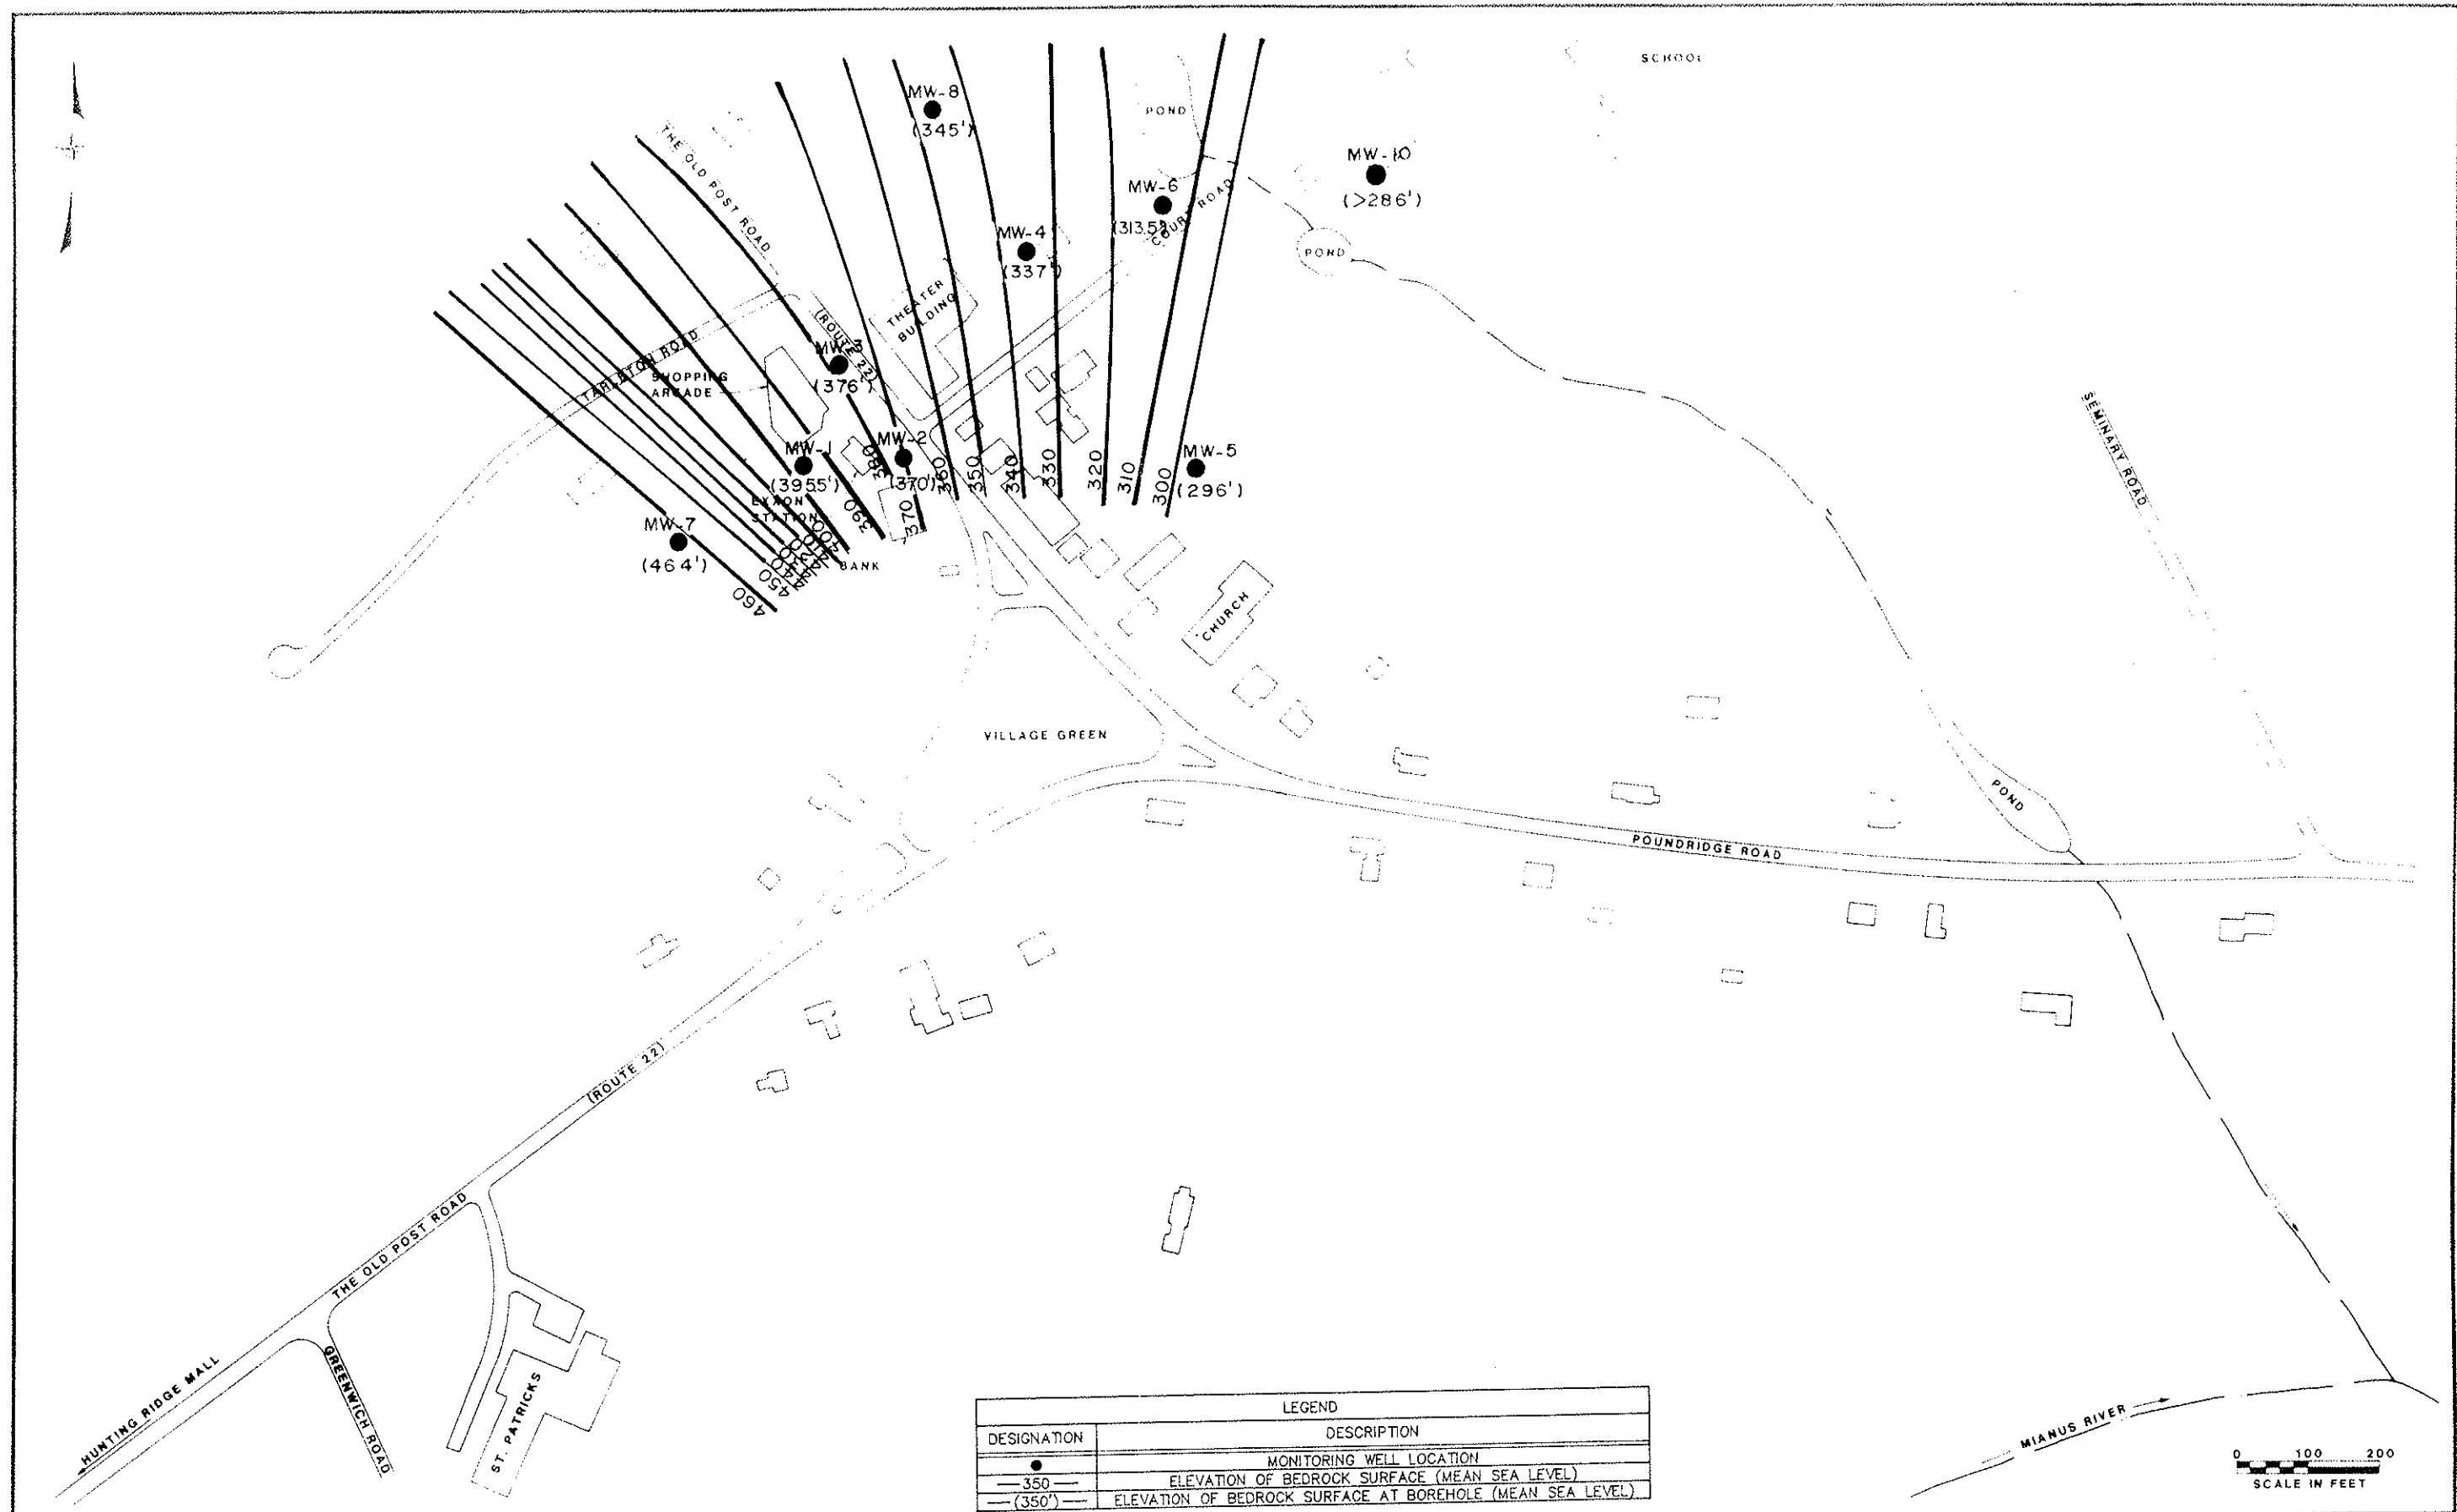
PROJECT NO.	FIGURE NO.																																						
842																																							
DATE																																							
SCALE	AS NOTED	4-13																																					
PROJECT ENGINEER		DRAWN BY																																					
DESIGNED BY		CHECKED BY

Dvirka and Bartolucci CONSULTING ENGINEERS SYRACUSE, NEW YORK	BEDFORD VILLAGE REMEDIAL INVESTIGATION & FEASIBILITY STUDY WESTCHESTER COUNTY, NEW YORK SHOPPING ARCADE SITE		SHOPPING ARCADE STUDY AREA BEDFORD SURFACE CONTOUR MAP		<table><tr><td>PROJECT NO.</td><td rowspan="3">FIGURE NO.</td></tr><tr><td>842</td></tr><tr><td>DATE</td></tr><tr><td>SCALE</td><td>AS NOTED</td><td>4-13</td></tr></table>		PROJECT NO.	FIGURE NO.	842	DATE	SCALE	AS NOTED	4-13
NO.	DATE	REVISION	BY
