**REMEDIAL INVESTIGATION  
AND FEASIBILITY STUDY**

**REMEDIAL INVESTIGATION REPORT  
VOLUME NO. 1**

**Bedford Village Wells  
Hunting Ridge Mall Site  
Westchester County, New York**

**JUNE 1989**

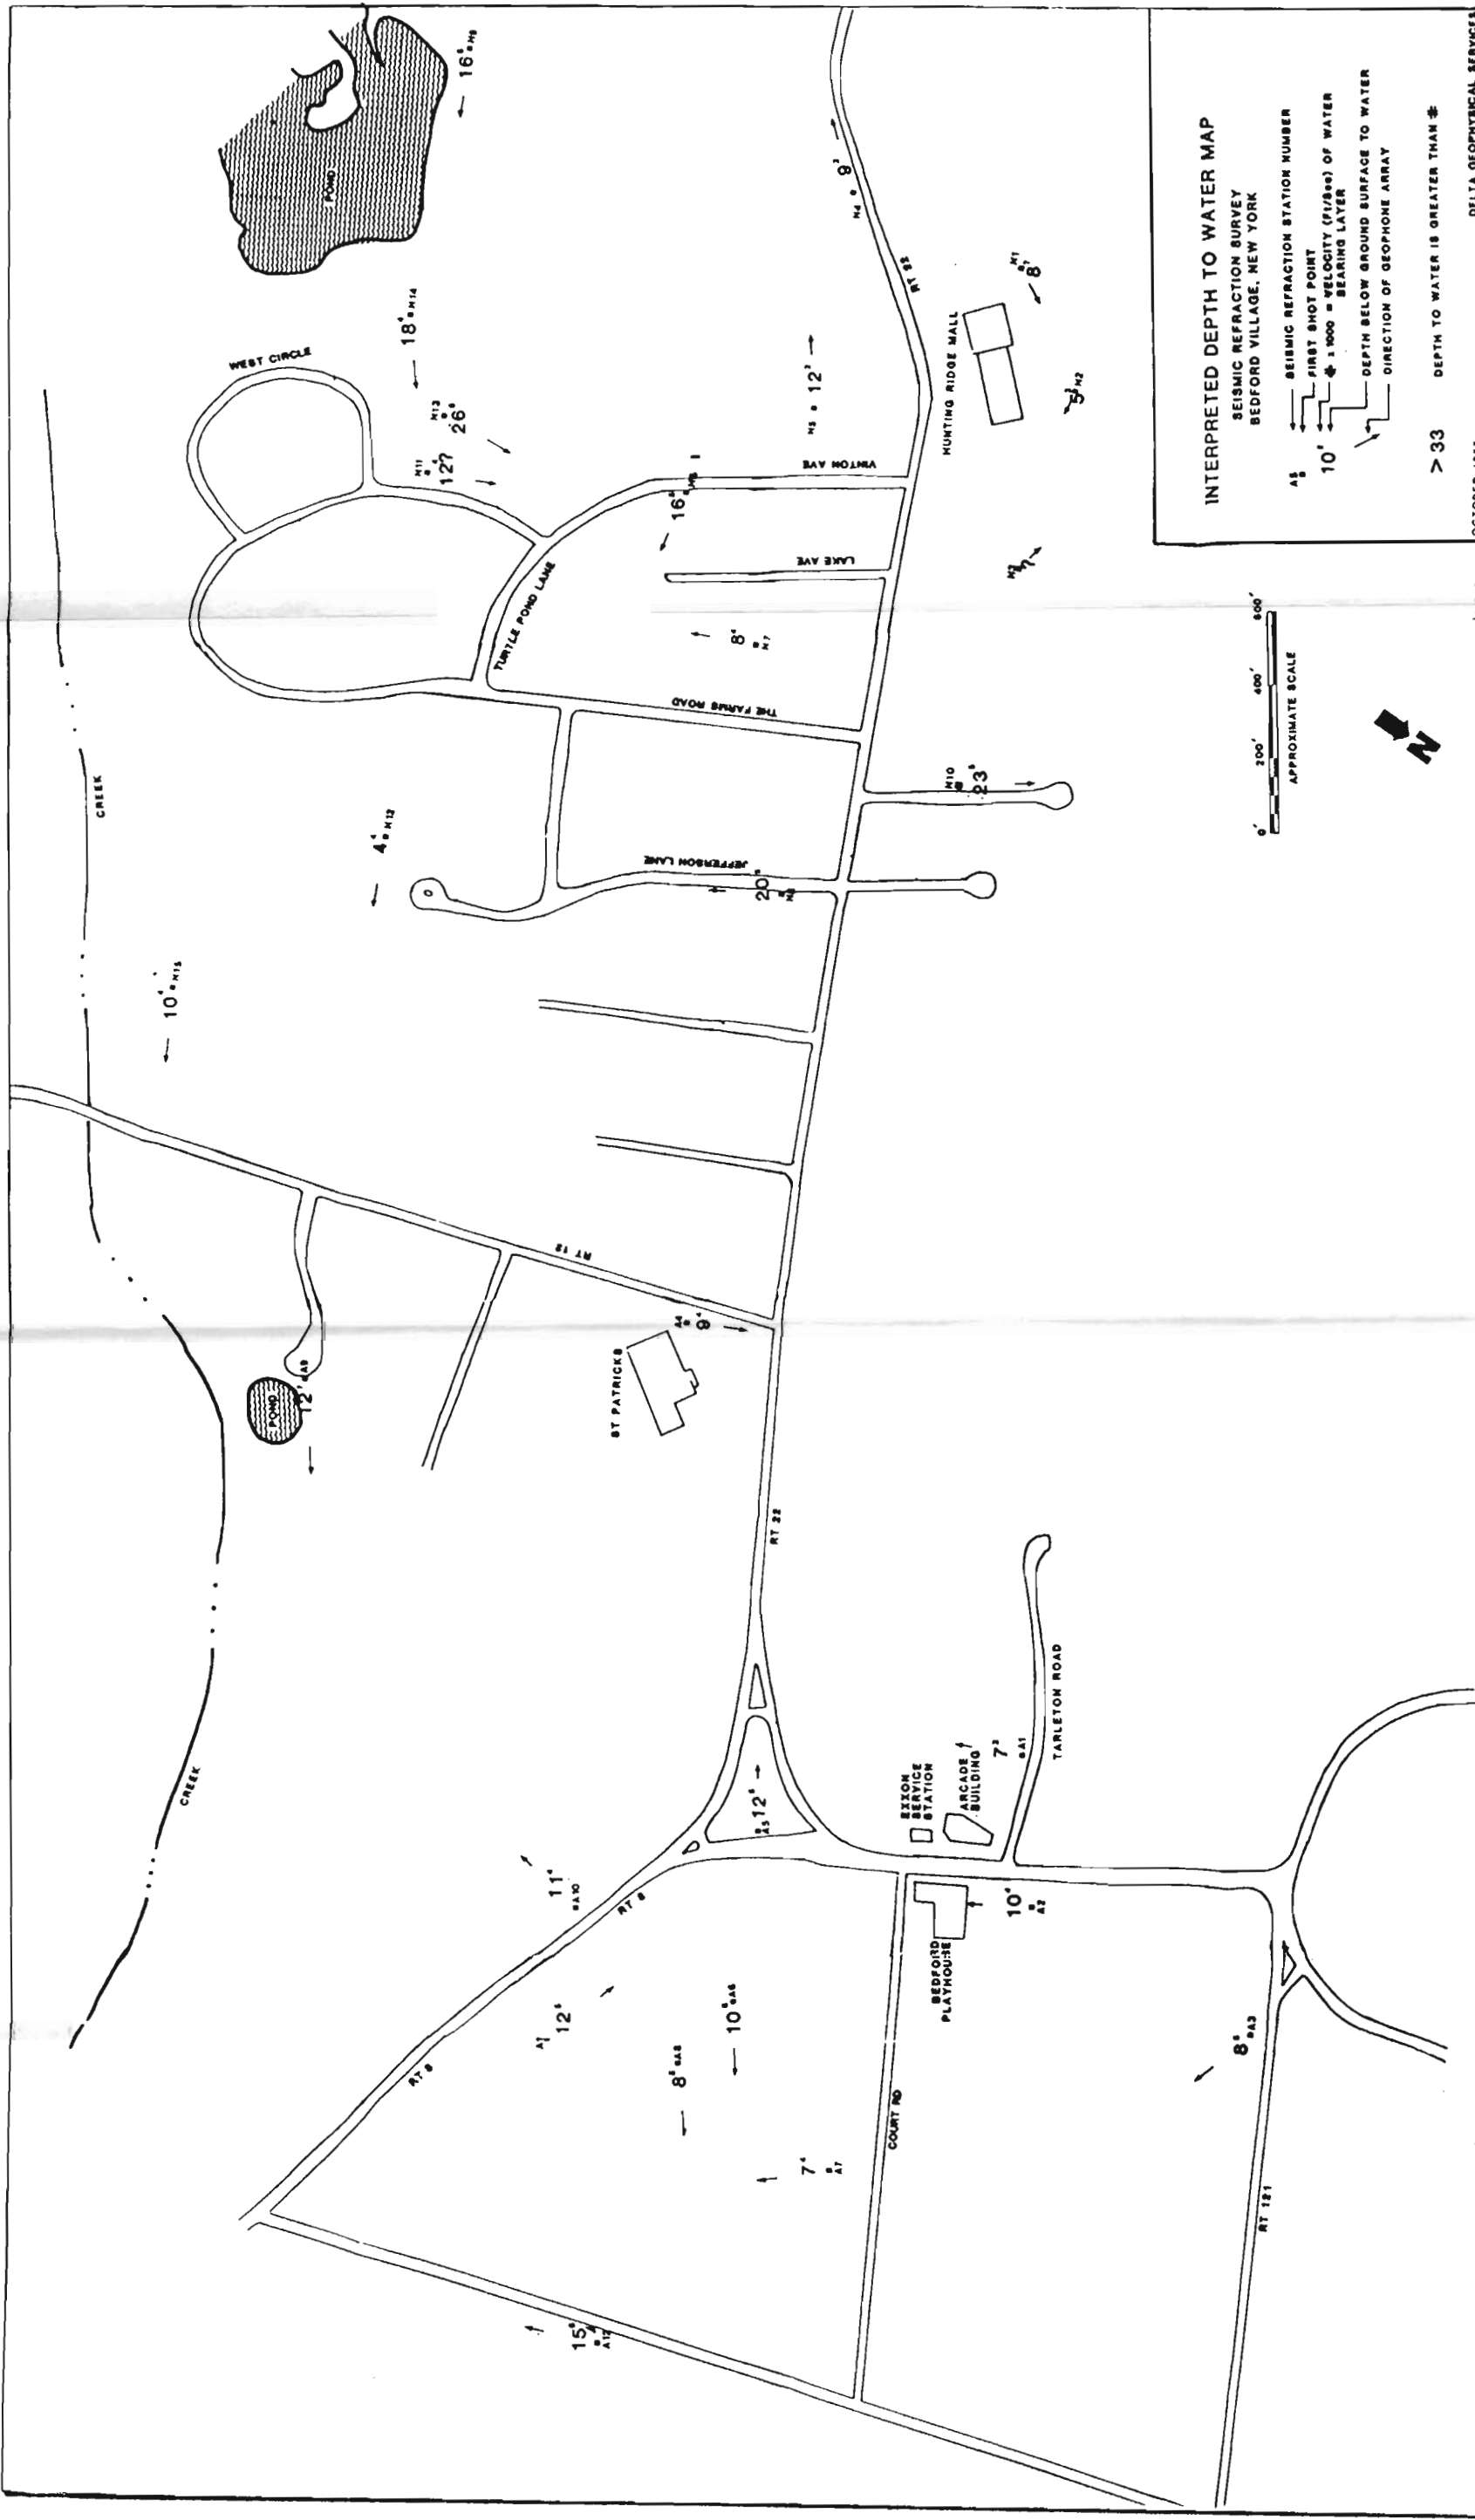
FIGURE NO. 4-1

The interpretation of the seismic data is presented on two maps, Figure Nos. 4-1 and 4-2, and in a table of results, Table No. 4-1. Figure No. 4-1 graphically depicts the seismic station location and number, depth to ground water (below ground surface) and the velocity of the water bearing layer. The velocity of the seismic wave is indicated by a number (smaller size) above the depth value. By multiplying this number by 1,000, the actual velocity can be determined.

**INTERPRETED DEPTH TO WATER MAP**  
 SEISMIC REFRACTION SURVEY  
 BEDFORD VILLAGE, NEW YORK
