SITE MANAGEMENT PLAN STATUS REPORT
REPORT PERIOD: June 1, 2015 THROUGH August 31, 2015
HARMON RAILROAD YARD
OU-I AND OU-II
WESTCHESTER COUNTY, NEW YORK
SITE NO. 3-60-010

Project Title
**METRO-NORTH RAIL ROAD
 HARMON YARD OPERABLE UNITS OU-I AND OU-II
 CROTON-ON-HUDSON, NEW YORK**

Drawing Title
SITE MANAGEMENT PLAN

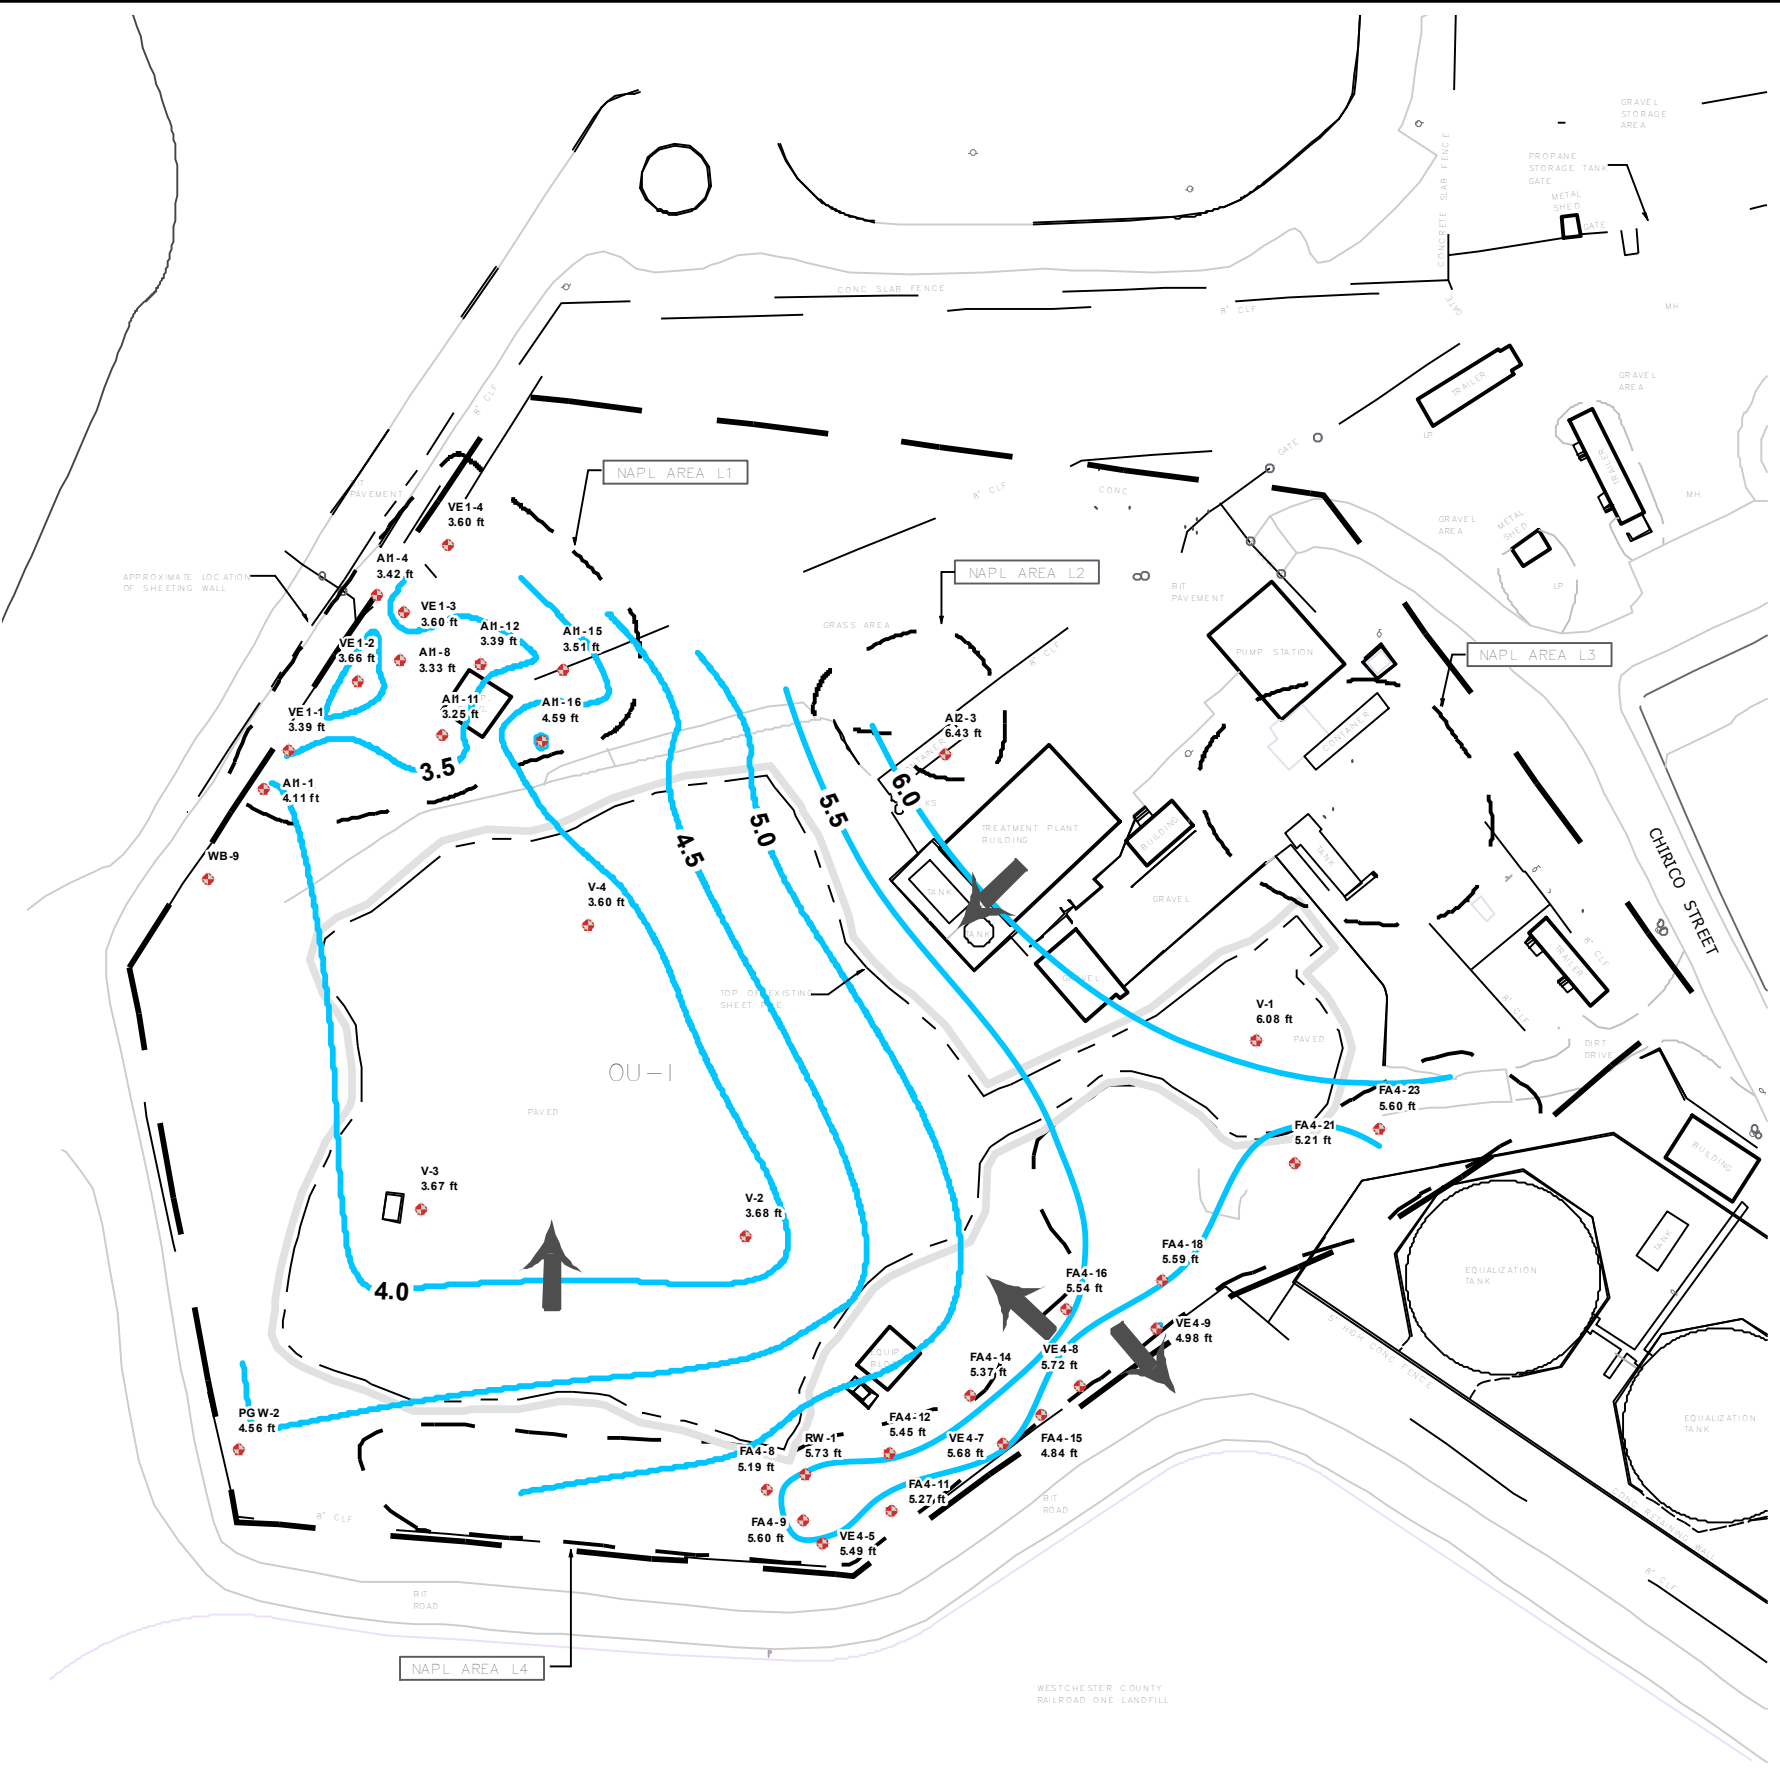
Groundwater Conour Map: August 14, 2015

DEPTH TO GROUNDWATER AND NAPL MEASUREMENTS: During this report period, quarterly monitoring was conducted on August 14 and August 20, 2015. This monitoring included the measurement of static water levels and the evaluation of NAPL in functioning monitoring wells. The results of this monitoring are summarized on the tables presented in Attachment A. A groundwater contour map developed using static water levels measured on August 14, 2015 is included as Figure 1.

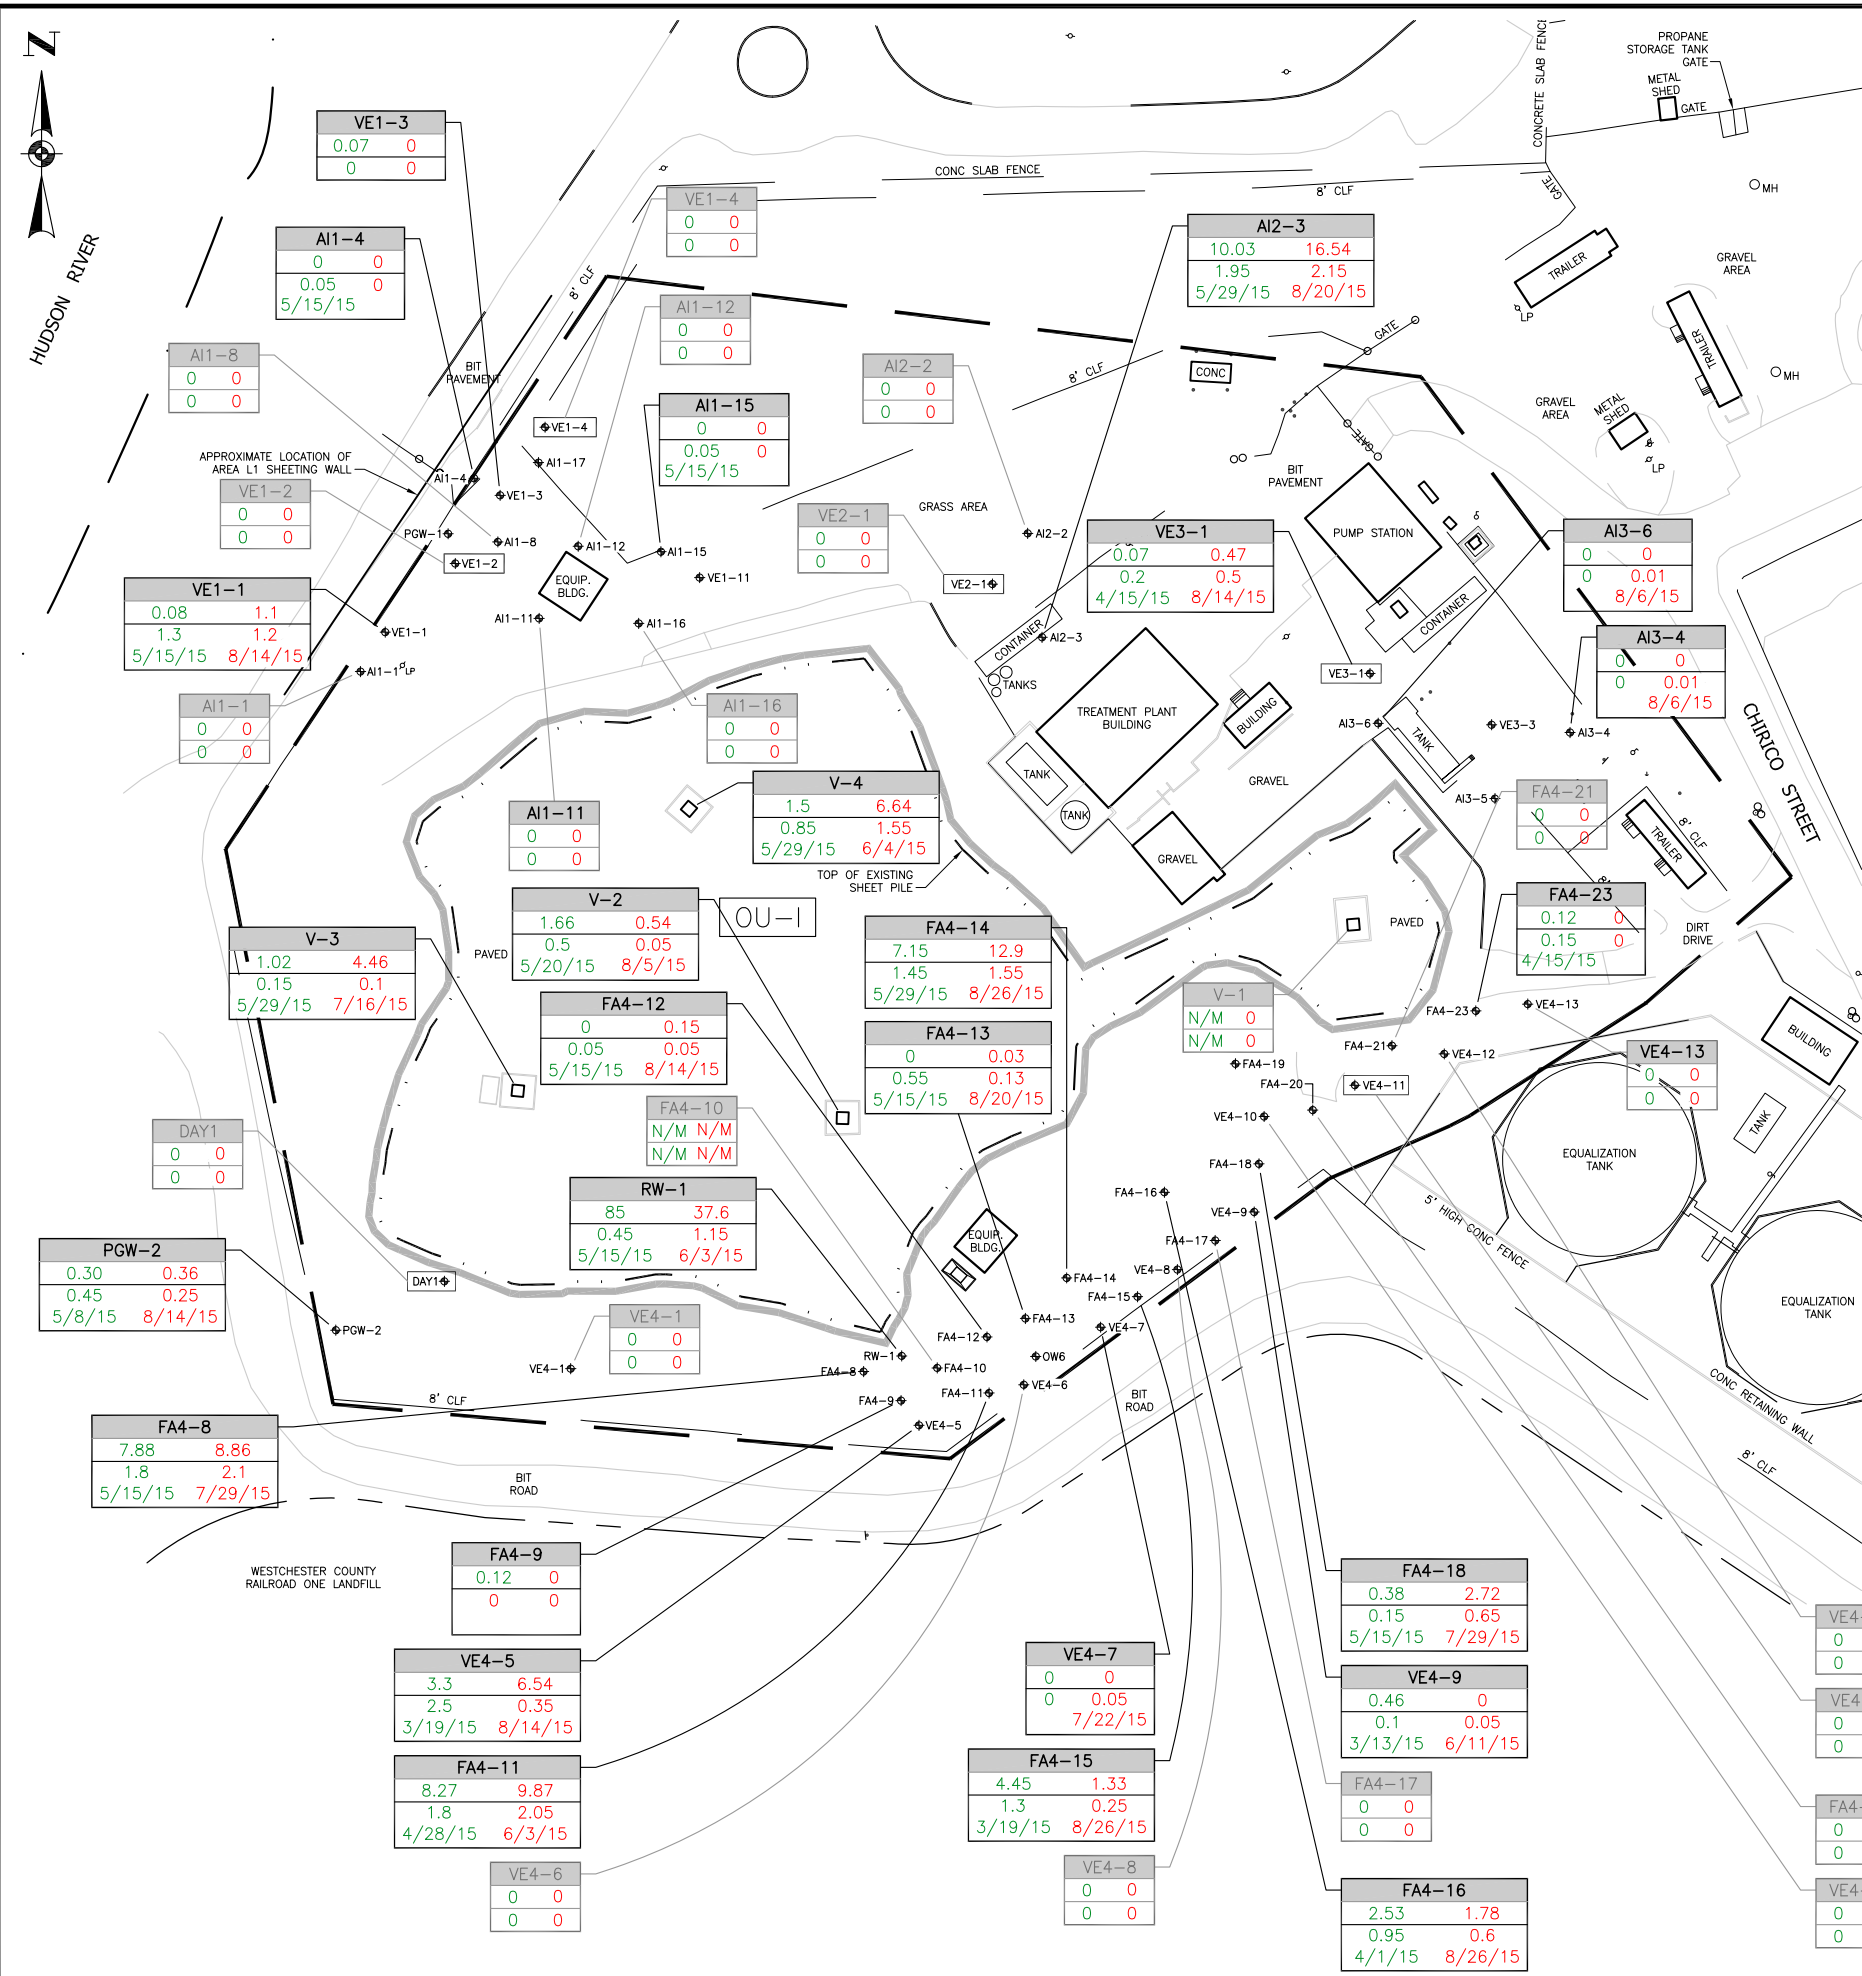
FIGURE 2

DRAWING TITLE
**Summary Of NAPL Removal For The Quarters
 March - May 2015 and June - August 2015**

NAPL REMOVAL RECORDS: The depth to groundwater, NAPL thickness measurements and NAPL removal records completed/compiled during this report period are presented on the tables included in Attachment A. A summary of the total amount of NAPL removed from each well during the current report period is attached as Table 1, and a summary of the total amount of NAPL historically removed from each well between December 1, 2012 and May 31, 2015 is attached to this report as Table 2. A spider diagram presenting the maximum NAPL thicknesses and the amount of NAPL removed from the wells monitored is included as Figure 2. This figure shows measurements obtained during the current and preceding report period.
