SITE MANAGEMENT PLAN STATUS REPORT
REPORT PERIOD: September 1, 2015 THROUGH November 30, 2015
HARMON RAILROAD YARD
OU-I AND OU-II
WESTCHESTER COUNTY, NEW YORK
SITE NO. 3-60-010

Project Title
**METRO-NORTH RAIL ROAD
 HARMON YARD OPERABLE UNITS OU-I AND OU-II
 CROTON-ON-HUDSON, NEW YORK**

INSPECTION RESULTS FOR SEPTEMBER 10, 2015

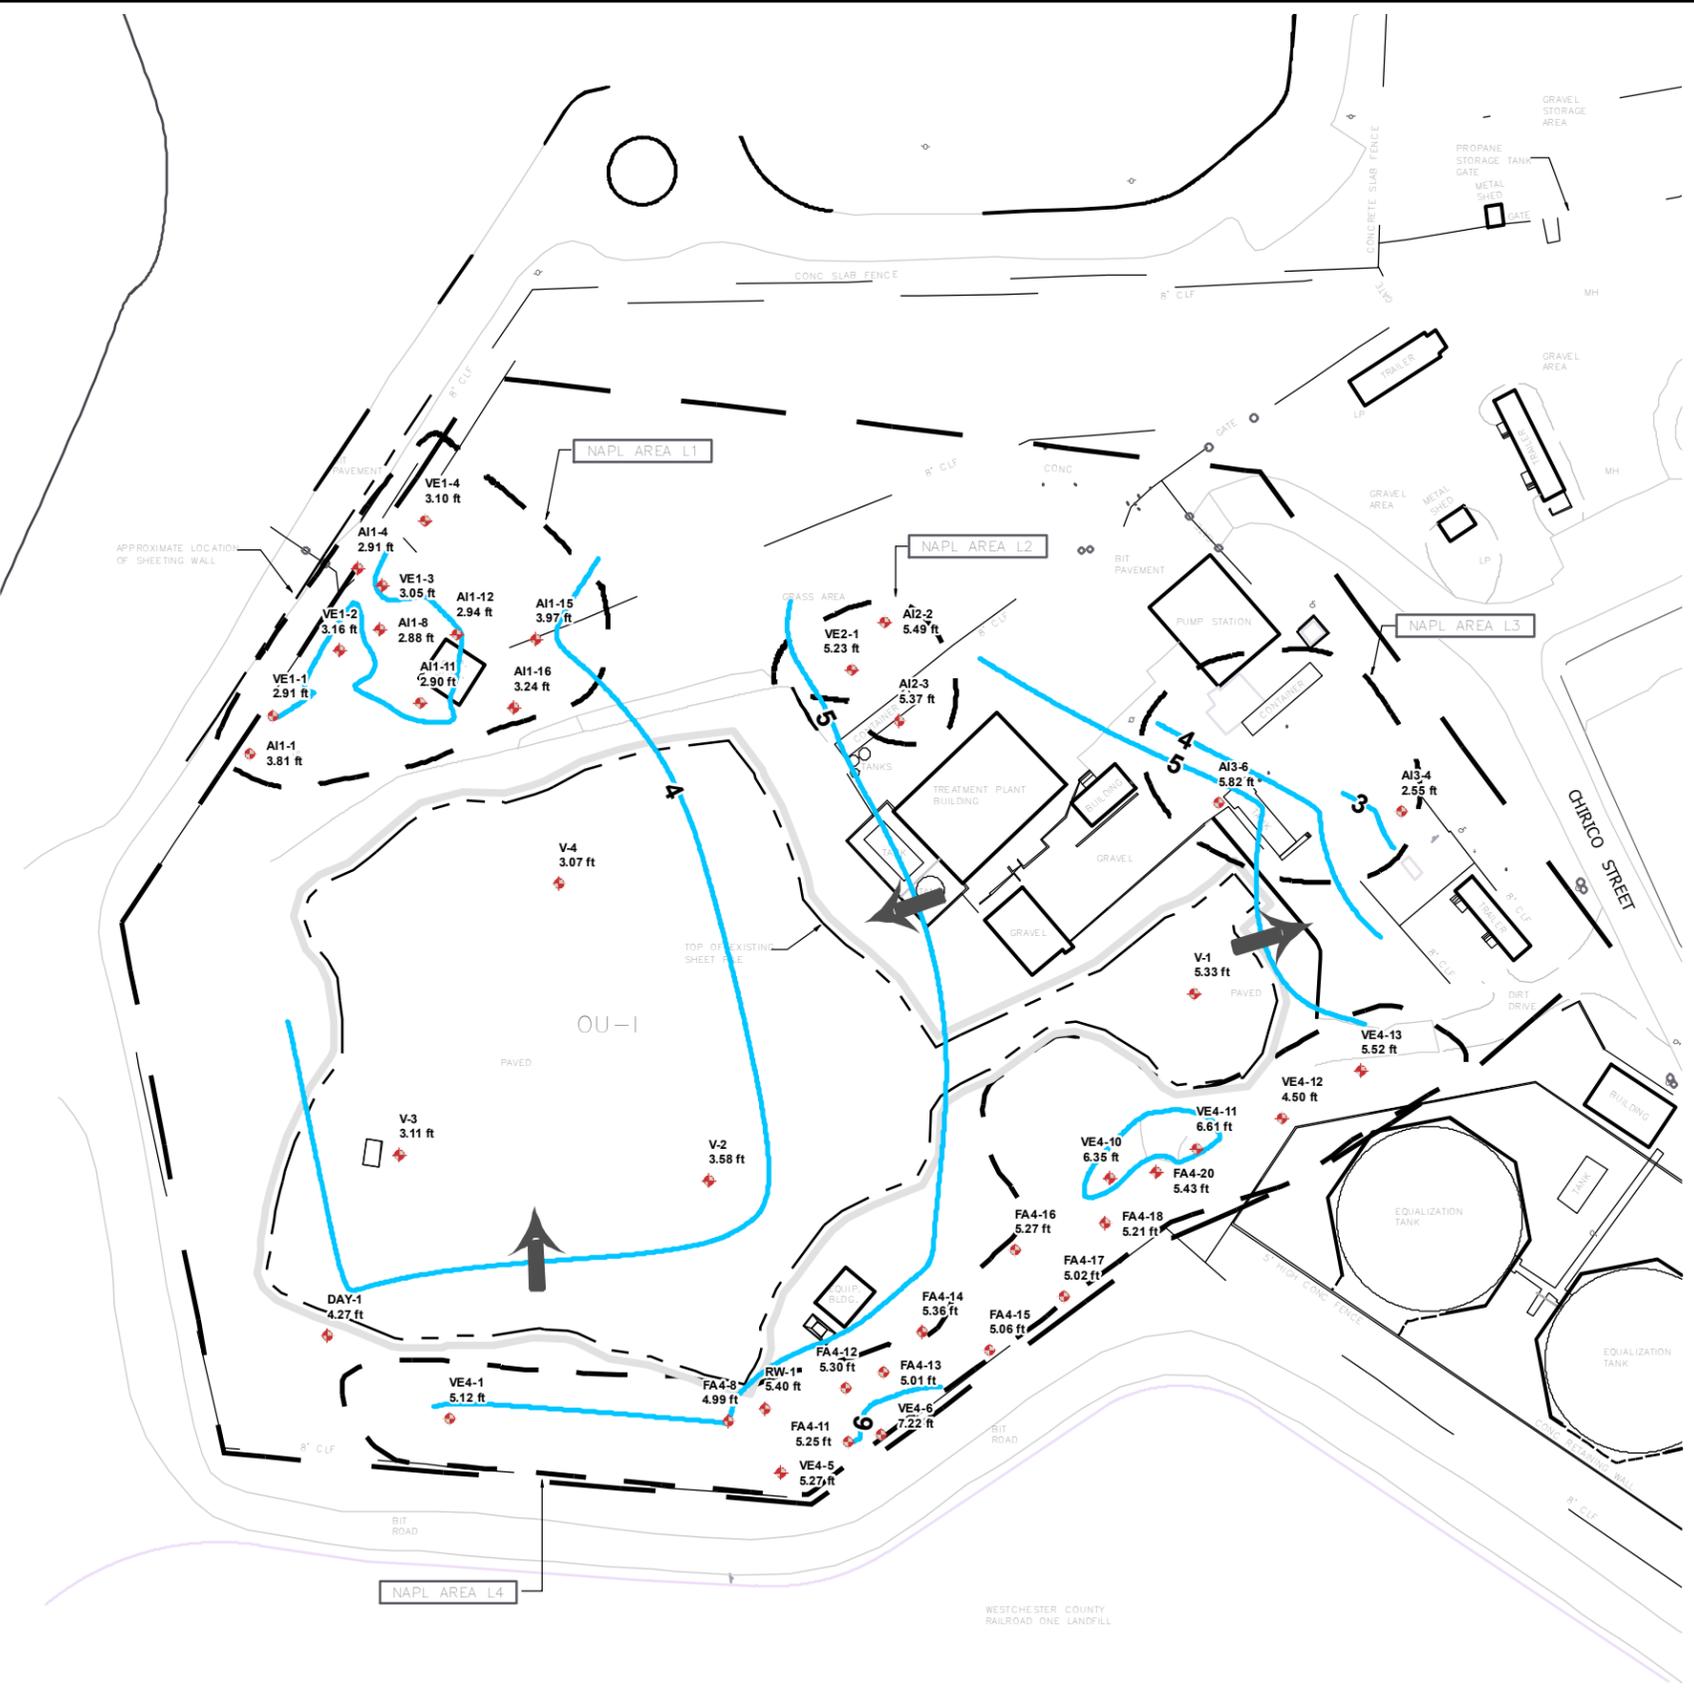
FIGURE 1

DEPTH TO GROUNDWATER AND NAPL MEASUREMENTS: During this report period, quarterly monitoring was conducted on November 3, 2015. This monitoring included the measurement of static water levels and the evaluation of NAPL in functioning monitoring wells. The results of this monitoring are summarized on the tables presented in Attachment B. A groundwater contour map developed using static water levels measured on November 3, 2015 is included as Figure 1.

Groundwater Conour Map: November 03, 2015

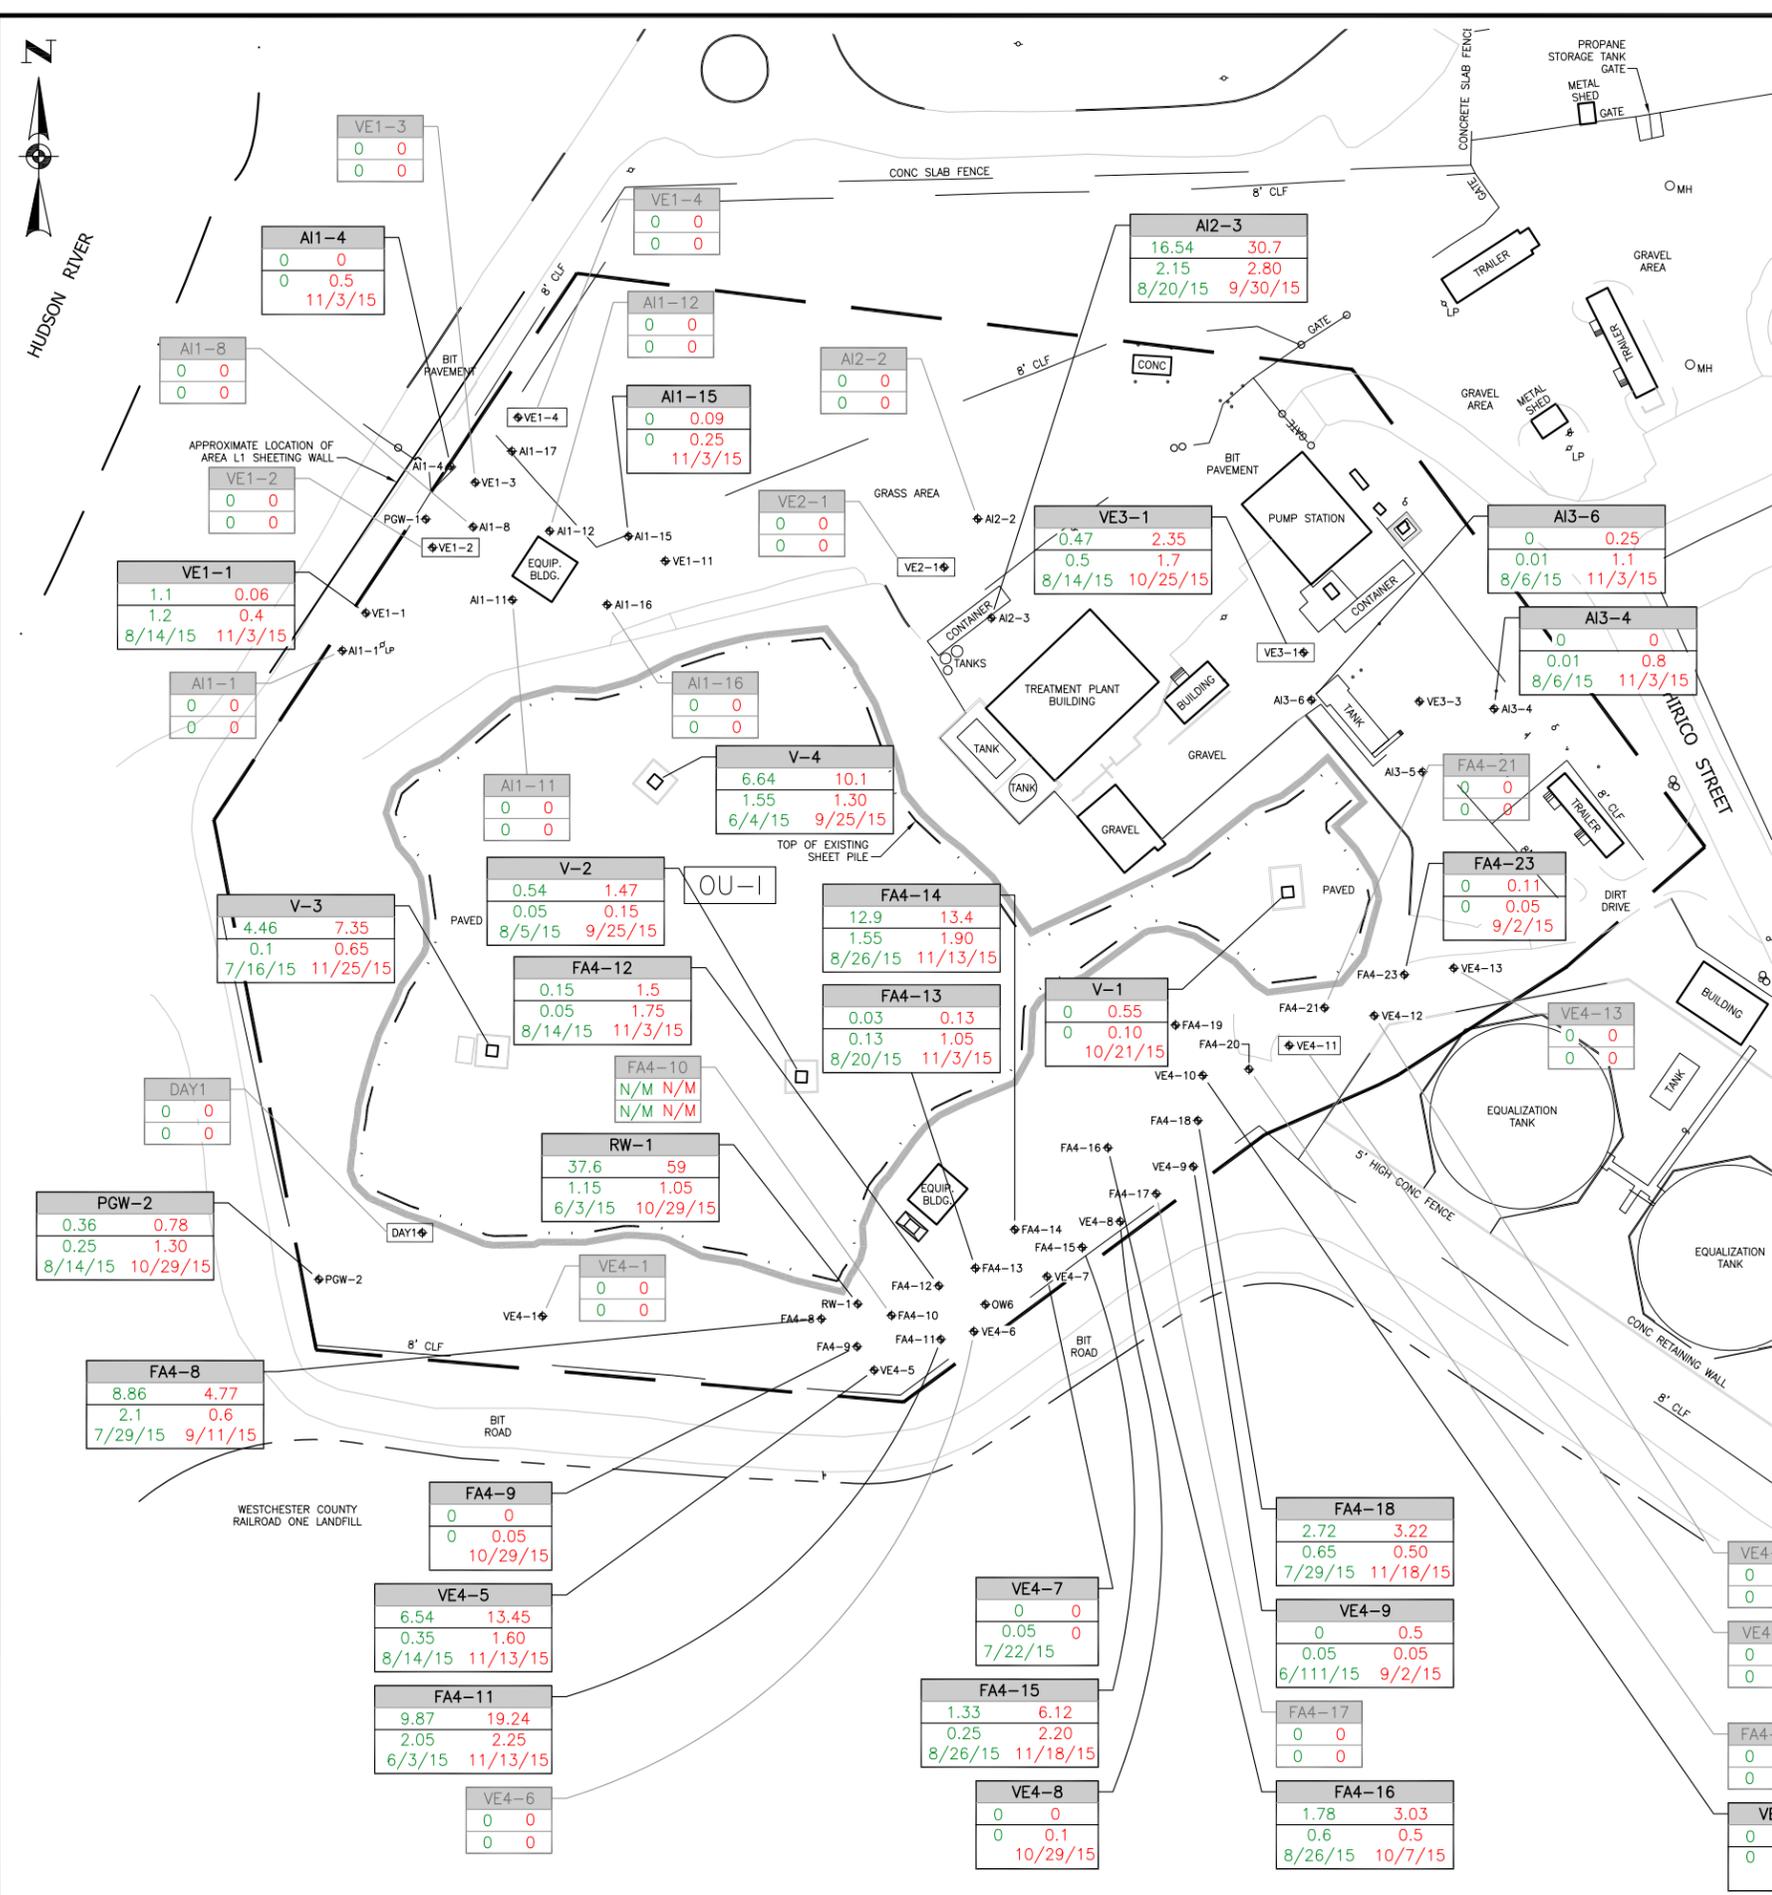
FIGURE 2

NAPL REMOVAL RECORDS: The depth to groundwater, NAPL thickness measurements and NAPL removal records completed/compiled during this report period are presented on the tables included in Attachment B. A summary of the total amount of NAPL removed from each well during the current report period is attached as Table 1, and a summary of the total amount of NAPL historically removed from each well between December 1, 2012 and August 31, 2015 is attached to this report as Table 2. A spider diagram presenting the maximum NAPL thicknesses and the amount of NAPL removed from the wells monitored is included as Figure 2. This figure shows measurements obtained during the current and preceding report period.

DRAWING TITLE
**Summary Of NAPL Removal For The Quarters
 June - August 2015 and September - November 2015**

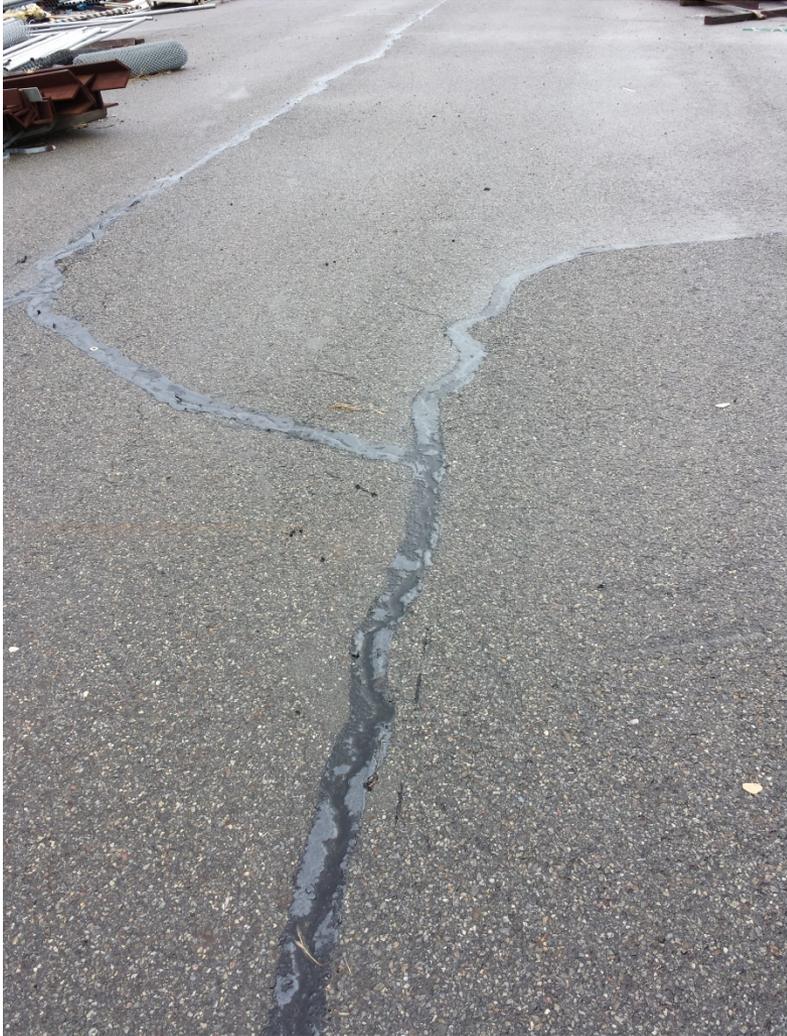
Crack repair began on 8/29/15 and will continue through the Fall until complete. (photo attached)

Sealing of asphalt cap began
on 8/29/15 and will
continue through Fall 2015

observations of the crack sealing work completed on December 9, 2015 indicated that greater than 90% of target cracks (i.e., cracks greater than approximately ¼ inch in width) in accessible areas (i.e., not covered by debris or equipment) have been sealed. It is anticipated that the crack sealing work will continue in the Spring of 2016 subsequent to the removal of additional debris/material from the OU-I asphalt pavement.

It is anticipated that the crack repairs will continue in the Spring of 2016.
