Former Taylor's Lane Composting Site
NYSDEC Site No. 360021
Site Management Plan
July 2024
41629.00

Former Taylor's Lane Composting Site

SITE MANAGEMENT PLAN

NYSDEC Site Number: 360021

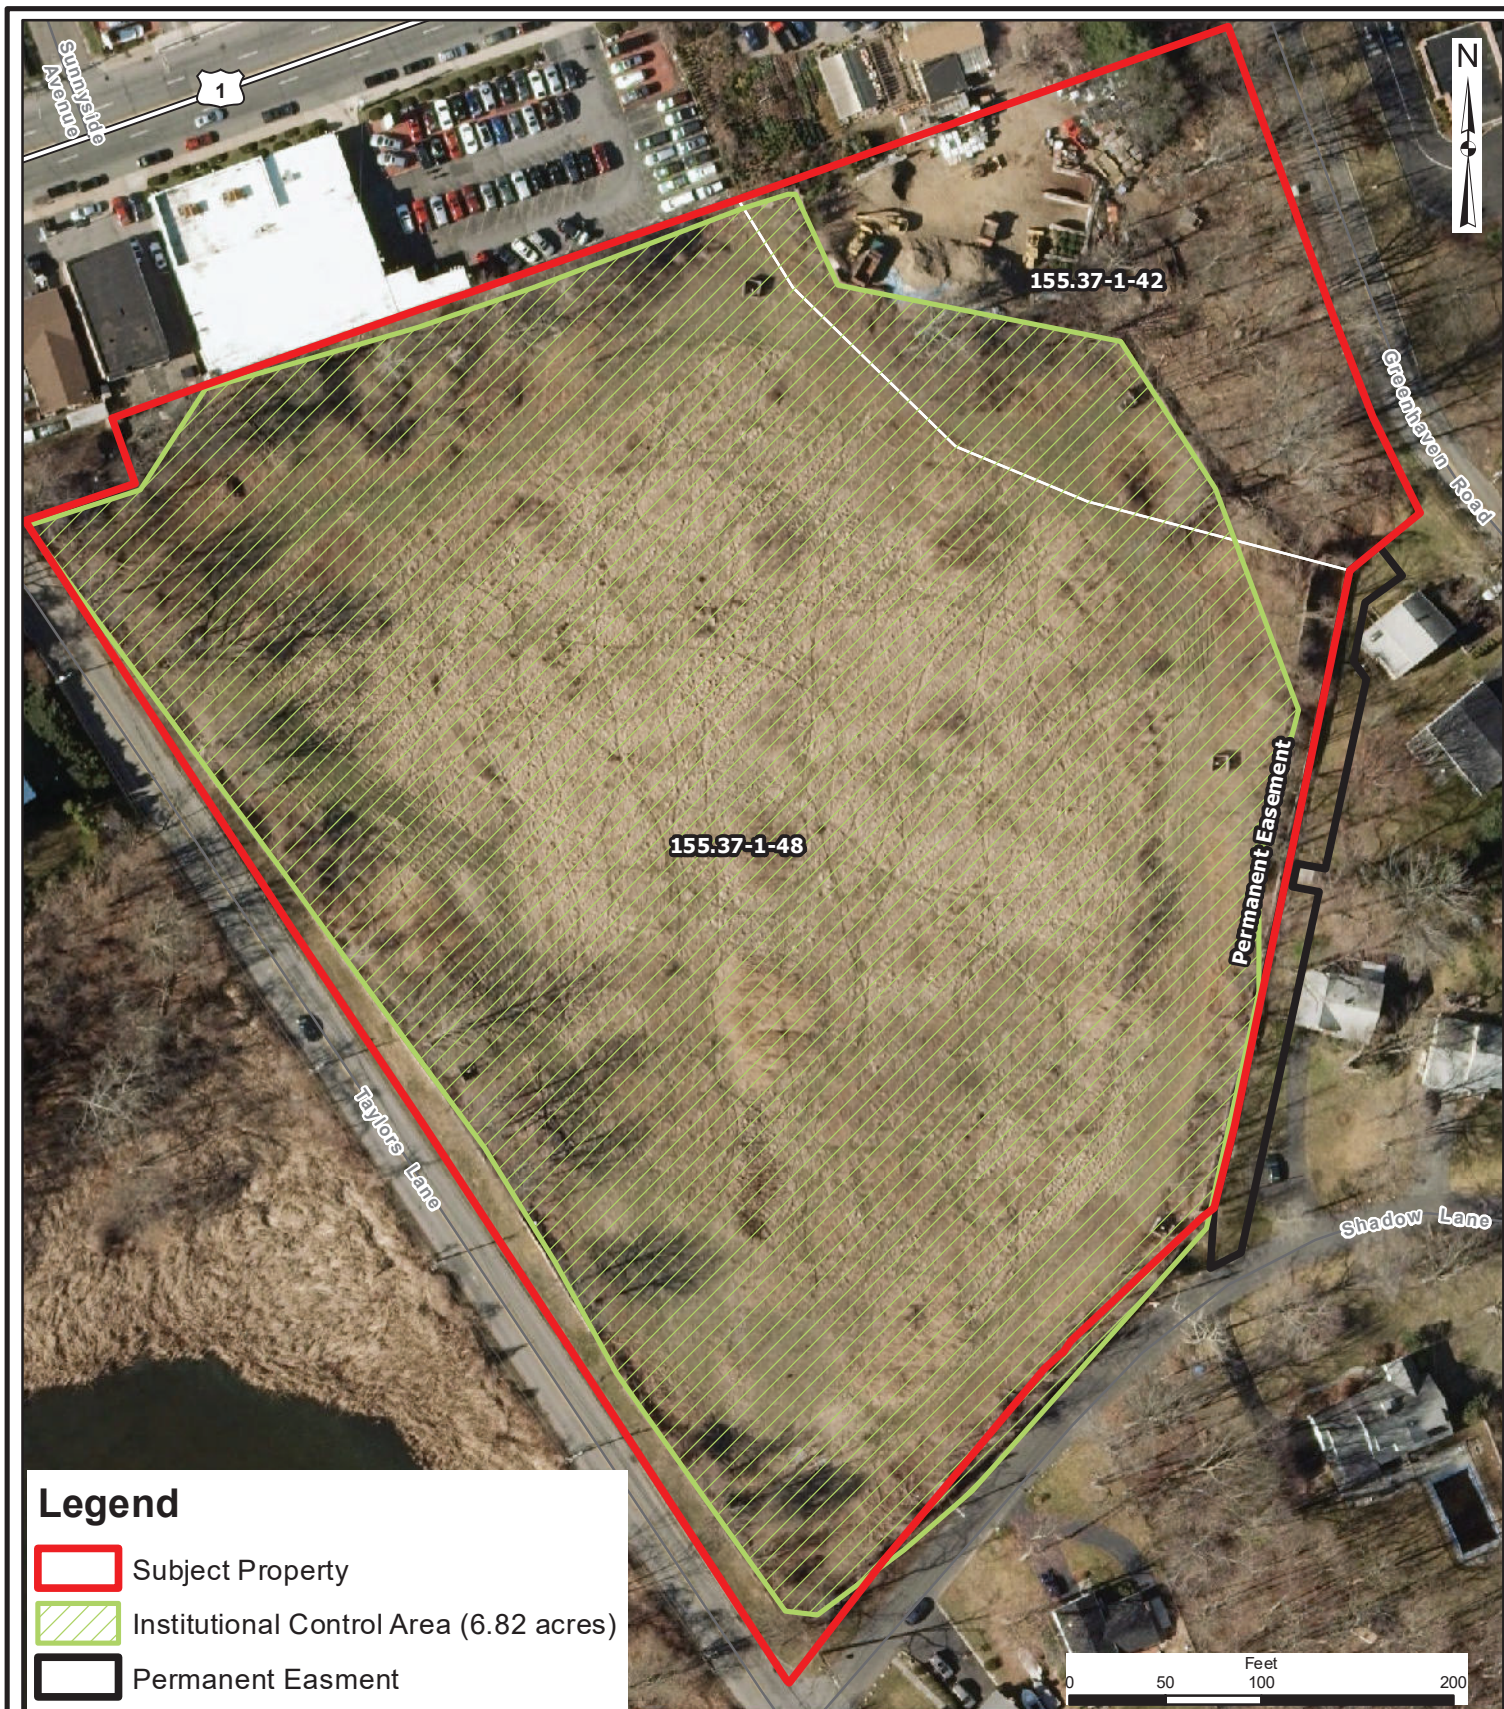
- Subject Property
- Institutional Control Area (6.82 acres)
- Permanent Easement

- The potential for vapor intrusion must be evaluated for any buildings developed in the area within the IC boundaries noted on **Figure 12**, and any potential impacts that are identified must be monitored or mitigated, and
