**REMEDIAL SYSTEM OPTIMIZATION REPORT  
BALDWIN PLACE MALL SITE  
SITE NO. 360023**

**WORK ASSIGNMENT NO. D007619-28**

**MACTEC Engineering and Consulting, P.C.  
Portland, Maine**

**SEPTEMBER 2014**

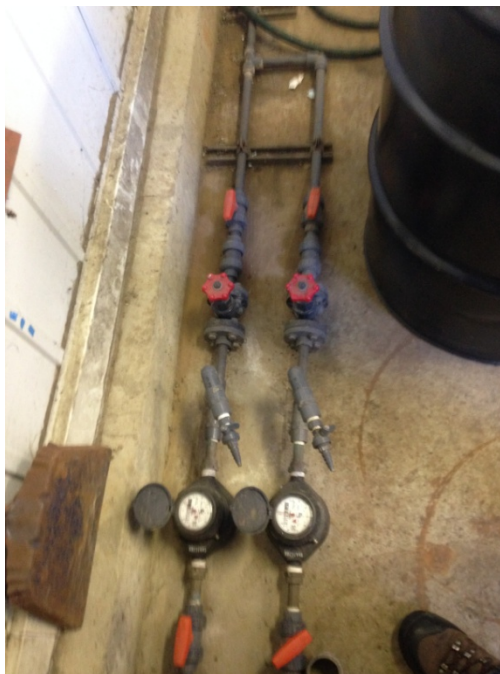
Recovery well manifold with flow meters and sample ports

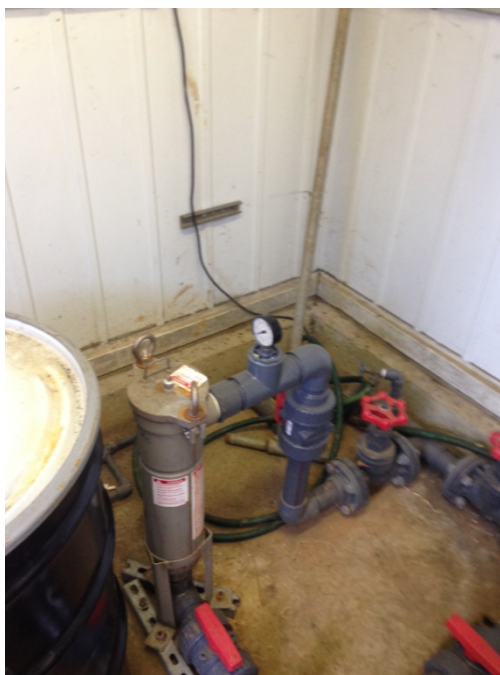
10 micron bag filter

Bag Filters. Groundwater is pumped through a series of bag filters prior to the Liquid-Phase GAC. A 50-micron bag filter and a 5-micron bag filter operate in series upstream of the activated carbon to reduce the potential of plugging of the carbon. The units are housed in steel containers and are rated at 80 gpm with a 1 pounds per square inch pressure drop across the filter for clean water. Each unit has a removable strainer. Filter bags are typically changed out monthly but are only changed out as needed. The used filters are placed in a plastic drum and then disposed of as hazardous waste with waste code, F002.

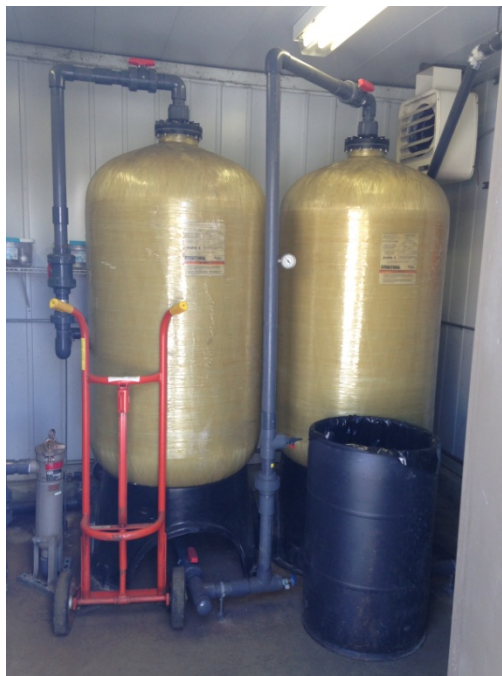
Carbon Vessels

Liquid-Phase Carbon Filters. Removal of the groundwater contaminants is achieved with GAC. The GAC system consists of two 165 pound drums of activated carbon that are operated in series. The units are returnable, meaning that the spent carbon is shipped off-site in the original drum in which the carbon was delivered. Spent carbon is disposed of as a listed hazardous waste with the waste code, F002.

Iron fouling. The O&M logs note continued issues with iron fouling at the pumps in the extraction wells and at the carbon drums. Several instances occurred where fouling of the carbon drums occurred where the carbon had to be replaced. The iron fouling has also caused pre-mature rusting of the carbon drums where the drums also had to be replaced.

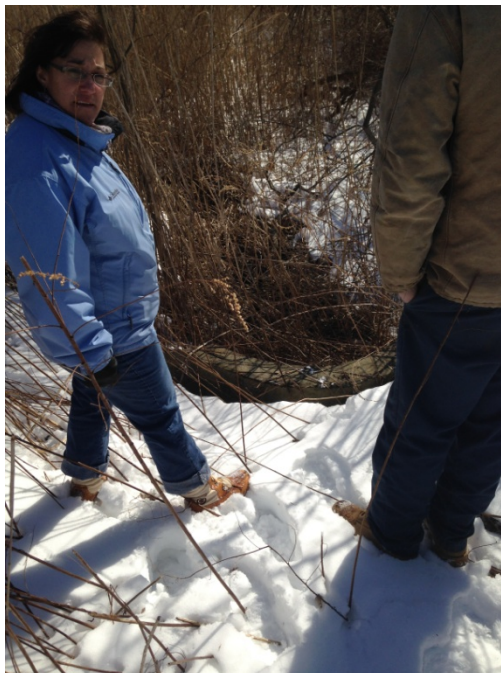
Effluent outfall

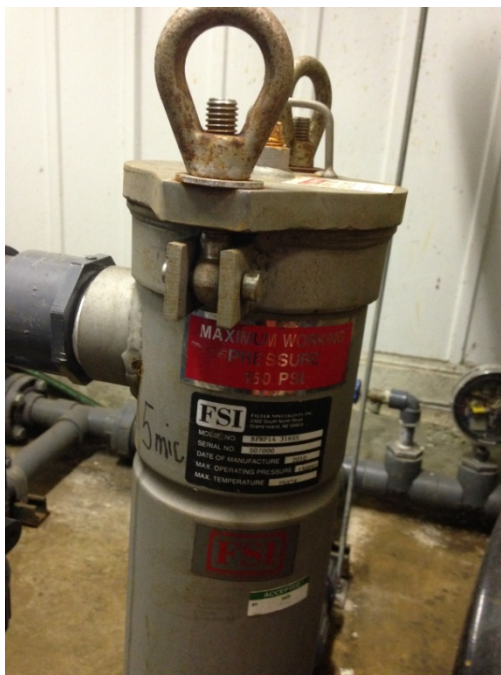
5 Micron Bag Filter

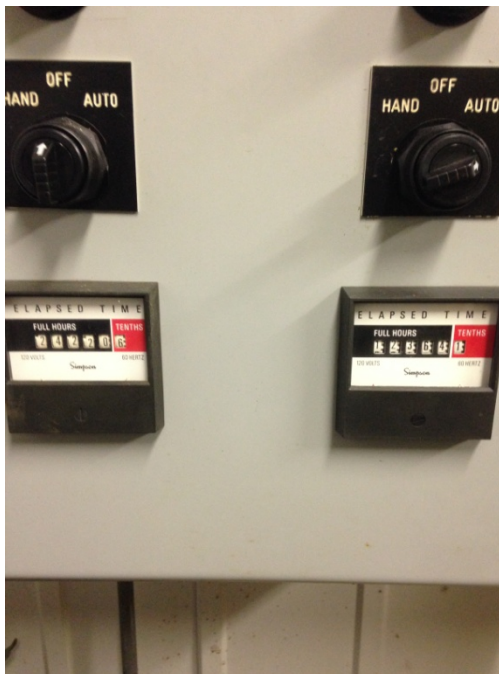
Recovery Wells  
Control Panel

Frequent issues with well transducers. Level transducers installed in the wells have been prone to failure. Frequent issues with the well transducers are noted in the O&M logs. See Appendix C for a listing of non-routine maintenance items. Currently, site reports indicate that RW-1S is not operational due to an issue with the transducer. The malfunction of the RW-1S transducer has been an on-going issue since August 2011. Based upon document review and discussion with Aztech, the issue with the transducer has been found to be poor interfacing capabilities of the Precision Digital pump controller with the pump control panel and system programming. Aztech indicates that the NYSDEC has given approval to proceed with upgrading the system from the Precision Digital pump controller to a ProFlow, Inc system which will include remote access and control as
