**Periodic Review Report
for the
Baldwin Place Shopping Center
(now Somers Commons)**

80 U.S. Route 6
Baldwin Place, Westchester County, New York

Covering the Time Period from
February 15, 2009 Through February 15, 2014

NYSDEC Site No. 3-60-023

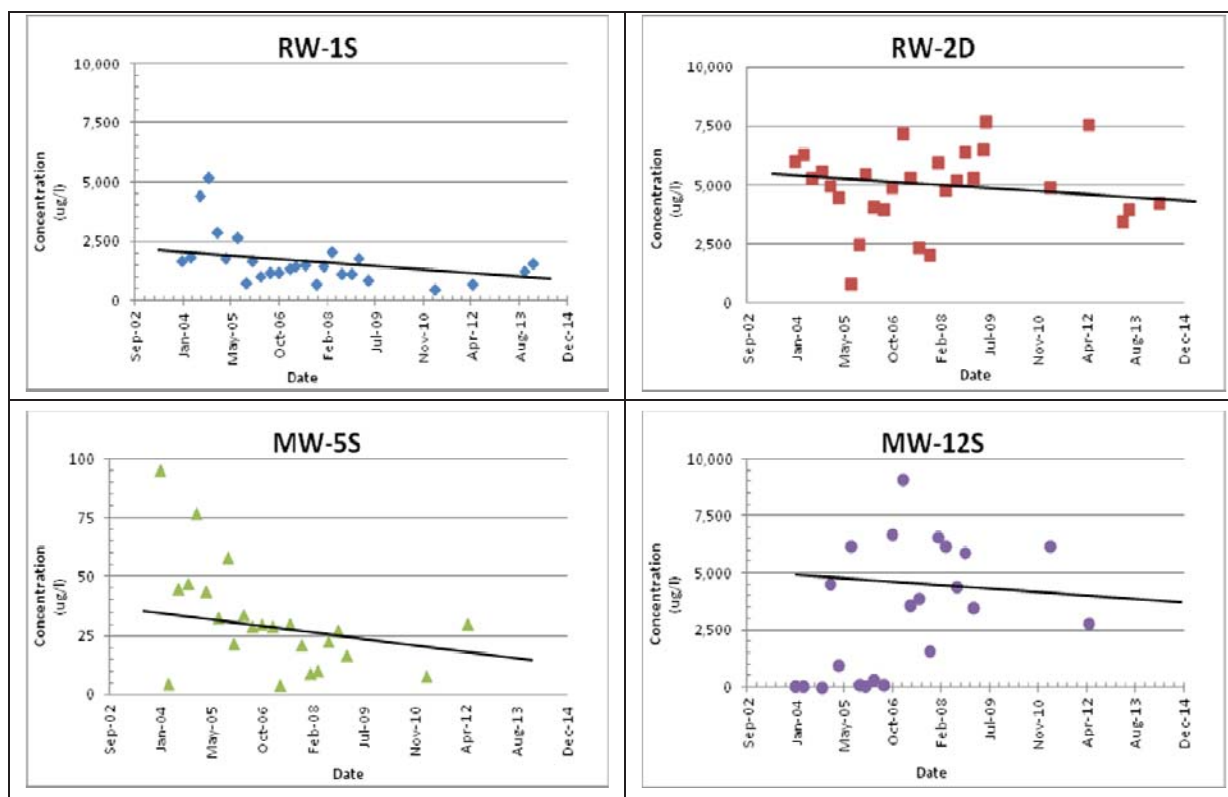
A review of the groundwater analytical results obtained from sampling events conducted since 2004 indicates that, in general, total VOC concentrations are following an overall declining trend in groundwater. This overall declining trend in total VOC concentrations is shown in the charts below for groundwater extraction wells RW-1S and RW-2D and on-site monitoring wells MW-5S and MW-12S. Each of these wells is located in proximity to the former source area.

Based on the declines noted, the concentrations of the VOCs identified in groundwater are trending toward the remedial goals for the site. However, the most recent concentrations of PCE in groundwater are currently in excess of the standards, criteria and guidance for Class GA groundwater (TOGS 1.1.1).
