Air Sparging and Soil Vapor Extraction System

Operation and Maintenance Report for March 2001

Re: **D008873, PIN 8007.31.301**
Harrison Petroleum Spill – Remediation
Town of Harrison, Westchester County, New York
Air Sparging/Soil Vapor Extraction System
Monthly Operations & Maintenance Report #5 (March 2001)

MONTHLY OPERATION AND MAINTENANCE REPORT

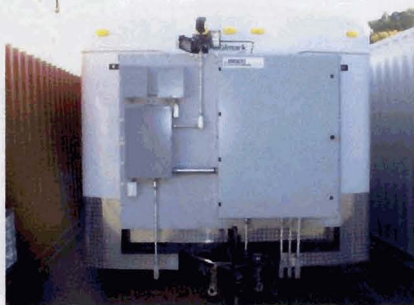
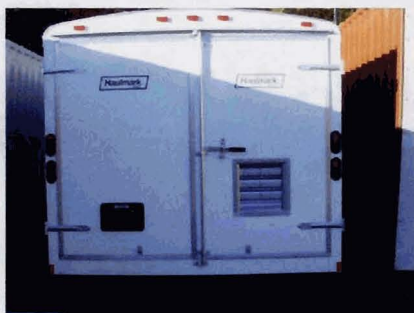
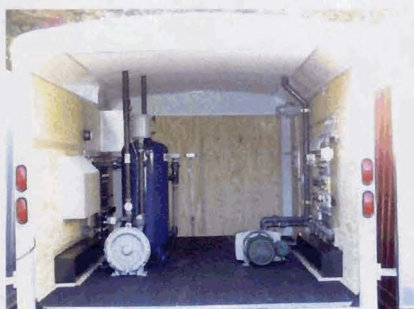
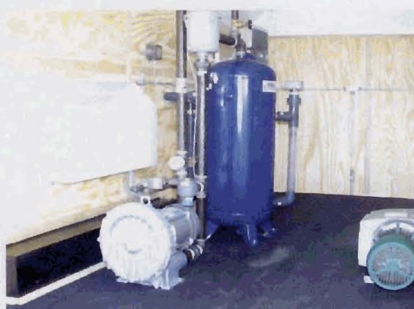
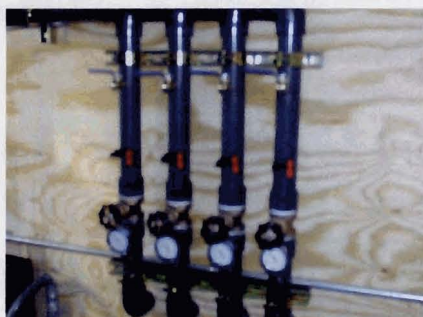
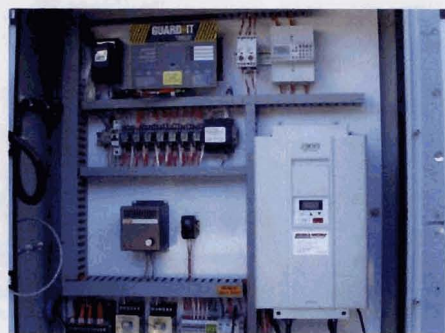
FIGURE 4
AS/SVE EQUIPMENT SPECIFICATIONS AND LAYOUT
Harrison Subresidency

**AIR SPARGING AND SOIL
VAPOR EXTRACTION
SYSTEM SPECIFICATIONS**

TRAILER (Class 1 , Div. 2)

AIR SPARGING SYSTEM

Blower Becker KDT
Model # 3.140
HP 12
Voltage 230 V/3 phase
Converter VFD
Max. pressure 22 psig
Max. flow 90 scfm
Max. temp. 125 F
Noise level 84 max. dBA
Outlet size 1 1/2 " bsp

SOIL VAPOR EXTRACTION

Blower Gast
Model # R6P155Q-50
HP 5.5
Voltage 230 V/1 phase
Max. vacuum 85" w.c.
Max. flow 280 scfm
Max. temp. 100 F
Noise level 81 max. dBA
Moisture sep. 60 gal.
