Harrison Subresidency
Town of Harrison
Westchester County, New York

D008873
PIN 8807.31.301

Air Sparging and Soil Vapor Extraction System

Operation and Maintenance Report for April 2001

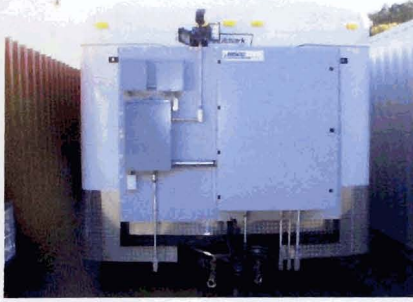
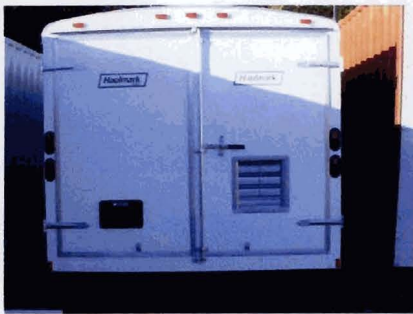
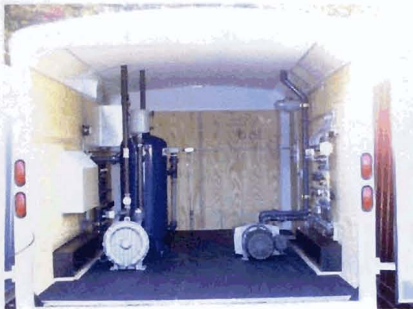
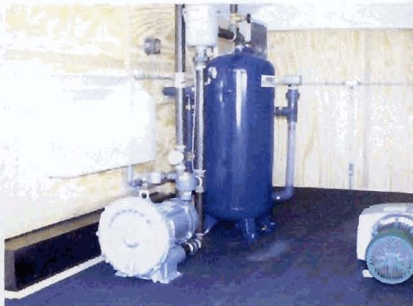
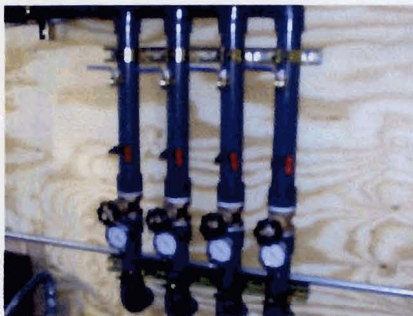
FIGURE 4
AS/SVE EQUIPMENT SPECIFICATIONS AND LAYOUT
 Harrison Subresidency

**AIR SPARGING AND SOIL
 VAPOR EXTRACTION
 SYSTEM SPECIFICATIONS**

TRAILER (Class 1 , Div. 2)

AIR SPARGING SYSTEM

Blower Becker KDT
Model # 3.140
HP 12
Voltage 230 V/3 phase
Converter VFD
Max. pressure 22 psig
Max. flow 90 scfm
Max. temp. 125 F
Noise level 84 max. dBA
Outlet size 1 1/2" bsp

SOIL VAPOR EXTRACTION

Blower Gast
Model # R6P155Q-50
HP 5.5
Voltage 230 V/1 phase
Max. vacuum 85" w.c.
Max. flow 280 scfm
Max. temp. 100 F
Noise level 81 max. dBA
Moisture sep. 60 gal.

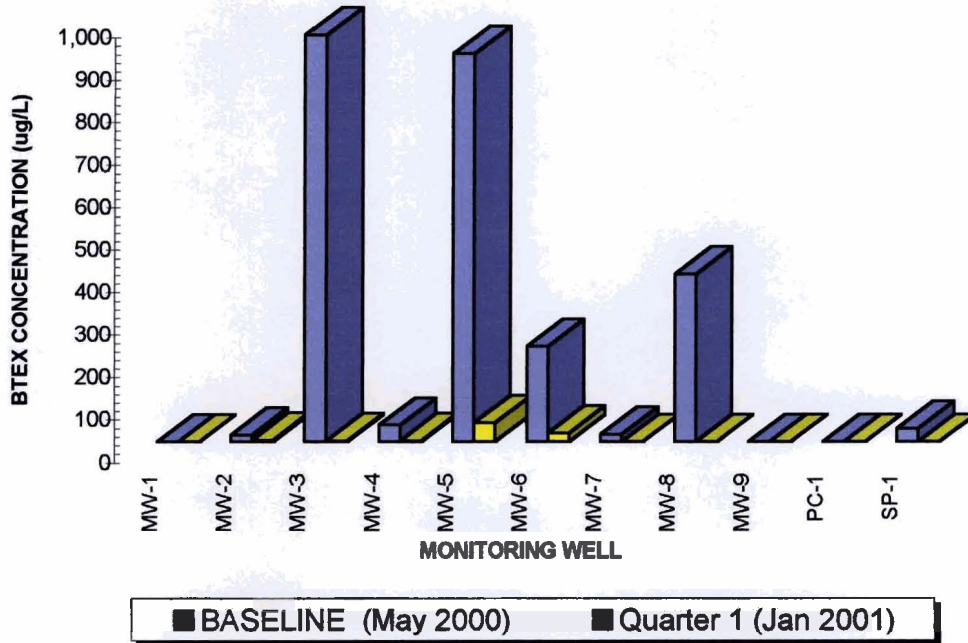
FIGURE 7
GROUNDWATER MONITORING - QUARTER ONE RESULTS (JAN 2001)
