# **NEW YORK STATE DEPARTMENT OF TRANSPORTATION**

**Harrison Subresidency  
Town of Harrison  
Westchester County, New York**

MONTHLY OPERATION AND MAINTENANCE REPORT  
AIR SPARGING / SOIL VAPOR EXTRACTION SYSTEM  
HARRISON SUBRESIDENCY, WESTCHESTER, NEW YORK

SEPTEMBER 2001

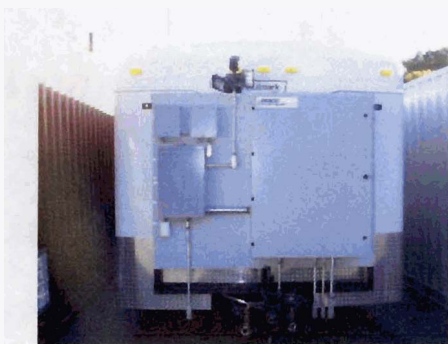
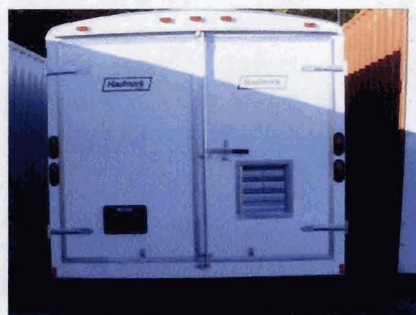
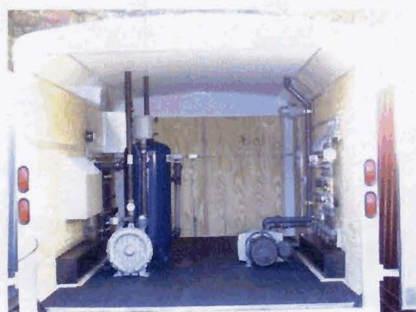
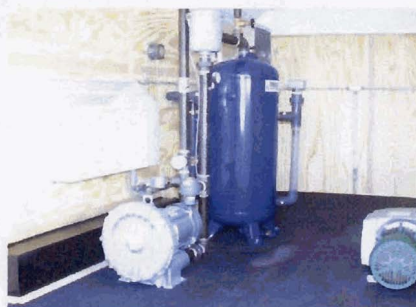
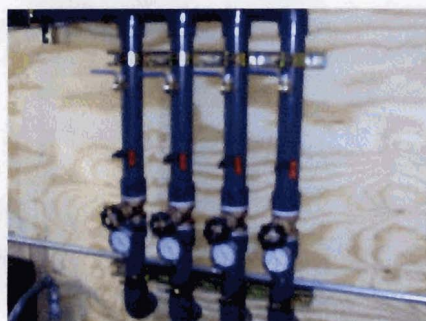
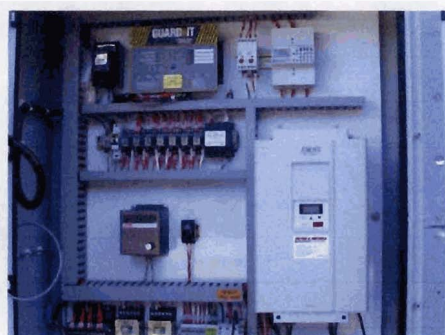
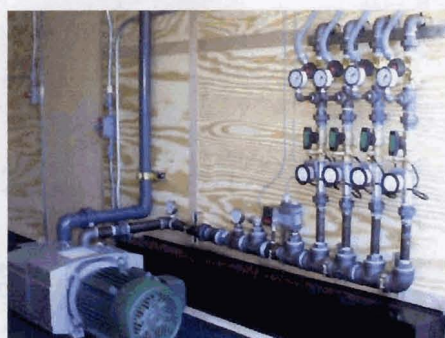
| Haulmark Model | Grizzly #G816B2 |

| Blower Model # | Becker KDT 3.140 |

| Blower Model # | Gast R6P155Q-50 |
