RE: SITE MANAGEMENT PERIODIC REVIEW REPORT  
SITE NUMBER 360035  
NYSDOT HARRISON SUBRESIDENCY  
ROUTE 120  
TOWN OF HARRISON  
WESTCHESTER COUNTY

**Site Management Periodic Review Report  
NYSDOT Harrison Sub-Residency  
Harrison, New York  
Site Number 360035  
May 2, 2013**

- a 2.6 acre landfill, which is listed in the New York State Registry of Inactive Hazardous Waste Sites and is classified as a "Category 4", meaning that it has been remediated and only ongoing monitoring is required, and
- a "closed, does not meet standards" petroleum spill (#94-07349) which, at present, still requires monitoring.

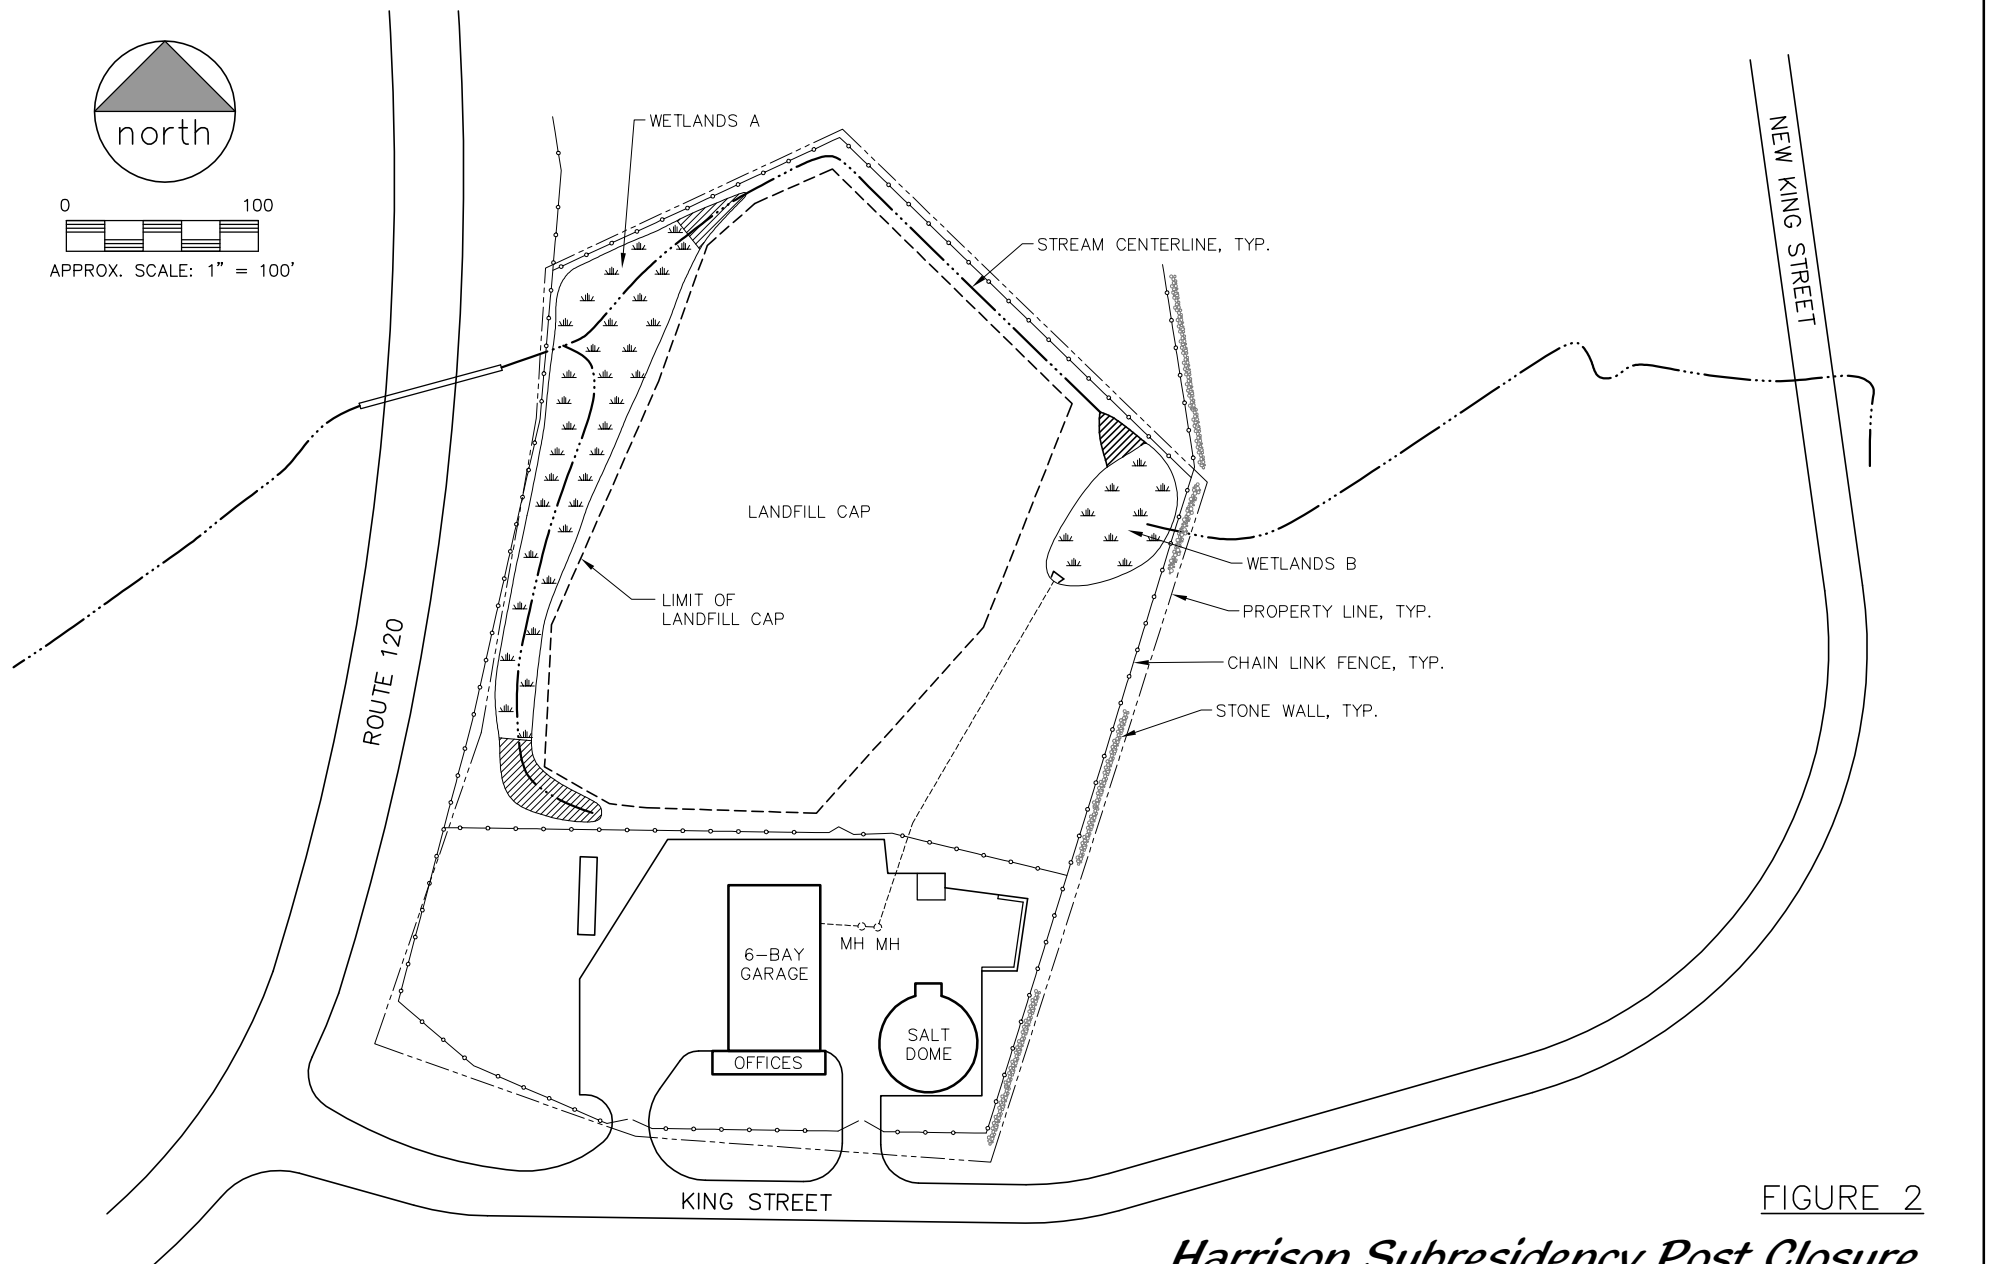
FIGURE 2

*Harrison Subresidency Post Closure  
Quarterly Monitoring Report  
Site Map*

environment. A small stream that drains into the reservoir was rerouted around the landfill so that it could not act as a collector trench for contaminants (see Attachment 2). The plastic liner extends beneath the repositioned stream, so that any leachate generated within the fill cannot discharge into surface water. Environmental monitoring results have shown no evidence of toxic contaminants from the landfill with the potential of reaching the reservoir.

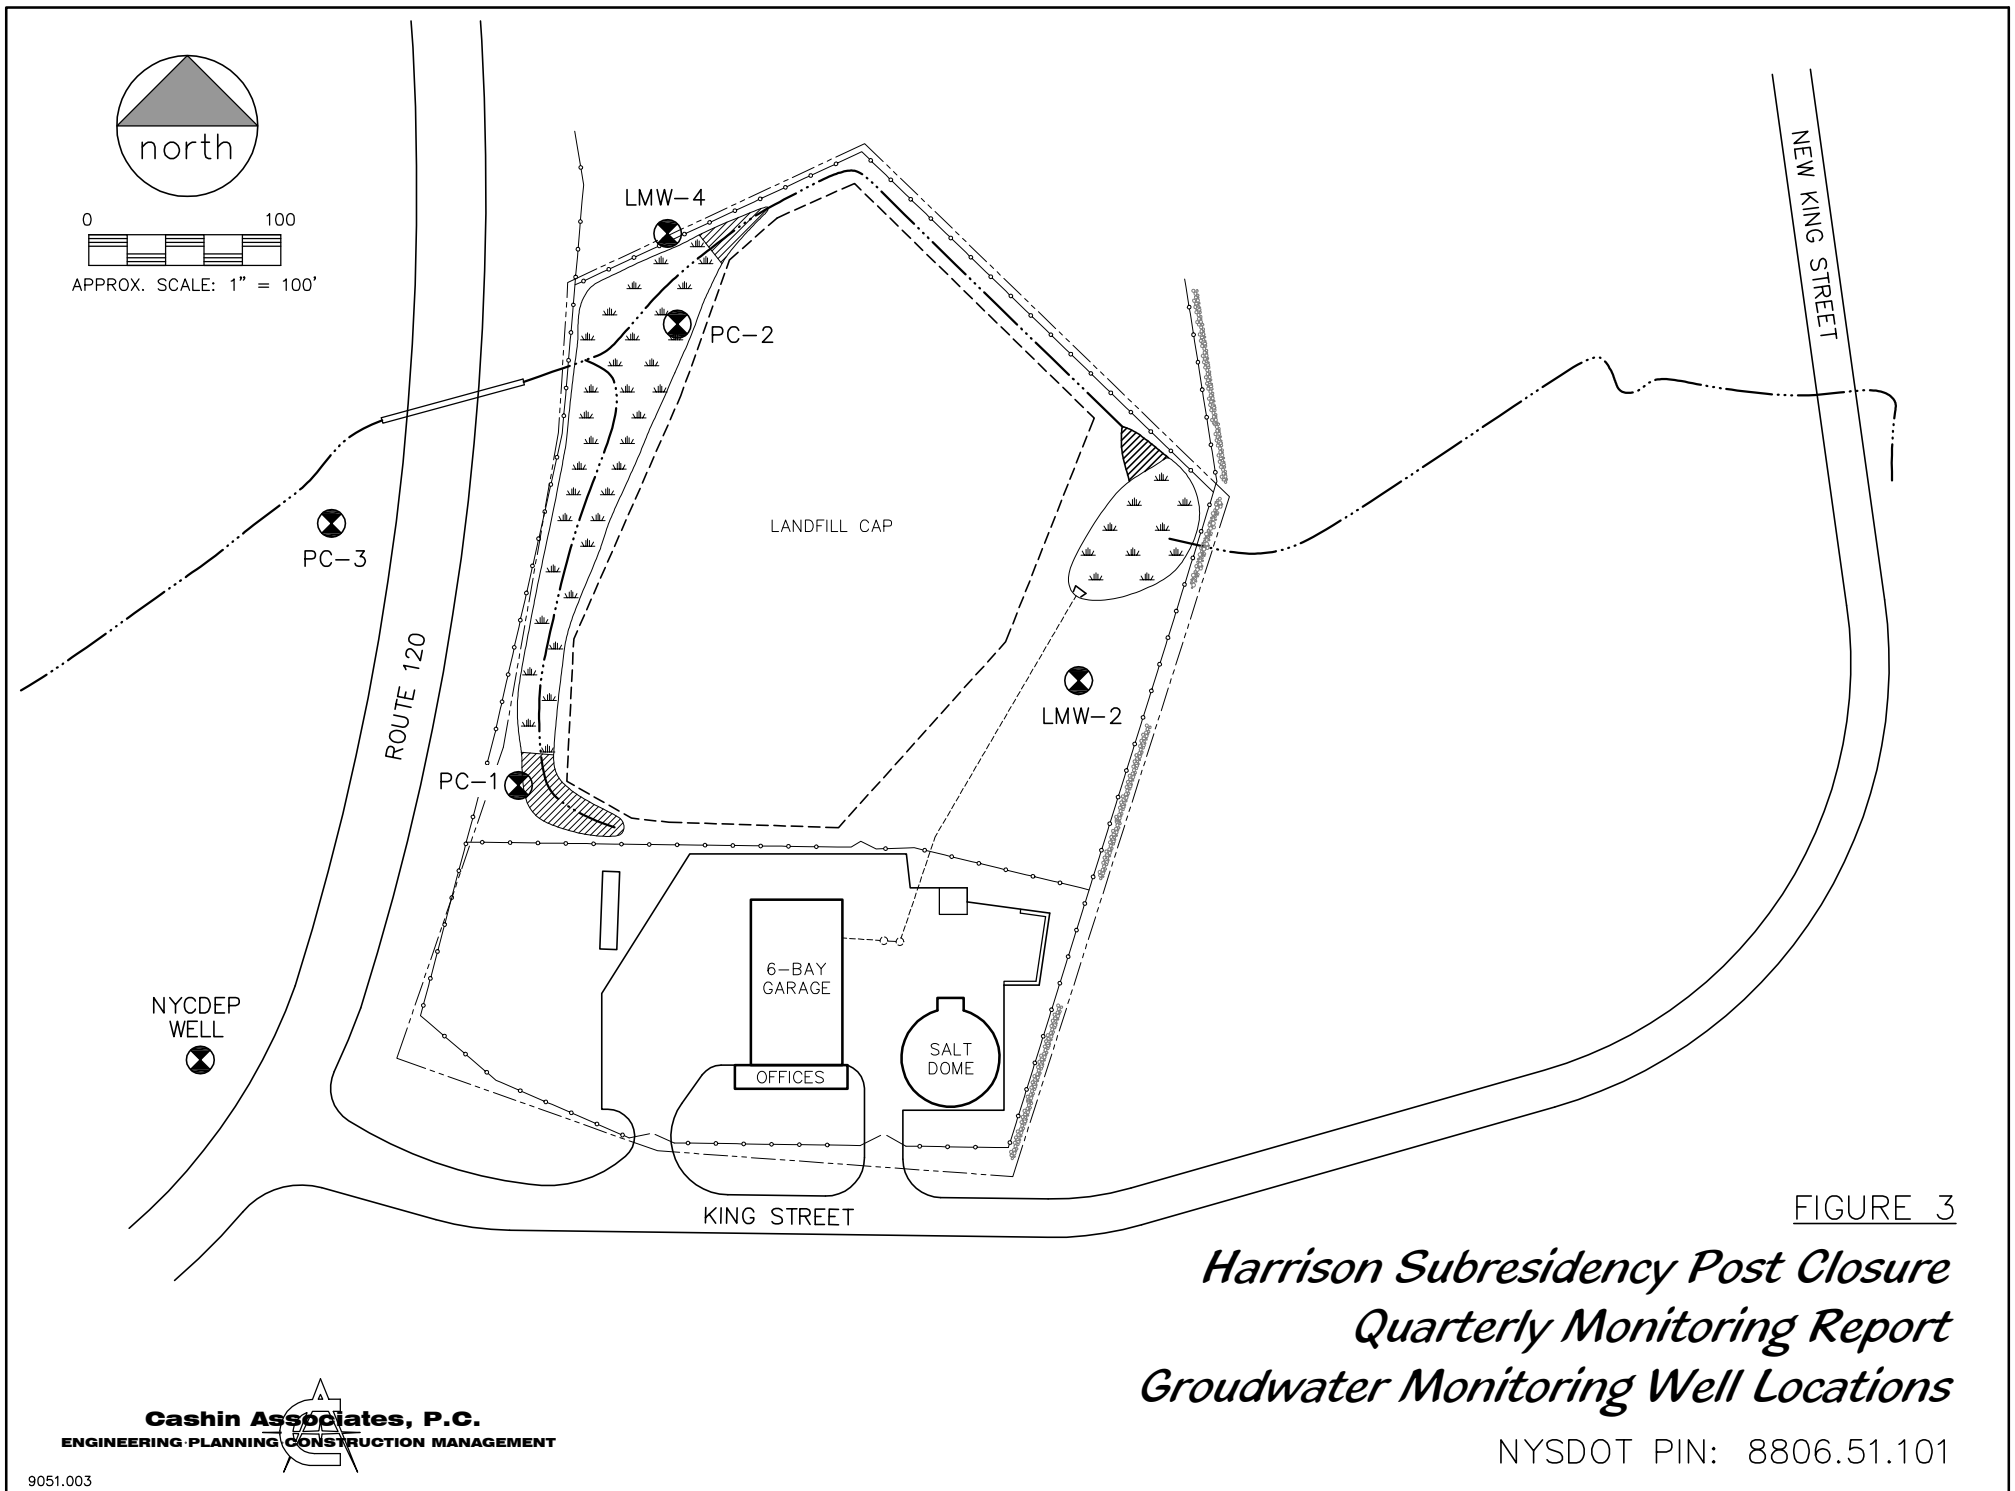
FIGURE 3

*Harrison Subresidency Post Closure  
Quarterly Monitoring Report  
Groundwater Monitoring Well Locations*

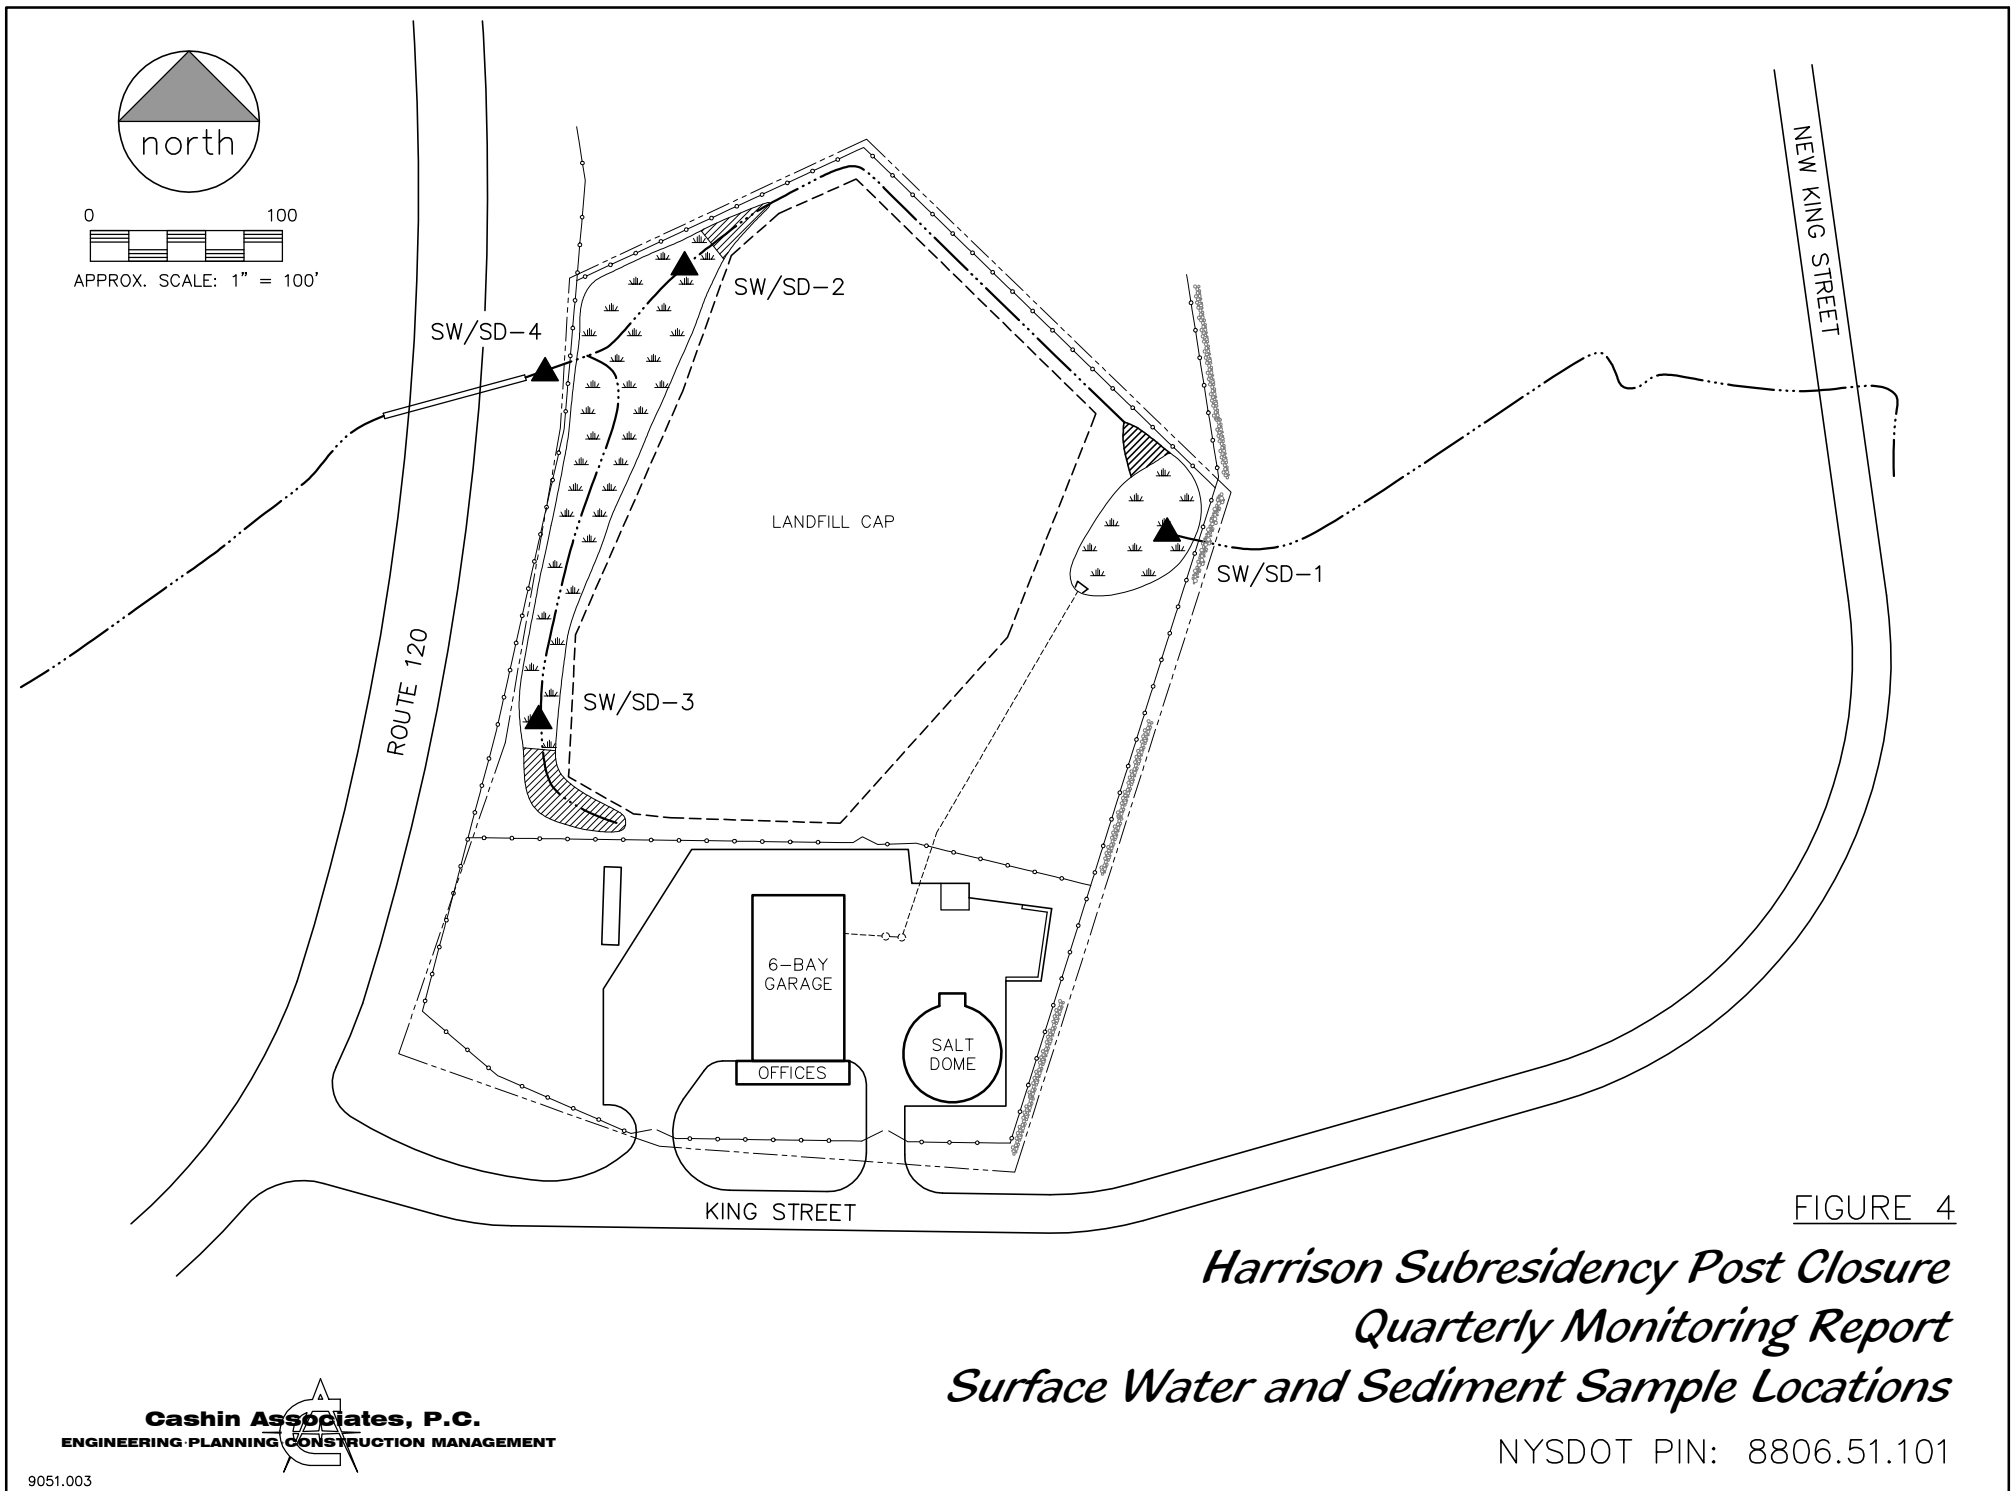
FIGURE 4

*Harrison Subresidency Post Closure  
Quarterly Monitoring Report  
Surface Water and Sediment Sample Locations*

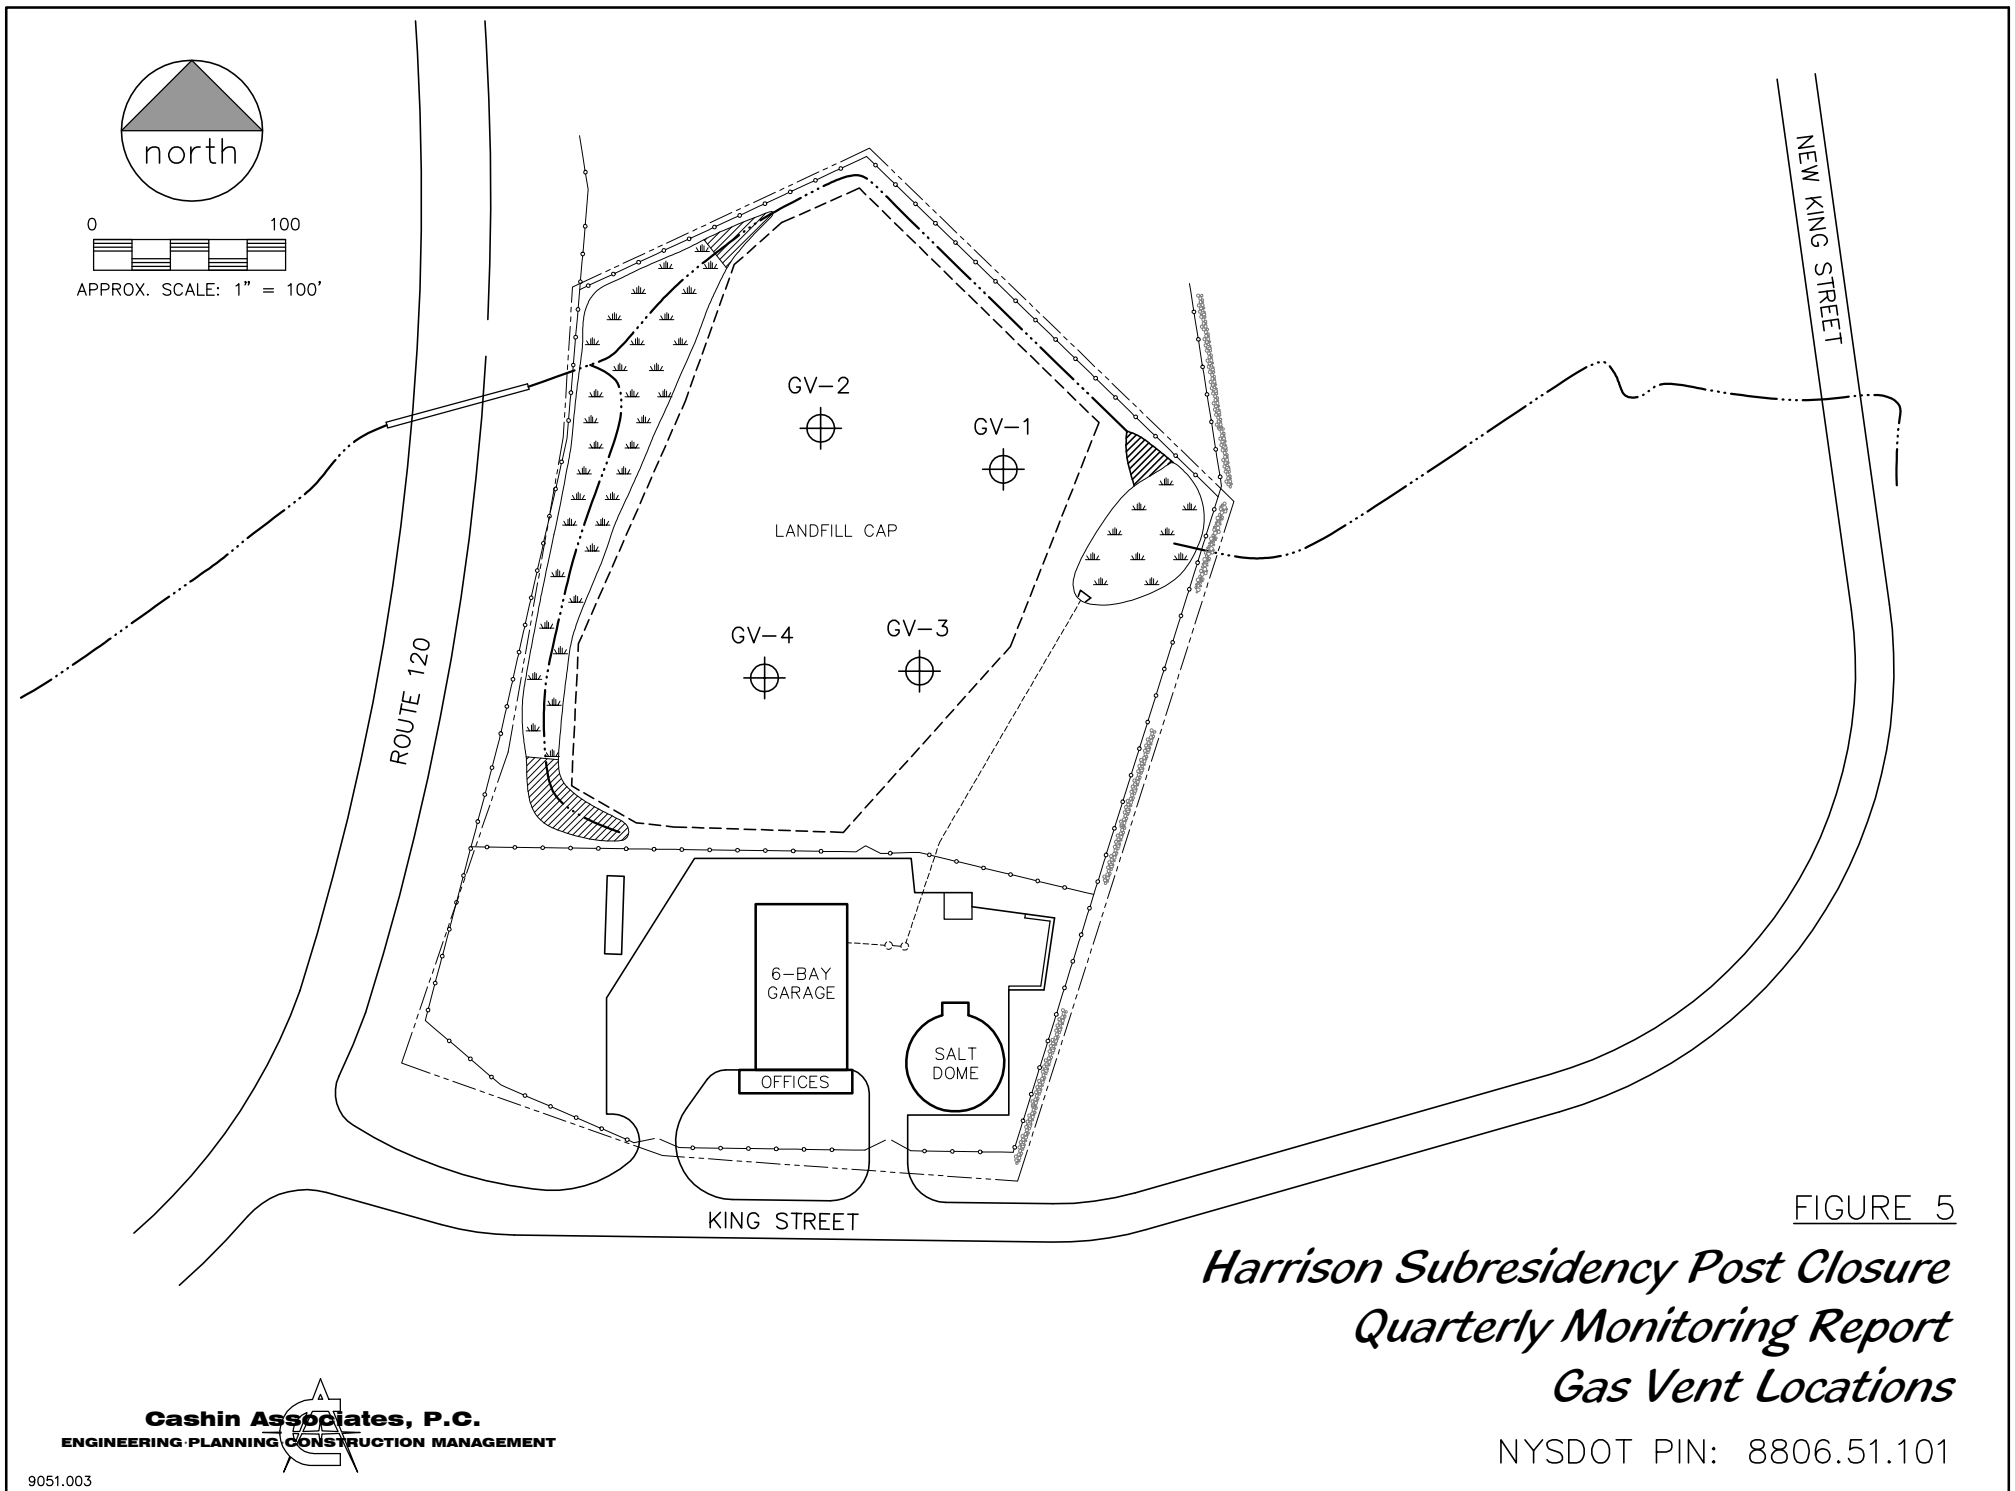
FIGURE 5

*Harrison Subresidency Post Closure  
Quarterly Monitoring Report  
Gas Vent Locations*

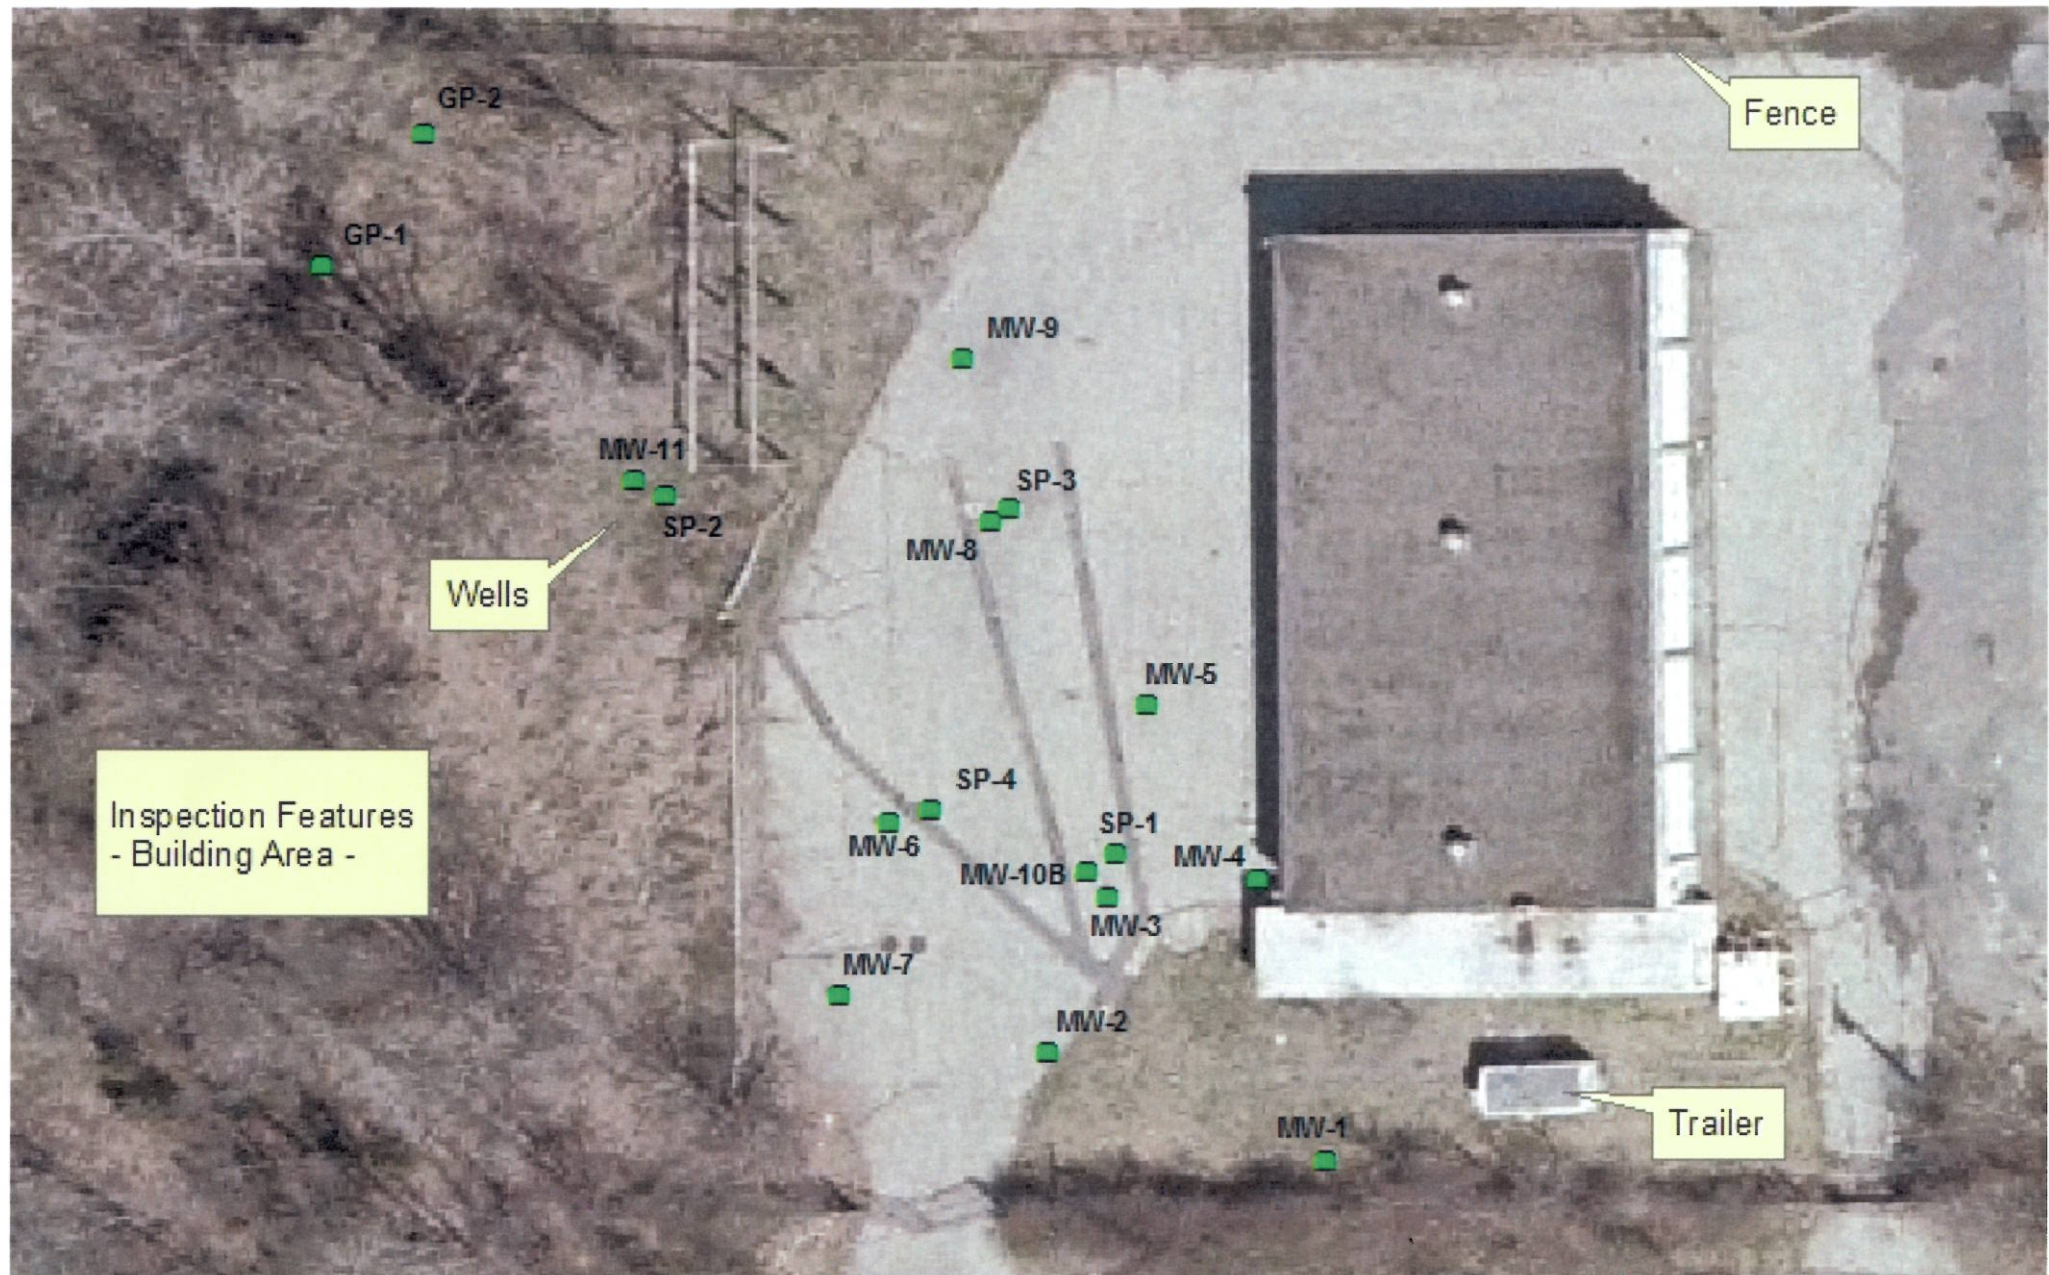
# Attachment 6

Monitoring  
Well Locations  
May 2009

In May –June 2008, after discussions among DOT, DEC, DOH, and DEP, thirteen wells in the petroleum spill area were "closed" or decommissioned. In June of 2008, two new wells, MW-12 and MW-13, were installed (see Attachments 6, 7, 13).

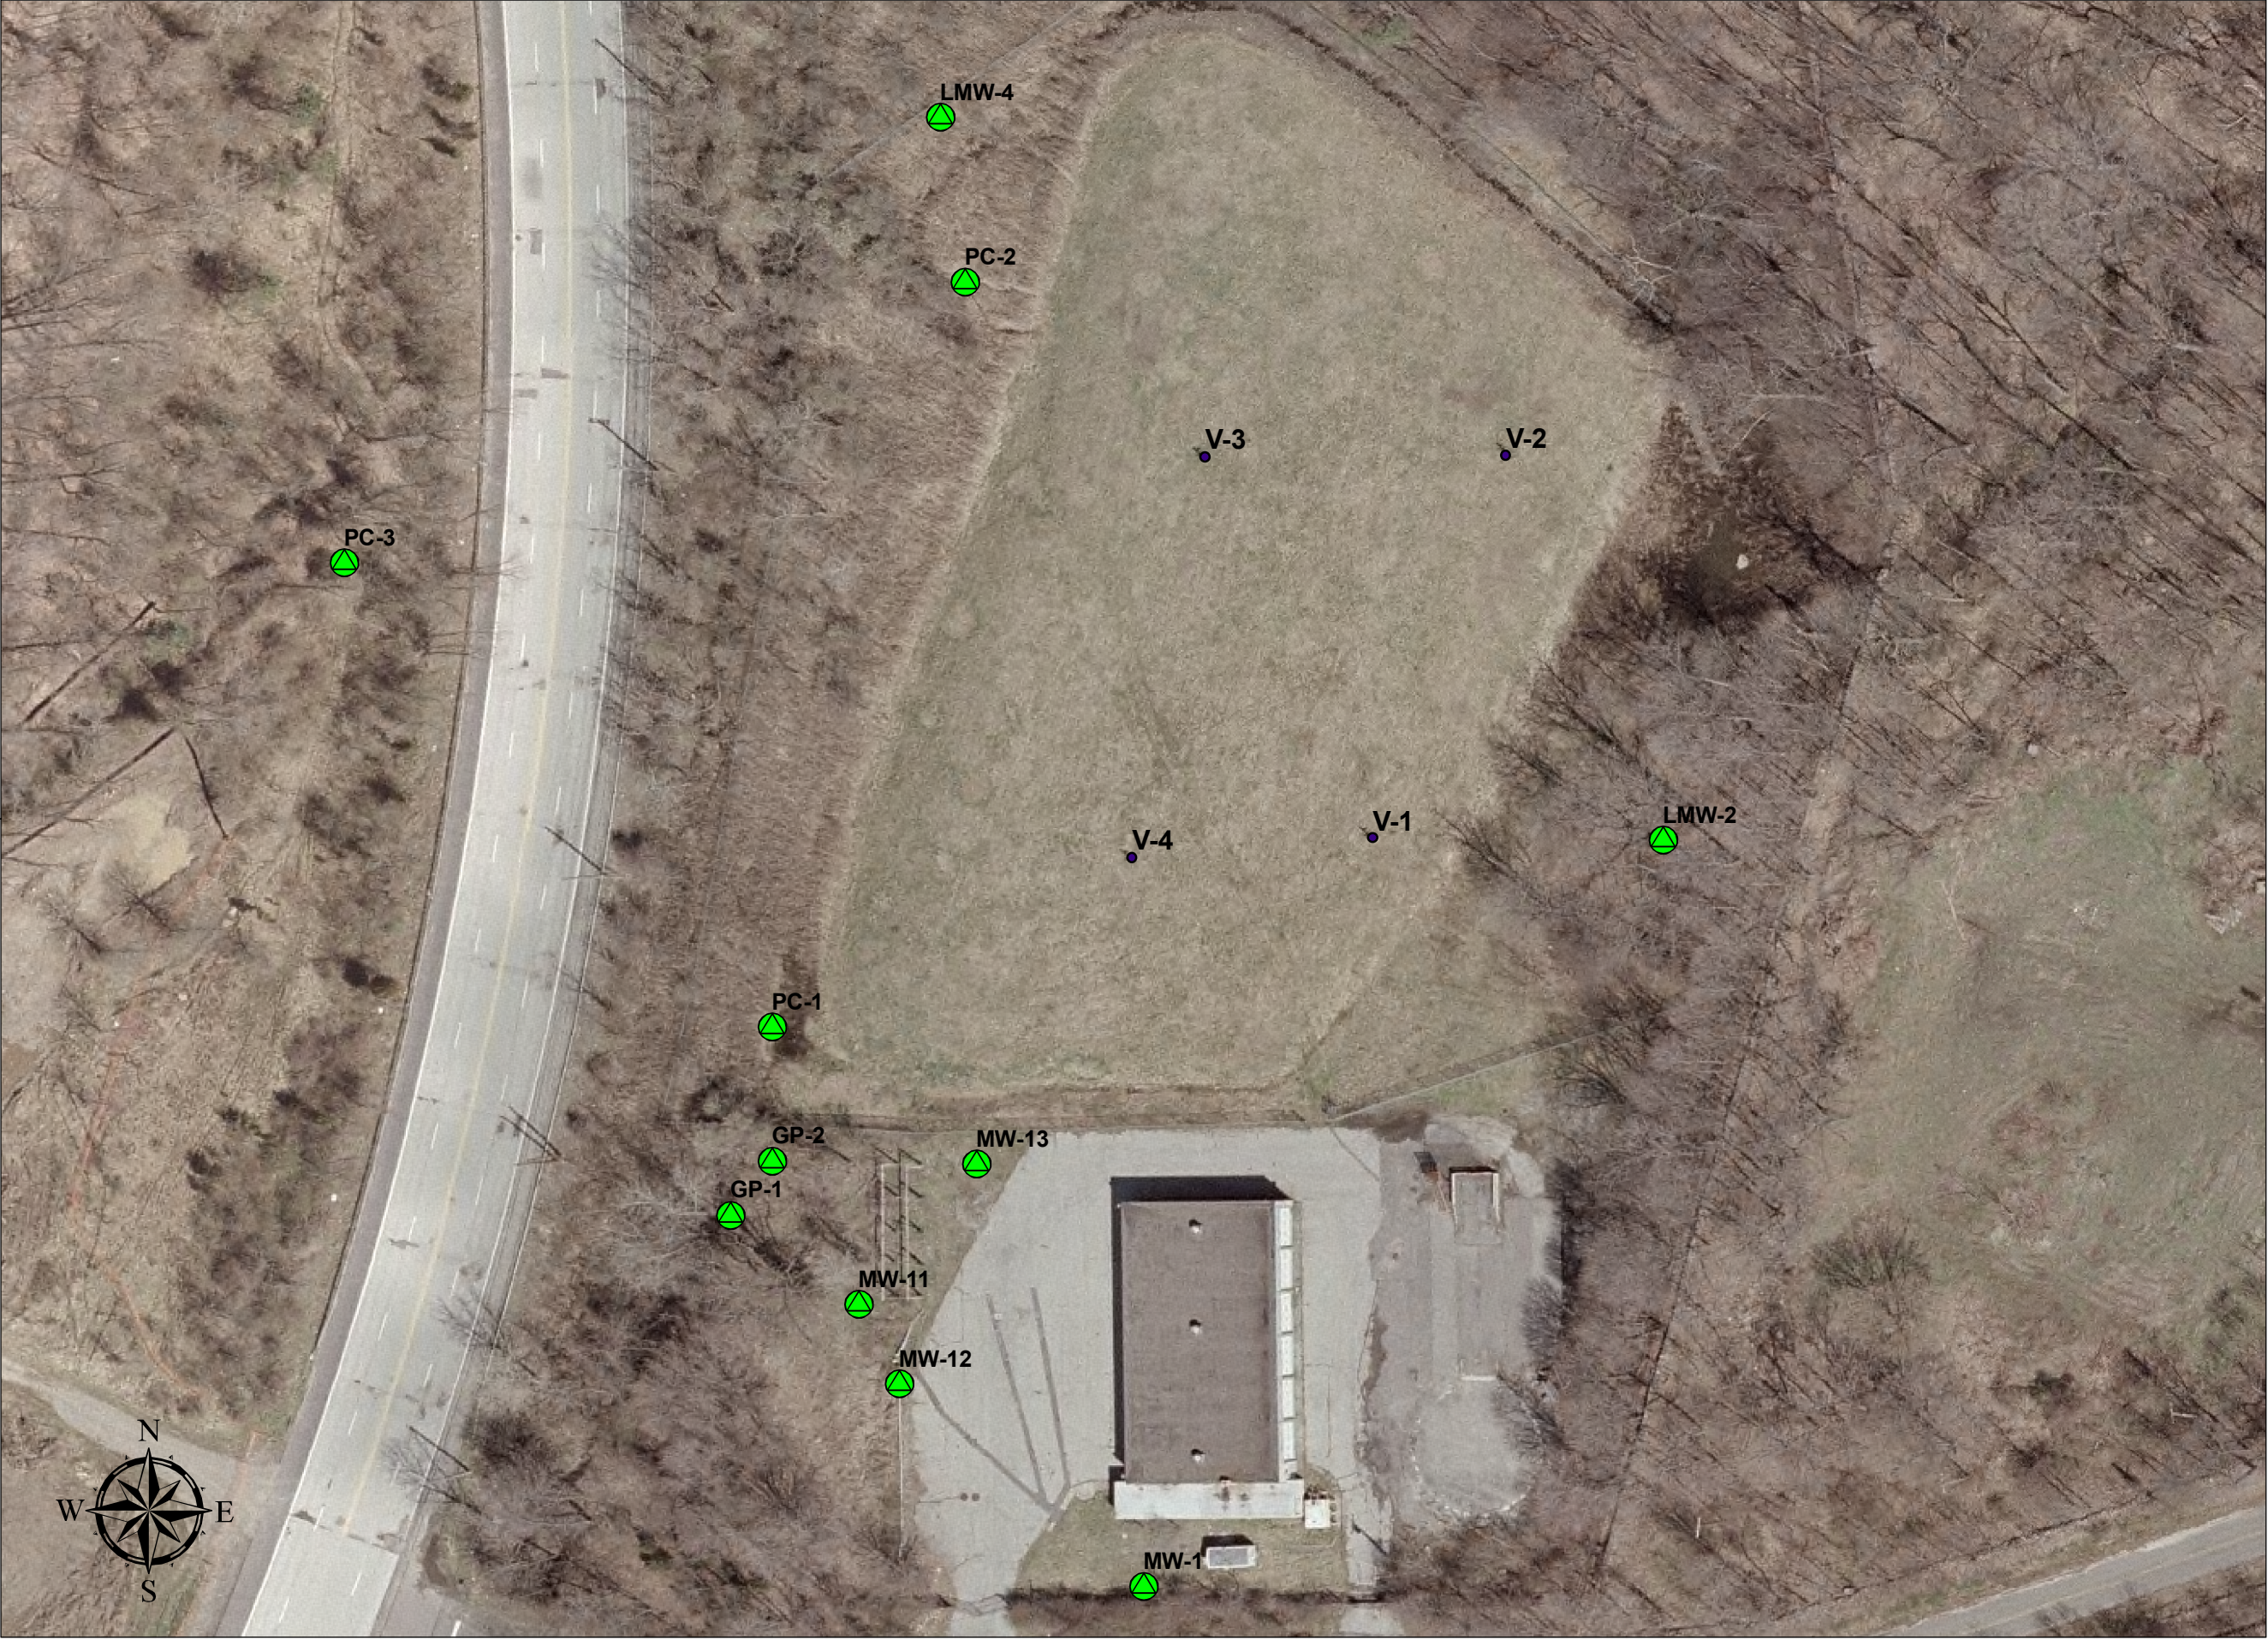
Monitoring  
Well Locations  
May 2012

In November 2011 and May 2012, again after discussions among DOT, DEC, DOH, and DEP, five more wells were "closed" or decommissioned (three in the petroleum spill area, one in the landfill area, and one "outlier"). The existing well in the petroleum spill area which has been left open is MW-11 (see Attachments 8, 14).

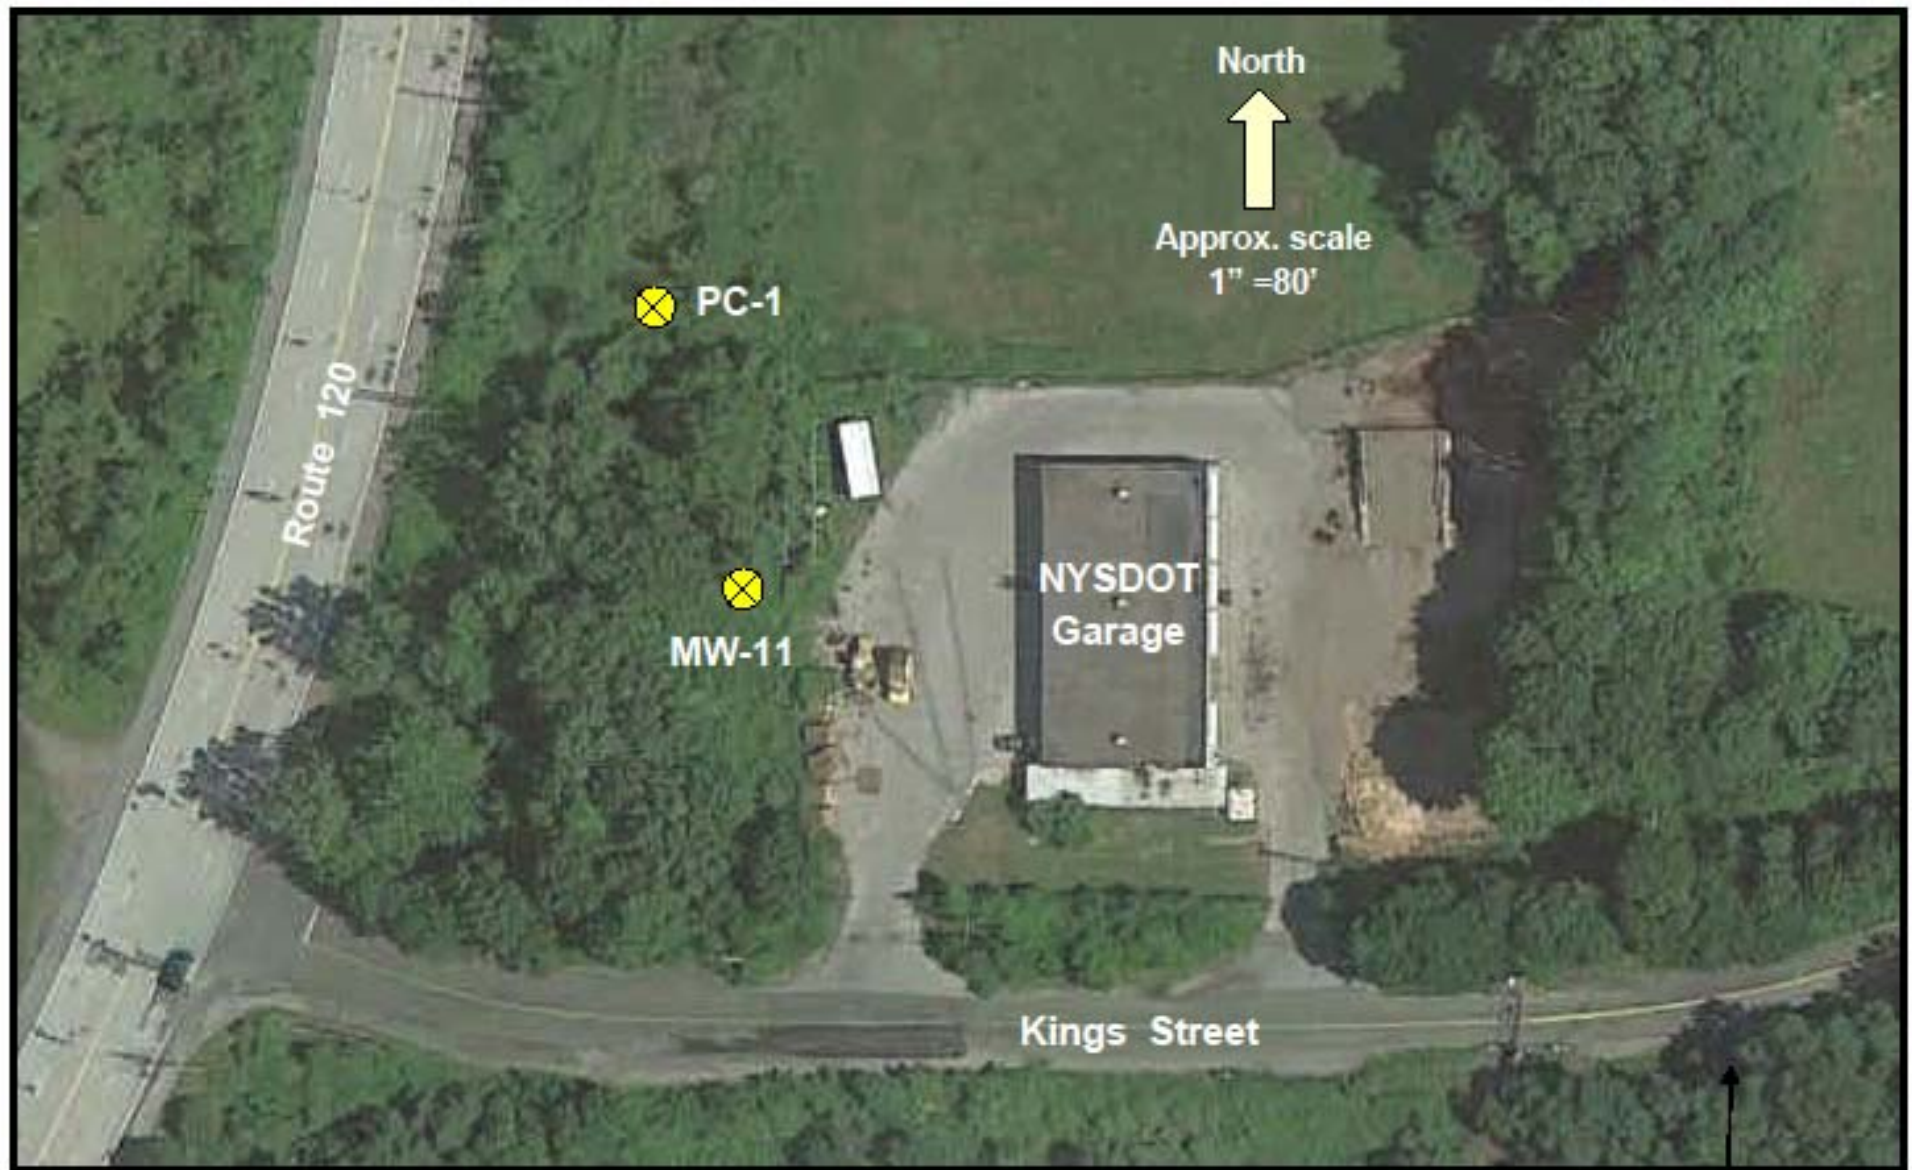
*Figure 2  
Harrison Subresidency Spill Site  
Monitoring Well Locations  
NYSDOT Harrison, N.Y.*
