**SITE CHARACTERIZATION / PRELIMINARY REMEDIAL
INVESTIGATION REPORT**

**DP 16 LLC
ONE COMMERCE PARK SITE
115 WALL STREET
VALHALLA, NEW YORK**

September 13, 2010

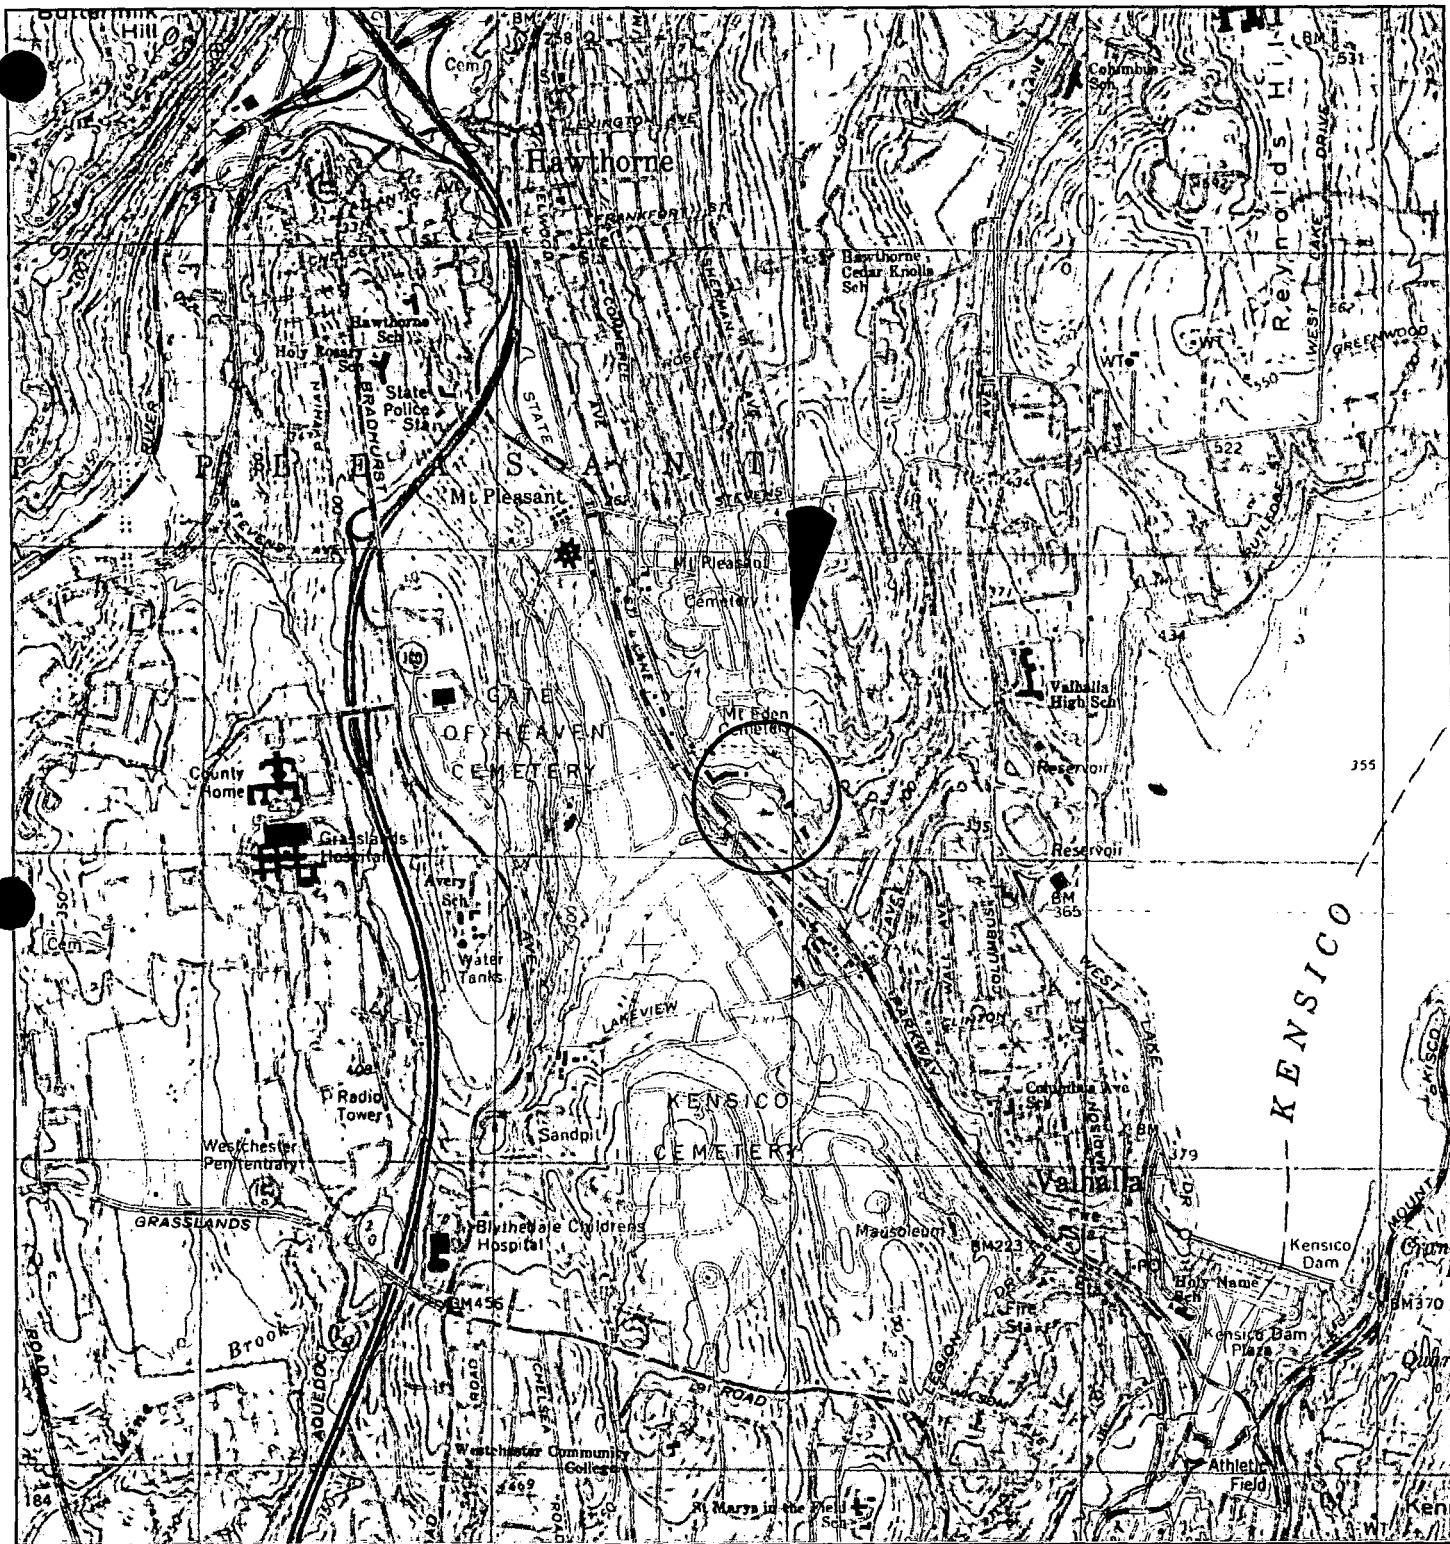
Historical Topographic Map

<p>N ↑</p>	<p>TARGET QUAD NAME: WHITE PLAINS MAP YEAR: 1994 SERIES: 7.5 SCALE: 1:24000</p>	<p>SITE NAME: 115 Wall Street ADDRESS: 115 Wall Street Valhalla, NY 10595 LAT/LONG: 41.0881 / 73.7878</p>	<p>CLIENT: APEX Companies LLC CONTACT: Greg Mendez-Chicas INQUIRY#: 2501979.4 RESEARCH DATE: 05/22/2009</p>
----------------	--	---	---

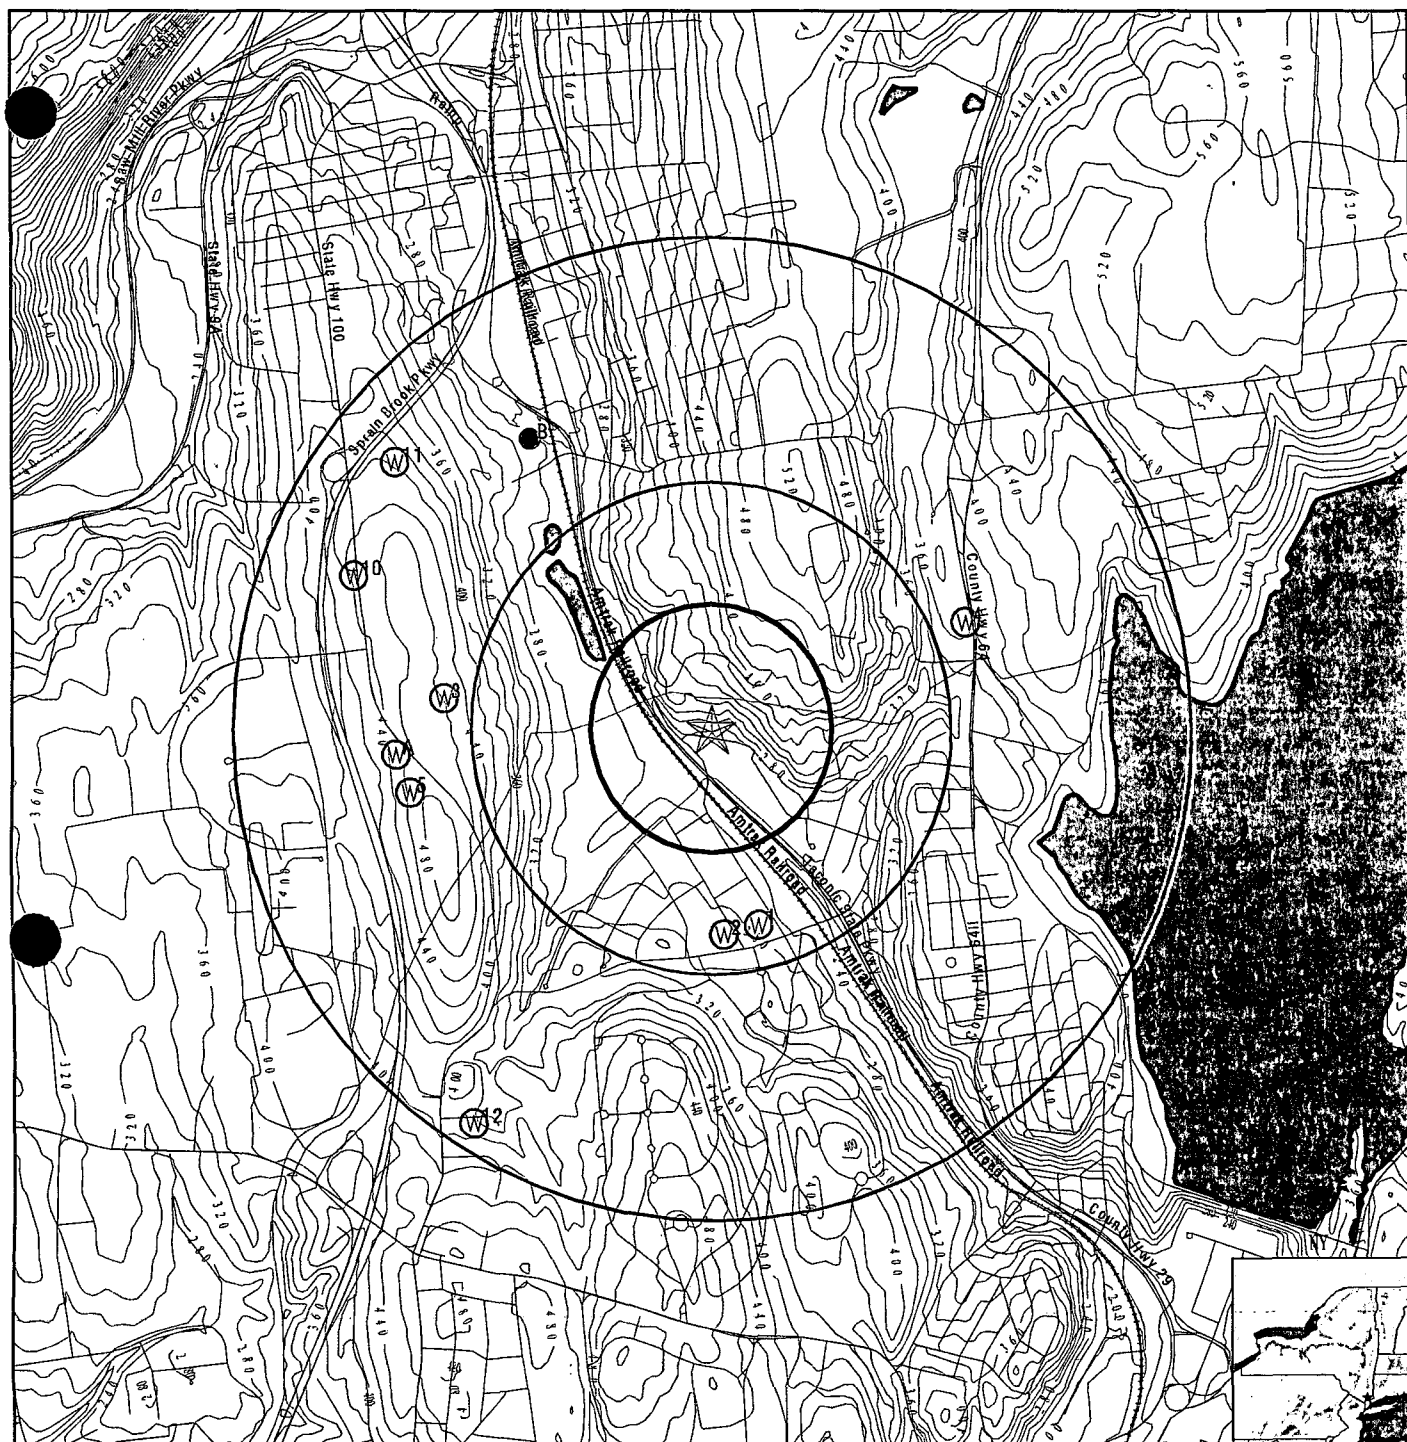
PHYSICAL SETTING SOURCE MAP - 2511937.1s

- County Boundary
- Major Roads
- Contour Lines
- Earthquake epicenter, Richter 5 or greater
- Water Wells
- Public Water Supply Wells
- Cluster of Multiple Icons

- Groundwater Flow Direction
- Indeterminate Groundwater Flow at Location
- Groundwater Flow Varies at Location
- Closest Hydrogeological Data
- Oil, gas or related wells
