**River Plaza Shopping Center  
(Currently Known as Tarrytown Station Center)**

**124 TO 162 WILDEY STREET  
TARRYTOWN, WESTCHESTER COUNTY, NEW YORK**

**Periodic Review Report**

**NYSDEC Site Number: 360084**

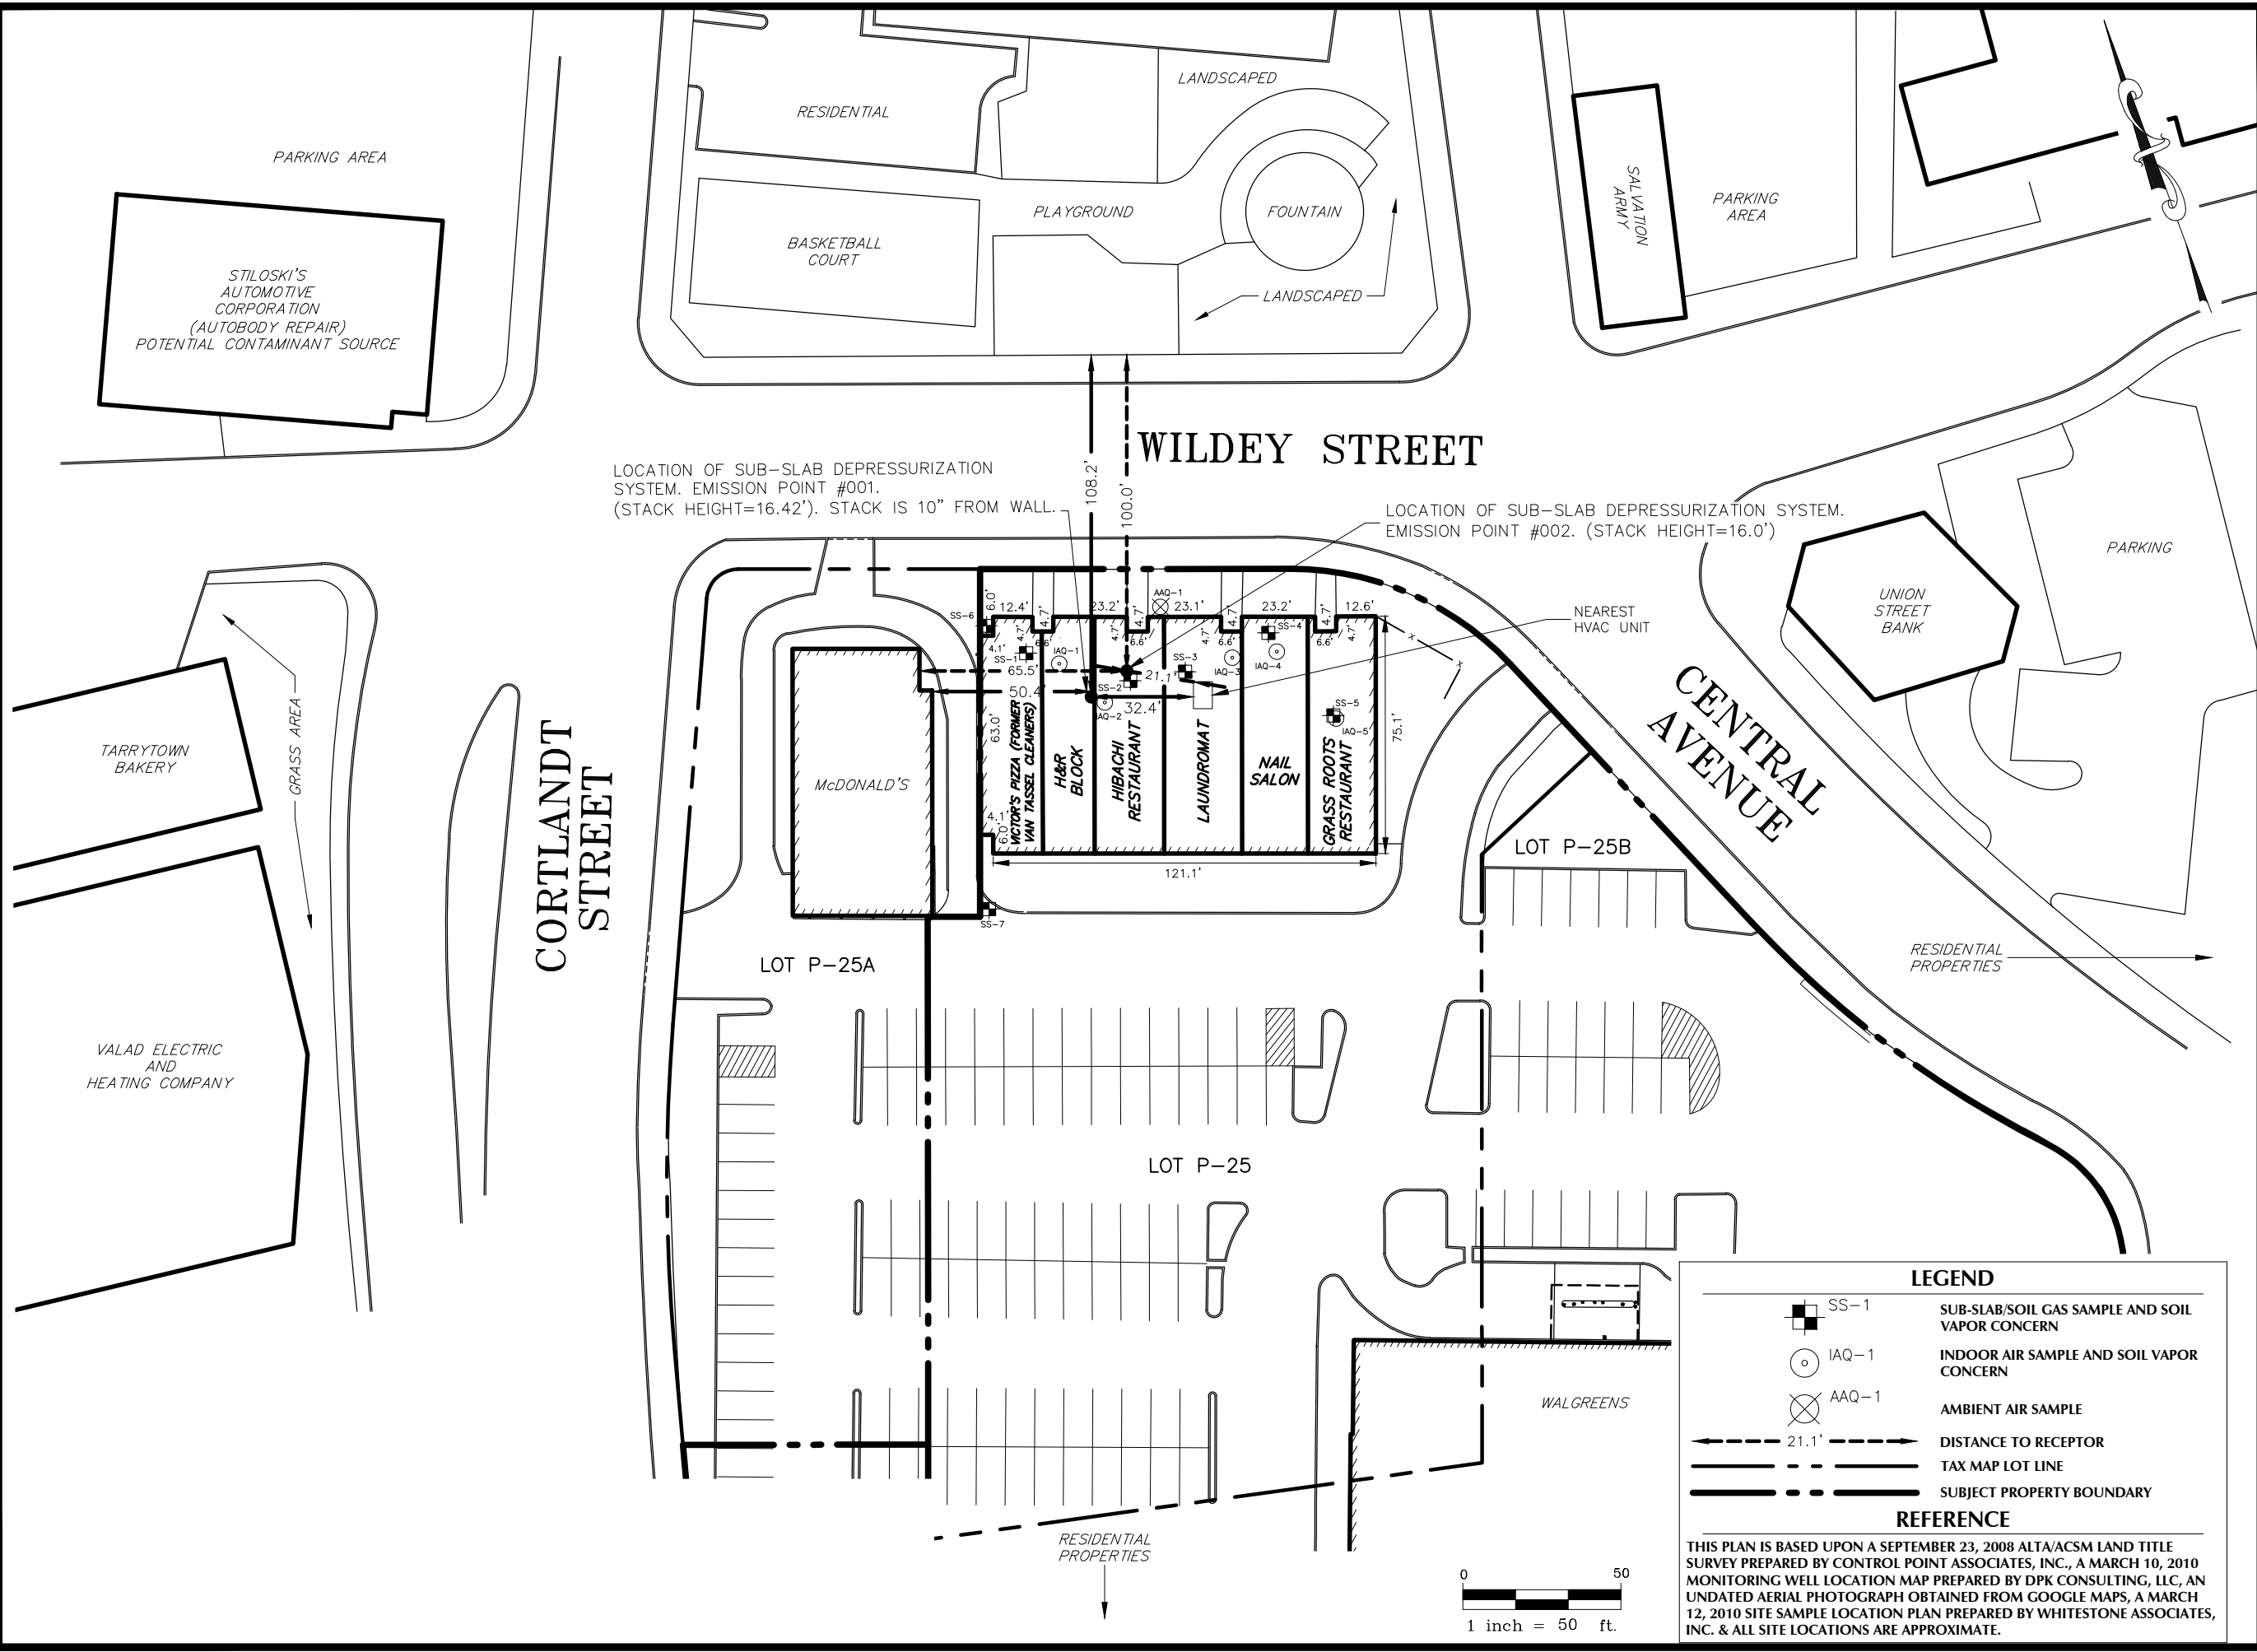
**FIGURE 1**  
**Location of Remedial Treatment**  
**Systems (SSDSs) and Soil Vapor**  
**Concern**

DRAWING TITLE: LOCATION OF REMEDIAL TREATMENT SYSTEMS (SSDSS) AND SOIL VAPOR CONCERN	
CLIENT: WILDEY GROUP, LLC	
PROJECT: RIVER PLAZA SHOPPING CENTER (CURRENTLY KNOWN AS TARRYTOWN STATION CENTER) 124 TO 162 WILDEY STREET TARRYTOWN, WEST CHESTER COUNTY, NY	
PROJECT #: EJ1312650.Y09	
DESIGNED BY: GR	PROJ. MGR.: CS
DATE: 8/23/21	FIGURE: 1
SCALE: 1" = 50'

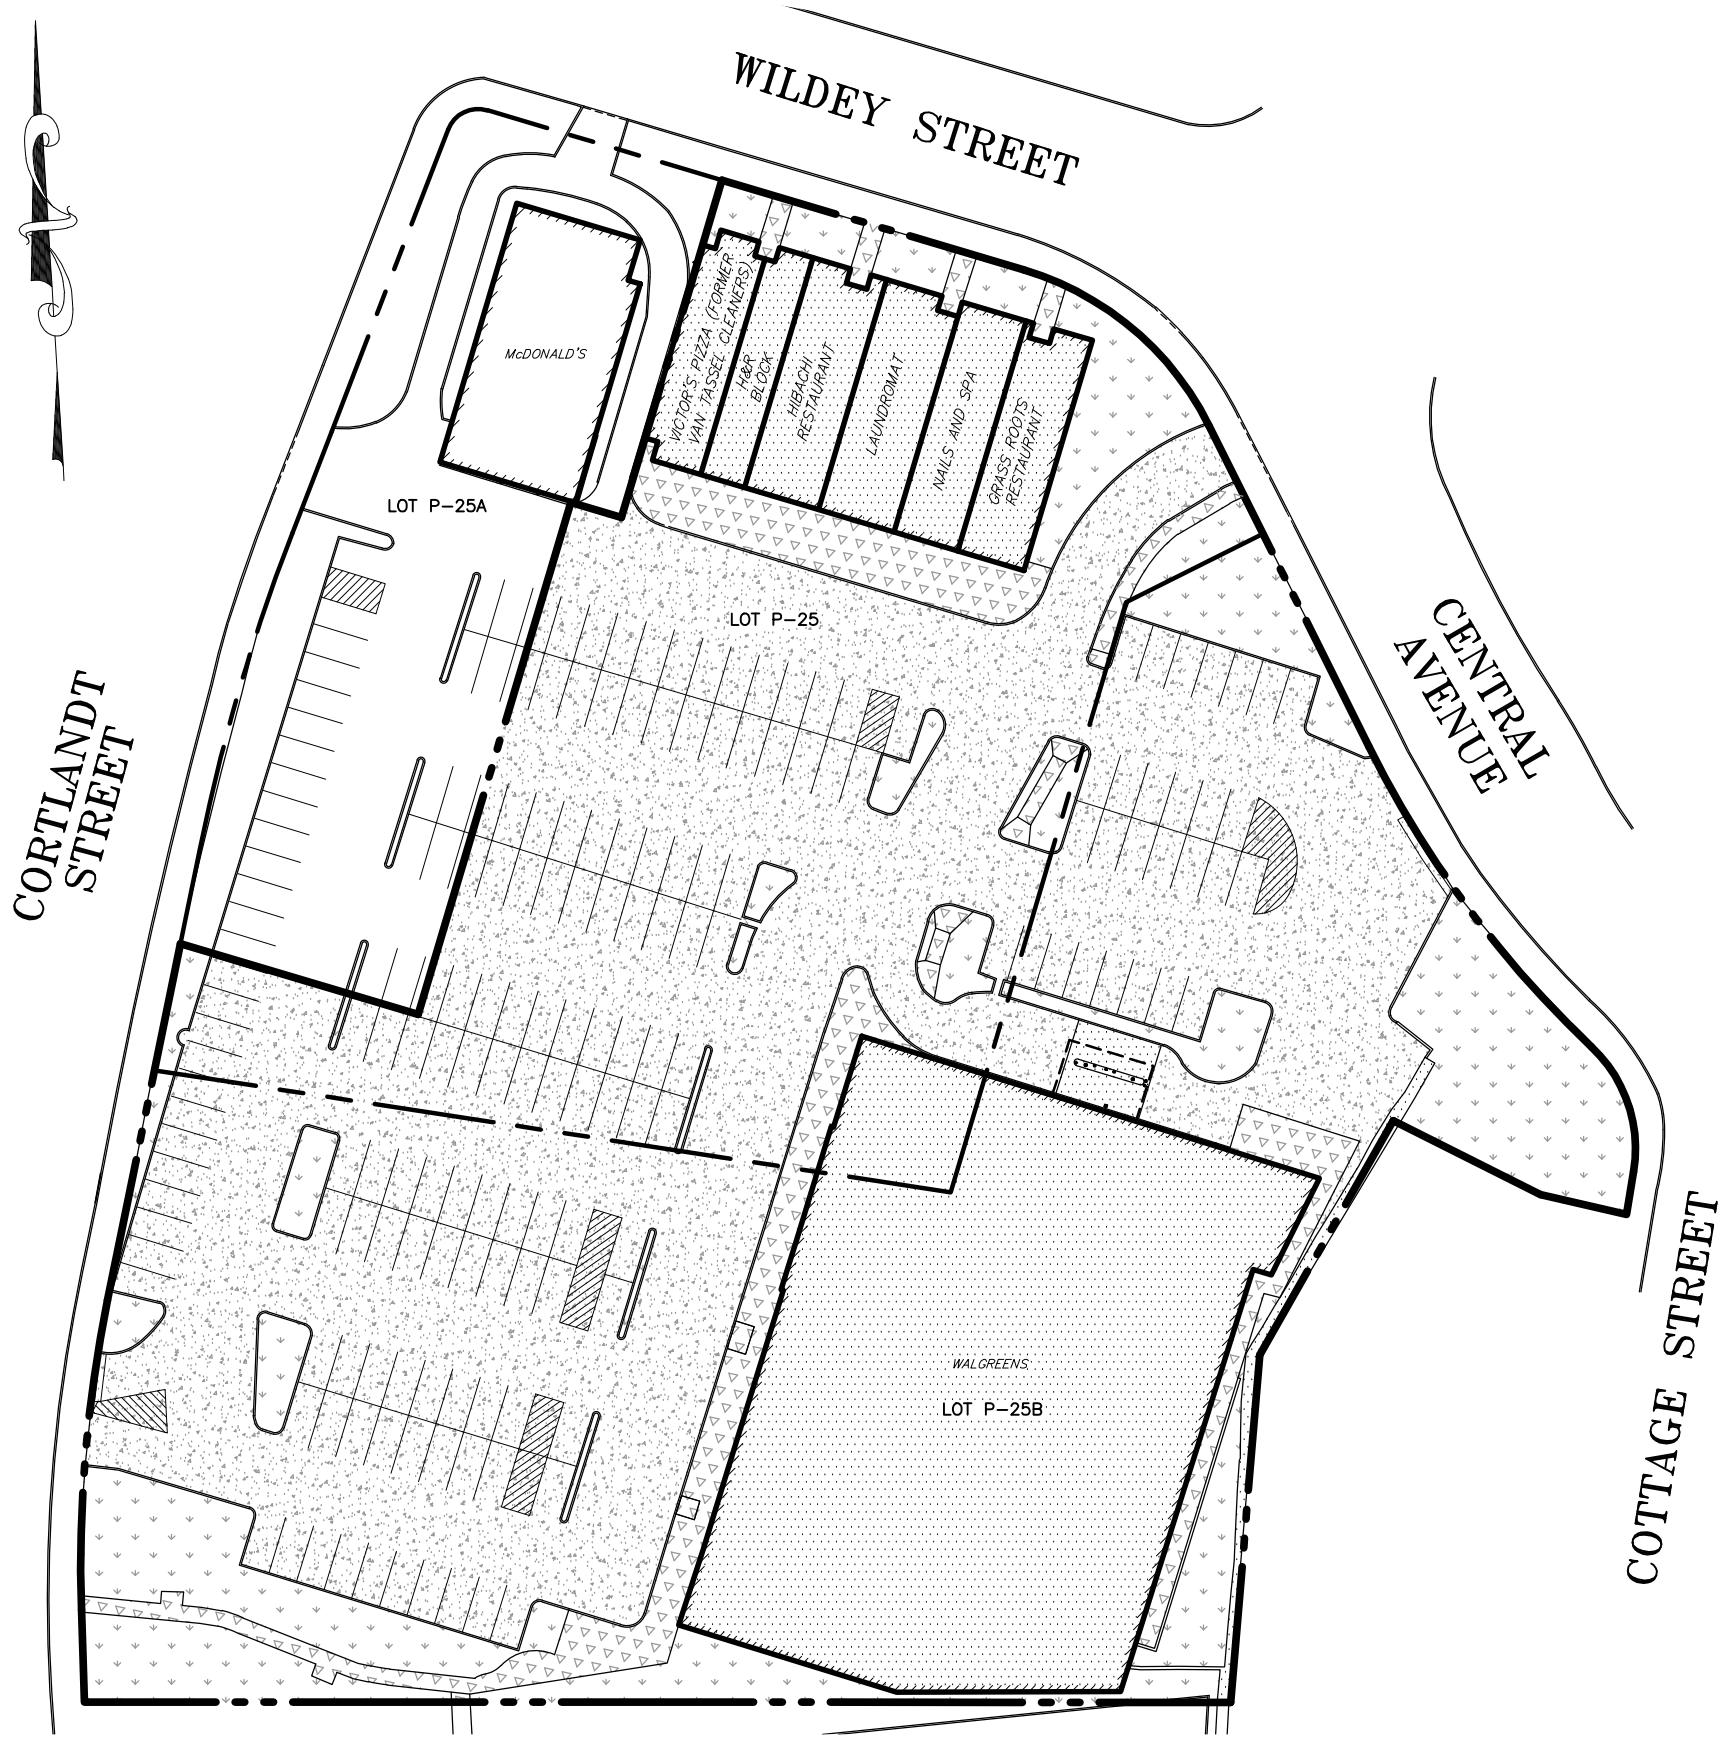
## **FIGURE 2**

### **Location of Cover System Types**

**PAVEMENT DETAIL**

4" (MIN.) EXISTING ASPHALT

EXISTING SUBBASE

FILL MATERIAL

**CONCRETE SLAB DETAIL**

4" (MIN.) EXISTING CONCRETE

**SOIL COVER CAP DETAIL**

6" (MIN.) EXISTING TOPSOIL

**CONCRETE SIDEWALK DETAIL**

3" (MIN.) EXISTING CONCRETE

Exposure to remaining contamination in soil/fill at the site is prevented by a soil cover system placed over the site. This cover system is comprised of a minimum of six inches of clean topsoil, four inches of asphalt pavement, three inches of concrete-covered sidewalks, and four inches of concrete building slabs. The Excavation Work Plan that appears in Appendix A of the April 2013 SMP outlines the procedures required to be implemented in the event the cover system is breached, penetrated, or temporarily removed, and any underlying remaining contamination is disturbed.
