**River Plaza Shopping Center  
(Currently Known as Tarrytown Station Center)**

**Periodic Review Report**

**NYSDEC Site Number: 360084**

**AUGUST 4, 2025**

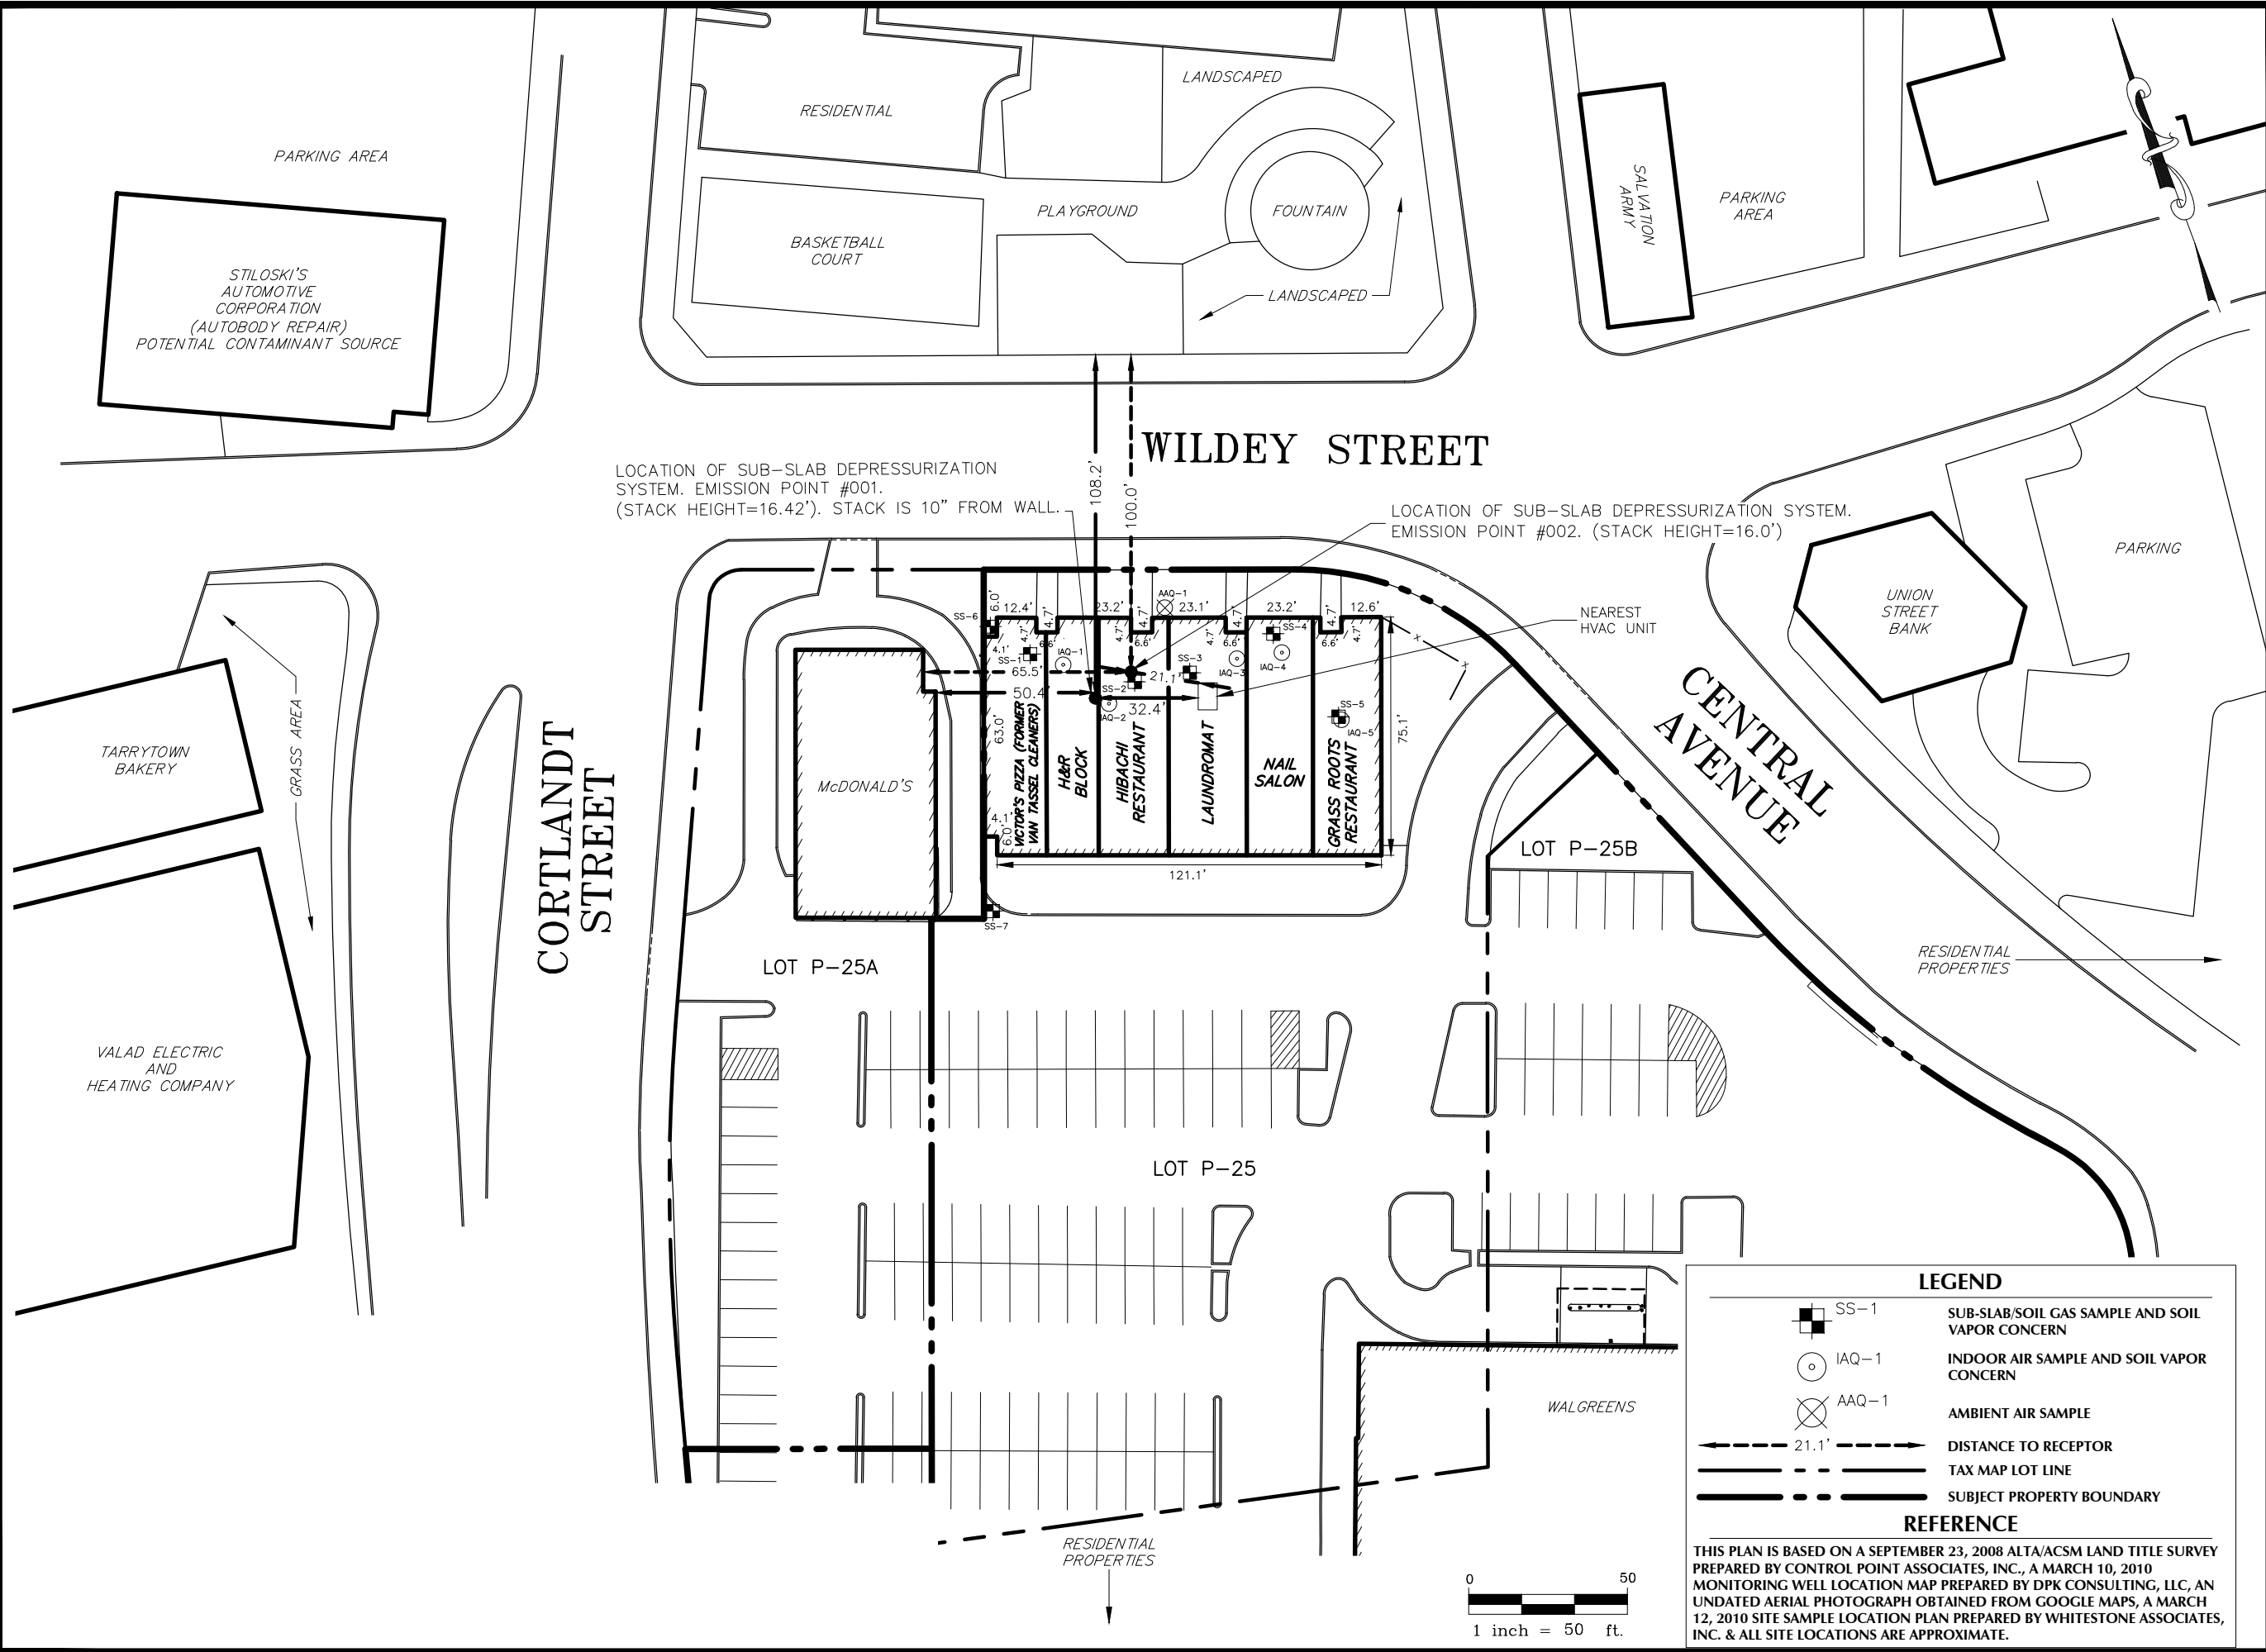
**FIGURE 1**  
**Location of Remedial Treatment**  
**Systems (SSDSS) and**  
**Soil Vapor Concern**

The SSDSs were constructed in the northeastern portion of the former drycleaners unit (currently occupied by H&R Block and Victor's Pizza) and the northeastern portion of the Osaka Japanese Restaurant unit of the retail-strip building by placing four-inch diameter PVC pipes in the sub-base immediately below the building's floor slab. The pipes extend vertically (upward) through the units and vent to the exterior atmosphere above the roof. Fans (Radonaway Model HS-5000) capable of mechanically venting a minimum of 53 cubic feet per minute (CFM) of air from beneath the slab were placed in line with the vent pipes above the roof. Sealable sampling ports were installed at the base of the units for future sampling purposes (if necessary). Additionally, in-line magnahelic vacuum gauges and alarm systems (Radonaway Checkpoint II) were installed on the SSDS units. The fans and gauges/alarm systems each have their own dedicated electrical circuits. The SSDSs continually operate to remove soil vapors from and depressurize beneath the building.

The SSDSs located within the H&R Block unit (former Van Tassel Cleaners) and the Osaka Japanese Restaurant consist of a four-inch diameter PVC pipes placed in the sub-base immediately below the building's floor slab. The pipes extend vertically (upward) through the units and vent to the exterior atmosphere above the roof. Fans (Radonaway Model HS-5000) capable of mechanically venting a minimum of 53 CFM of air from beneath the slab were placed in line with the vent pipes above the roof. Sealable sampling ports were installed at the bases of the units for future sampling purposes (if any). Additionally, in-line magnahelic vacuum gauges and alarm systems (Radonaway Checkpoint II) were installed on the SSDS units. The fans and gauges/alarms each have dedicated electrical circuits. The operation and maintenance program was designed to ensure that the SSDSs operate on a continuous basis at the site and provide the appropriate depressurization beneath the floor slab of the retail-strip building. The program primarily consists of the inspection of non-mechanical components and the inspection, maintenance, and repair/replacement of mechanical components. The SSDS in the former Van Tassel Cleaners began operation in October 2010 and the SSDS in the Osaka Japanese Restaurant began operation in December 2012.

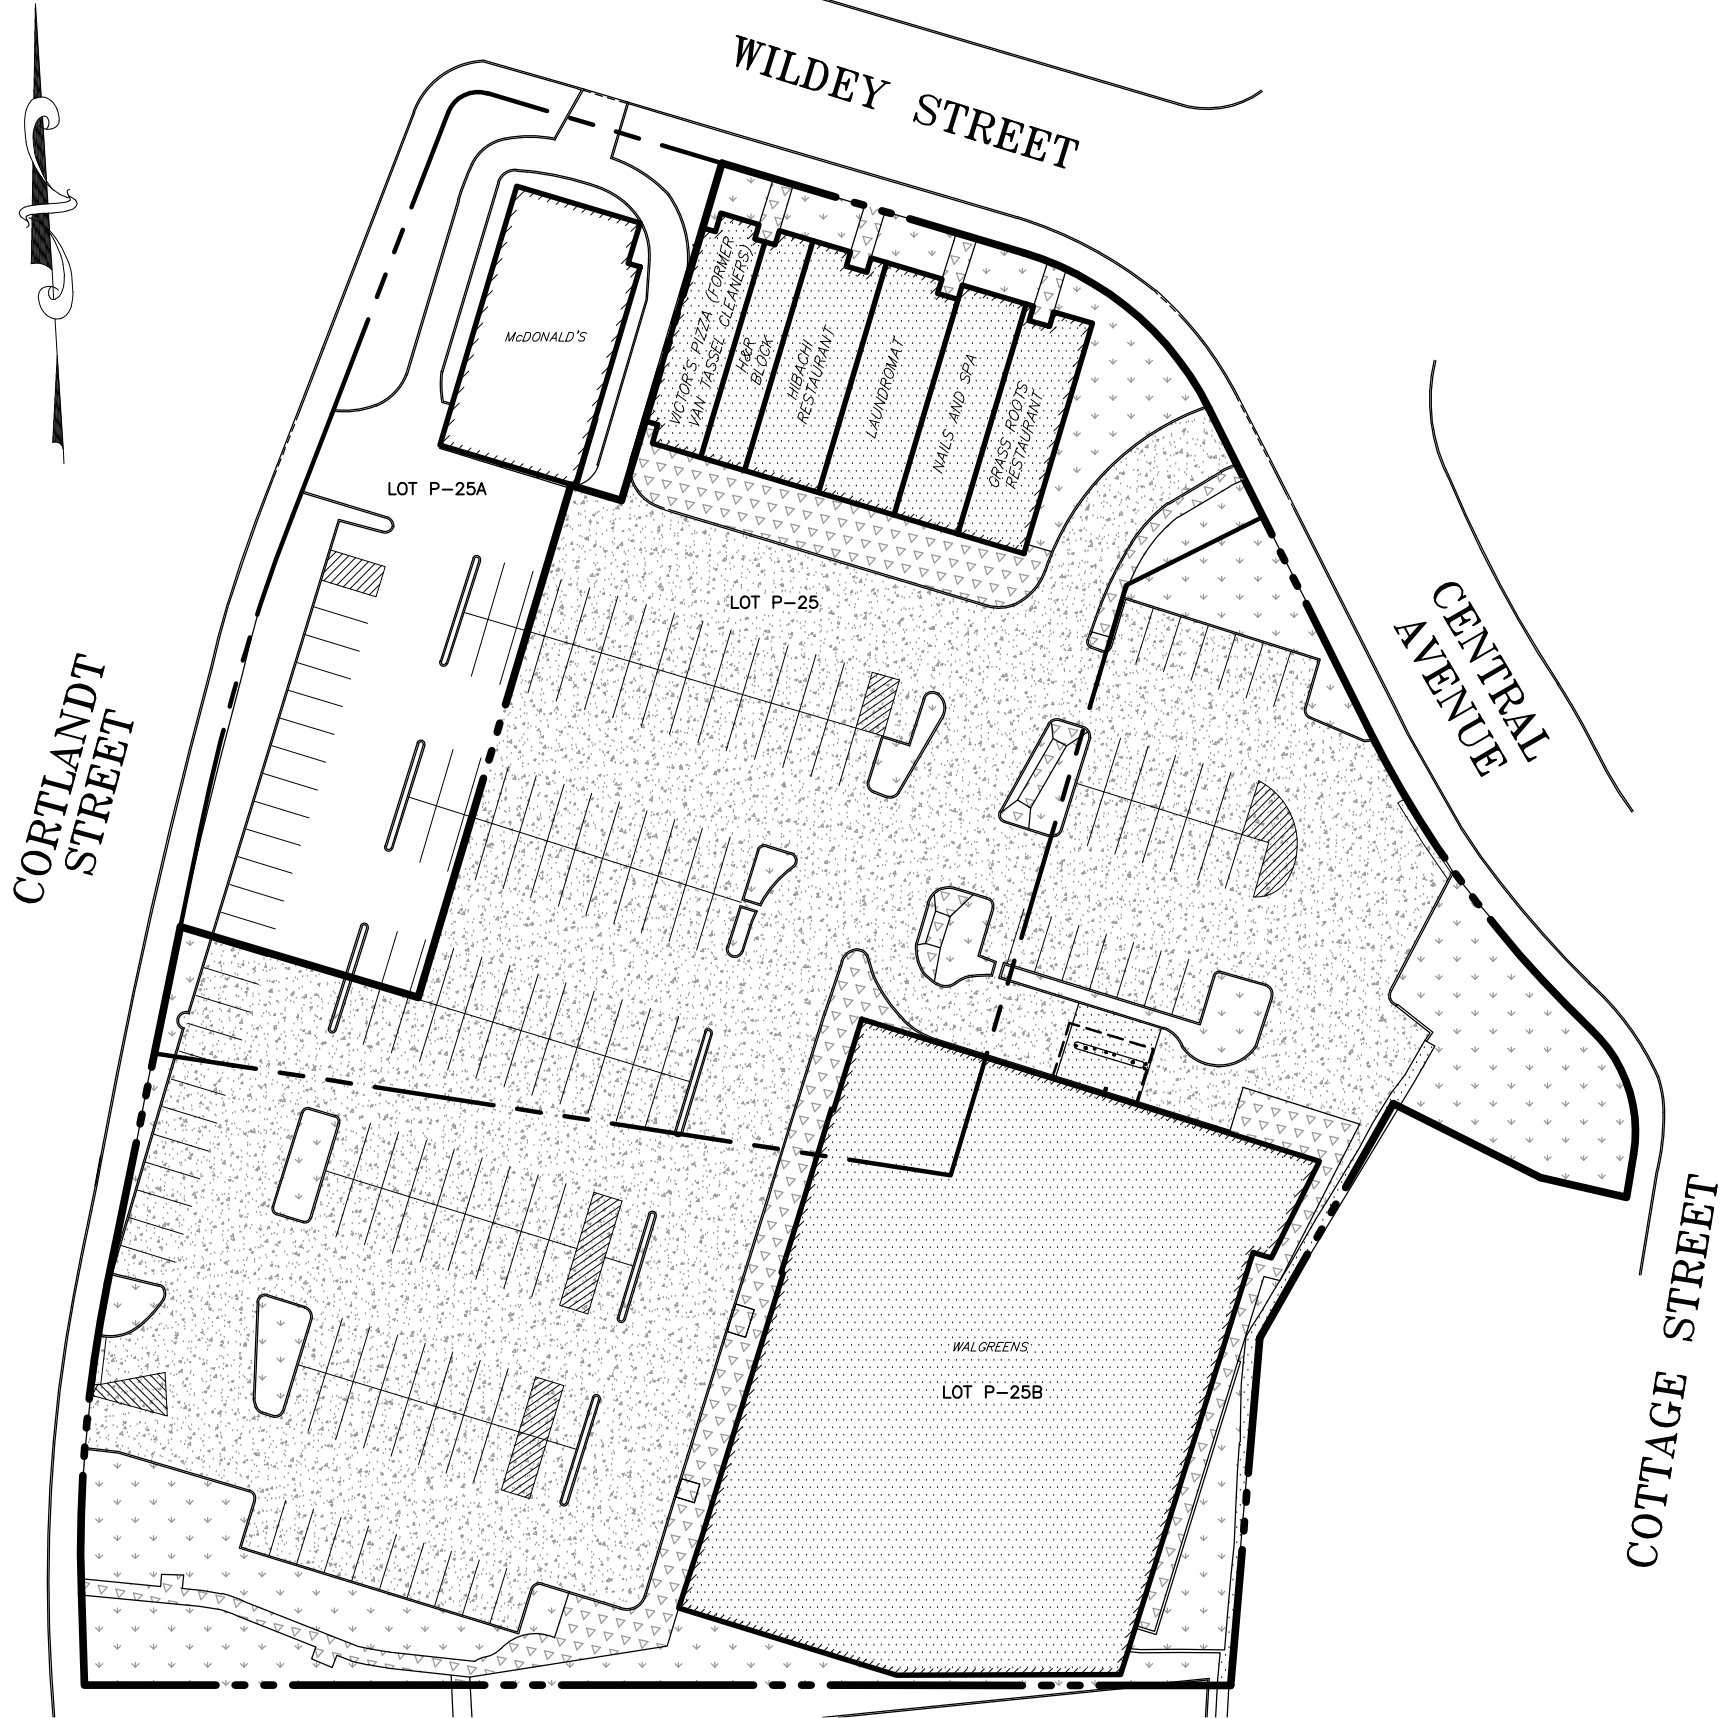
**FIGURE 2**  
**Location of Cover System Types**

Exposure to remaining contamination in soil/fill at the site is prevented by a soil cover system placed over the site. This cover system is comprised of a minimum of six inches of clean topsoil, four inches of asphalt pavement, three inches of concrete-covered sidewalks, and four inches of concrete building slabs. The Excavation Work Plan that appears in Appendix A of the April 2013 SMP outlines the procedures required to be implemented in the event the cover system is breached, penetrated, or temporarily removed, and any underlying remaining contamination is disturbed.

A soil cover/cap system inspection of the concrete building slabs, concrete sidewalks, asphalt pavement areas, and landscaped areas was performed on July 15, 2025 to ensure their integrities. The soil cover/cap was in place and intact during the inspection and is determined to be effectively reducing/minimizing human exposure to the remaining contamination on site. Moreover, the soil cover/cap system was not disturbed in the time period between Whitestone's August 2022 PRR and this submission.
