Mt. Kisco WTP Radiological Characterization Report

August, 2019

CoPhysics Corporation
1 Commercial Drive, Unit 1,
Florida, NY 10921

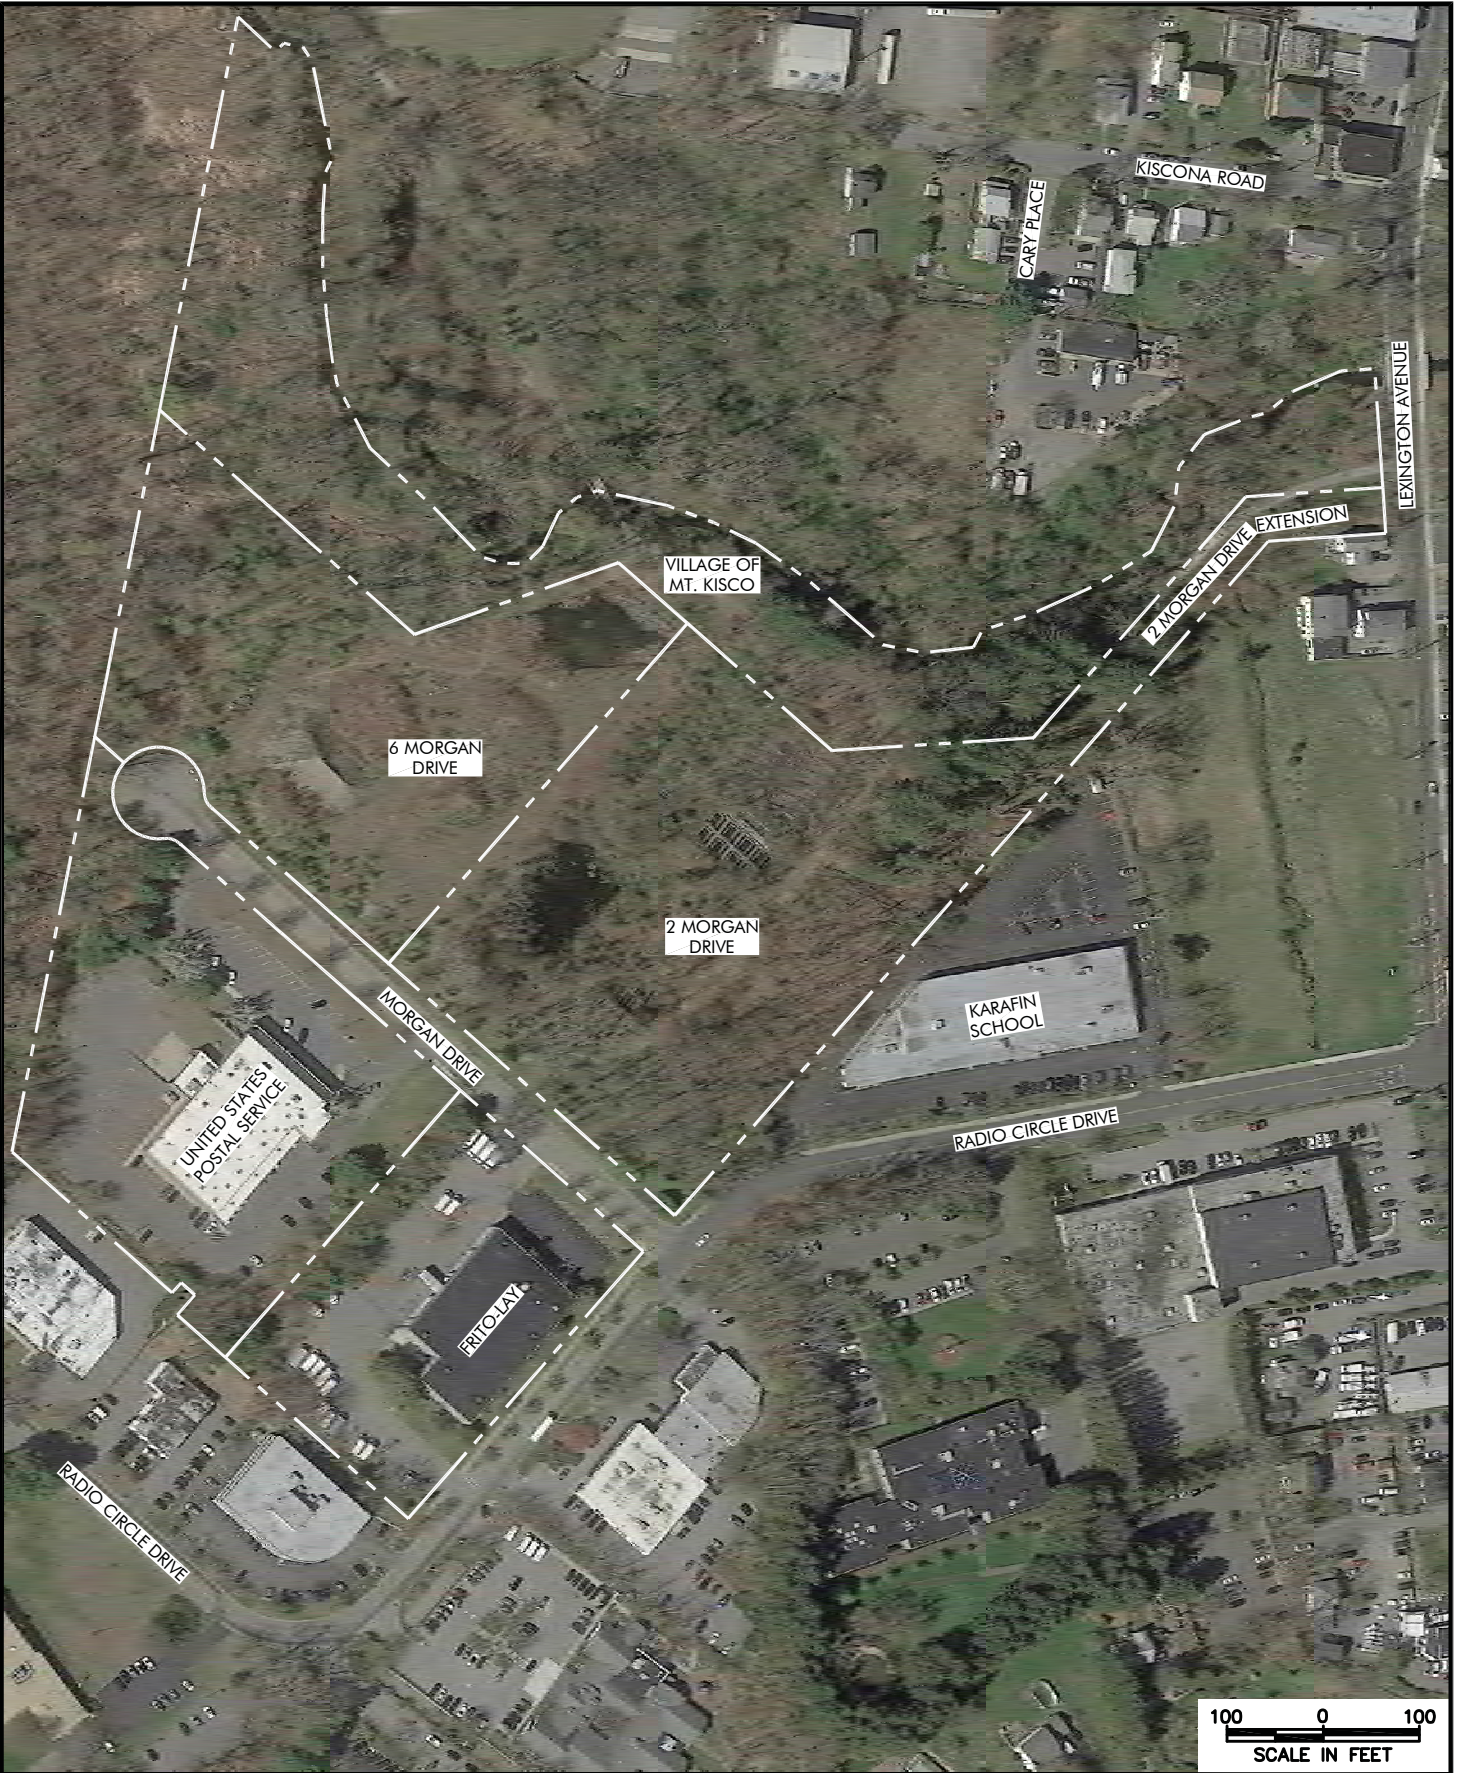
FIGURE NO.
1

FORMER MOUNT KISCO WWTTP SITE SITE LOCATION MAP

Based upon the United States Geological Survey (USGS) Mount Kisco Quadrangle 7.5 Minute Series from 2016, the elevation at the Site ranges from approximately 285 to 305 feet above mean sea level (Figure 1). The overall slope of the Site is generally toward the northwest and the Kisco River. The dominant topographic feature of the Site is a slight earthen rise that bisects the Site and is located to the east of the shared property line of the two (2) undeveloped parcels (Figure 2). The slope is gradual to the west of the aforementioned property line and a bit more steep to the east rising a total of 10 feet in elevation.

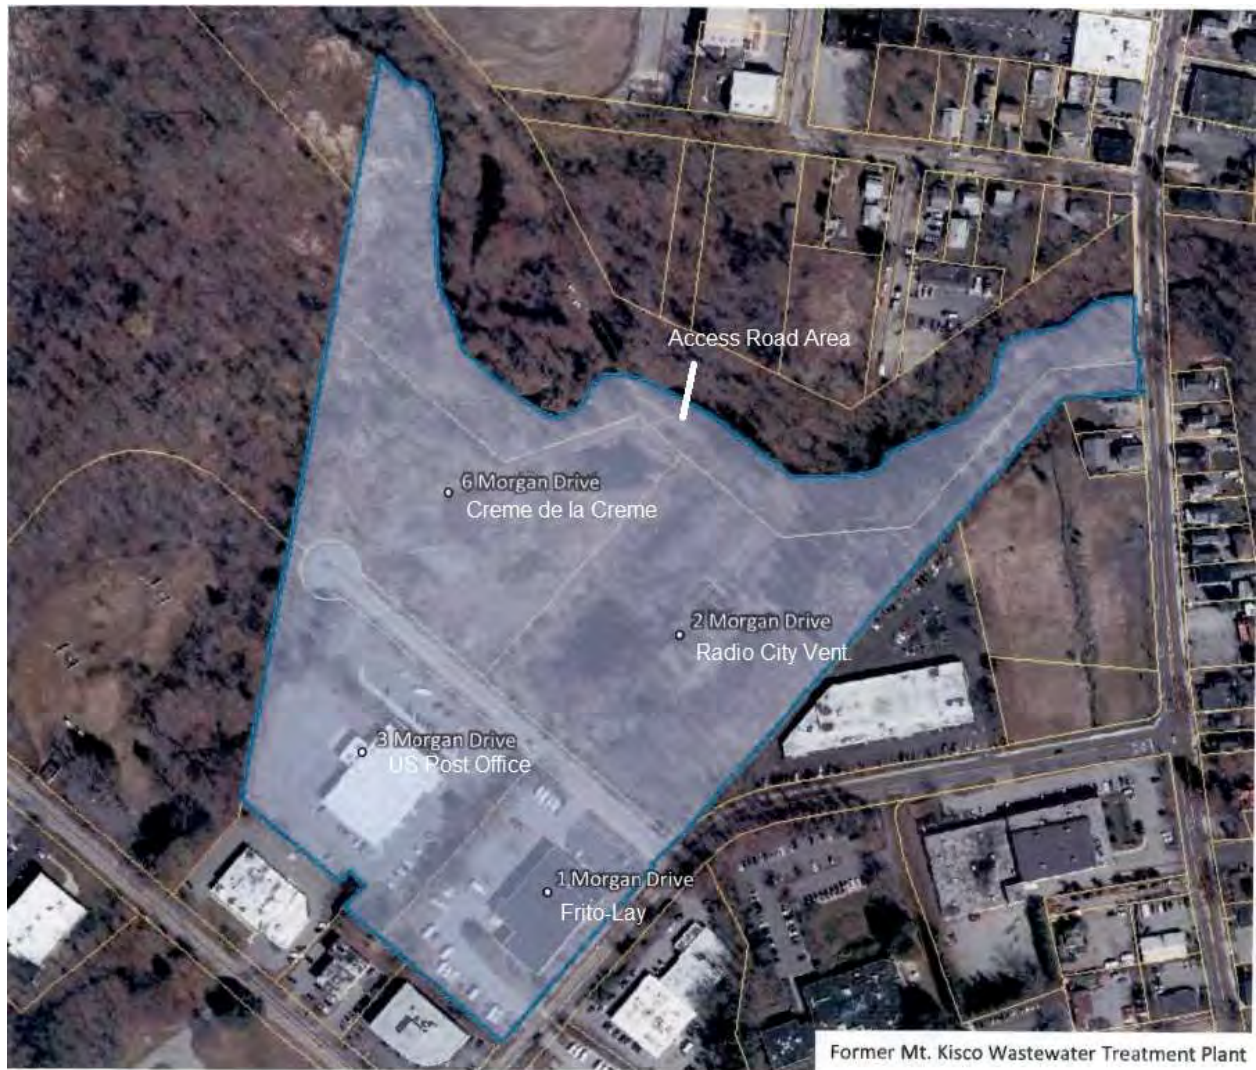
Figure 1. Survey Area and Underlying Parcels

The survey area is specified by the NYSDEC in the Consent Order as the gray area in Figure 1 above.
