Preliminary Assessment Report

Camp Smith Training Facility

Cortlandt, New York

Perfluorooctane-Sulfonic Acid (PFOS) and Perfluorooctanoic Acid (PFOA) Impacted Sites
ARNG Installations, Nationwide

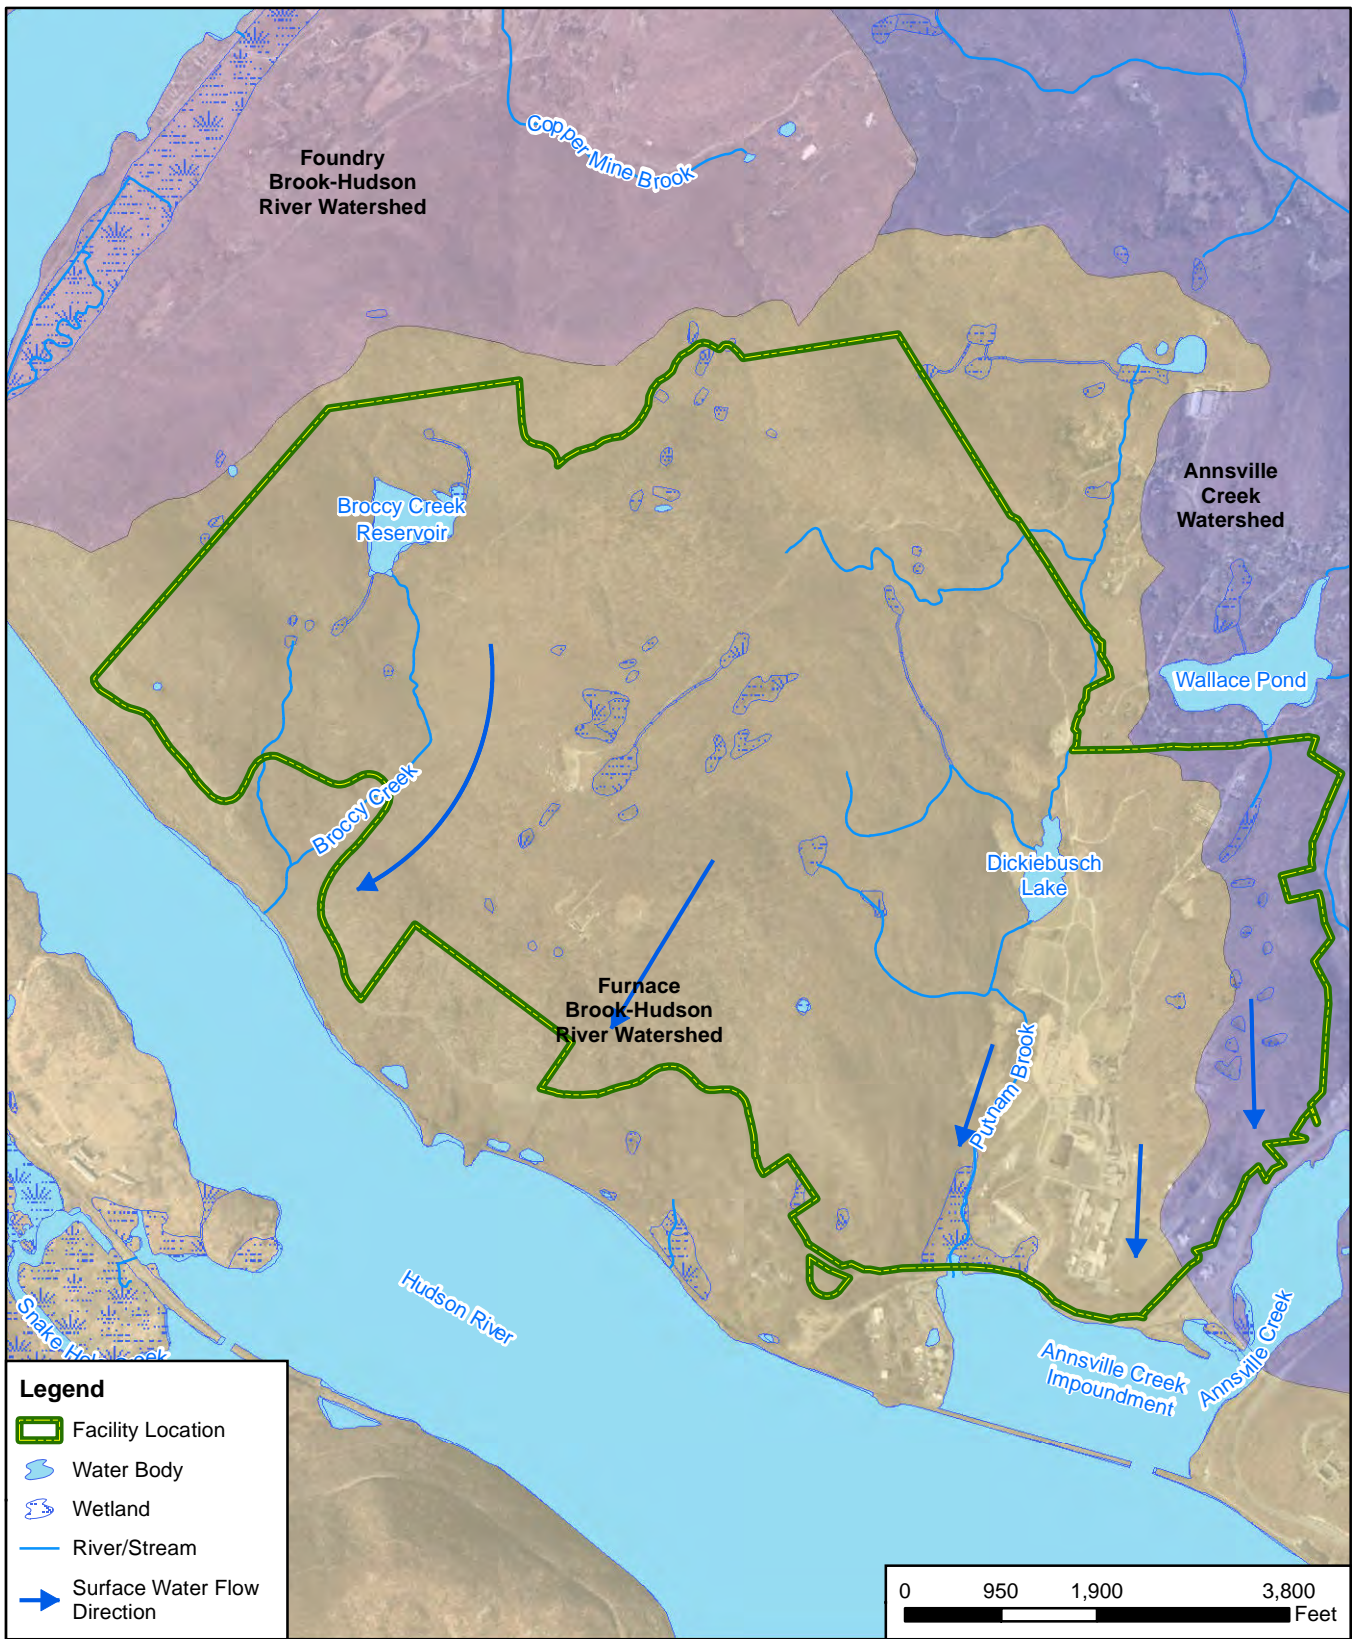
Figure 1-3

Dickiebusch Lake is on the northeastern end of Camp Smith (**Figure 1-2** and **1-3**). Dickiebusch Lake covers approximately six acres and is connected to several streams, one of which is Putnam Brook. The headwaters of Putnam Brook flow into the northern-most portion of Dickiebusch Lake, which then drains south, bordering Camp Smith on the west, before draining into the Annsville Creek impoundment. Annsville Creek borders Camp Smith on the eastern side of the facility before turning southwest to border the southern portion.

The confluence of the Annsville Creek and Putnam Brook at the Annsville Creek impoundment is tidally influenced, as this impoundment is connected to the Hudson River (**Figure 1-3**). This small bay/impoundment/tidal wetland was artificially created by a railroad berm.

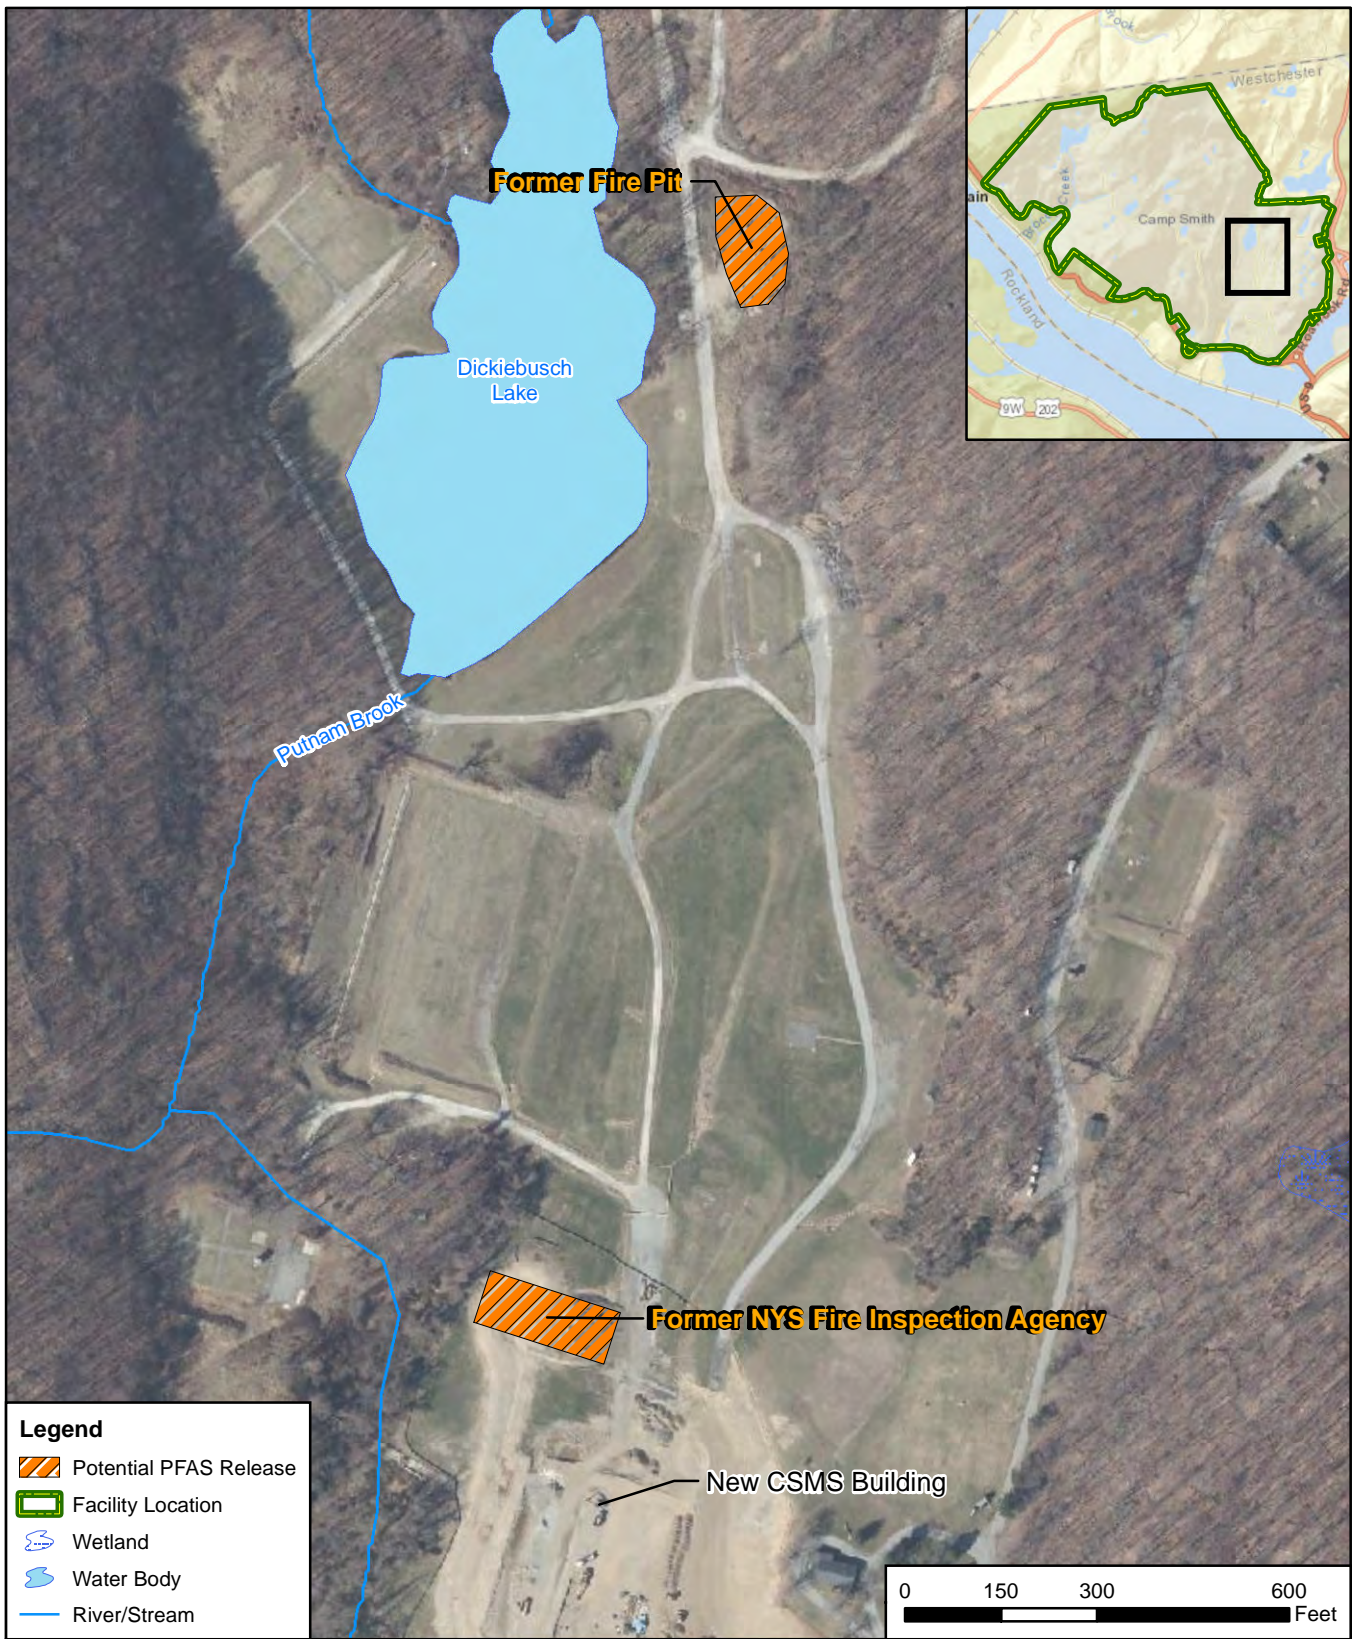
Fire Training Area	
AECOM 12420 Milestone Center Drive Germantown, MD 20876	Figure 2-1

The Former Fire Pit is on the northern end of the property, adjacent to Dickiebusch Lake (**Figure 2-1**) at geographic coordinates 41°18'36.96"N; 73°56'24.19"W. This area is approximately 184 feet long by 113 feet wide and is essentially a dirt expanse of sand and gravel on the eastern side of N. Camp Road.

During the VSI, a bare earthen patch was observed that appeared to have been smoothed and paved over multiple times in the past. Interviewees described it as a former live fire training exercise area where fire training exercises occurred with some frequency, possibly once per month; however, the presence or use of AFFF for these exercises could not be confirmed during the VSI or interviews with NYARNG personnel. The Former Fire Pit was the training ground for the Camp Smith firefighters and emergency responders and was active between 1980 and 1996.

Activities at the NYS Fire Inspection Agency were described as including classroom training, fire services, forensics, and arson investigation. Because personnel with first-hand knowledge of training activities that occurred at the Agency were not available for interviews during the PA, there are data gaps for this location. It is unknown if any of the training activities that occurred at the facility included fire training with AFFF or other firefighting foams. As such, PFAS may have been released at the former NYS Fire Inspection Agency and is thus a potential release area (**Figure 2-1**).

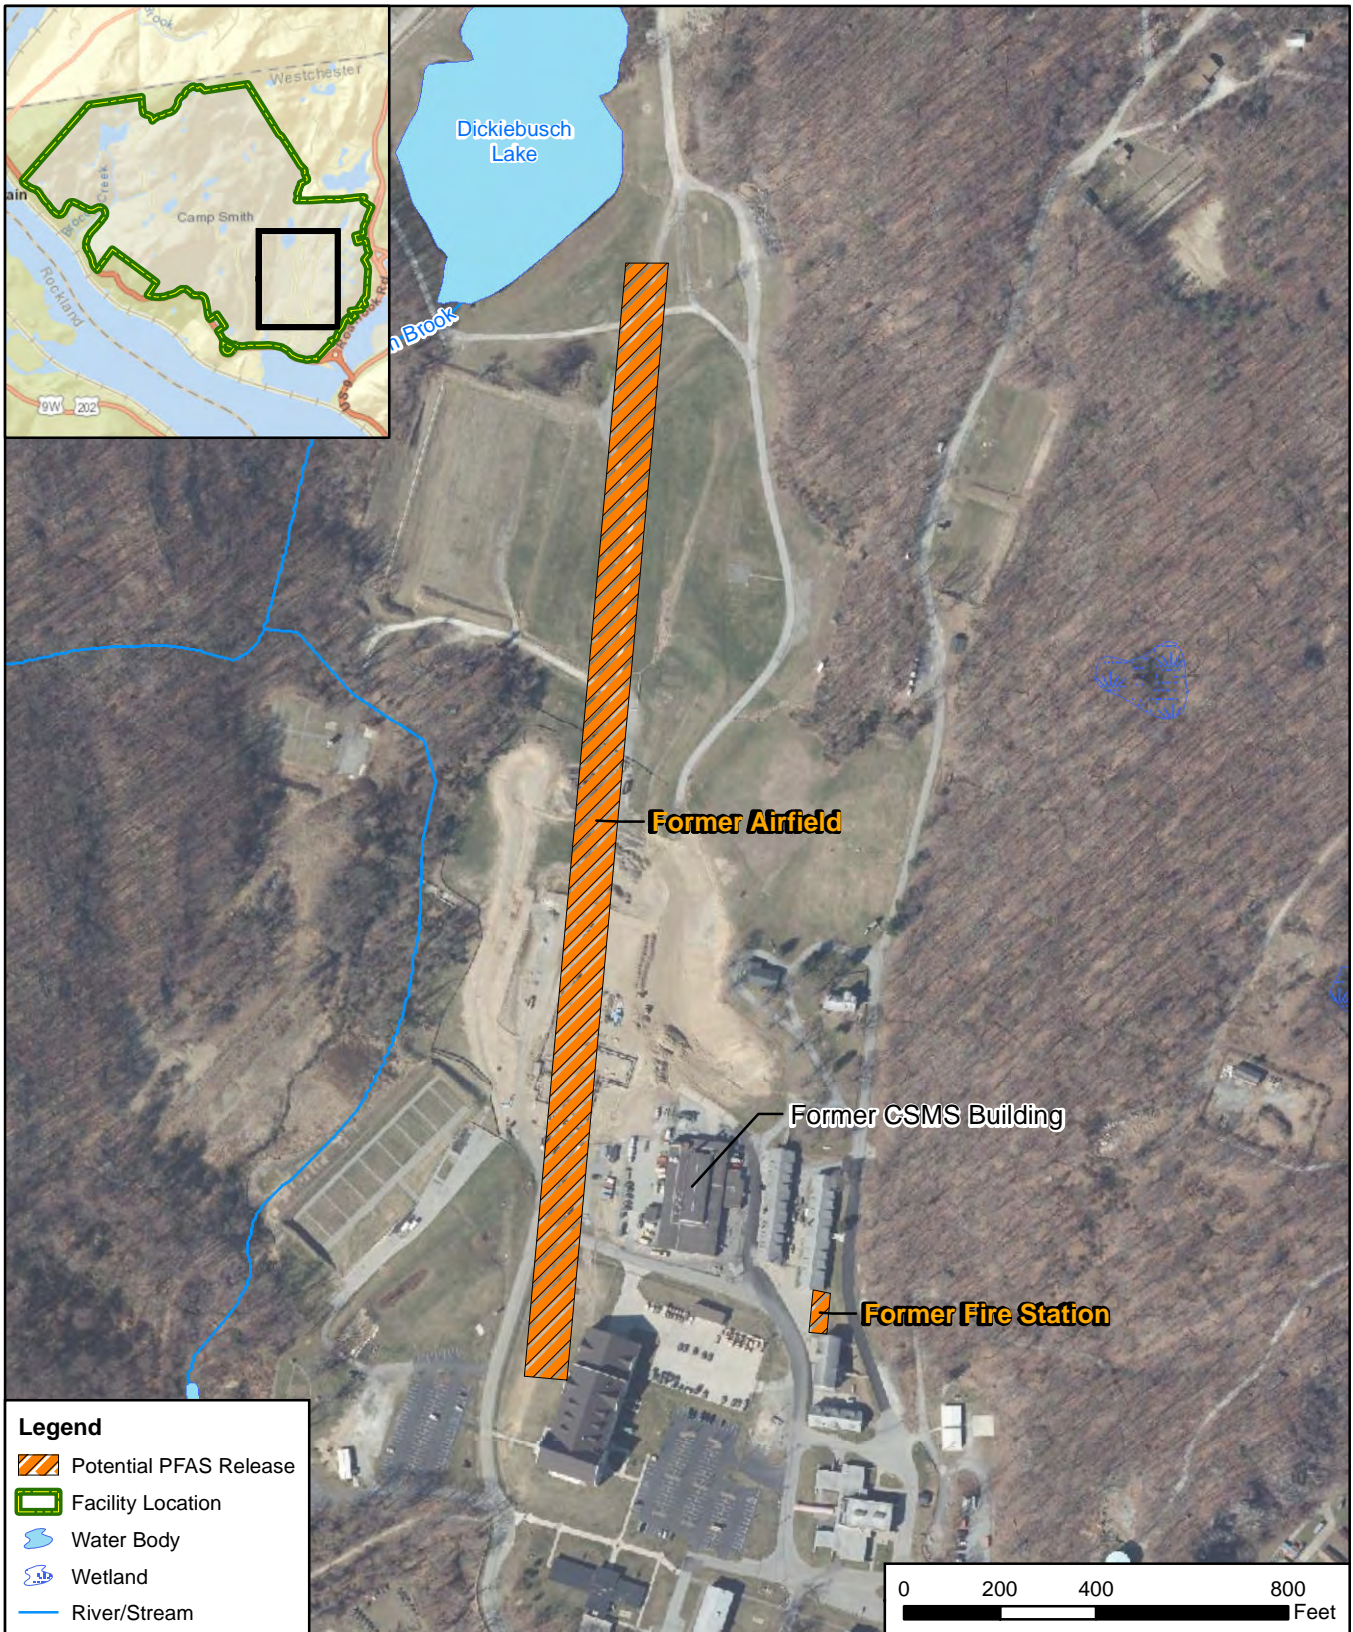
Non-Fire Training Areas	
AECOM 12420 Milestone Center Drive Germantown, MD 20876	Figure 3-1

Located at the southeastern end of Dickiebusch Lake, geographic coordinates 41°18'31.19"N; 73°56'24.87"W, and approximately 2,500 feet in length running north to south, interviews during the VSI described an area referred to as the "former airfield" (**Figure 3-1**). Aerial photographs (**Appendix A**) confirm a runway existed after 1955, but before 1960, and was later removed in the late 1970s. The Camp Smith Maintenance Equipment Mechanic, working at Camp Smith since 1988, stated that the Former Airfield was possibly active during parts of the Korean and Vietnam wars, but he is unaware of any incidents that occurred which required the use of AFFF.

Based on aerial photographs (**Appendix A**), the Former Fire Station was approximately 500 feet east of the southern end of the former airfield runway, geographic coordinates 41°18'10.01"N; 73°56'21.34"W, and was active between 1980 and 1996. When operational, the interviewee stated that two trucks were parked inside the Former Fire Station: an old Chevy half-deuce water truck and an old Ford that was not operational. In its last few years of operation, there were only civilian hourly employees on-site during the weekends. The interviewee indicated he was not aware of any AFFF use or storage at Camp Smith. After 1996, the Former Fire Station was torn down and replaced with a parking lot (**Figure 3-1**). The two trucks were given to the Continental Village Fire Department, the municipal fire department for Westchester County, which provides emergency services for all major incidents at Camp Smith.

The Former CSMS building was adjacent to the Former Firehouse from approximately 1976, until a new building was finished in 2018 (**Figure 3-1**). The interviewee stated there were no documents confirming AFFF storage, discharge, or use in the former CSMS building. A 2009 NYARNG Camp Smith Standard Operating Procedure (SOP) mandated that firefighting equipment be stored on-site and ready for use during refueling activities, but no firefighting equipment was observed during the VSI. The SOP was unclear as to what type of firefighting equipment was required. The interviewee also indicated that the CSMS personnel were the first to respond to any minor fire-related incidents that occurred after 1996.

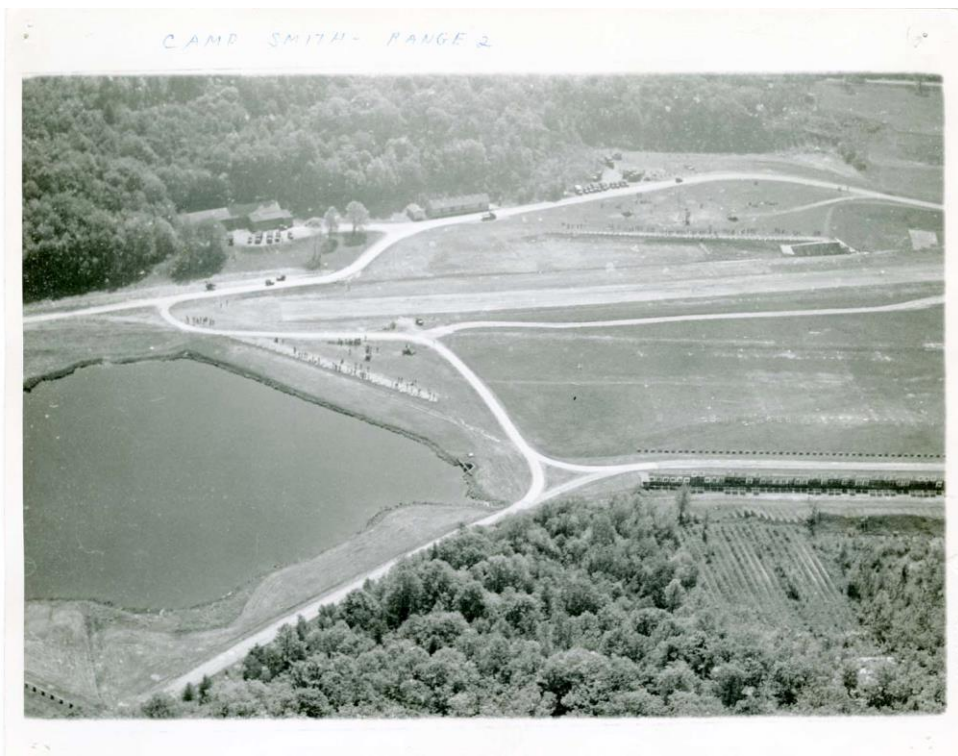
Area: Air Strip
Location: Cortlandt, New York
Photo ID: 1
Description: Looking West - View of former Airstrip, Vietnam era - 1960s

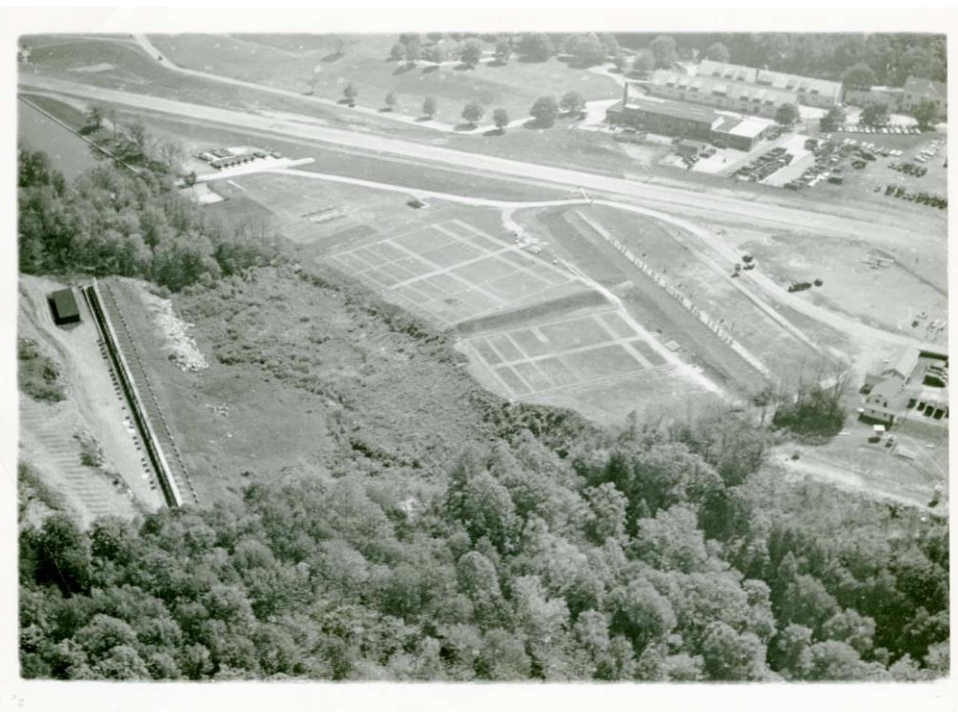
Area: Air Strip
Location: Cortlandt, New York
Photo ID: 2
Description: Looking North - View of former Airstrip, Vietnam Era - 1960s

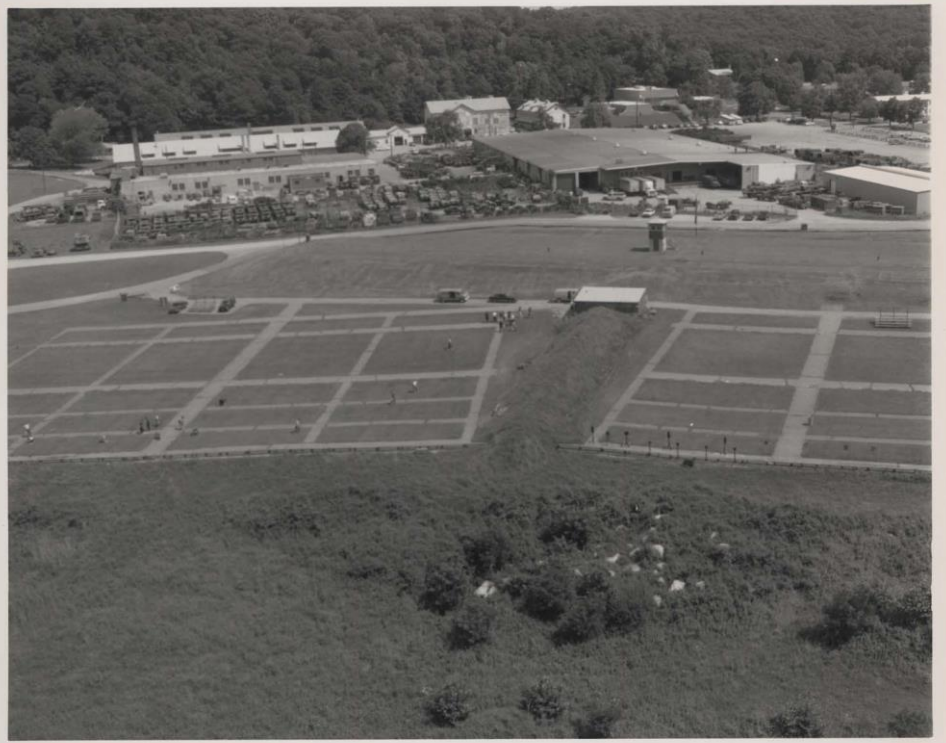
Area:	Former fire house
Location:	Cortlandt, New York
Photo ID:	3
Description:	View of former CSMS building (far top left) and former firehouse (adjacent to CSMS on the right)

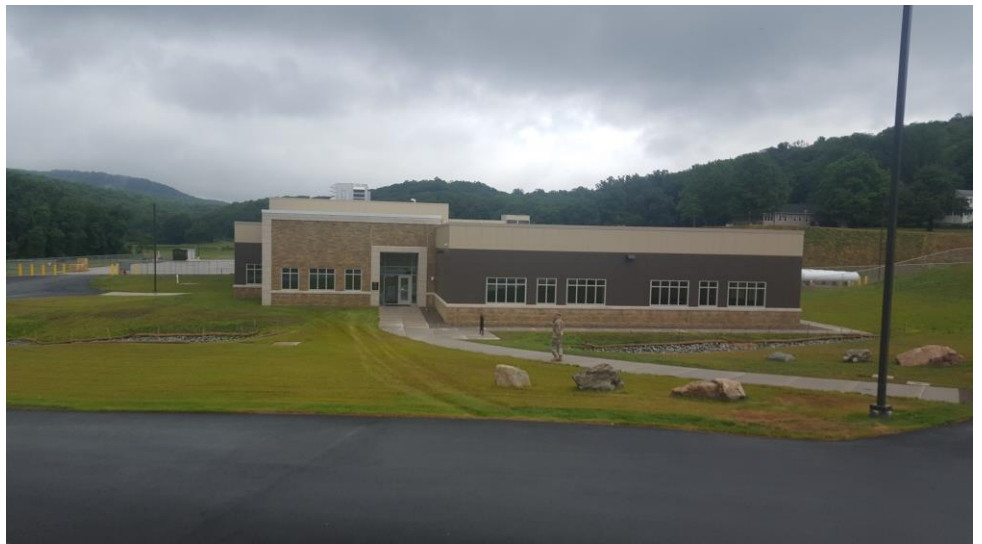
Area:	CSMS
Location:	Cortlandt, New York
Photo ID:	4
Description:	Side-view of new CSMS building

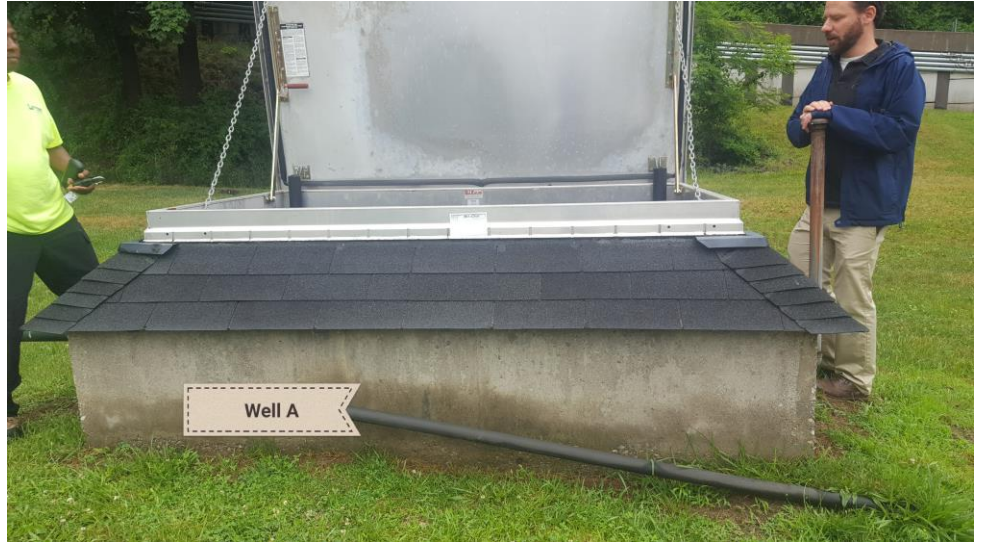
Area:	Well A
Location:	Cortlandt, New York
Photo ID:	5
Description:	
Well A location, southern portion of Camp Smith

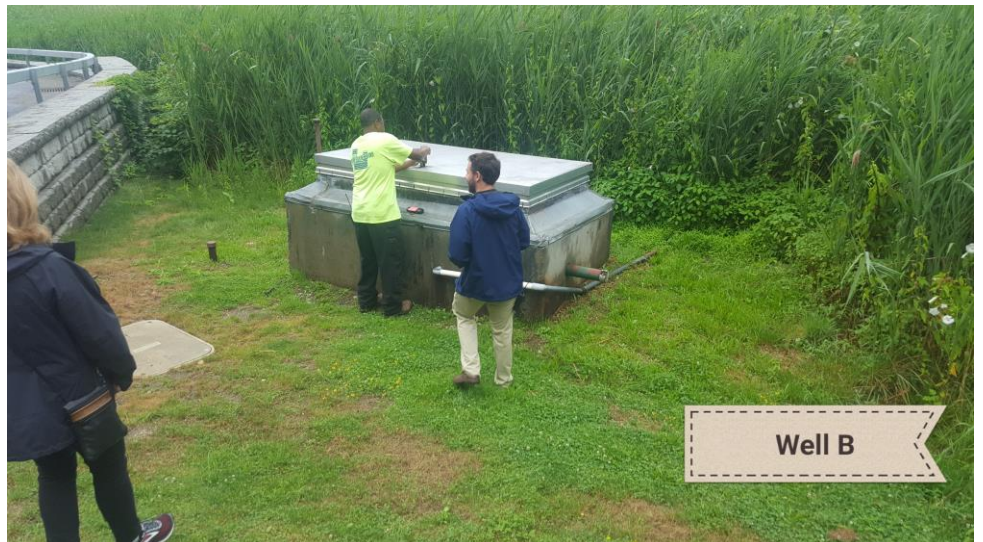
Area:	Well B
Location:	Cortlandt, New York
Photo ID:	6
Description:	
Well B location, southern portion of Camp Smith roughly 150ft northwest of Well A
