**RE: Report of Sub-slab Depressurization System Installation
432 Riverdale Avenue
Yonkers, New York 10705**

DT Consulting Services, Inc. (DTCS) has prepared this report summarizing the activities associated with installation of a sub-slab depressurization system (SSDS) at the property located at 432 Riverdale Avenue in Yonkers, New York (herein Subject Site). The SSDS installation activities were conducted between November 2018 and March 2019. The SSDS was commissioned on March 25, 2019, and has operated continuously since that time.

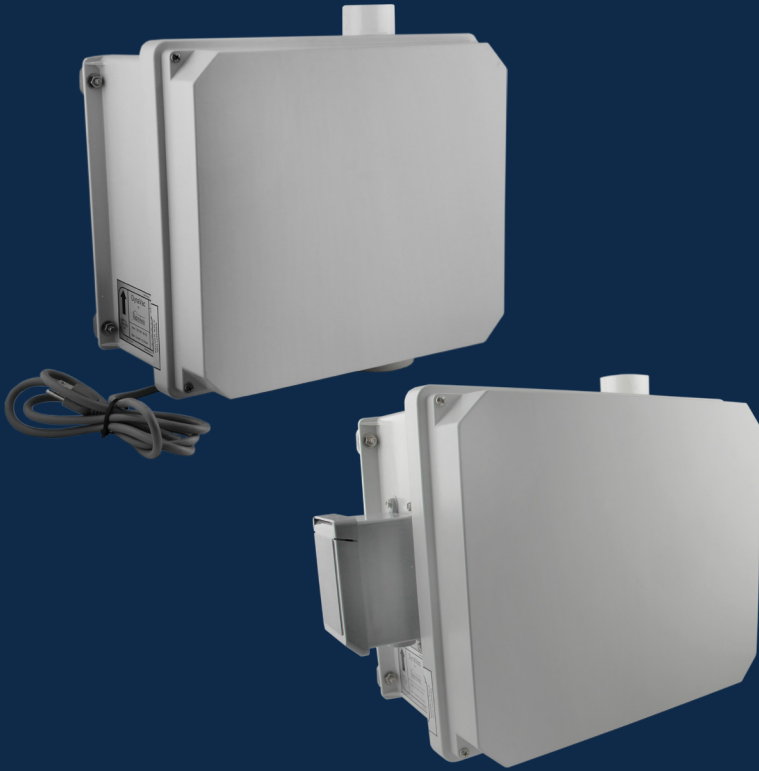
Radon Mitigation Fan

HS fans offer a proven solution for tough radon mitigation jobs, providing up to 25 times the suction of inline tube fans to deal with sand, tight soil or clay sub-slab material.
