2018 Periodic Review Report  
Mercury Refining Superfund Site  
26 Railroad Avenue  
Towns of Colonie and Guilderland  
Albany County, New York  
Superfund ID No. NY00048148175

Prepared for  
Mercury Refining Site Remedial Action  
Group  
June 2019

Project Number: 152682

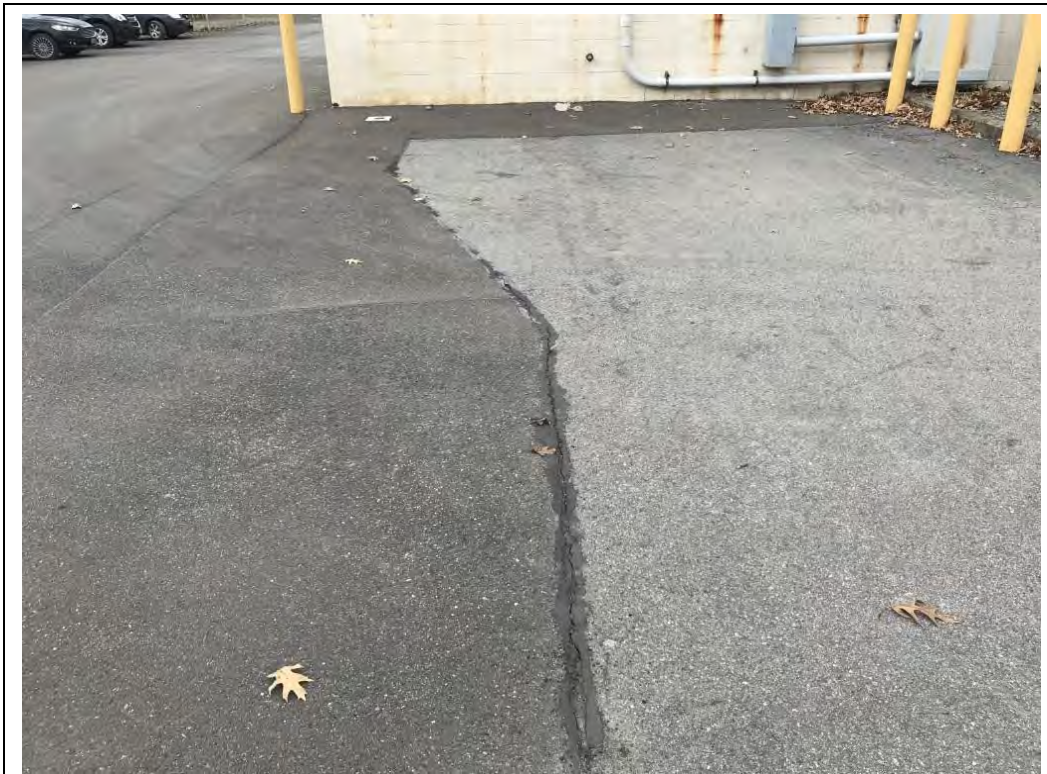
Photograph #1 – View from the eastern edge of MERECO property looking west. View shows a slight separation of a pavement joint filled with sealant/crack-filler.

Recommend to monitor cracks/separation in pavement joints

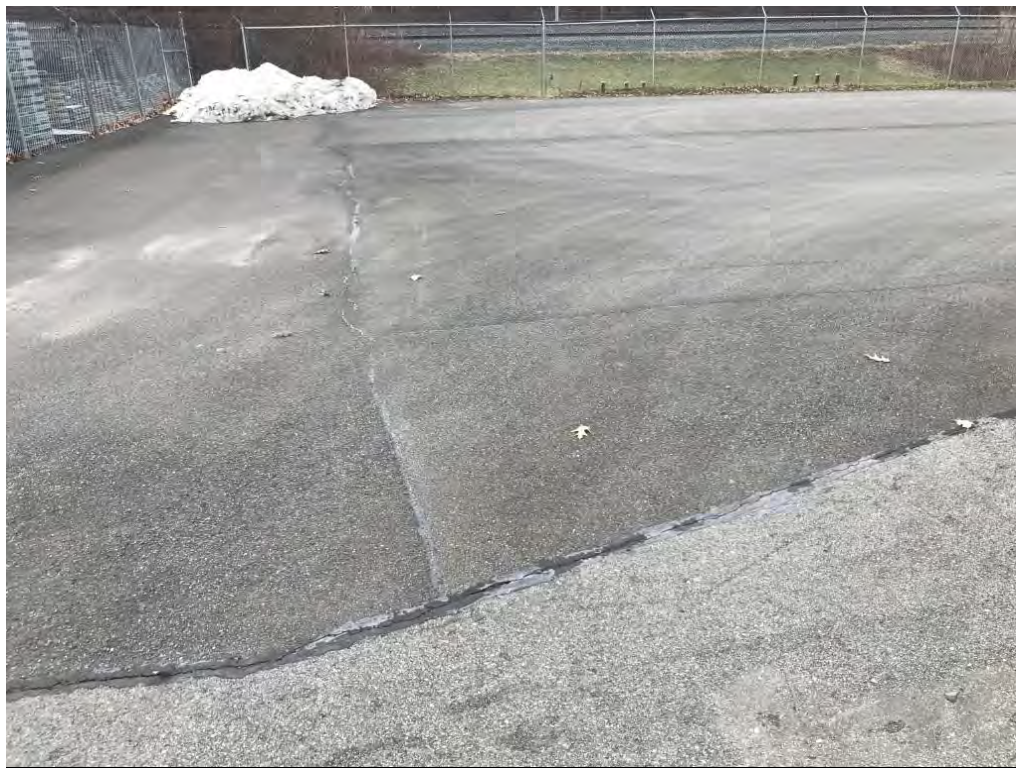
Photograph #2 – View from the eastern edge of MERECO property looking south. View shows a slight separation of a pavement joint filled with sealant/crack-filler

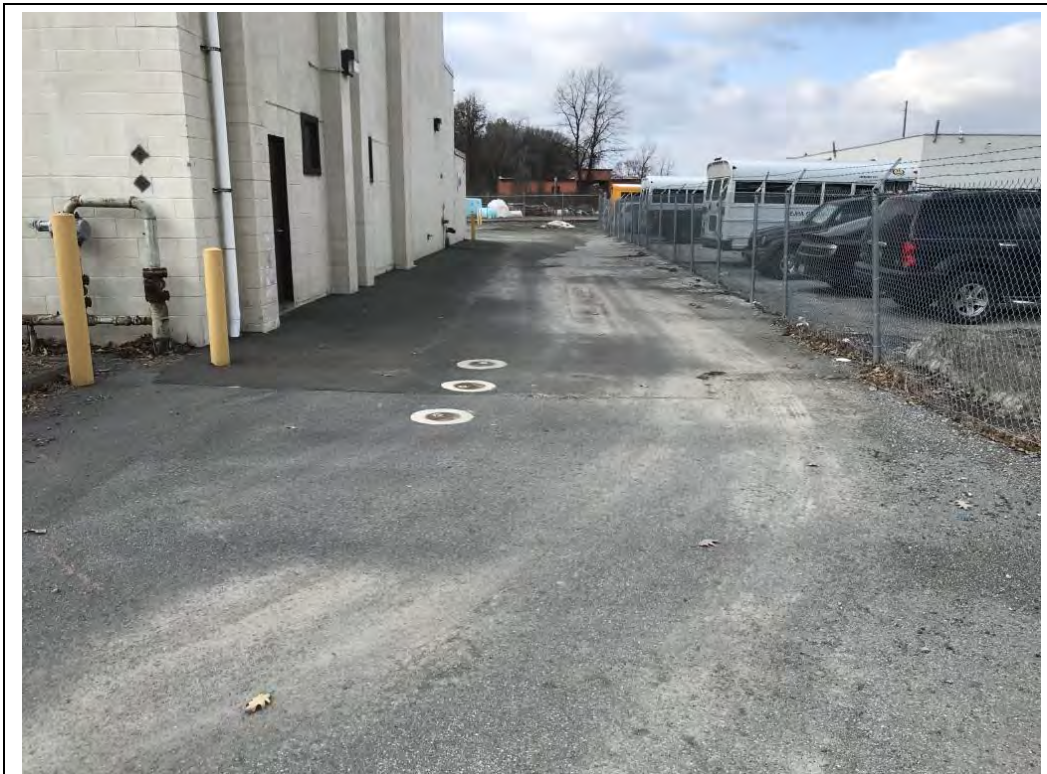
Photograph #3 – View from the northeast corner of MERECO property looking west.

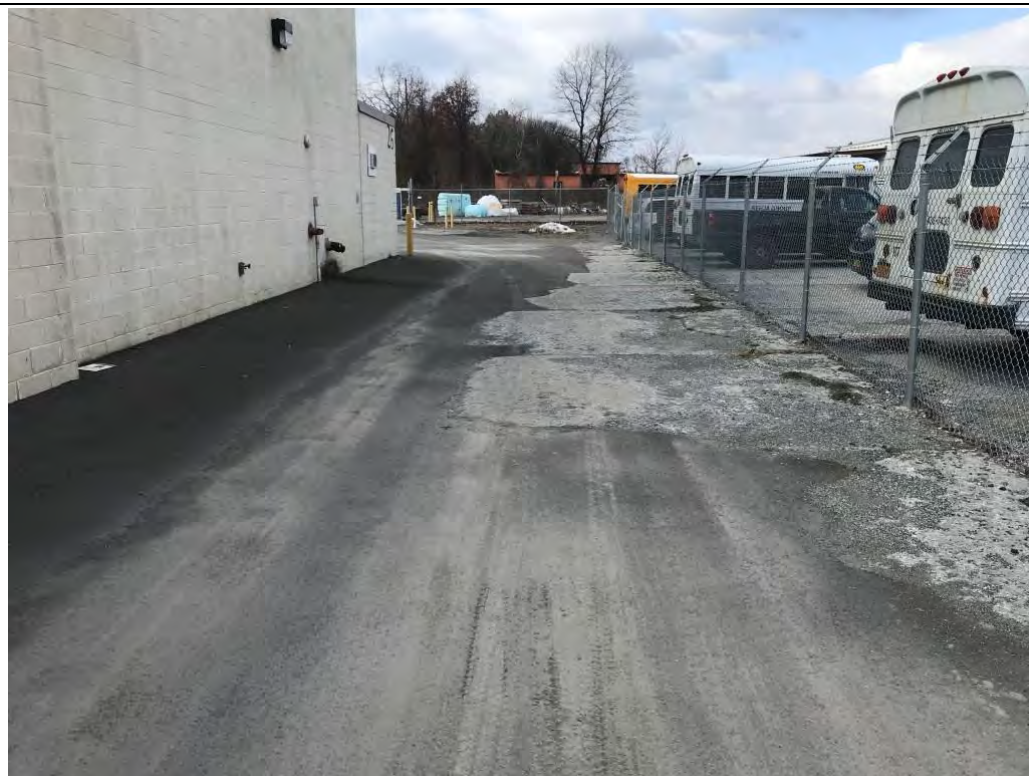
Photograph #4 – View from the northern portion of MERECO property looking west.

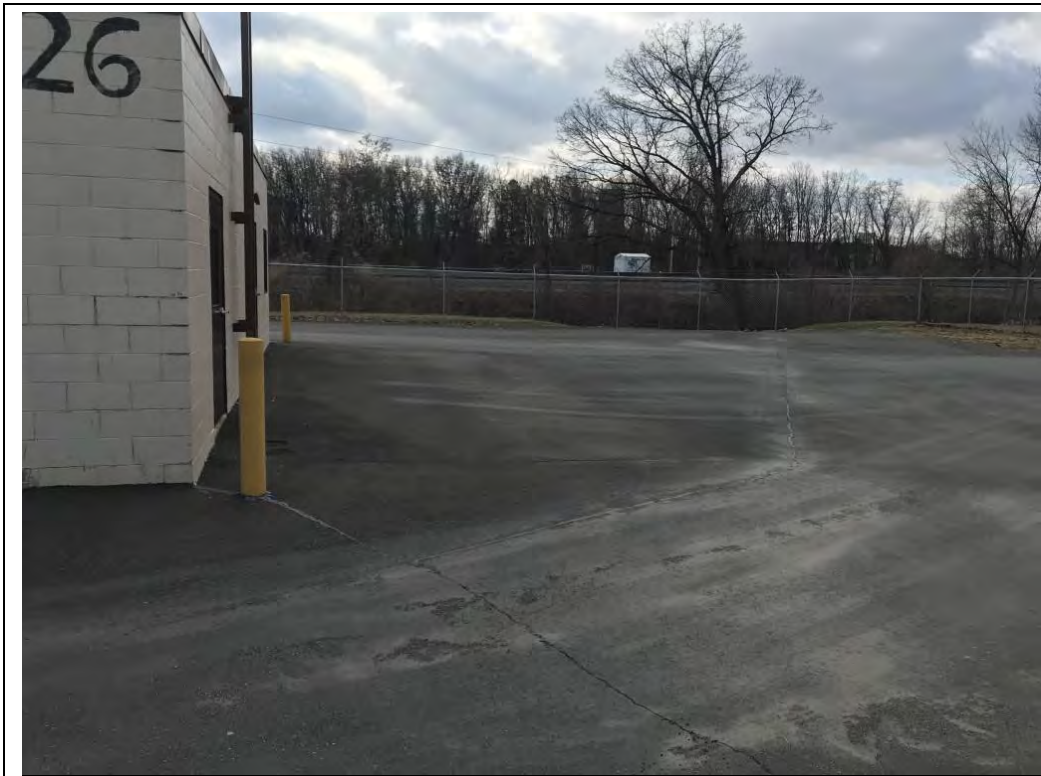
Photograph #5 – View near the northwestern corner of the MERECO building looking south. View shows a small crack extending from the northwest corner of the MERECO building, and a slight separation of a pavement joint extending towards the letdown channel in the background of the photograph. Both had been filled with sealant/crack-filler.

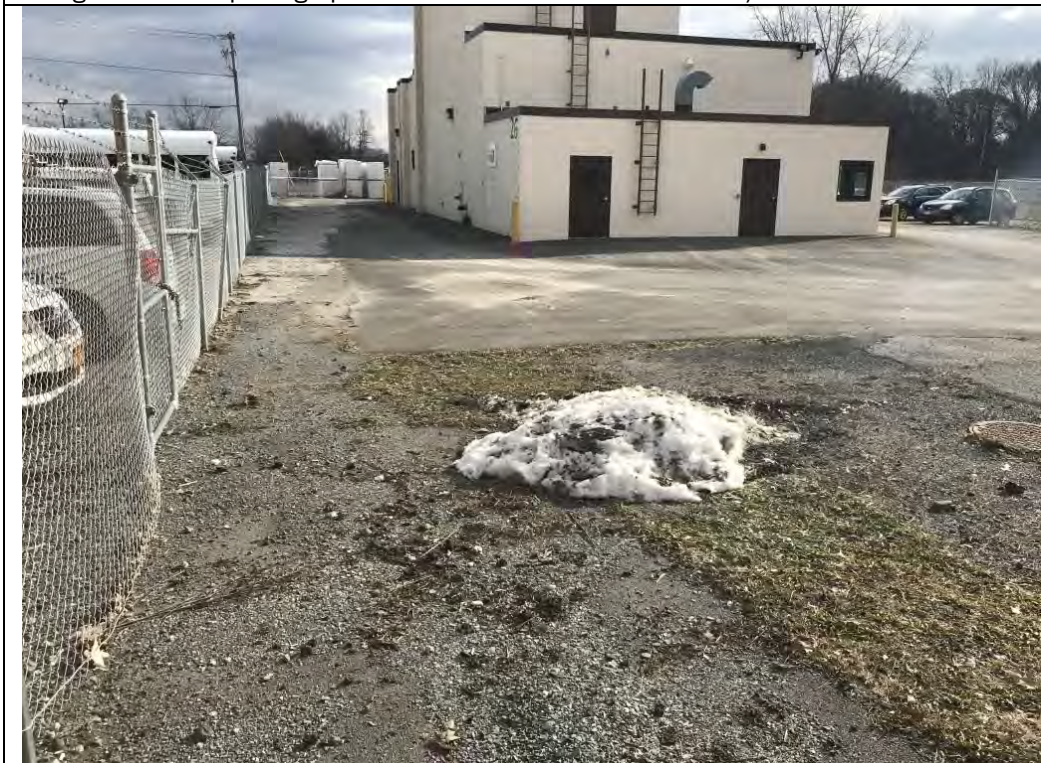
Photograph #6 – View from the western portion of MERECO property looking east.

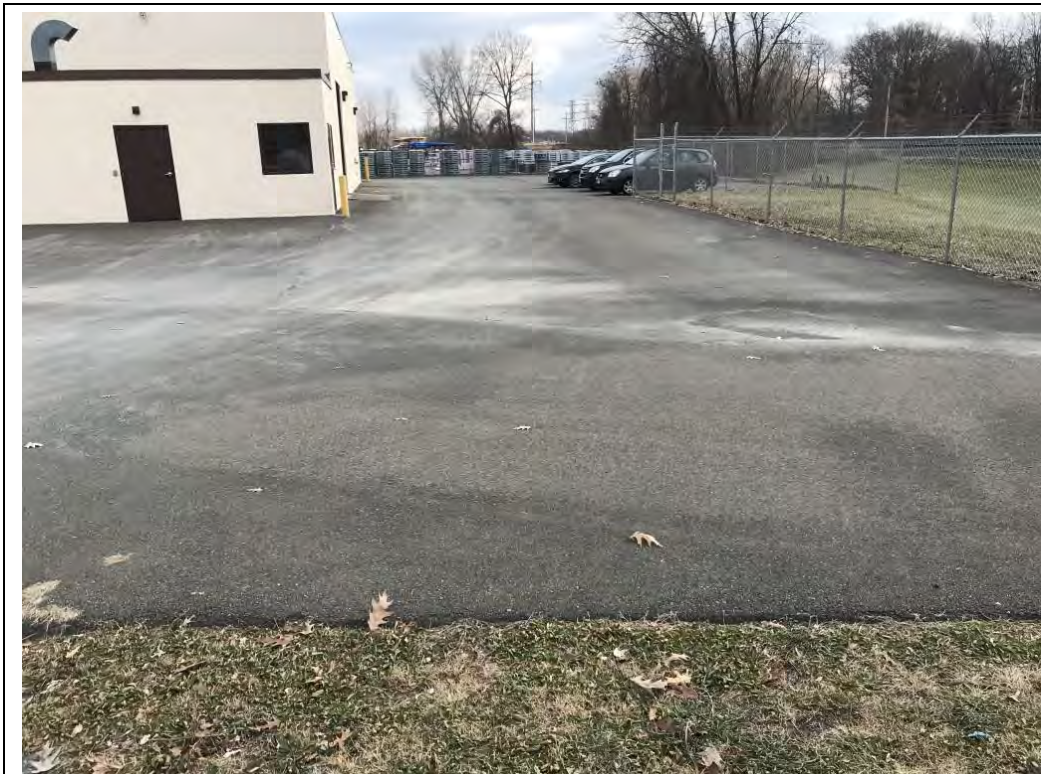
Photograph #7 – View from the western portion of MERECO property looking east. View shows a small crack extending from the southeastern corner of the MERECO building. The crack had been filled with sealant/crack-filler

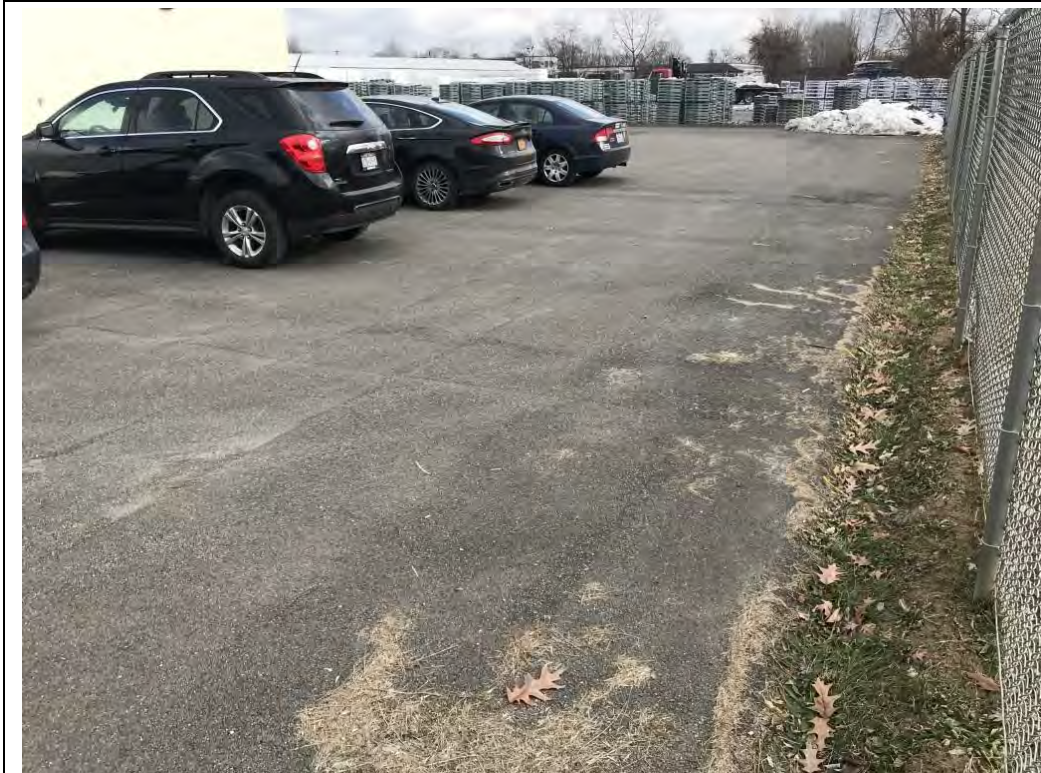
Photograph #8 – View from the southern portion of the MERECO parking area looking northeast.

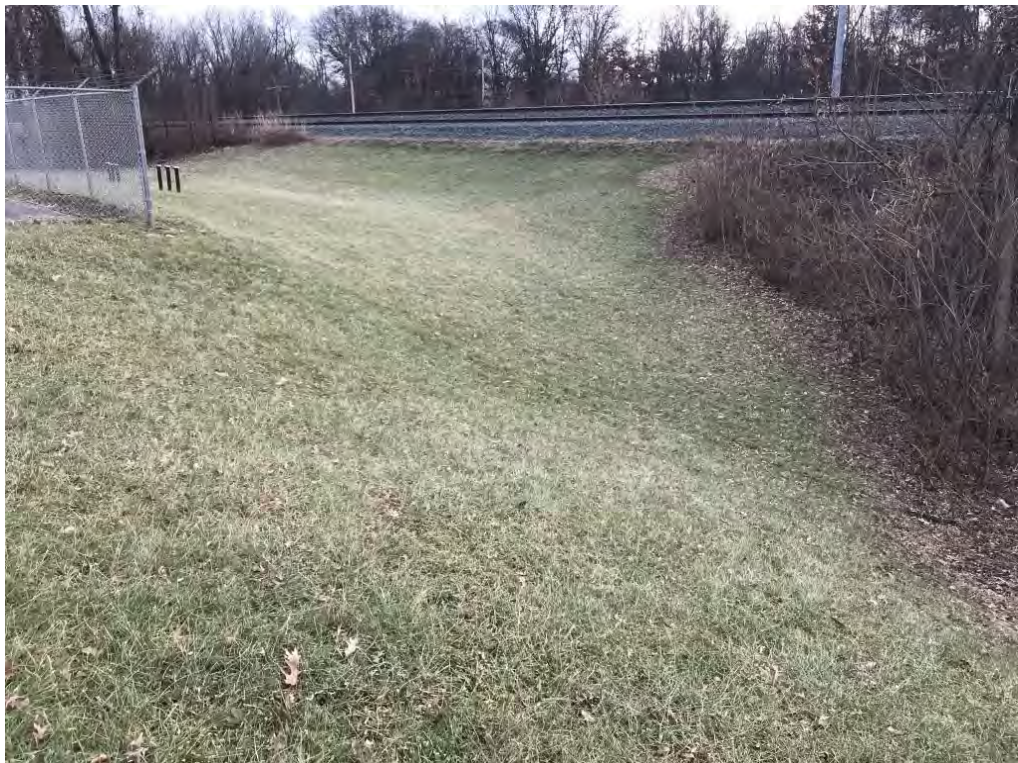
The clay cap in the southern portion of the MEREKO property was observed to be in good condition. Vegetation is being properly managed with no signs of erosion of the clay cap or the overlying topsoil.

Photograph #9 – View from the southwestern portion of MERECO owned property looking southeast. View shows the clay cap in the southern portion of MERECO property.

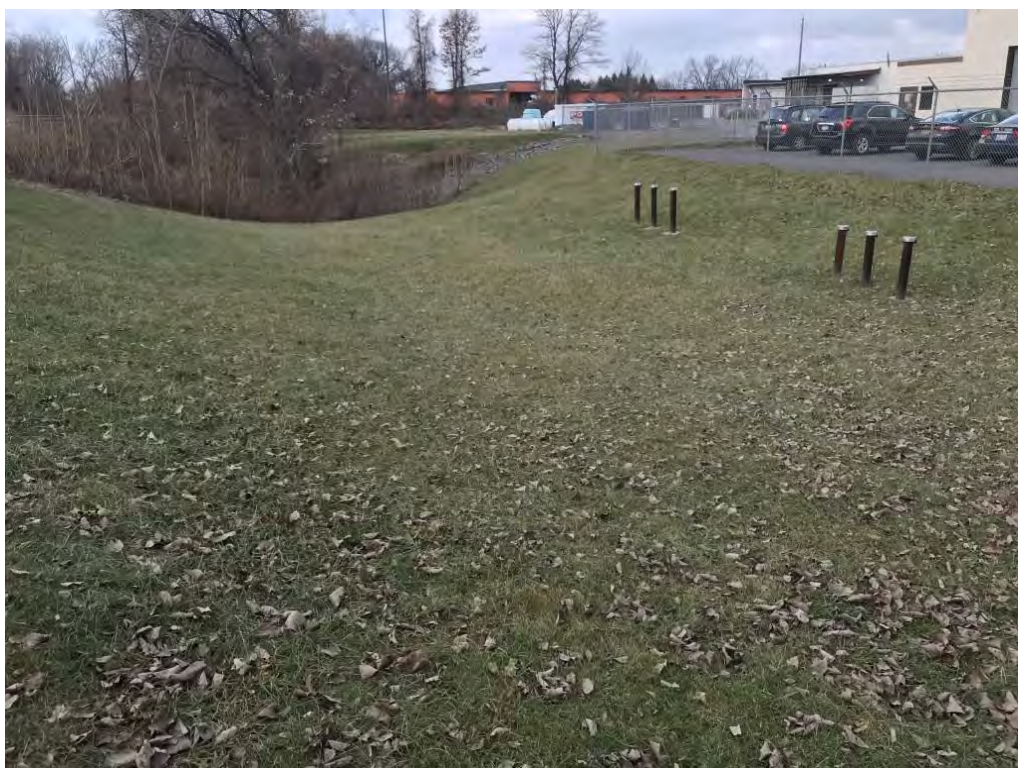
Photograph #10 – View from the southeastern corner of MERECO property looking west. View shows the clay cap in the southern portion of MERECO property.

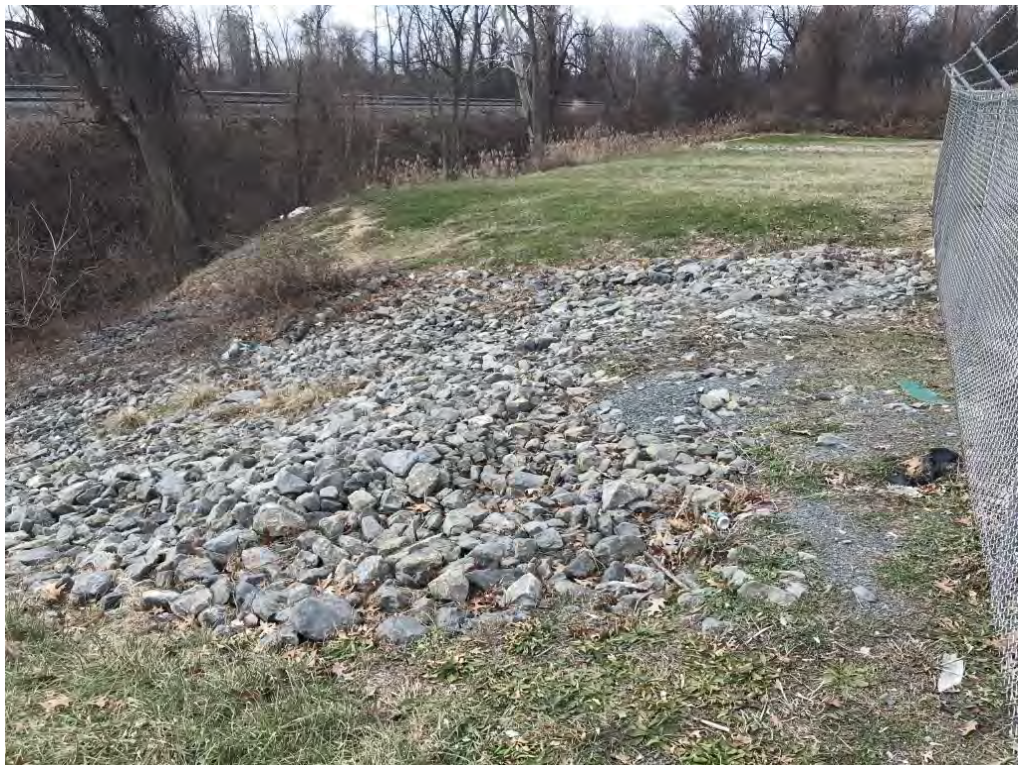
Photograph #11 – View from the southern portion of the MERECO parking area (located to the right-hand side of the photograph) looking west. View shows the upper portion of the letdown channel and vegetated surface cover in the background of the photograph.

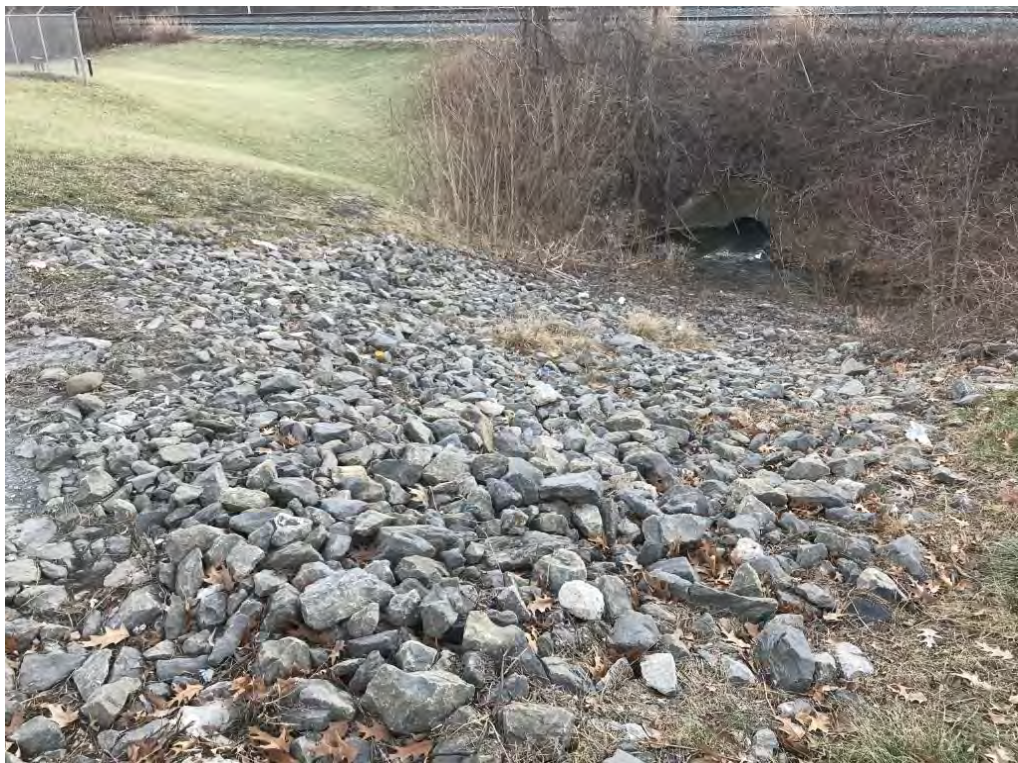
Photograph #12 – View from the southern portion of the MERECO parking area looking south. View shows the upper portion of the letdown channel.

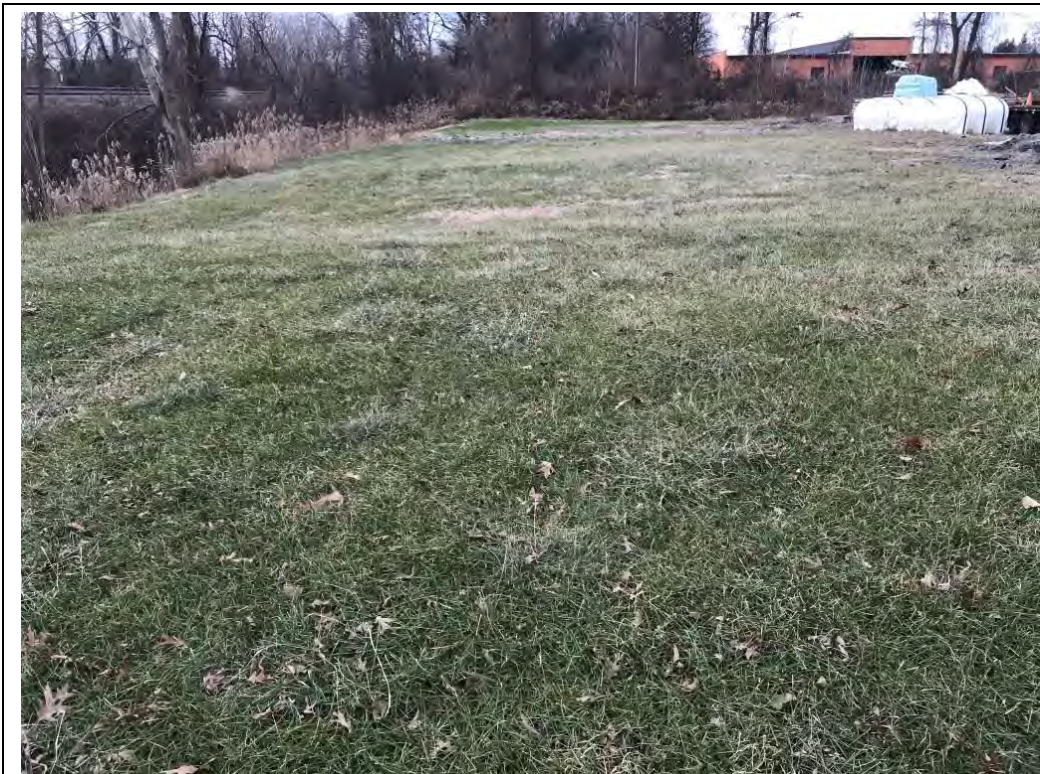
Photograph #13 – View from the western portion of the letdown channel looking west. View shows surface cover over the MEREKO-owned property.

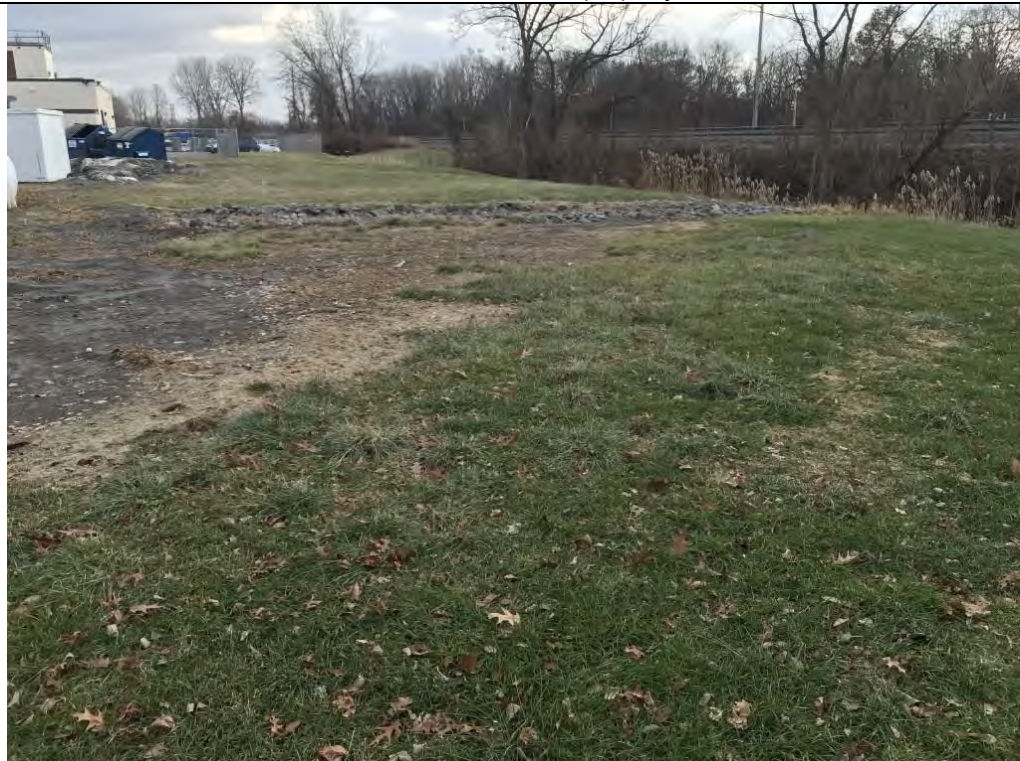
Photograph #14 – View from the northwestern corner of the MEREKO-owned property looking east. View shows surface cover over this area.

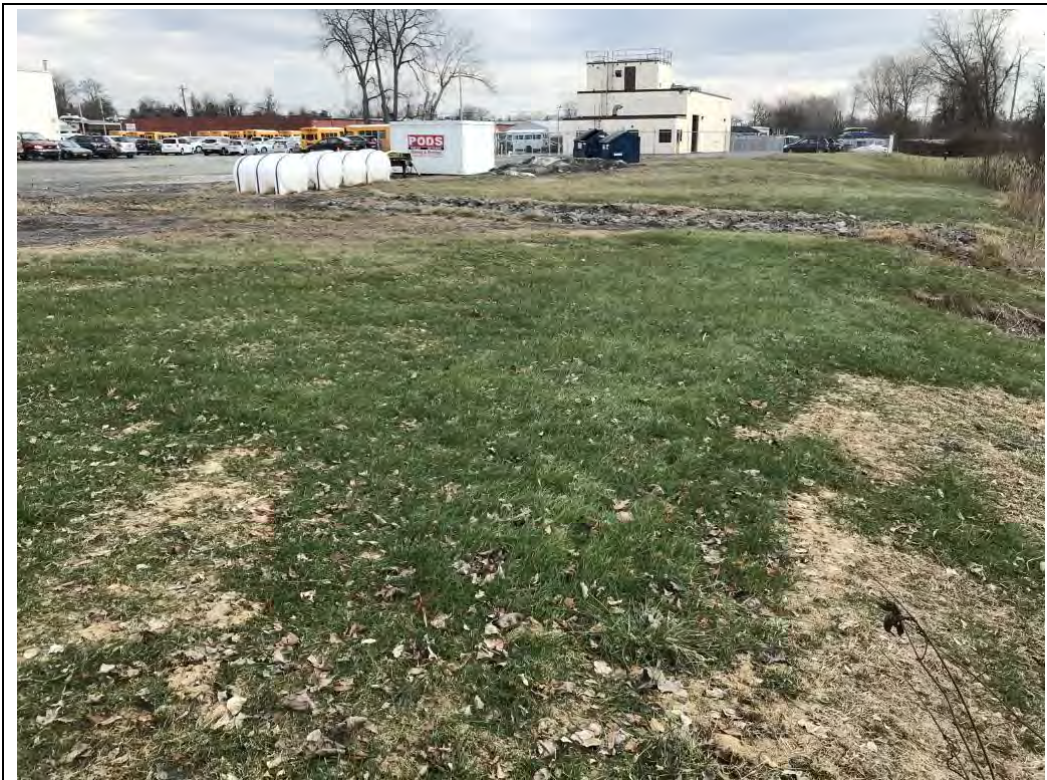
Photograph #15 – View from the southeastern portion of the MEREKO-owned property looking northeast. View shows surface cover over this area.

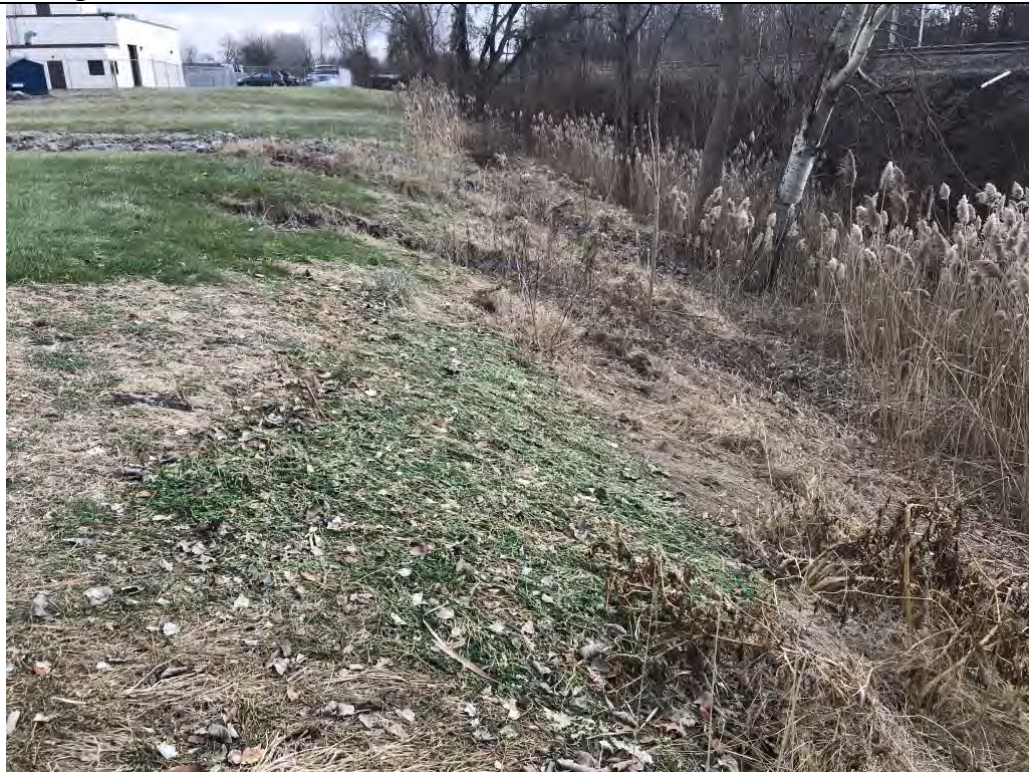
Two areas on the slope (top and mid-slope) adjacent to the Unnamed Tributary in the area of the non-ISS RA were observed to have erosion occurring beneath the erosion blanket installed as part of the cover system. These two erosion areas were observed to be similar in size to observations during previous Site inspections. The remainder of the Site was observed to be in generally good condition.

*There are two areas on the slope adjacent to the Unnamed Tributary that show evidence of erosion beneath erosion mats. The areas are similar in size to what was observed during the previous inspection (12/13/17).*

Photograph #16 – View from the southeastern portion of the MEREKO-owned property looking east. View shows two eroded areas on the slope.

A corrective action to address the two erosional areas identified on the slope adjacent to the Unnamed Tributary is recommended in order to return the area to its post-RA condition. The corrective action will be implemented to repair the erosion noted in 2018, prevent future erosion, and prevent direct exposure to underlying contaminants. Corrective measures will be implemented during the 2019 calendar year and documented in the 2019 PRR.

The disturbed / eroded areas on the slope adjacent to the unnamed tributary are scheduled to be repaired in spring of 2019.

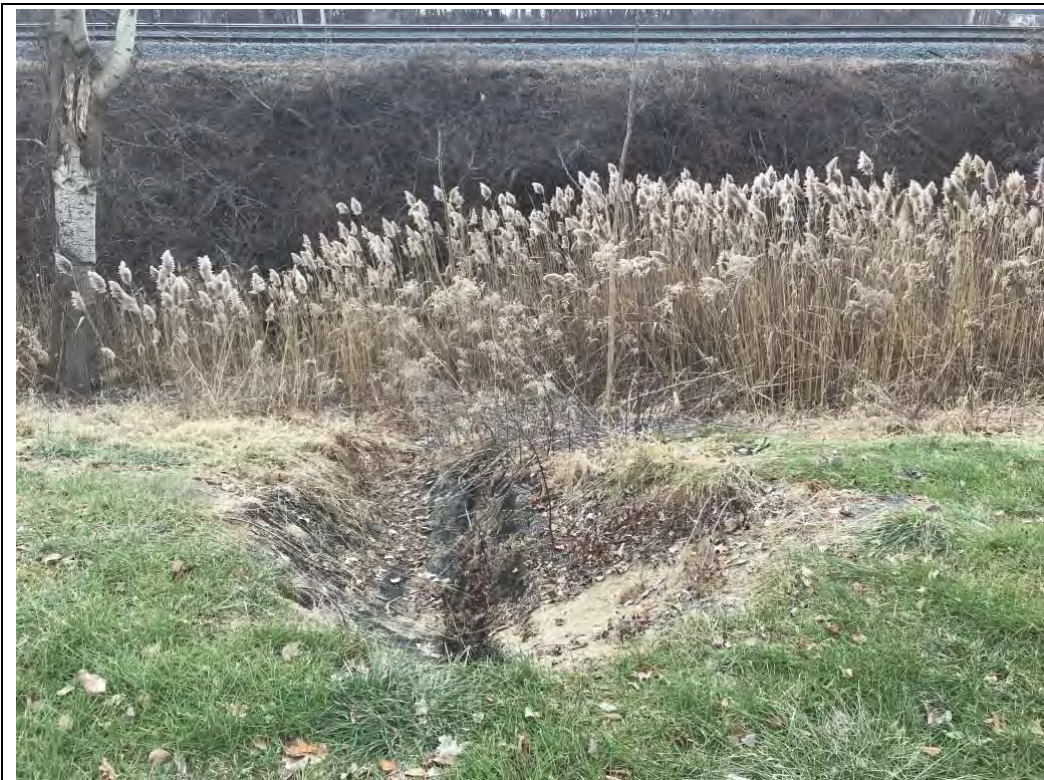
Photograph #17 – View from the southern portion of the MEREKO-owned property looking south. View shows the western erosion area.

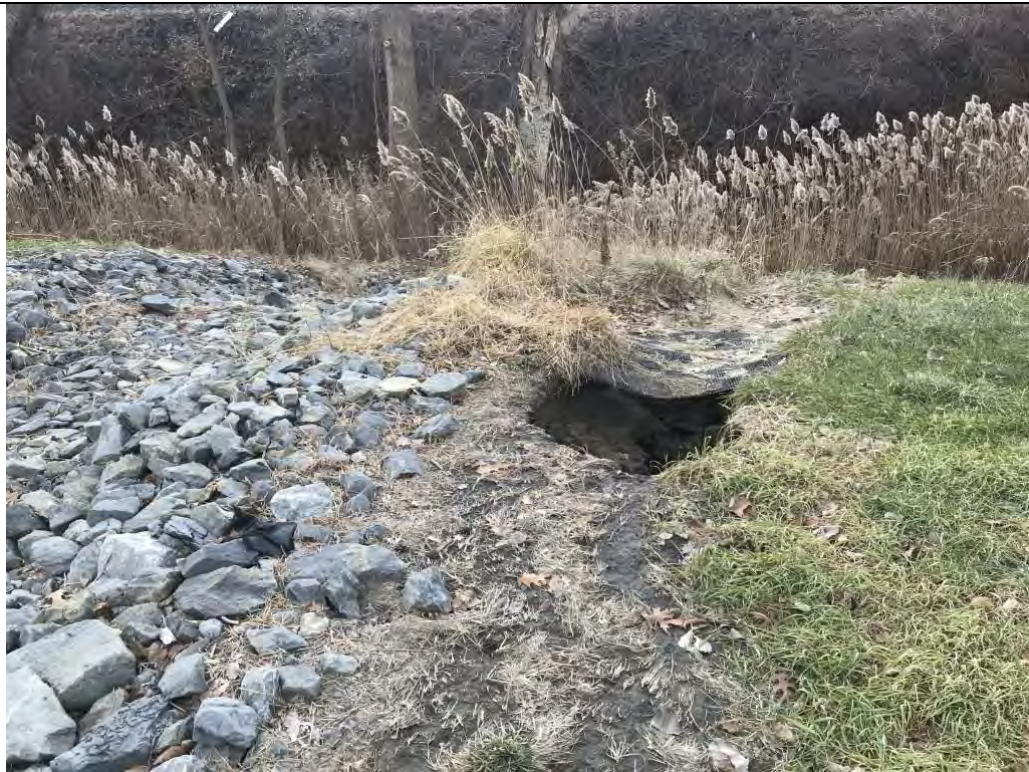
Photograph #18 – View from the southern portion of the MEREKO-owned property looking south. View shows a previous repair (riprap area) on the left-hand side of the photograph and the eastern erosion area on the right-hand side of the photograph, respectively.

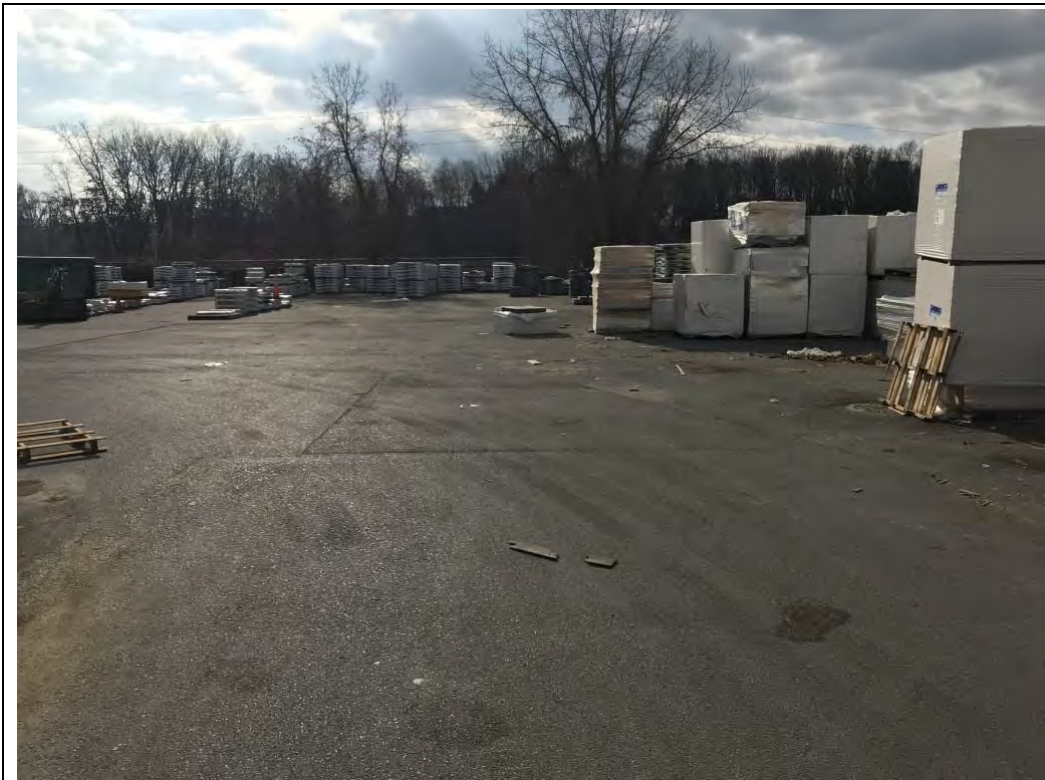
Photograph #19 – View from the western portion of Allied property looking south. View shows the asphalt pavement cap on Allied property.

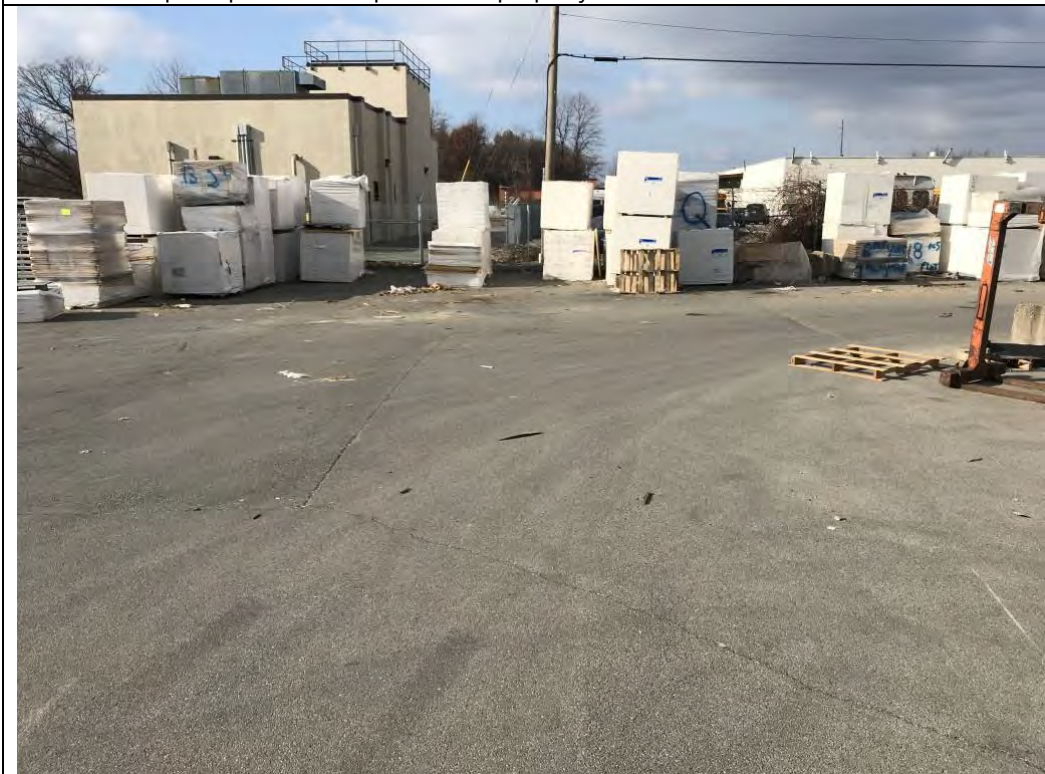
Photograph #20 – View from the western portion of Allied property looking west. View shows the asphalt pavement cap on Allied property.

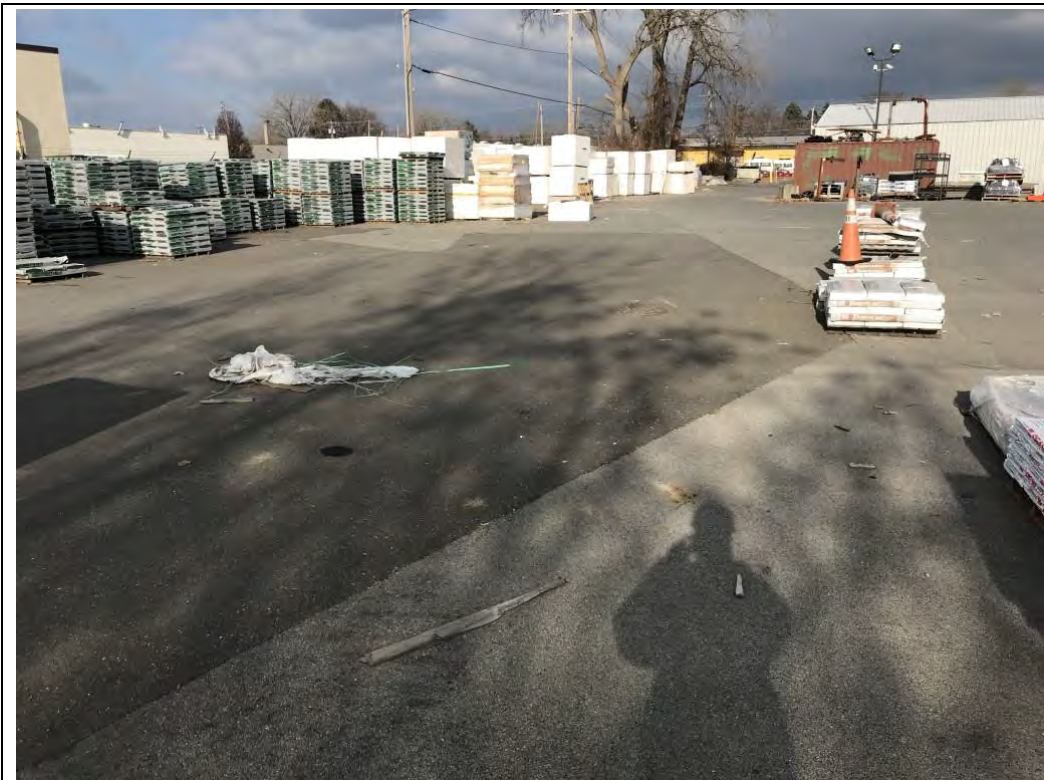
Photograph #21 – View from the southern portion of Allied property looking north. View shows the asphalt pavement cap on Allied property.

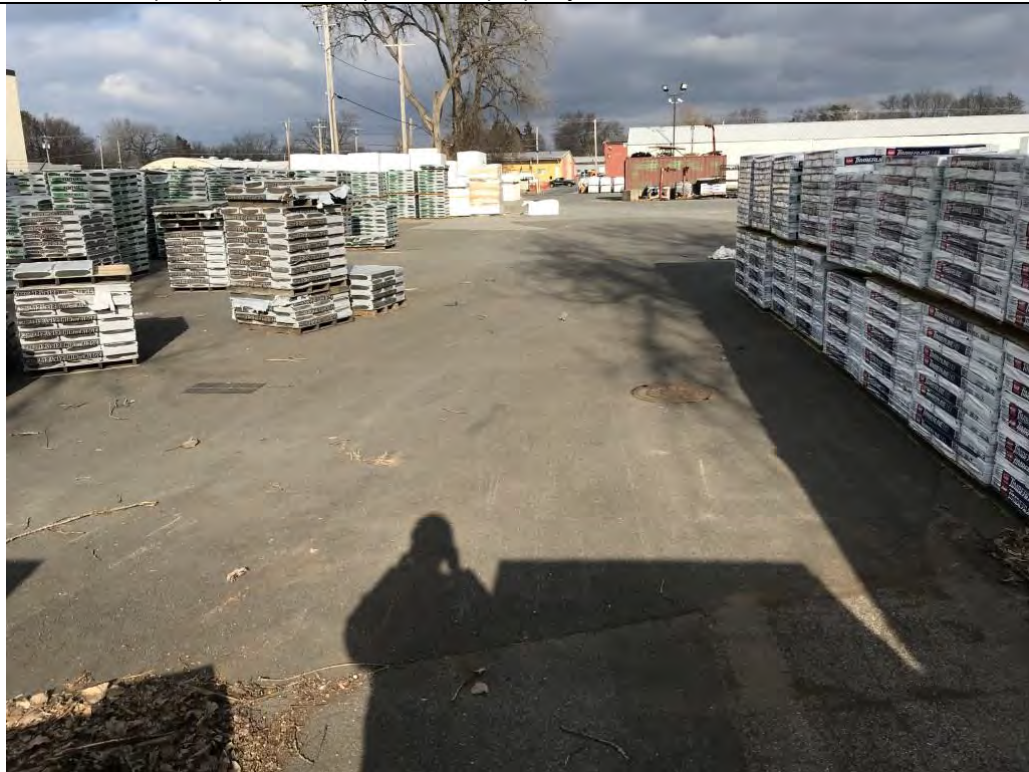
Photograph #22 – View from the southern portion of Allied property looking north. View shows the asphalt pavement cap on Allied property.

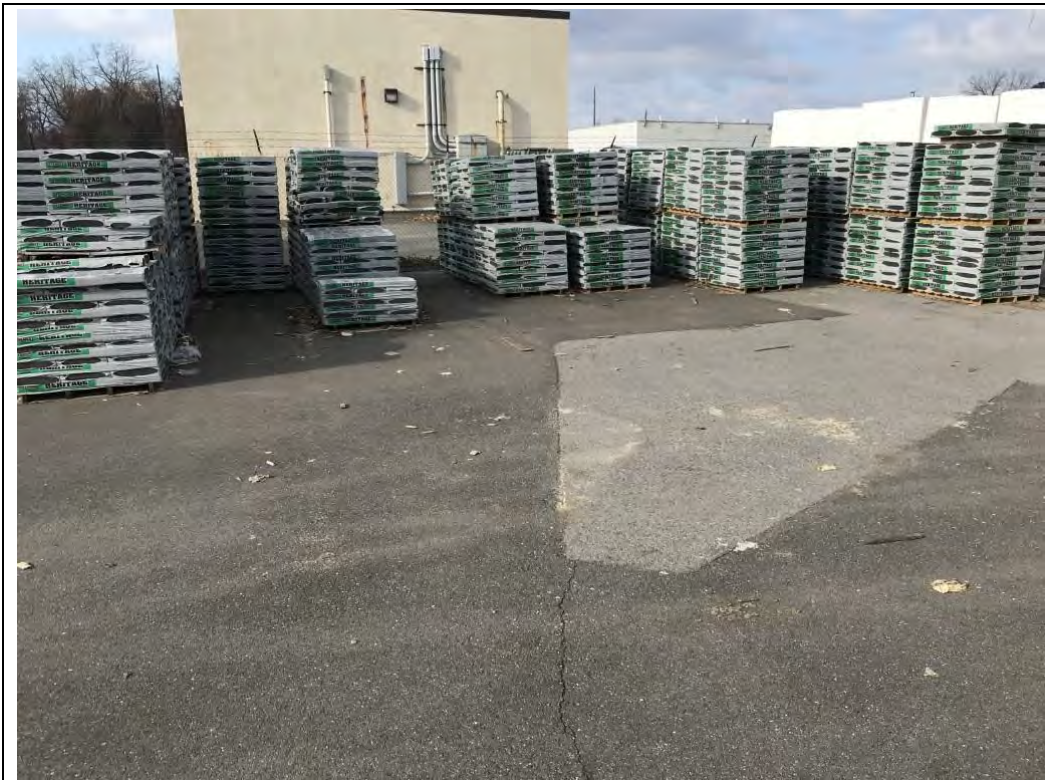
Photograph #23 – View from the western portion of Allied property looking east. View shows a small crack and a slight separation at the edge of the asphalt pavement cap on Allied property.

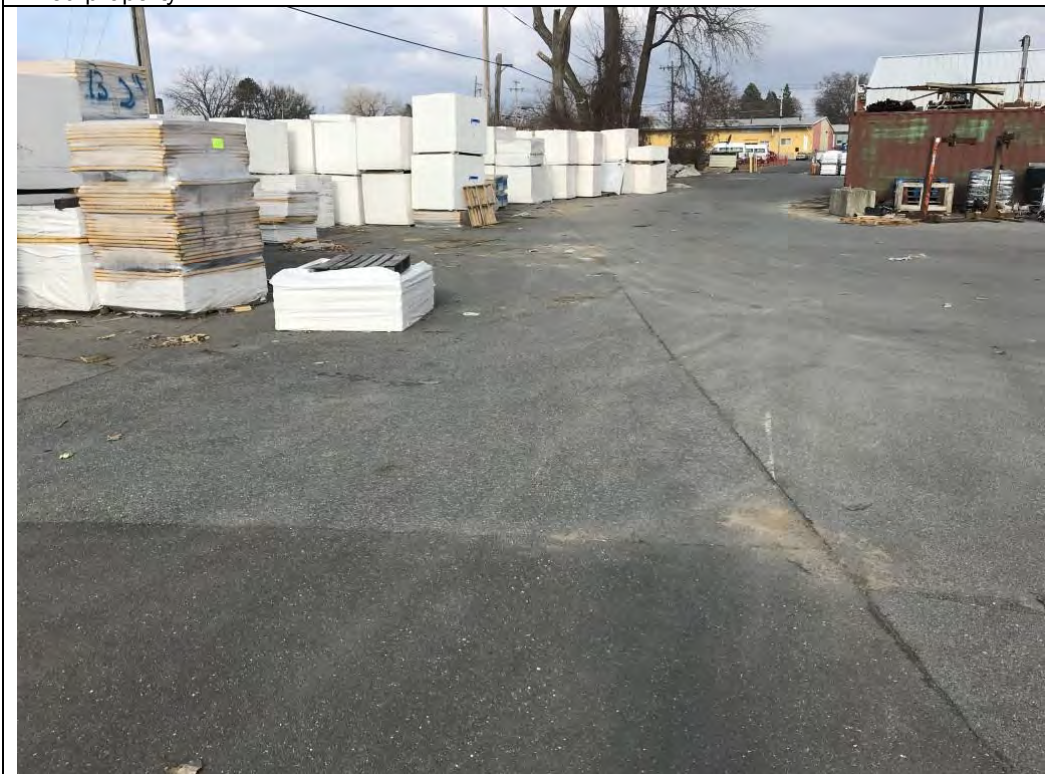
Photograph #24 – View from the western portion of Allied property looking north. View shows the asphalt pavement cap on Allied property.
