# TRANSPARENCIES FOR SITE CLOSURE MEETING - DAVID A. AXELROD CENTER

September 29, 1999

Elizabeth G. Mahoney and John M. Matuszek, Ph.D.

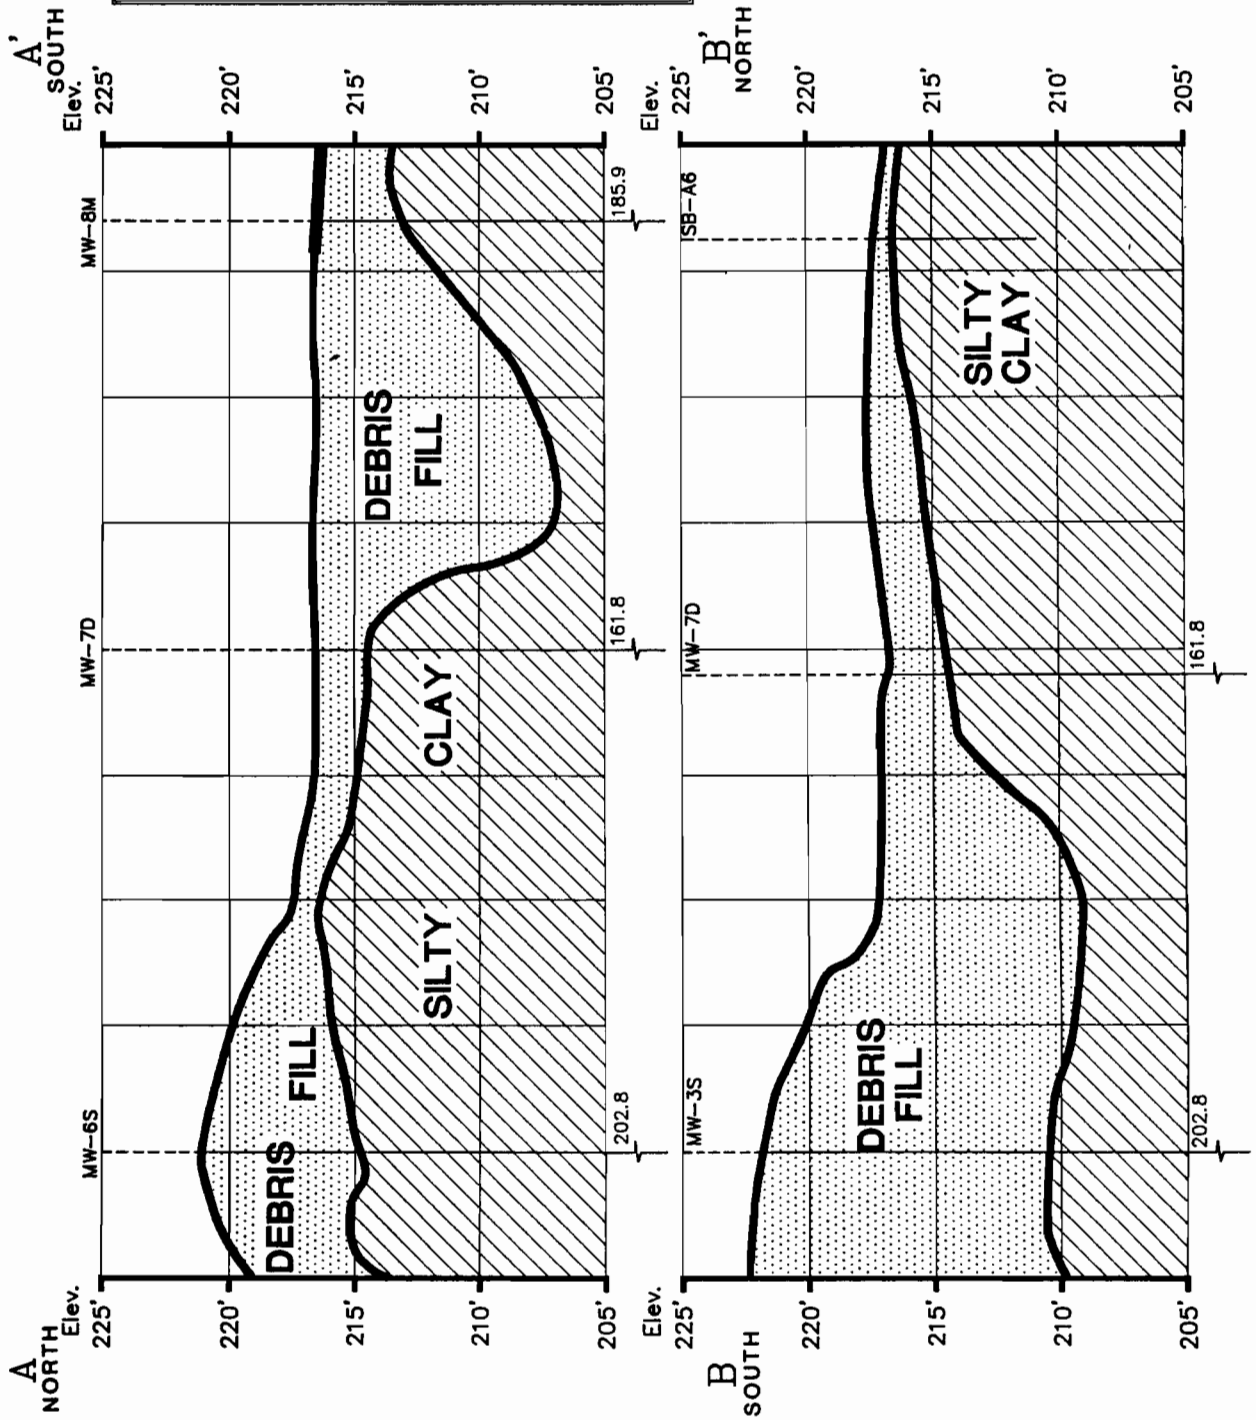
FIGURE 10

9. Soil boring locations for RI.
10. Typical cross-sections developed from soil borings.
11. Typical cross-section developed from soil borings.
12. Site topography at the time of the RI. The elevations represented here were used in conjunction with the borehole logs to estimate the subsurface interface of the undisturbed glacial till (see figure 7). These elevations are greater than those of the 1914/1917 topographic maps due to the addition of fill into the swamp from construction projects on the various properties. The “mound” on the Armory property is from the construction (post-1949) of an outdoor maintenance facility for heavy armored vehicles.

TYPICAL CROSS SECTIONS

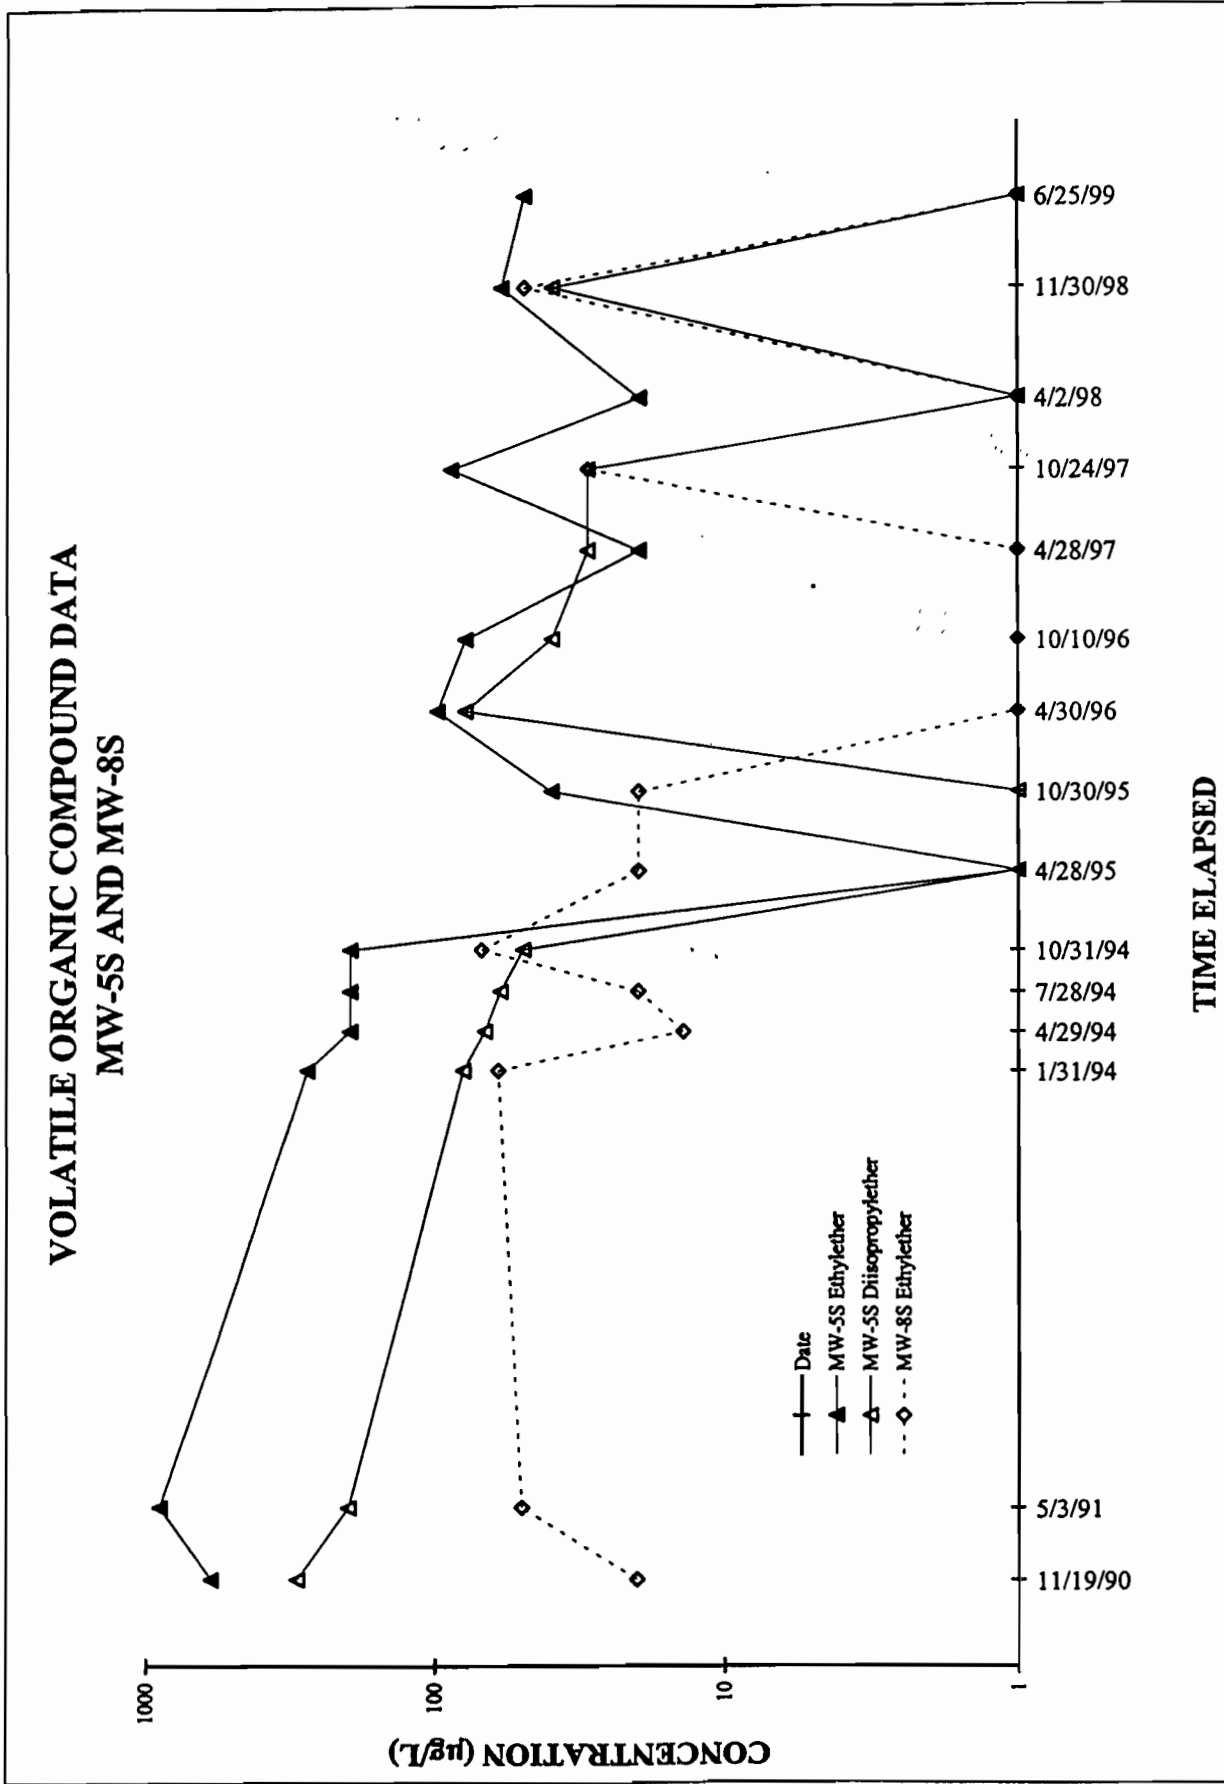
Figure 33.

33. Concentrations of volatile organic compounds in monitoring wells MW-5S and MW-8S. **All of the concentration values depicted in this figure represent detection-limits or quantitation-limits.** Furthermore, neither of the contaminants, ethyl ether and diisopropyl ether, is found in the intervening monitoring well MW-4S (analytical data for MW-4S report these as “ND”; i.e., not detectable) Thus, they have little or no merit for establishing an estimate of the extent of groundwater contamination (see discussion above regarding figure 19).
