# **Periodic Review Report For NYS DOH Wadsworth Center (Site No. 401031) Albany, New York**

2015 Report

RE: David Axelrod Institute Parking Lot Repair Environmental Monitoring

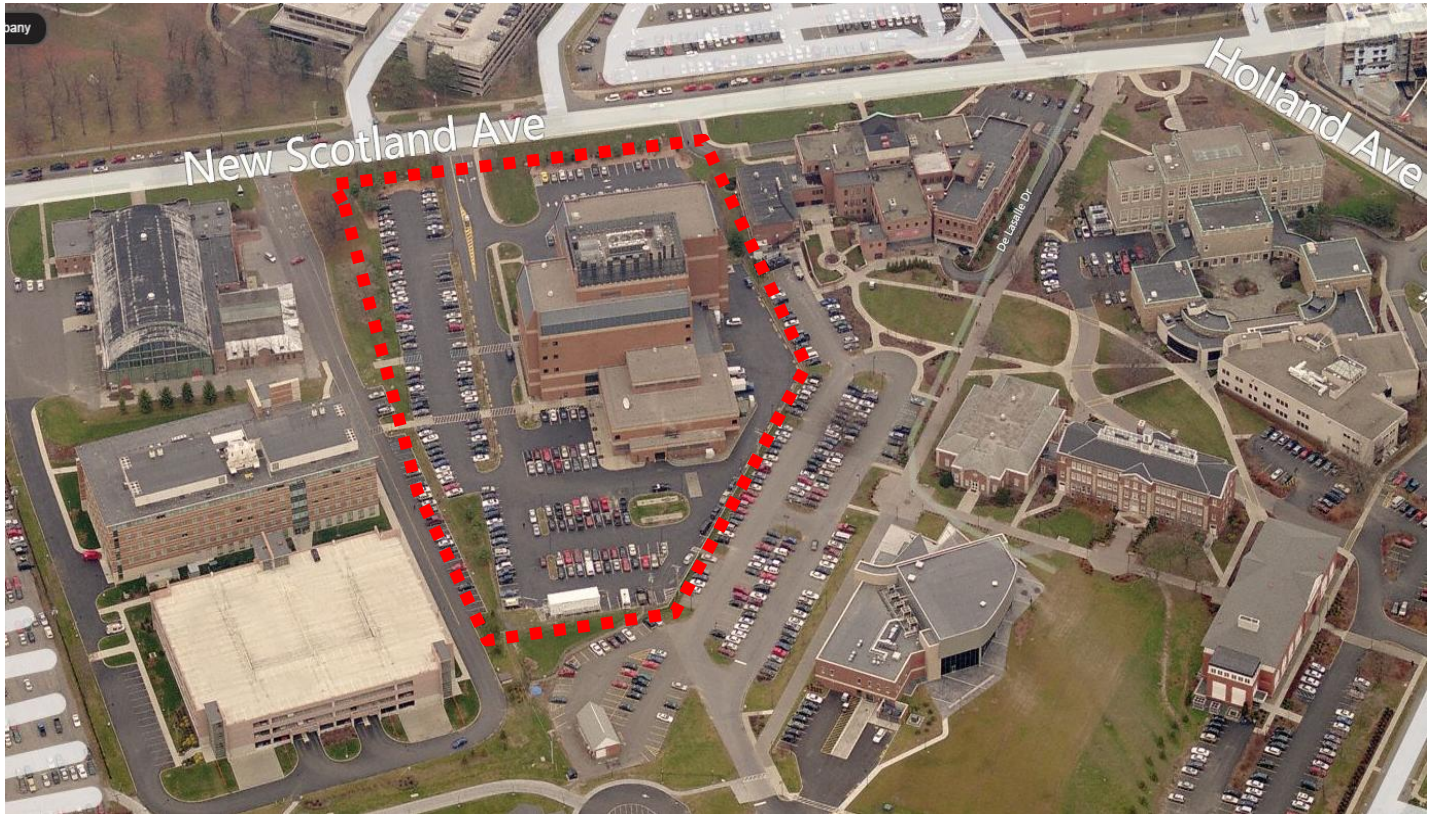
**FIGURE 1**  
**DAI PARKING LOT**

MJ Engineering & Land Surveying P.C., (MJ) has prepared this summary report for an environmental investigation recently completed at the the New York State Department of Health (NYSDOH) Wadsworth Center (WC). This report summarizes excavation and sampling activities completed for an approximate 45 foot by 45 foot temporary repair work area (Site) associated with the David Axelrod Institute (DAI) parking lot. The DAI is located at 120 New Scotland Avenue, Albany, New York. The Site, located in the southernmost portion of the DAI parking lot, is located within an inactive hazardous waste disposal site containing soil impacted with halogenated and non-halogenated solvents that is reportedly capped approximately 18 inches below the parking lot pavement. Since parking lot repairs were planned within this inactive hazardous waste area, MJ was contacted to provide environmental oversight and sampling during construction. **Figure 1** and **2** provide a general overview of the DAI parking lot and the approximate Site location, respectively.

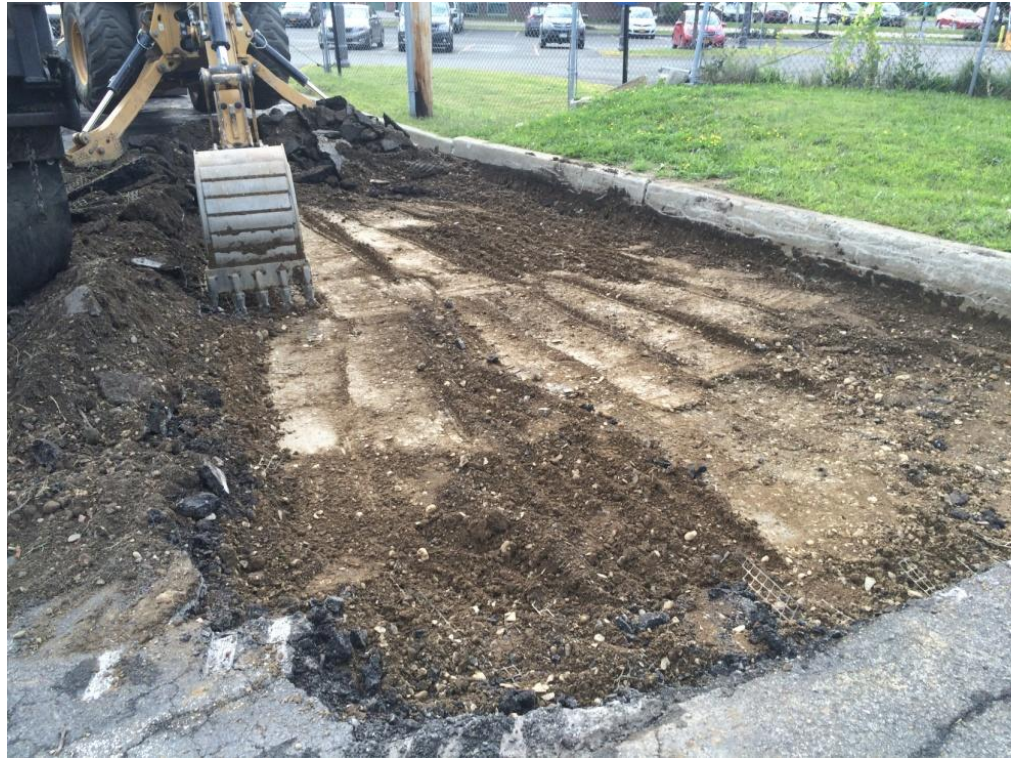
Initial depth of the excavation was approximately 16 inches below grade at the southern end of the Site, but was later modified to 12 inches as to prevent exposure of the underlying capped area. A layer of geogrid, unassociated with the cap, was encountered at a depth of approximately 10 inches below grade and was stockpiled along with the excavated material. There was no observation of the cap throughout the duration of excavation activities.

Excavated Area  
Approximately 16"  
in Depth

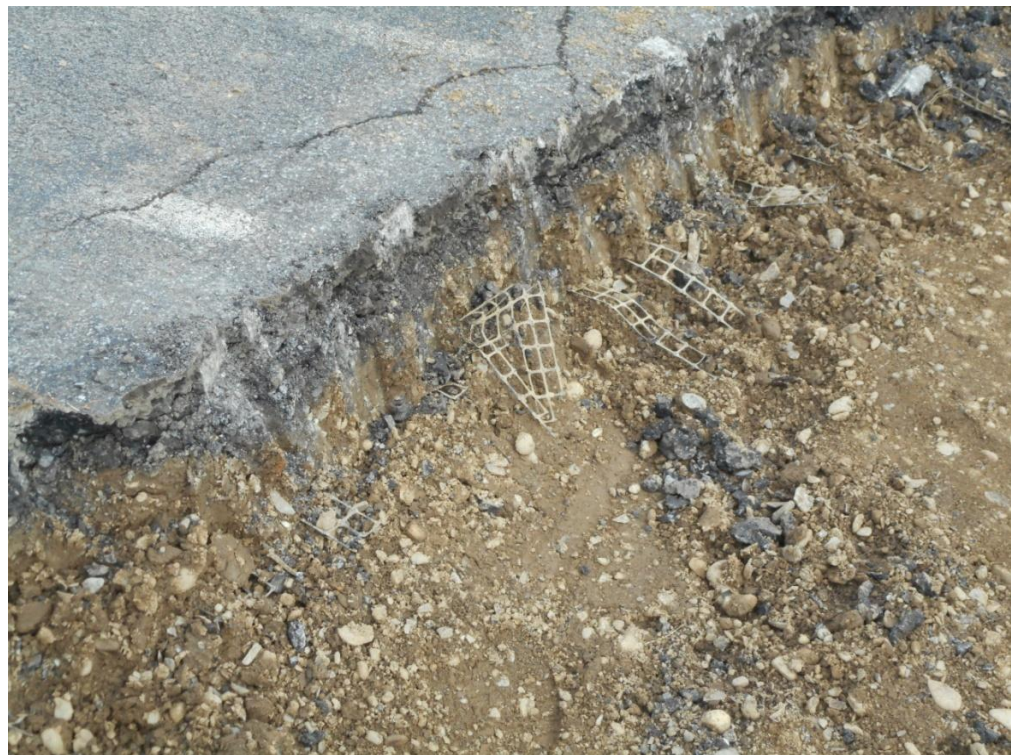
2

Geogrid Observed  
Approximately 10"  
Below Grade

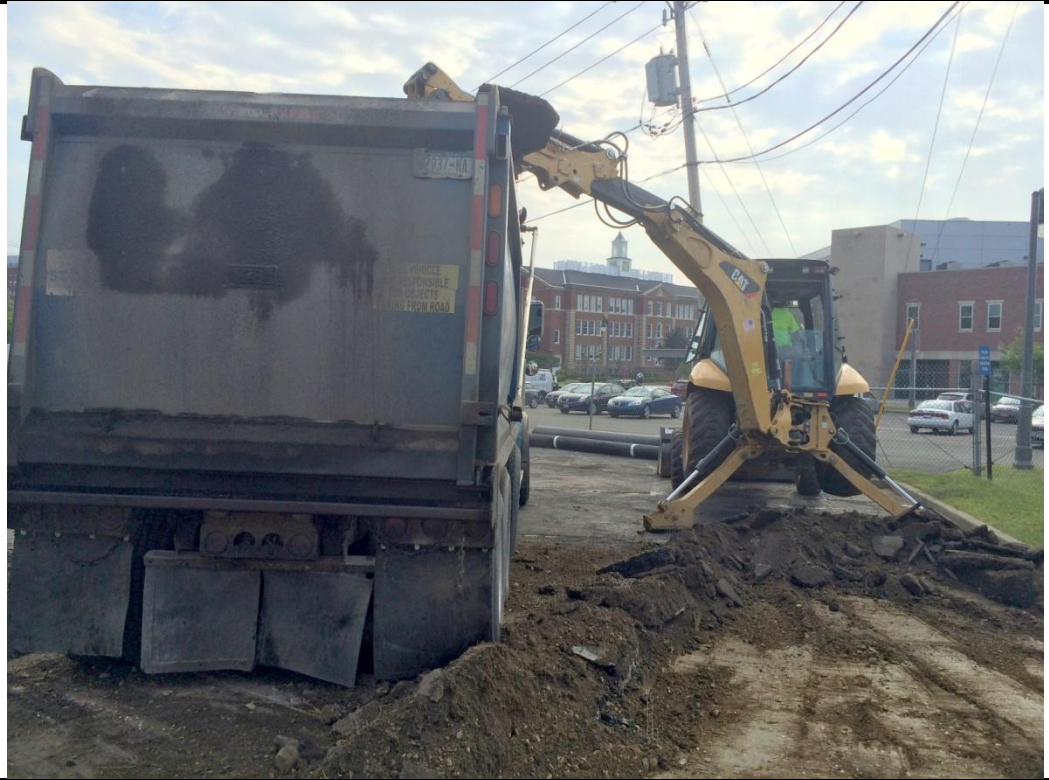
Excavator Loading  
Excavated  
Materials Into  
Dump Truck

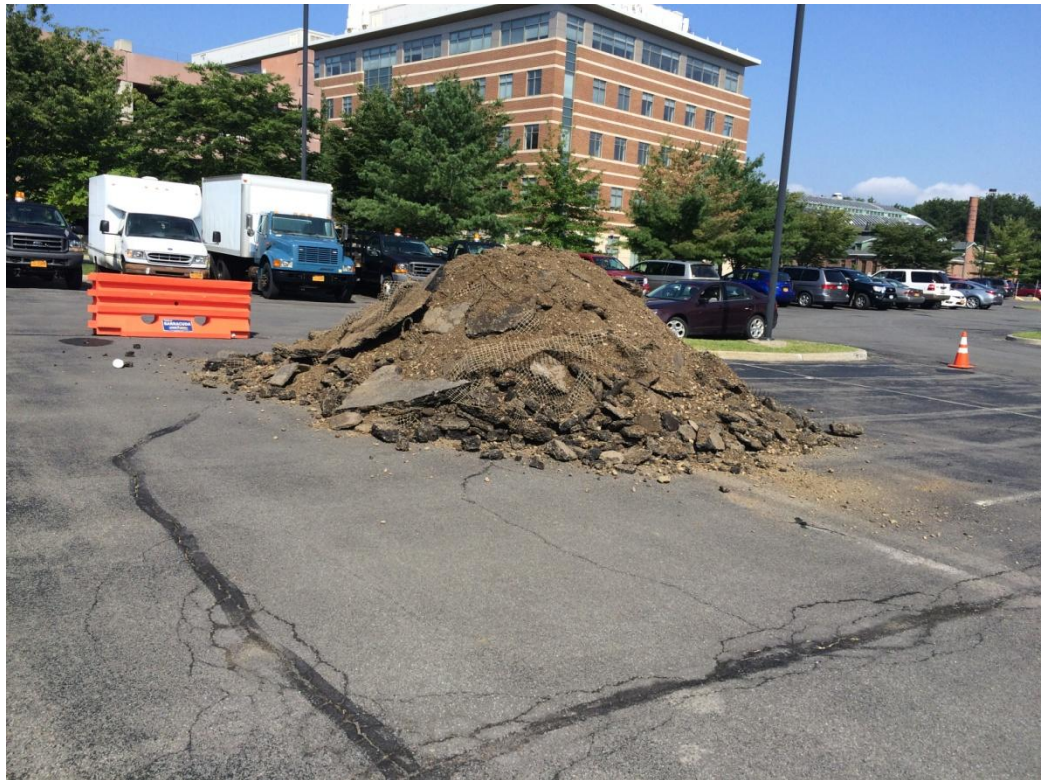
4

Callanan initiated the excavation of the parking lot on August 25, 2015. Asphalt and underlying soil were placed into a designated stockpile area located approximately 30 feet northwest from the excavated area.

Designated  
Stockpile  
Northwest of  
Excavated Area

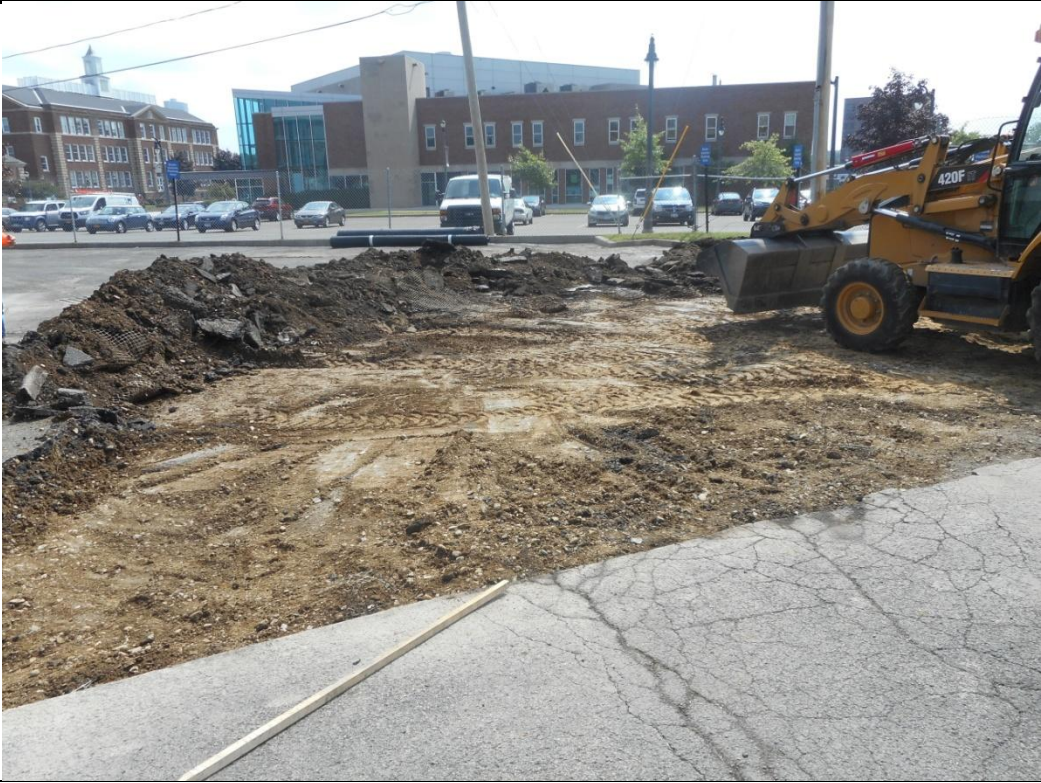
| 5 | | |

| Temporary Stockpiles Located on Perimeter of Excavated Area | | |

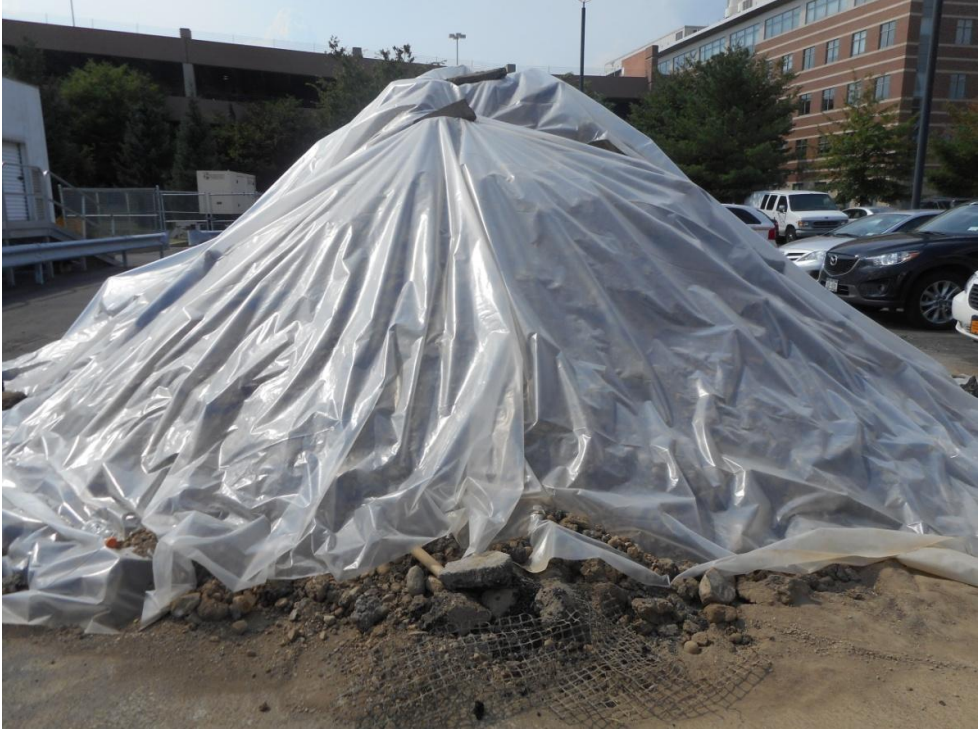
| <b>PHOTO ID:</b><br>7<br><b>DATE:</b><br>9/3/2015<br><b>DESCRIPTION:</b><br>Stockpile Covered With Poly | | |

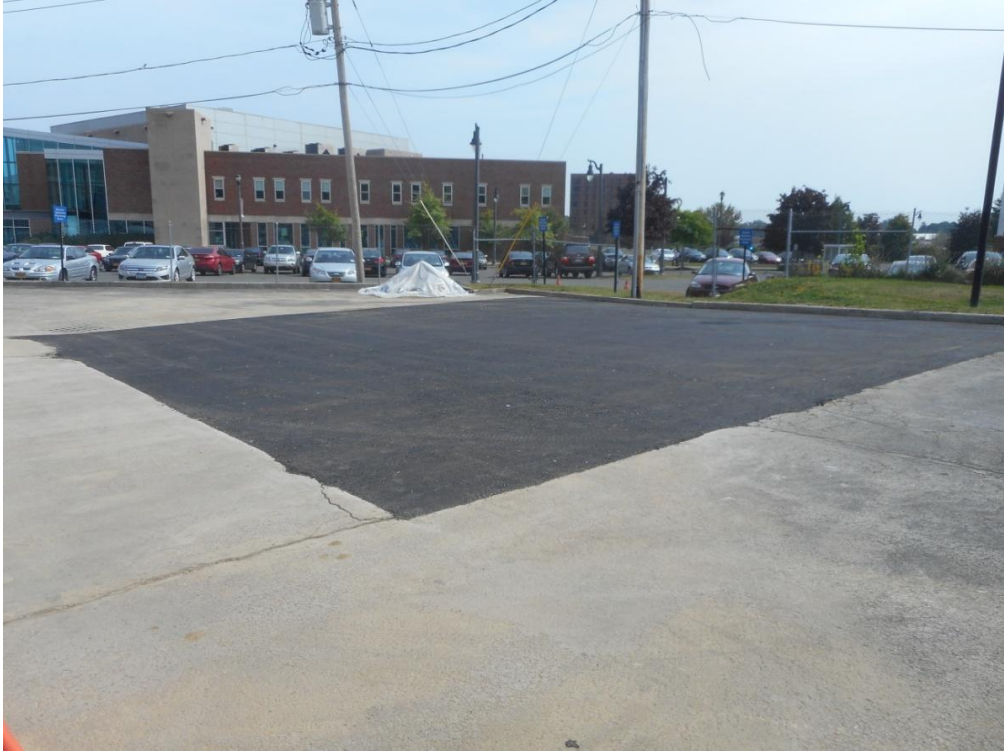
| <b>PHOTO ID:</b><br>8<br><b>DATE:</b><br>9/3/2015<br><b>DESCRIPTION:</b><br>Completed Paved Excavated Area | | |

On September 4, 2015, MJ returned to the site to confirm the completion of the paving process by Callanan. The approximately 70 cubic yards of stockpiled soil was removed from Site on September 14th by Callanan and transported to their facility in South Bethlehem. A photographic log of the excavation activities is provided in **Attachment 2**.
