Construction Certification Report

Vapor Intrusion Interim Corrective Measures

**Main Manufacturing Area
Watervliet Arsenal
Watervliet New York**

September 2010

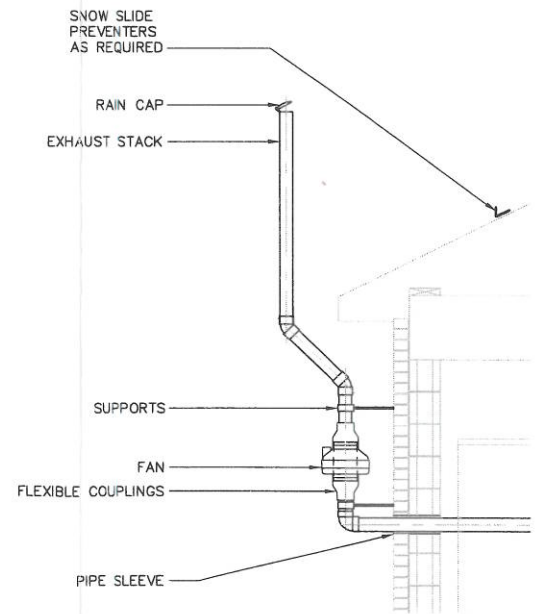
SSD SYSTEM - TYPE C DETAIL
NOT TO SCALE

The Type C SSDSs were used for smaller buildings and/or smaller treatment areas where off-gas treatment is not required. The systems consist of an in-line fan connected directly to the extraction well through piping and are similar to a traditional radon mitigation system. The fans are located outside of the structures and are connected to the extraction well through wall penetrations.

- In-line Fantech radon mitigation fan;
- Pressure gauge and sampling ports.

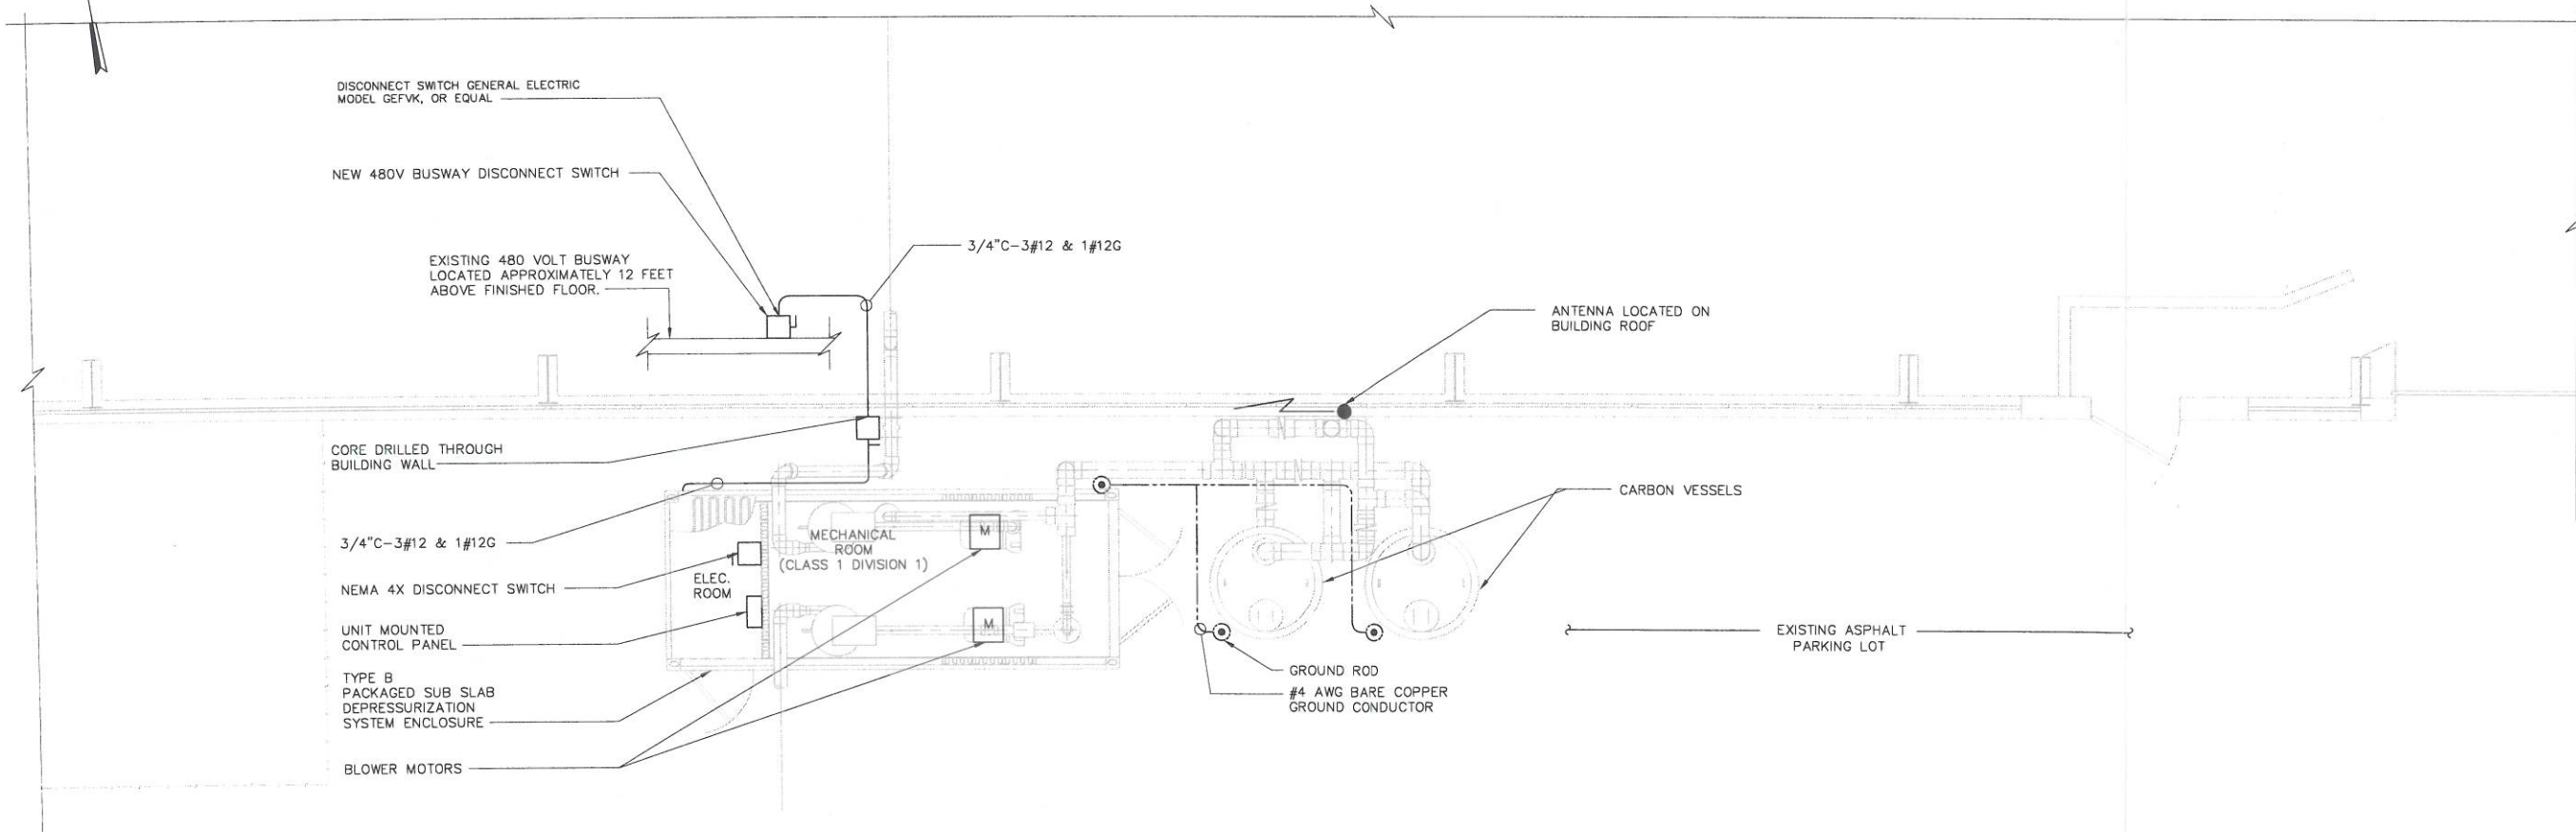
BUILDING 20
PLAN VIEW

As indicated in Section 3.3, a Type B SSDS was used for Building 20. As shown in the as-built drawings in Appendix A, three extraction wells (SSDS-B20-EW-1, EW-2, and EW-3) are located in the south east corner of the building. Based on the pilot test results, SSDS-B20-EW-1 had a radius of influence (ROI) of approximately 57 feet at a flow rate of approximately 120 cfm (Malcolm Pirnie, 2009). The maximum flow rate measured at SSDS-B20-EW-1 during the startup testing was 185 cfm. The maximum flow rates measured at extraction wells SSDS-B20-EW-2 and EW-3 were 85 cfm and 84 cfm, respectively.

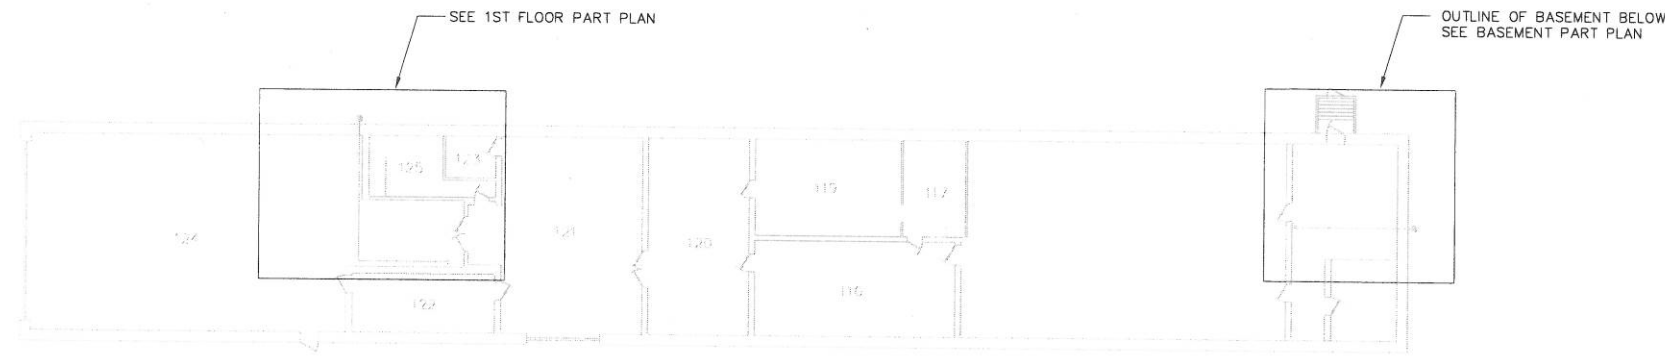
**BUILDING 22 - 1ST FLOOR
PLAN VIEW**

As indicated in Section 3.3, two Type C SSDSs were used for Building 22. As shown in the as-built drawings in Appendix A, extraction well SSDS-B22-1 is located in the eastern portion of the building in the rear of the vehicle garage area; SSDS-B22-2 is located in the basement portion of the building. Field pilot test results for Building 22 indicated that the pilot test well had a ROI of approximately 44 feet at a flow rate of approximately 120 cfm. Following installation of the Type C SSDSs, extraction wells SSDS-B22-1 and SSDS-B22-2 each had a ROI of approximately 45 feet at flow rates of 55 cfm and 12 cfm, respectively.

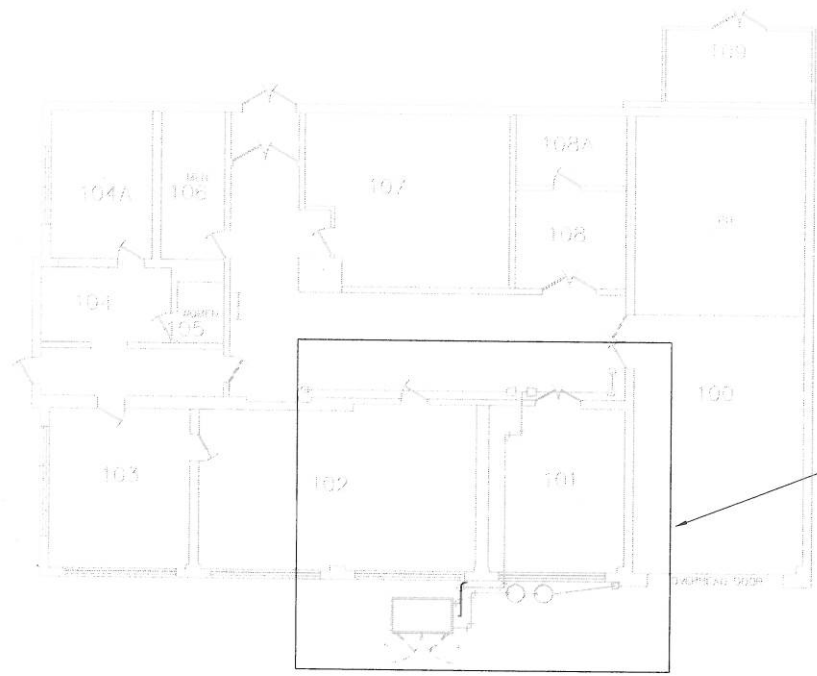
BUILDING 114 - 1ST FLOOR

As indicated in Section 3.3, a Type A SSDS was used for Building 114. As shown in the as-built drawings in Appendix A, two extraction wells (SSDS-B114-EW-1, EW-2, and EW-3) are located in the eastern and western portions of the building, respectively. Based on the pilot test results, SSDS-B114-EW-1 had a radius of influence (ROI) of approximately 23 feet at a flow rate of approximately 120 cfm (Malcolm Pirnie, 2009). The maximum flow rate for the startup testing was 69 cfm. A temporary sub-slab pressure monitoring point was installed approximately 23 feet from extraction well

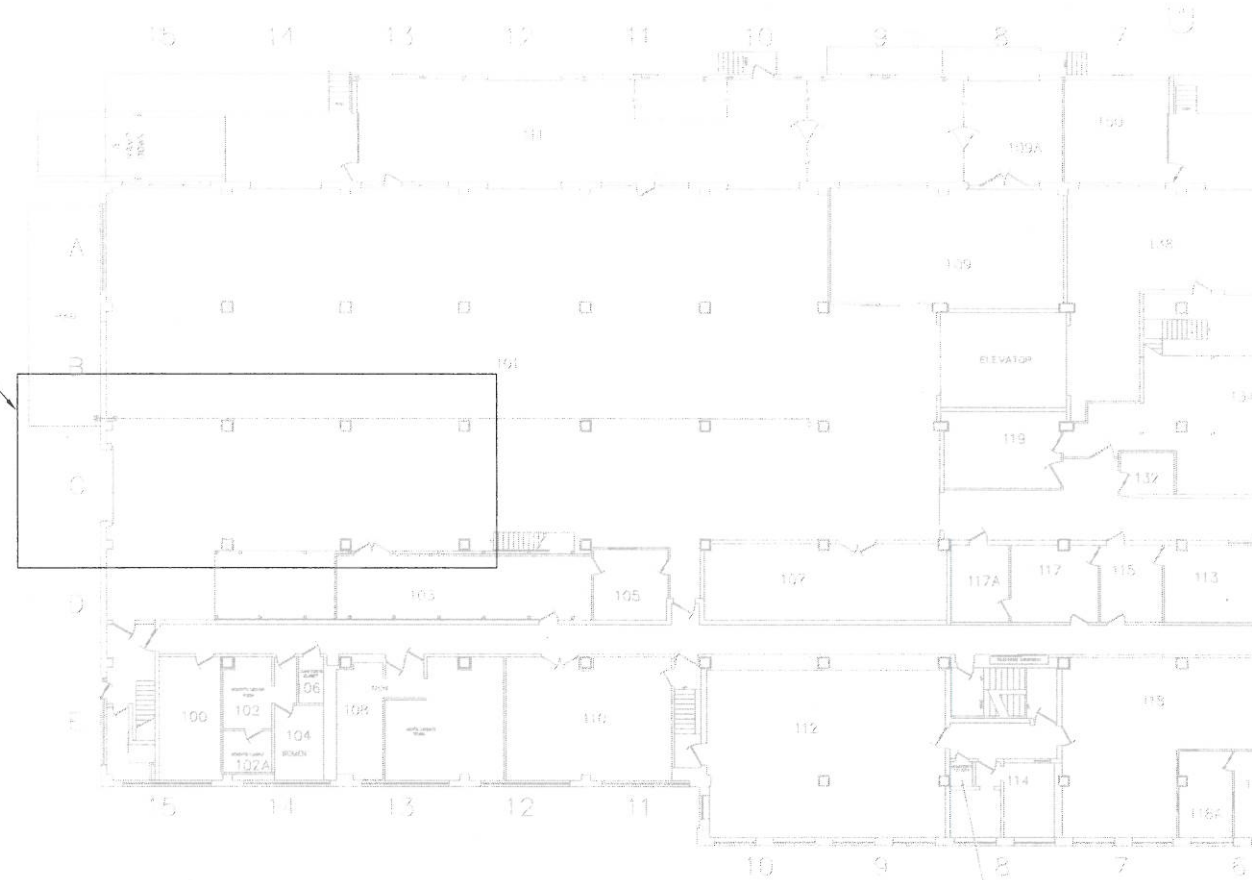
BUILDING 120 - 1ST FLOOR

As indicated in Section 3.3, a Type C SSDS was used for Building 120. As shown in the as-built drawings, two extraction wells (SSDS-B120-1 and SSDS-B120-2) are located in the southwest corner of the building. Based on the pilot test results, SSDS-B120-1 had a ROI of approximately 27 feet at a flow rate of approximately 140 cfm (Malcolm Pirnie, 2009). Following installation of the system, SSDS-B120-1 had a ROI of approximately 23 feet and SSDS-B120-2 had a ROI of approximately 32 feet. The flow rate measured at each extraction well during the startup testing was 32 cfm.

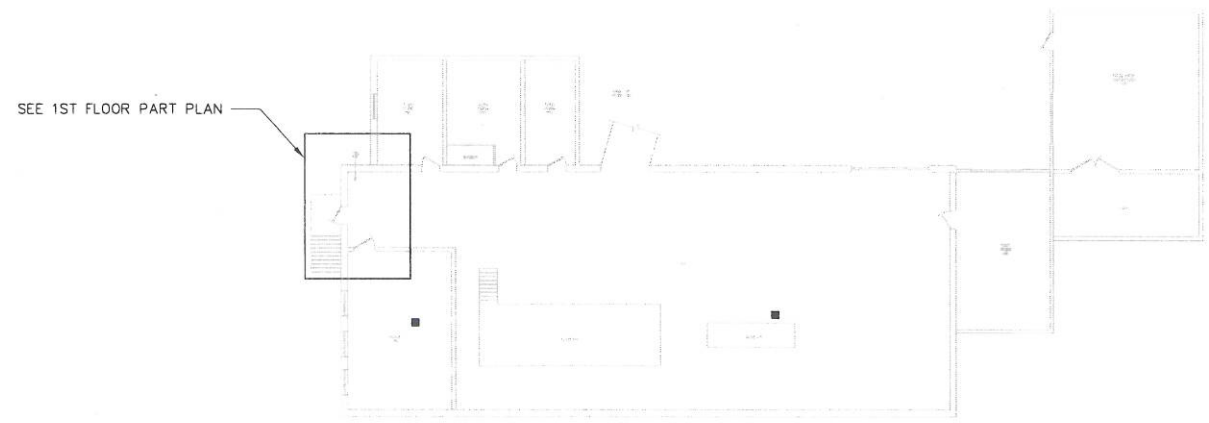
BUILDING 121 - 1ST FLOOR

As indicated in Section 3.3, a Type C SSDS was used for Building 121. As shown in the as-built drawings, extraction well SSDS-B121-1 is located in the southwest corner of the building. Based on the pilot test results, SSDS-B120-1 had a ROI of approximately 45 feet at a flow rate of approximately 120 cfm (Malcolm Pirnie, 2009). Following installation of the system, startup testing measurements confirmed a ROI greater than 45 feet at a flow of 65 cfm.

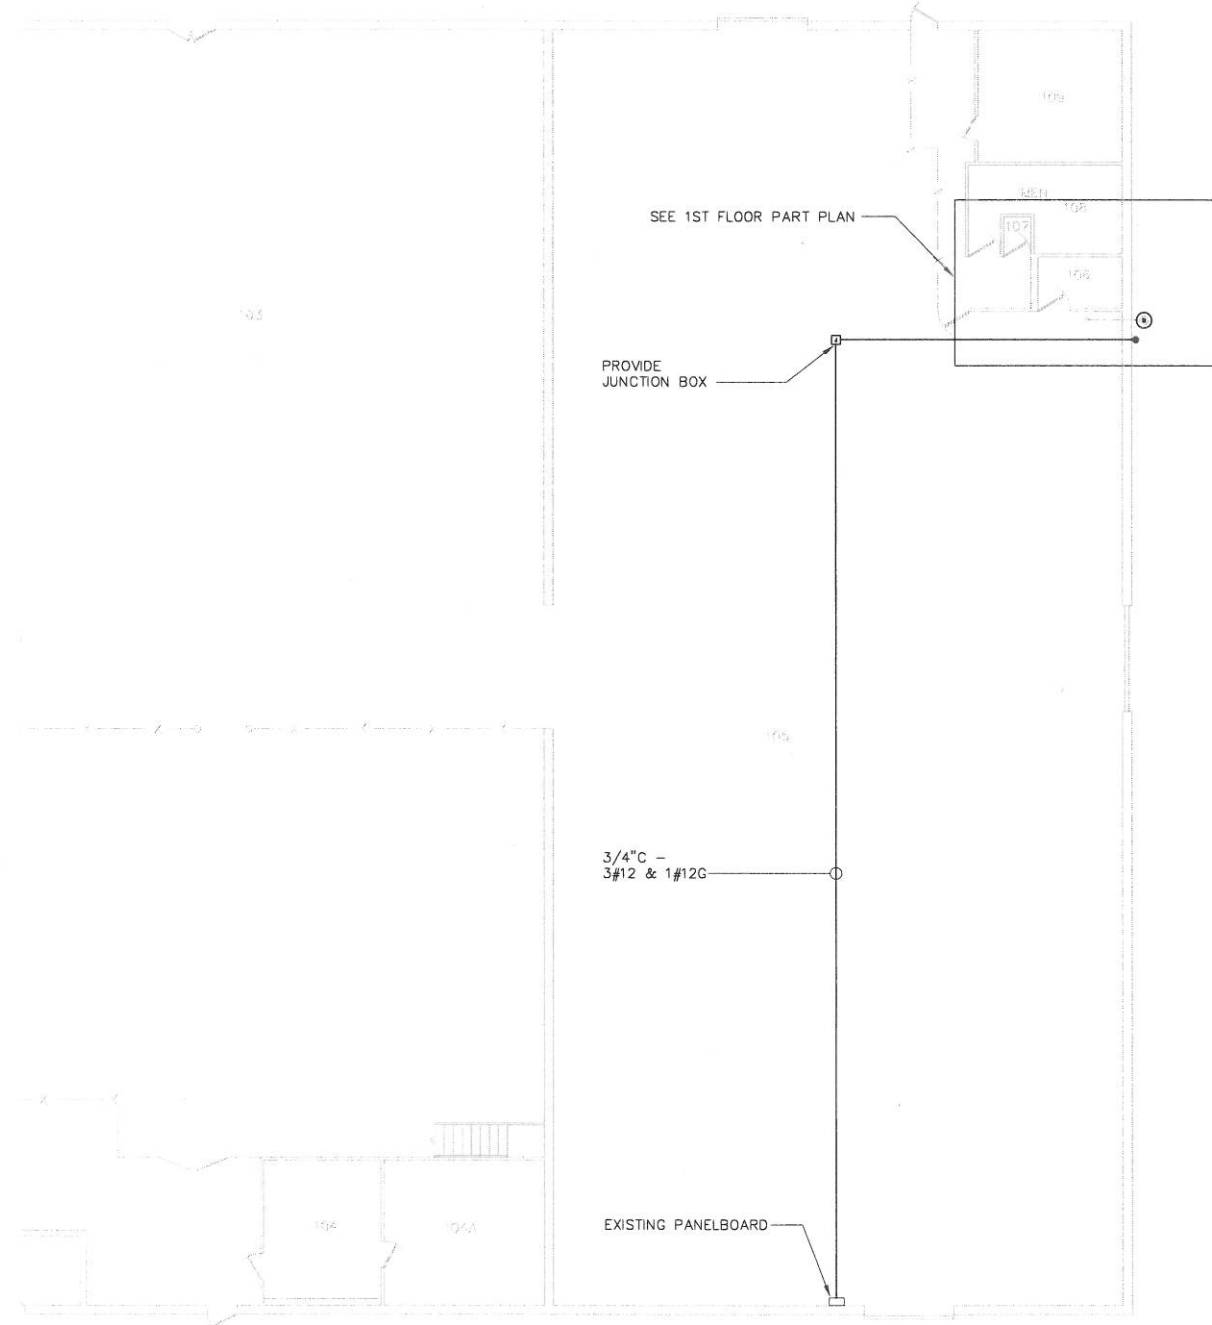
BUILDING 130 - 1ST FLOOR

As indicated in Section 3.3, a Type C SSDS was used for Building 130. As shown in the as-built drawings, extraction well SSDS-B130-EW1 is located in the northwestern corner of the building. Based on the pilot test results, SSDS-B130-EW1 had a ROI of approximately 25 feet at a flow rate of approximately 160 cfm (Malcolm Pirnie, 2009). Following installation of the system, startup testing measurements confirmed a ROI greater than 25 feet at a flow of 51 cfm.

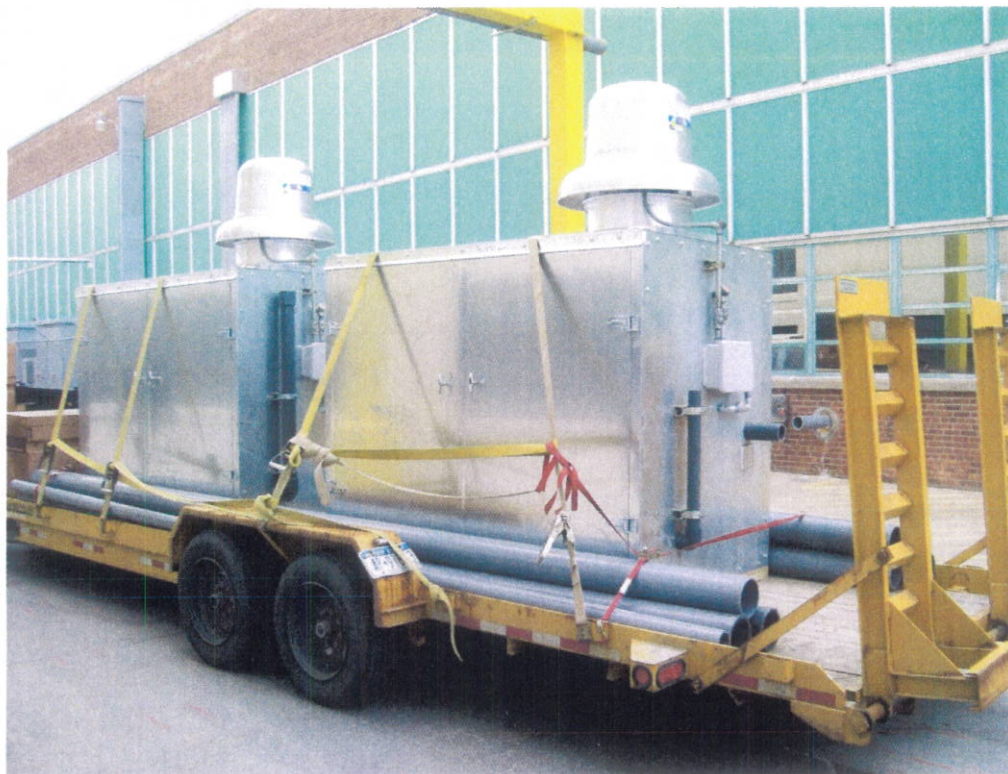
Photograph 1. Type A SSDSs being delivered to site.

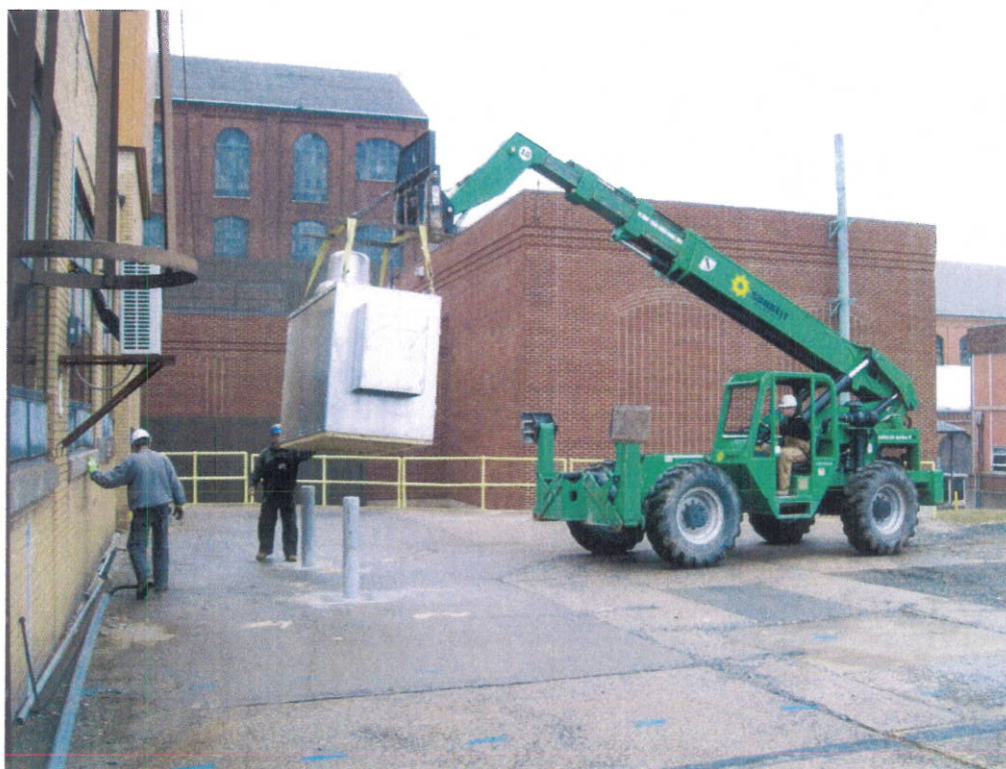
Photograph 2. Positioning Type A SSDS enclosure at Building 114.

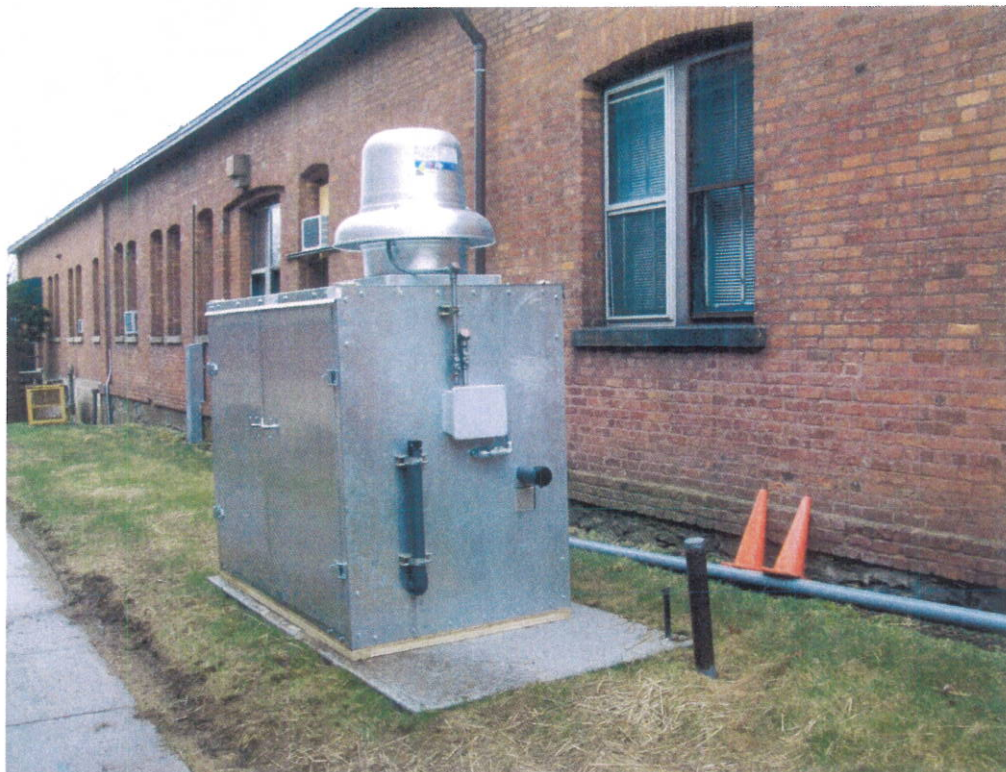
Photograph 3. Initial placement of Type A SSDS at Building 21.

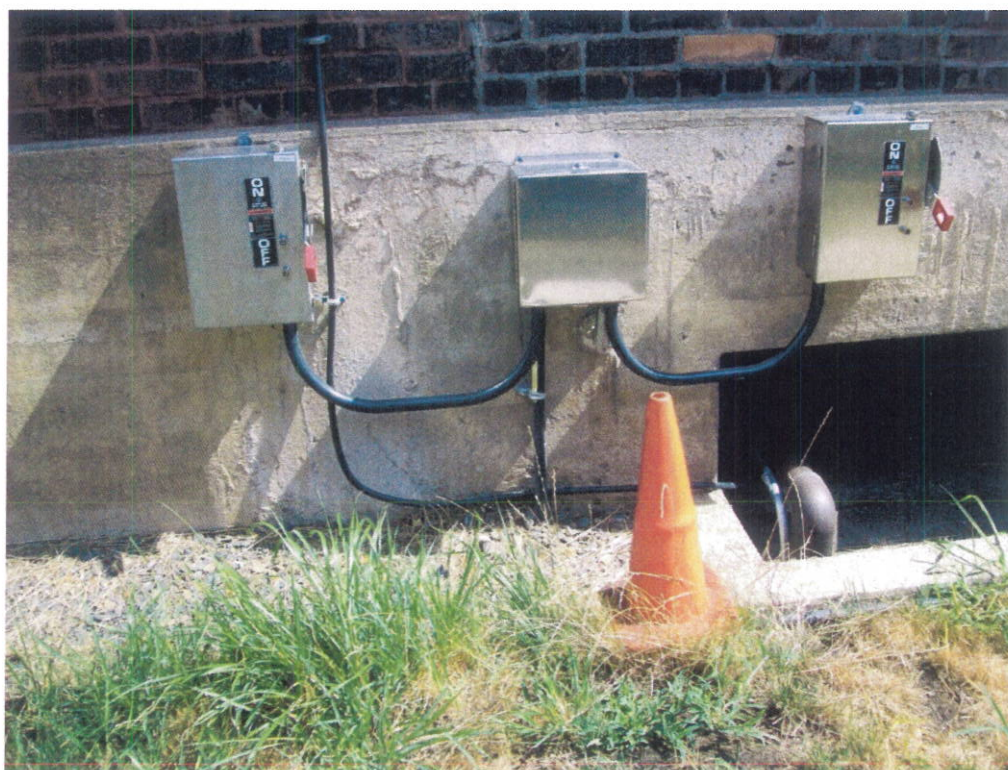
Photograph 4. Disconnect switches for Building 21 Type A SSDS.

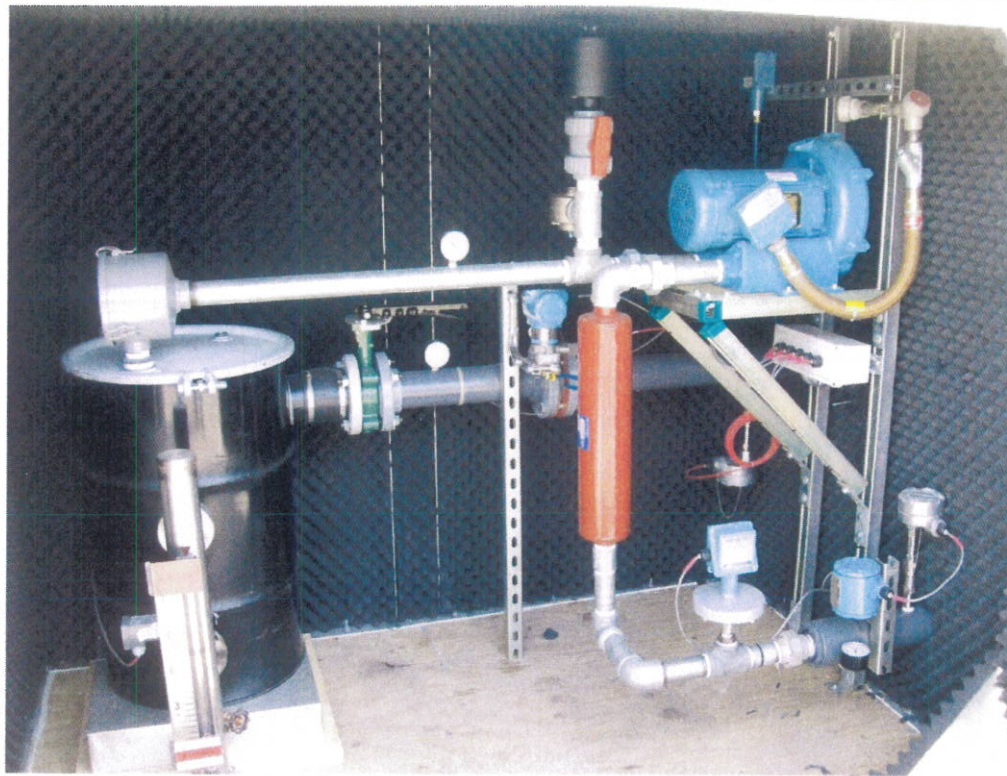
Photograph 3. Type A SSDS enclosure contents (Building 114).

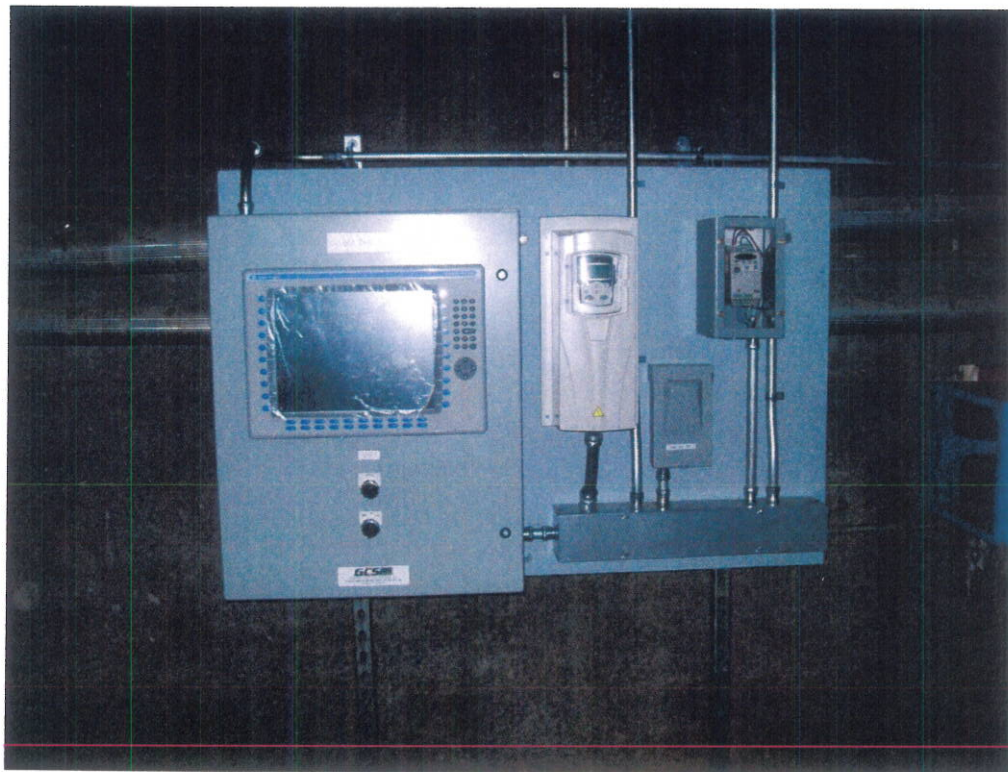
Photograph 4. Remote-mount control panel for Type A SSDS (Building 21 installation shown).

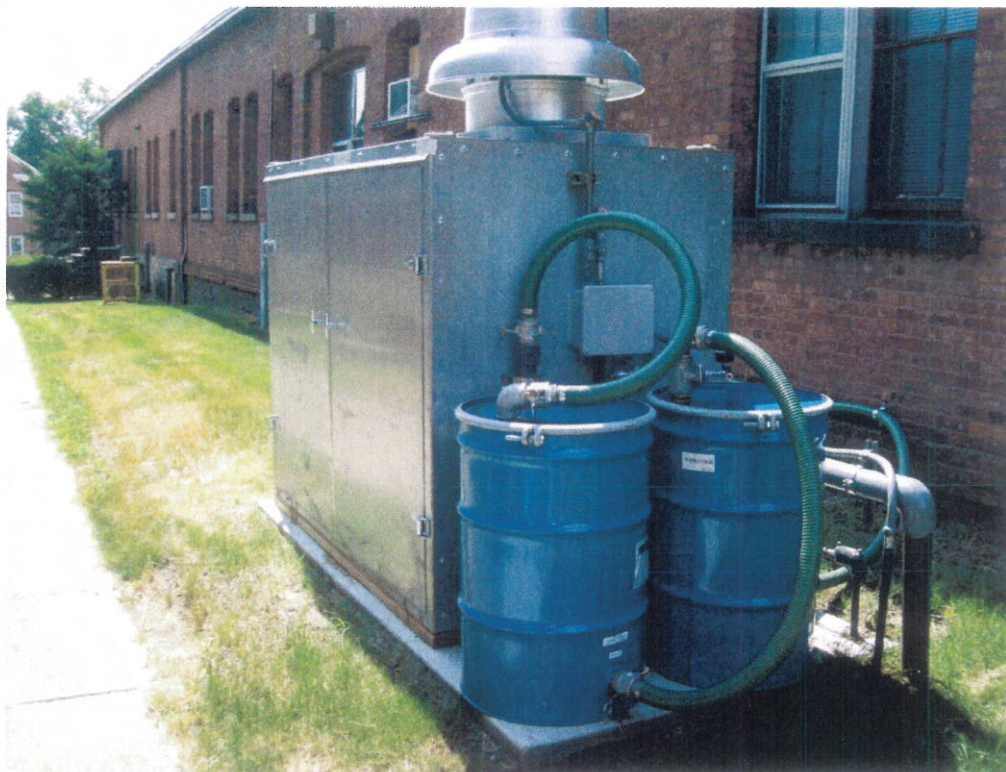
Photograph 5. Completed Building 21 Type A SSDS.

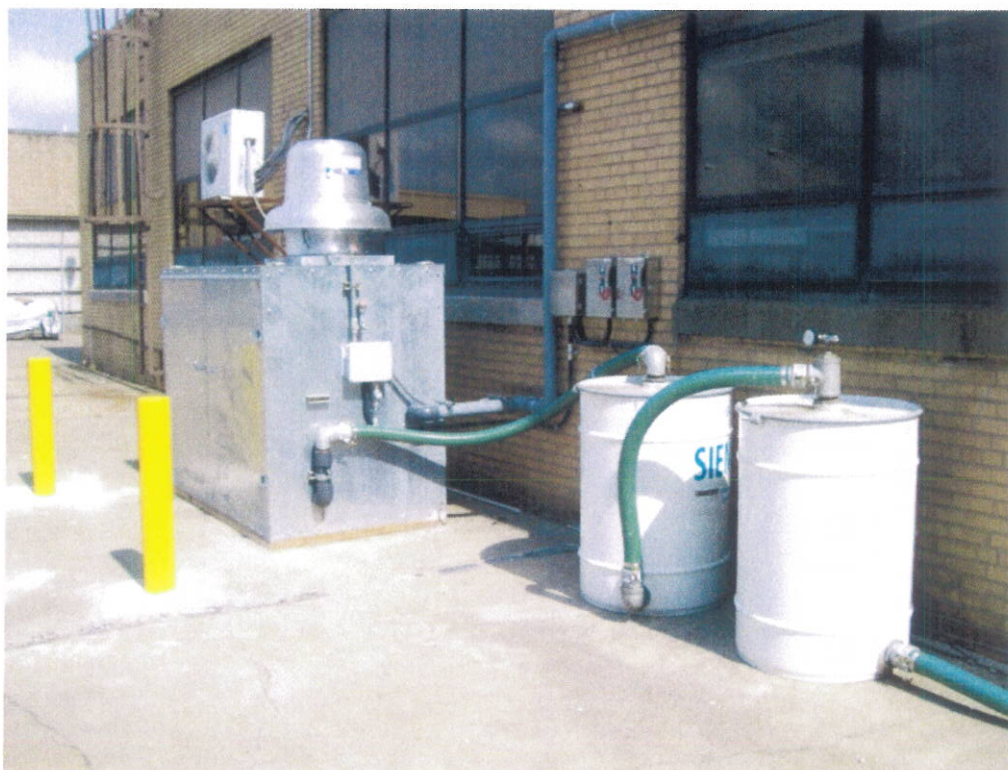
Photograph 6. Completed Building 114 Type A SSDS.

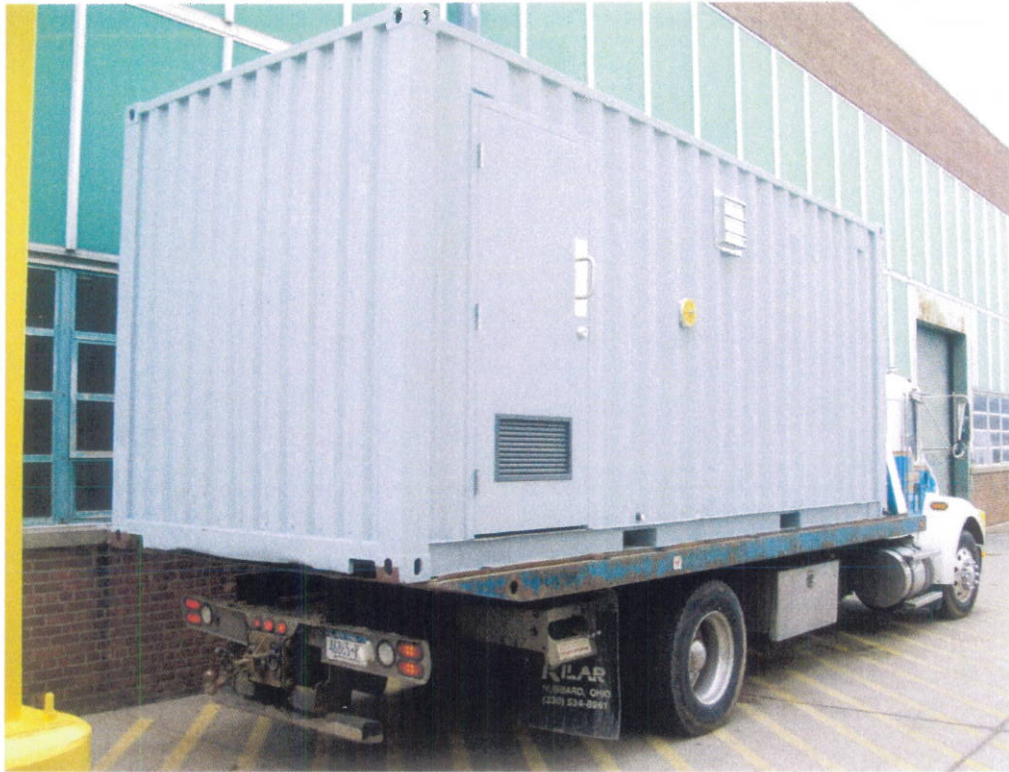
Photograph 7. Delivery truck with Type B SSDS.

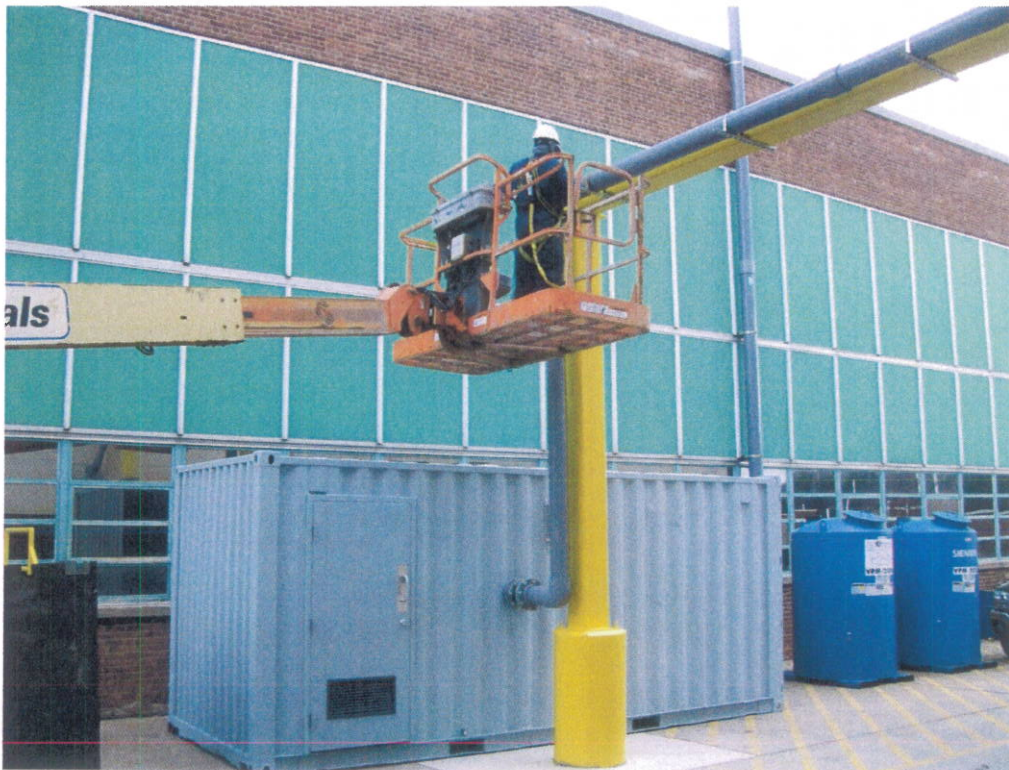
Photograph 8. Securing Building 25 suction line to pipe bridge. Type B SSDS and carbon vessels in background.

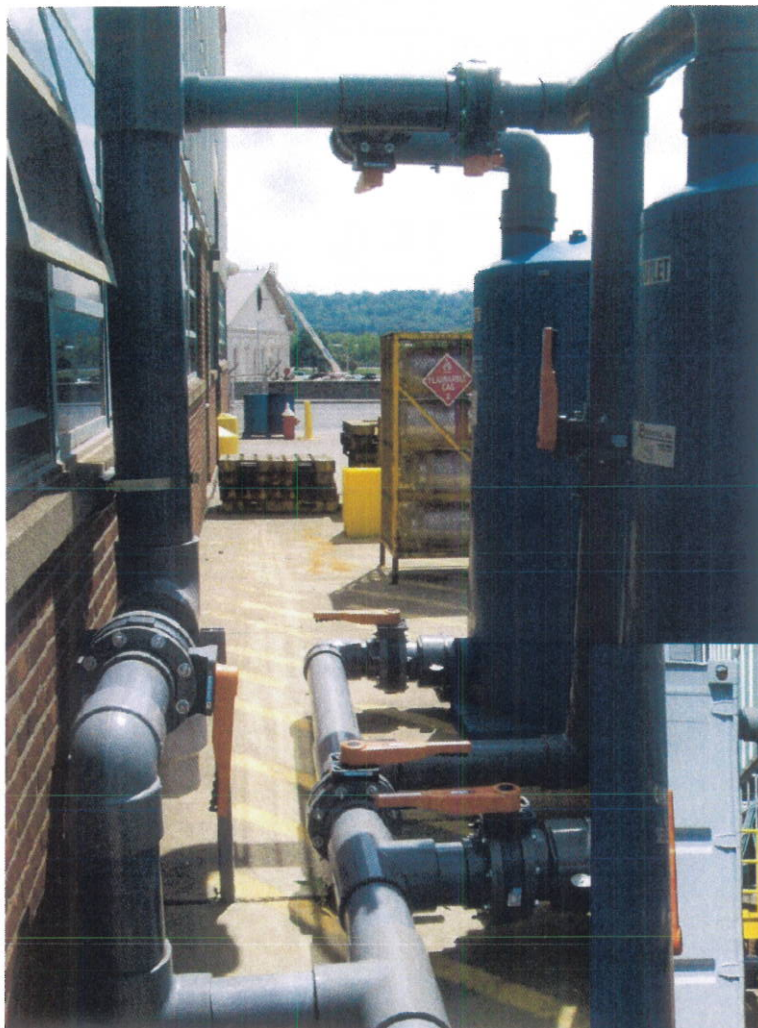
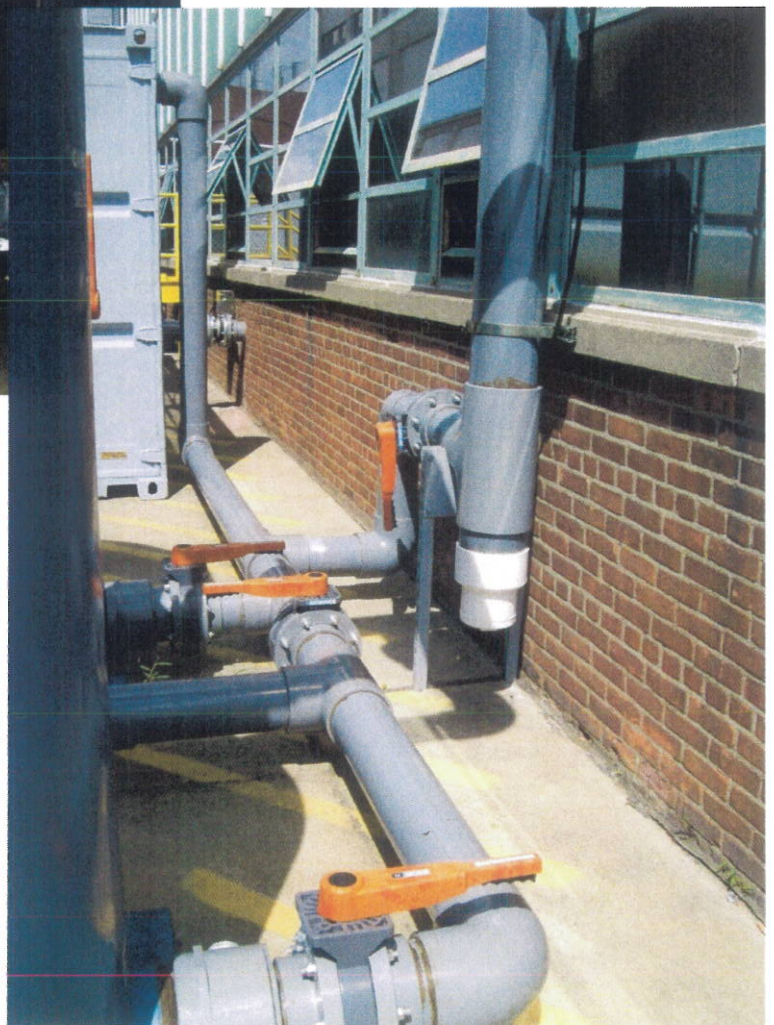
Photographs 9 and 10. Building 20/25 Type B SSDS discharge piping.

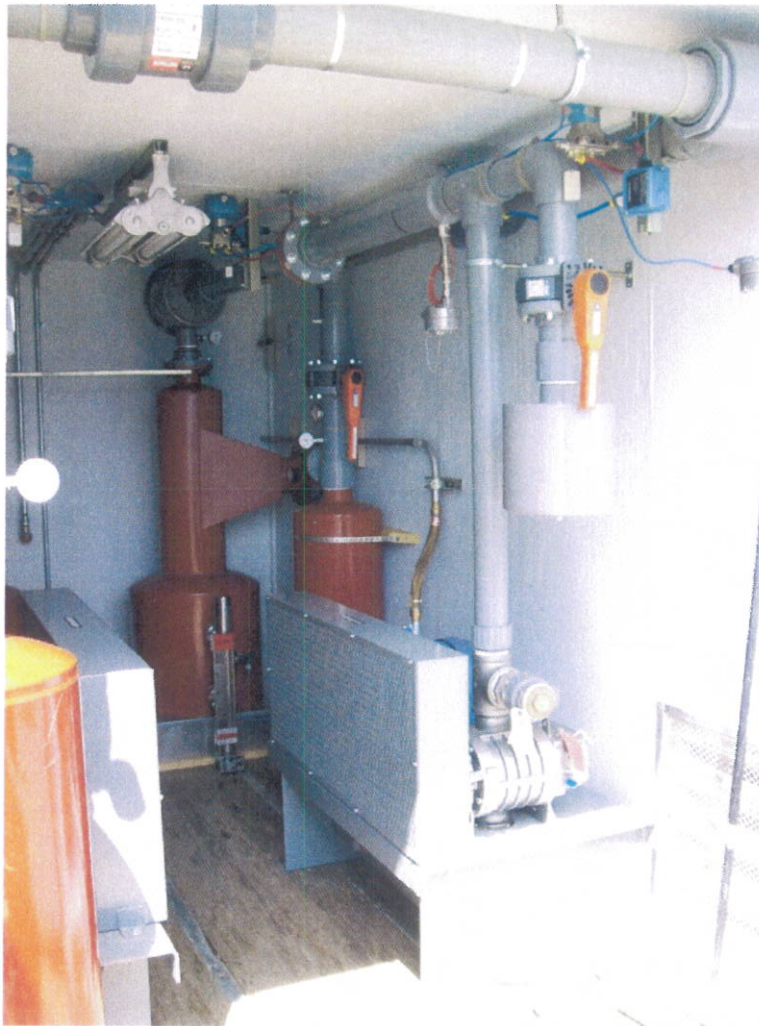
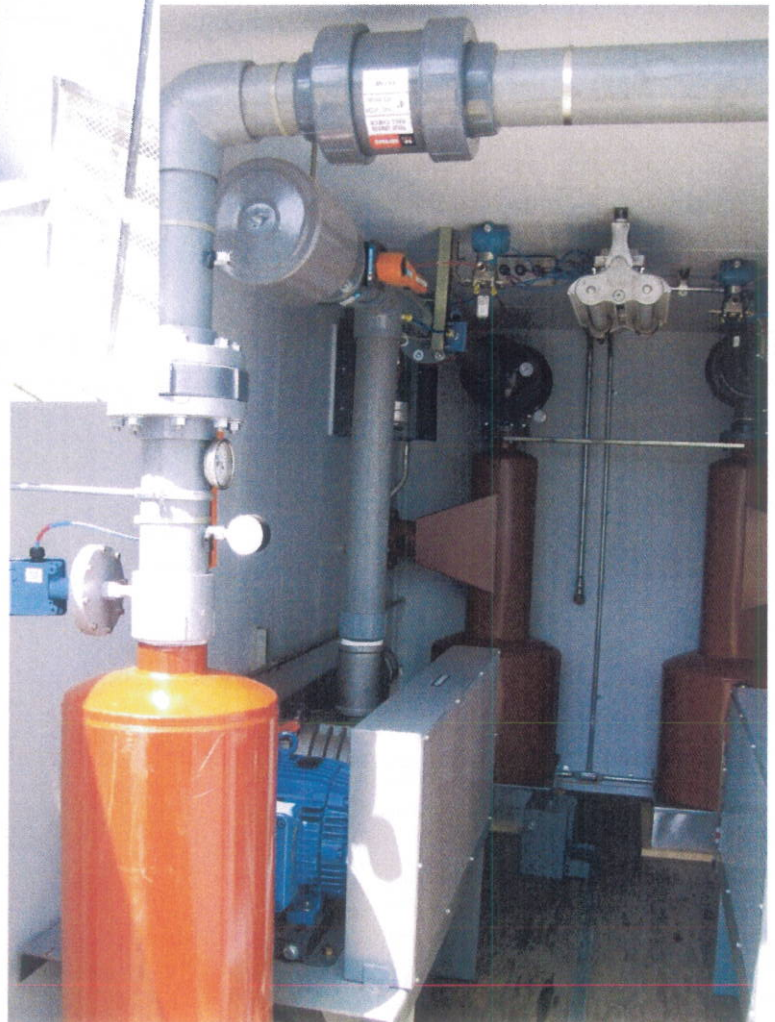
Photographs 11 and 12. Building 20/25 Type B SSDS mechanical room enclosure contents.

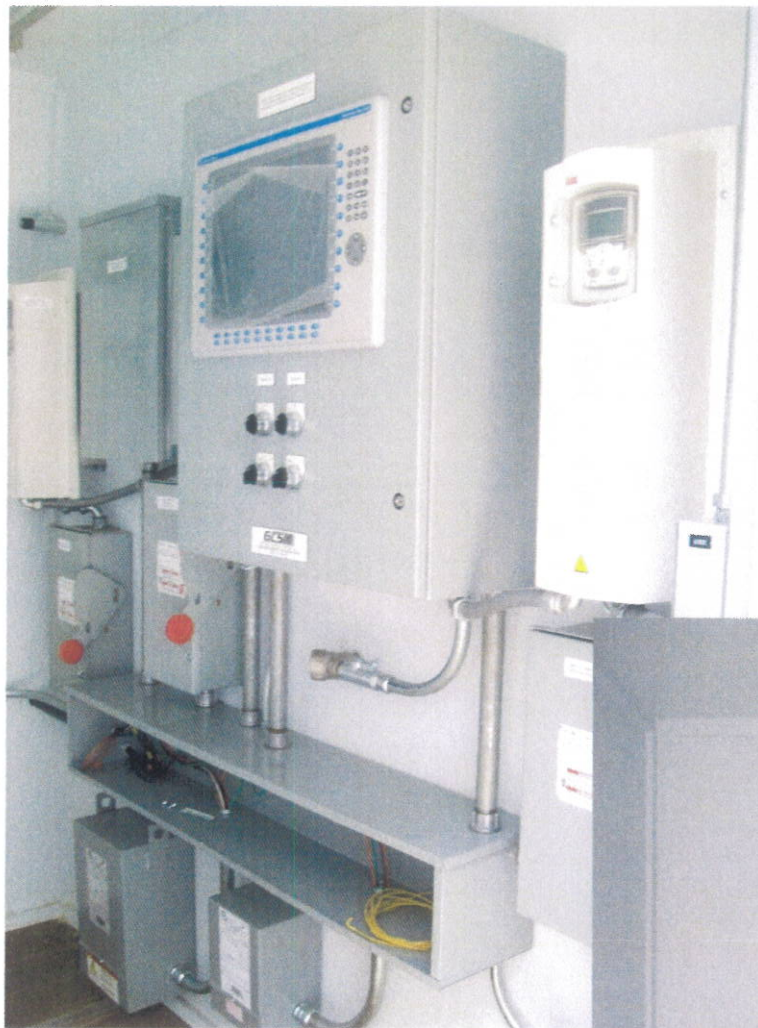
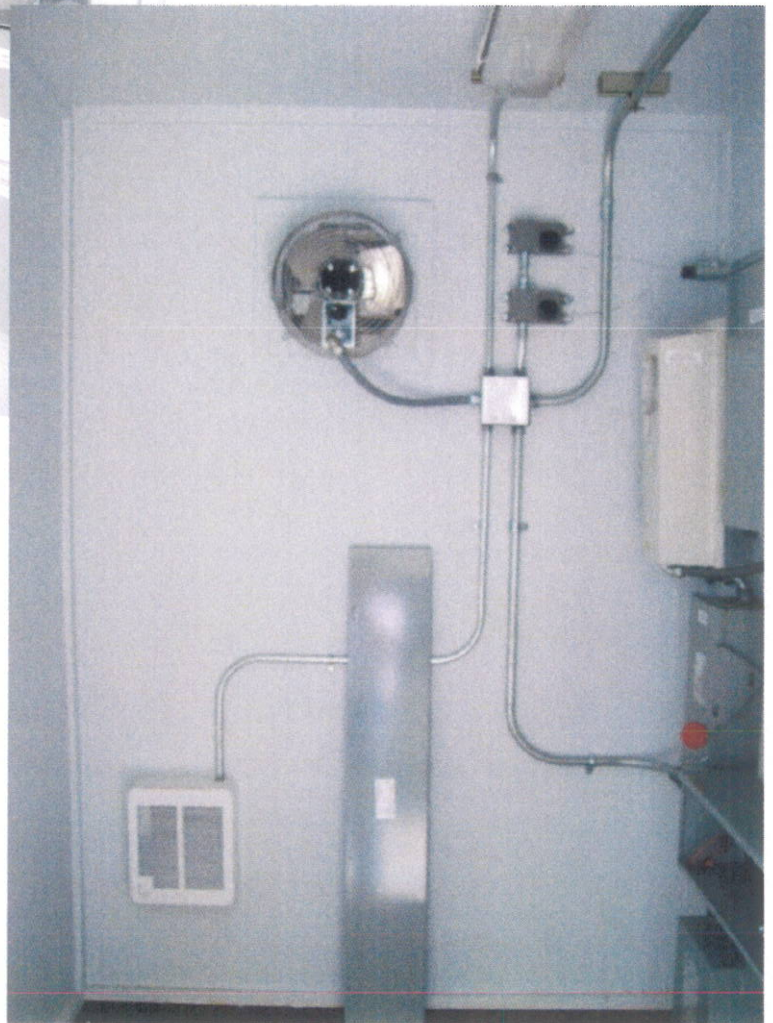
Photographs 13 and 14. Building 20/25 Type B SSDS electrical room enclosure contents.
