## **Watervliet Arsenal**

# **Focused Corrective Measures Study**

## **Main Manufacturing Area Watervliet Arsenal Watervliet, New York**

January 2011

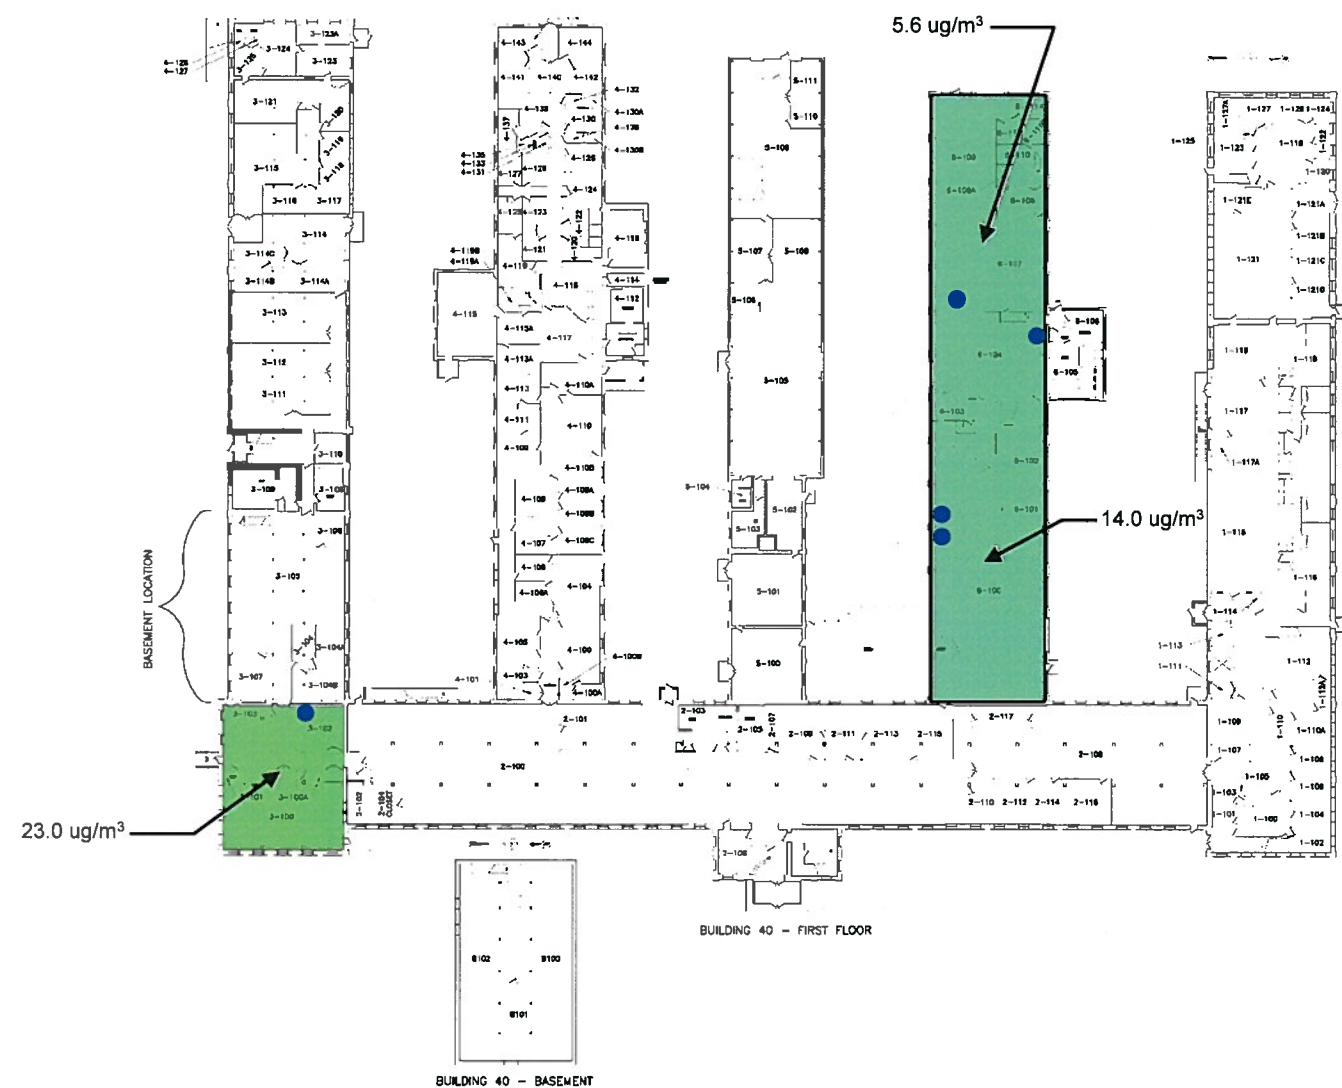
## FIRST FLOOR

- AIR FILTRATION UNIT (DUCT CONNECTIONS NOT SHOWN)
- AREA OF CONCERN
- 23.0 ug/m<sup>3</sup> MAXIMUM DETECTED INDOOR AIR TCE CONCENTRATION DURING INVESTIGATIONS
