Construction Certification Report

Vapor Intrusion Interim Corrective Measures

Main Manufacturing Area Watervliet Arsenal Watervliet New York

September 2010

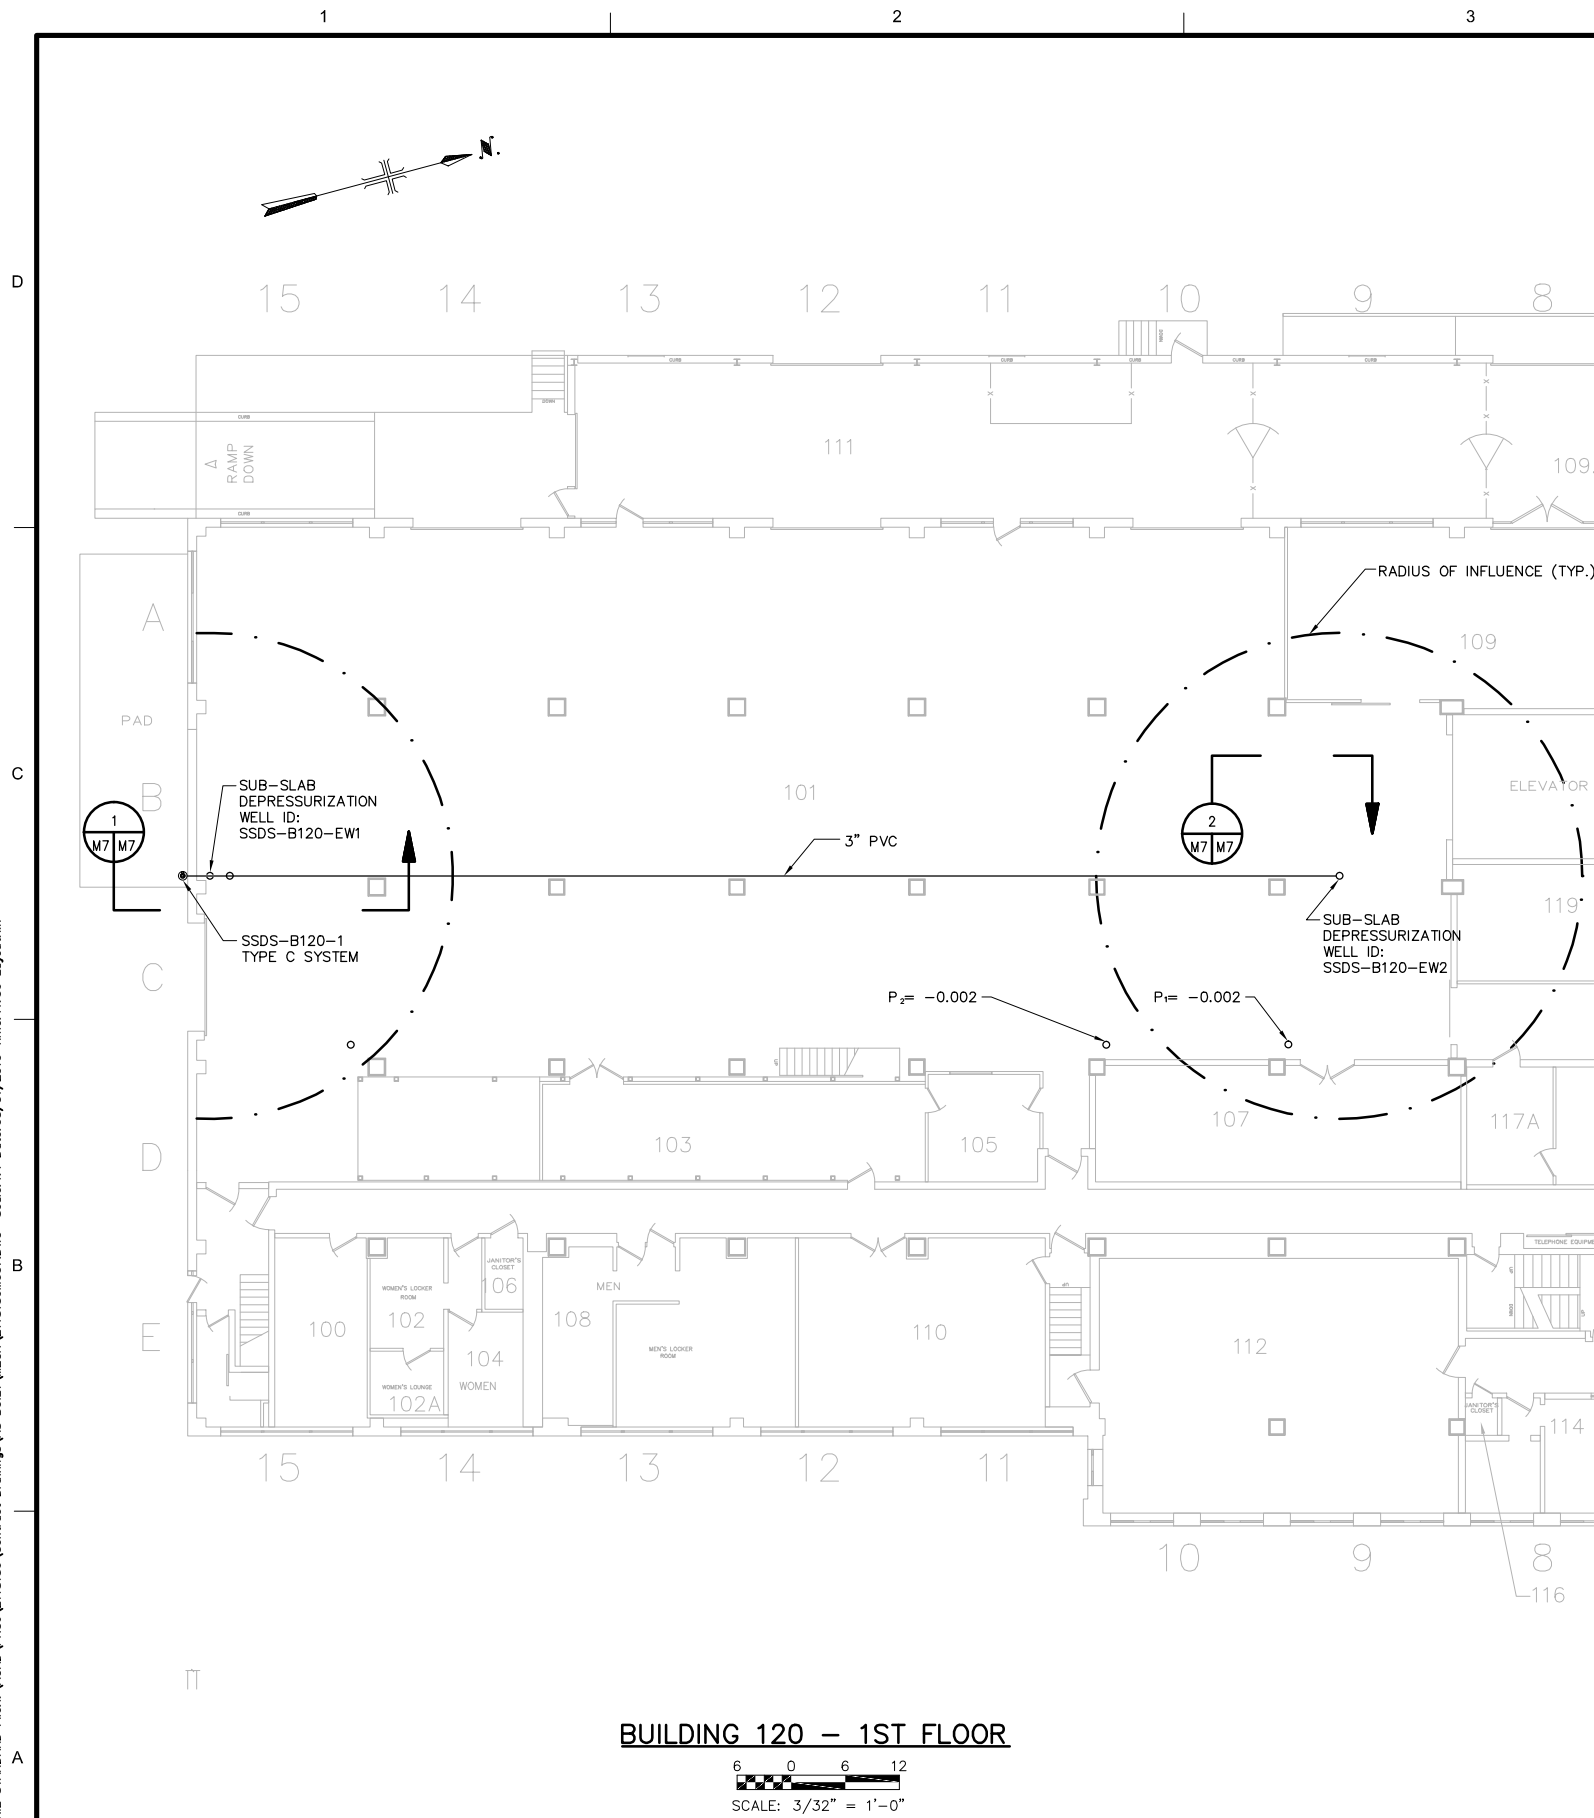
BUILDING 120 - 1ST FLOOR

As indicated in Section 3.3, a Type C SSDS was used for Building 120. As shown in the as-built drawings, two extraction wells (SSDS-B120-1 and SSDS-B120-2) are located in the southwest corner of the building. Based on the pilot test results, SSDS-B120-1 had a ROI of approximately 27 feet at a flow rate of approximately 140 cfm (Malcolm Pirnie, 2009). Following installation of the system, SSDS-B120-1 had a ROI of approximately 23 feet and SSDS-B120-2 had a ROI of approximately 32 feet. The flow rate measured at each extraction well during the startup testing was 32 cfm.

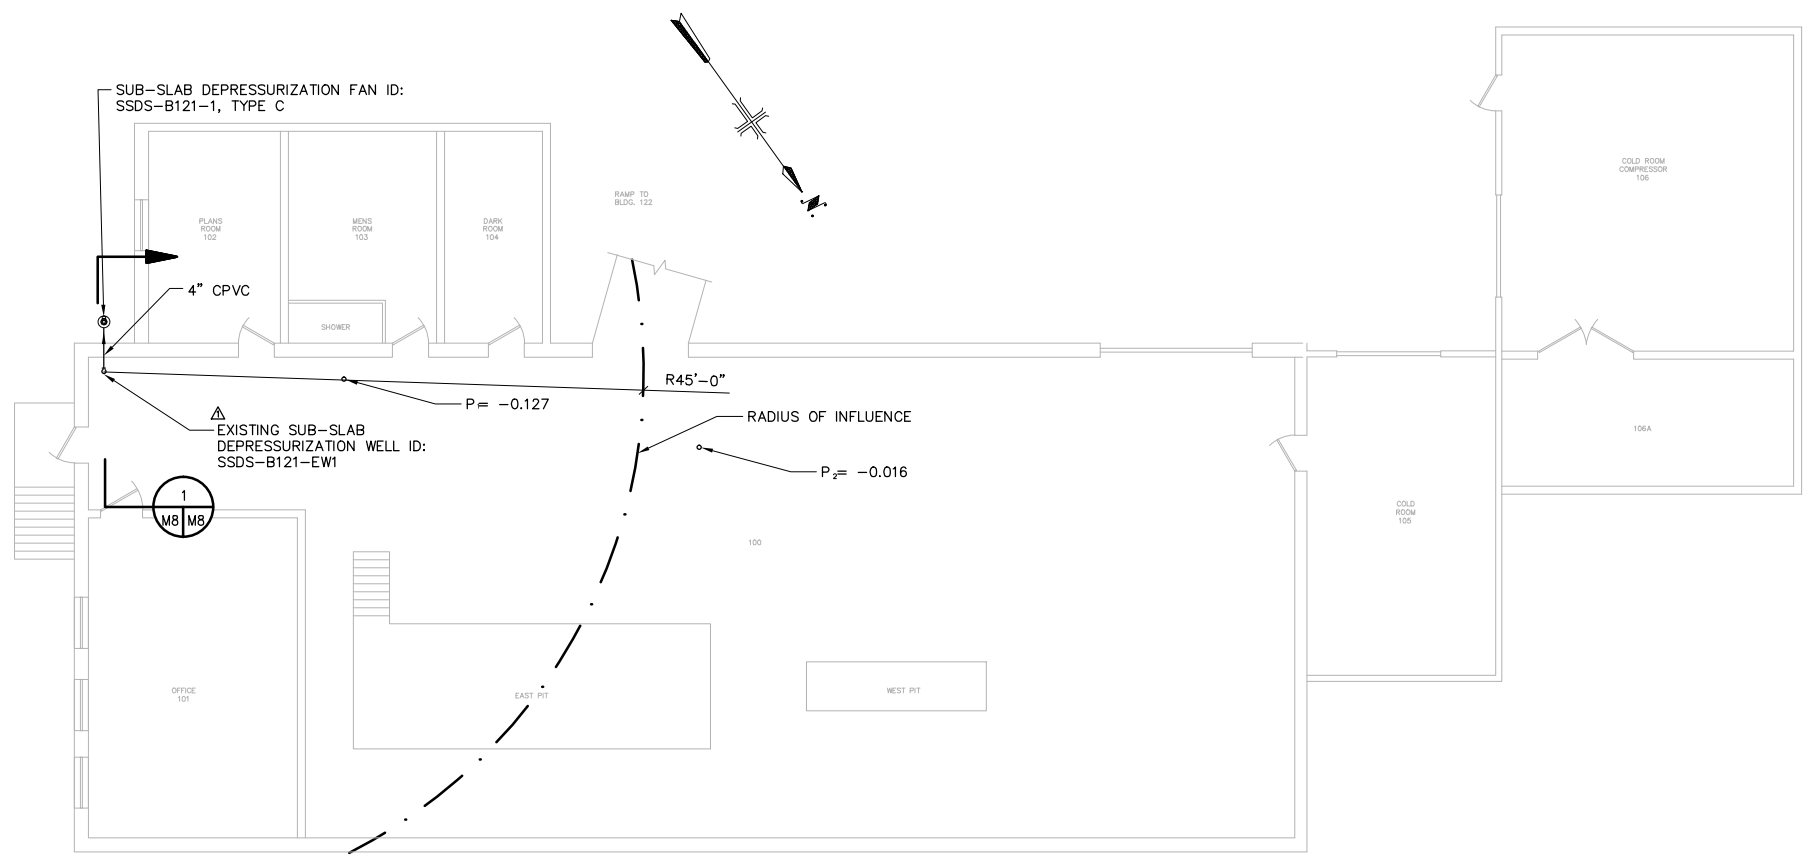
BUILDING 121 - 1ST FLOOR

As indicated in Section 3.3, a Type C SSDS was used for Building 121. As shown in the as-built drawings, extraction well SSDS-B121-1 is located in the southwest corner of the building. Based on the pilot test results, SSDS-B120-1 had a ROI of approximately 45 feet at a flow rate of approximately 120 cfm (Malcolm Pirnie, 2009). Following installation of the system, startup testing measurements confirmed a ROI greater than 45 feet at a flow of 65 cfm.

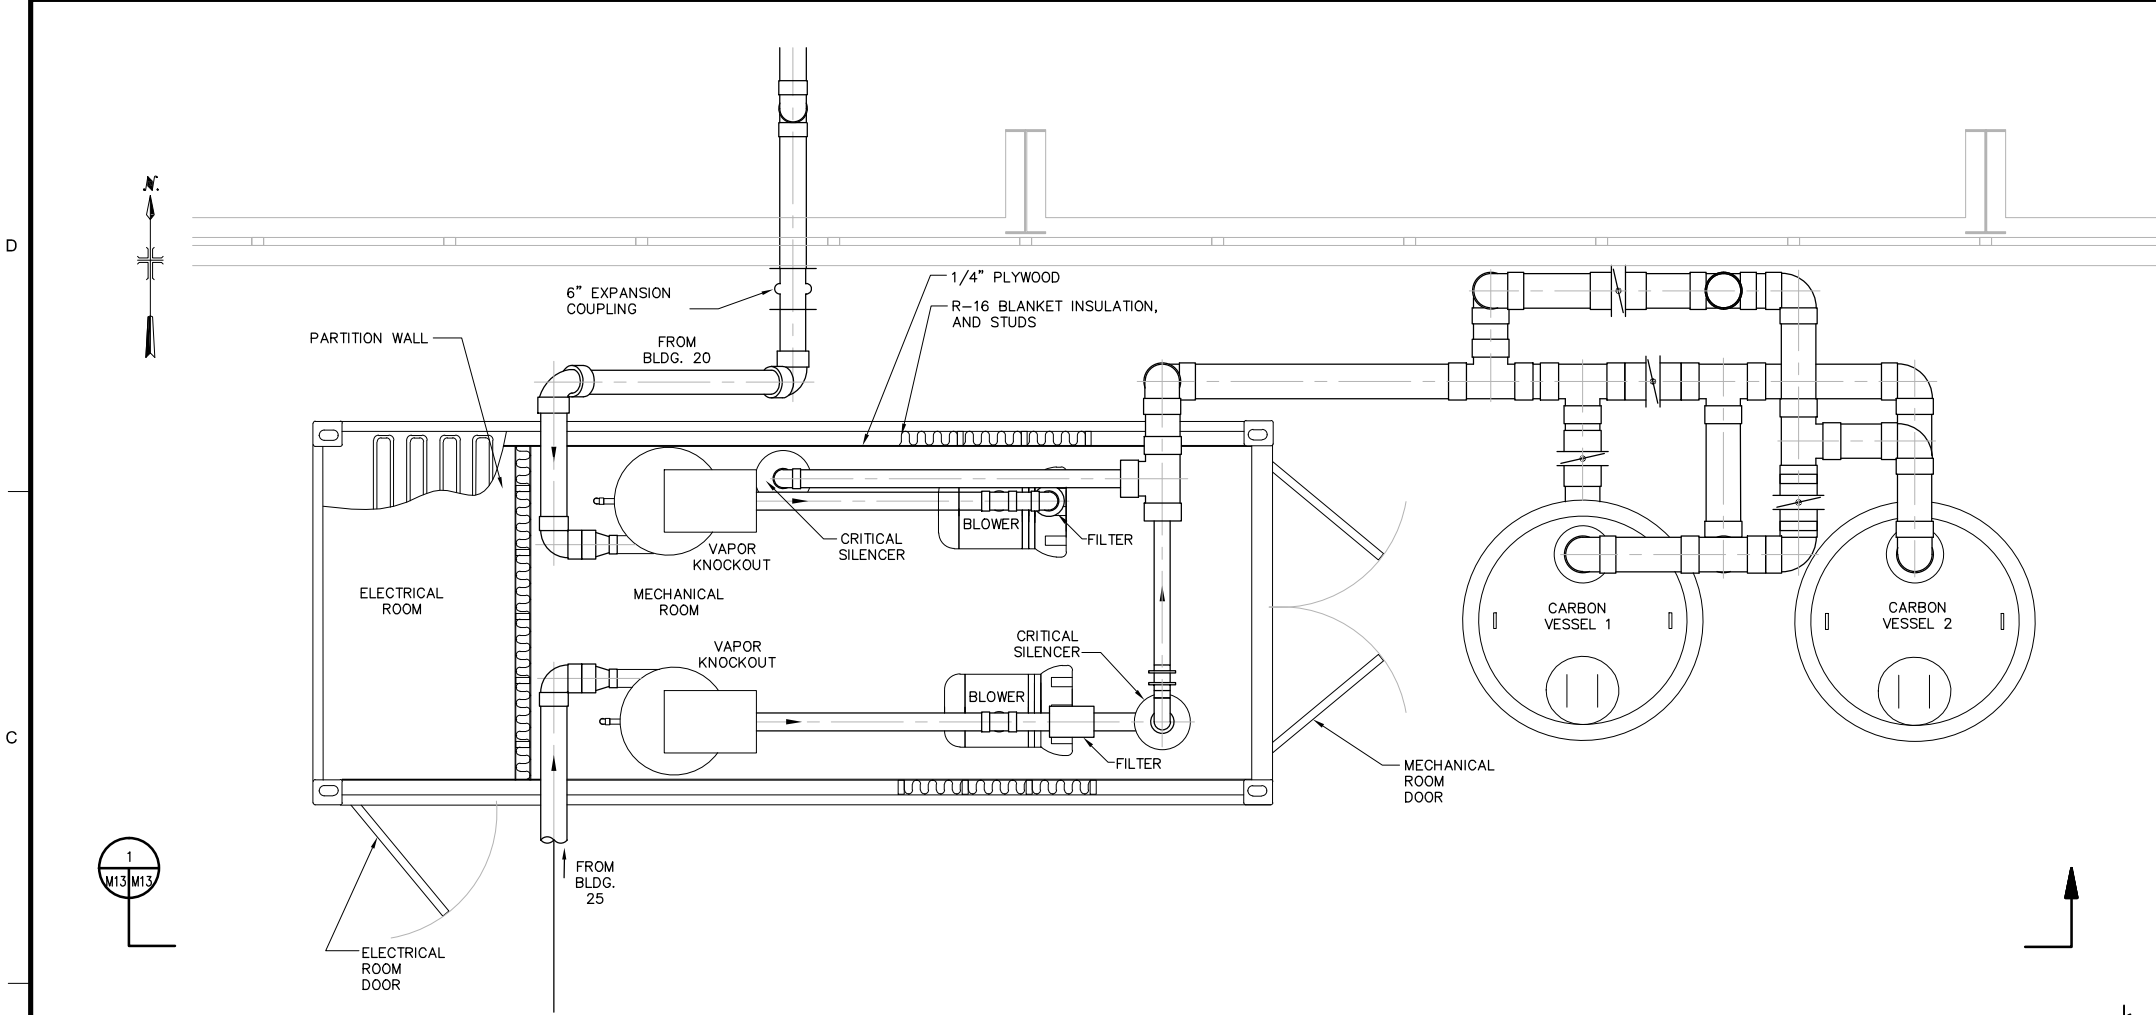
**BUILDING 20 AND 25
SSD SYSTEM PLAN VIEW**

- Two positive-displacement blowers equipped with variable-speed drives with a design flow rate of 360 cfm for Building 20 and 450 cfm for Building 25;
- Control panel with alarms and automatic shutdown capability;
- Electrical room with panels;
- PLC with telemetry transmission;
- Vapor Knockout Tanks;
- Critical Silencers;
- Air intake louver and dilution controls;
- Two 2,000-pound GAC vessels, in-series;
- Vacuum/pressure gauges and sampling ports; and
- Environmental controls, including thermostat, heating, exhaust fan, and lighting.

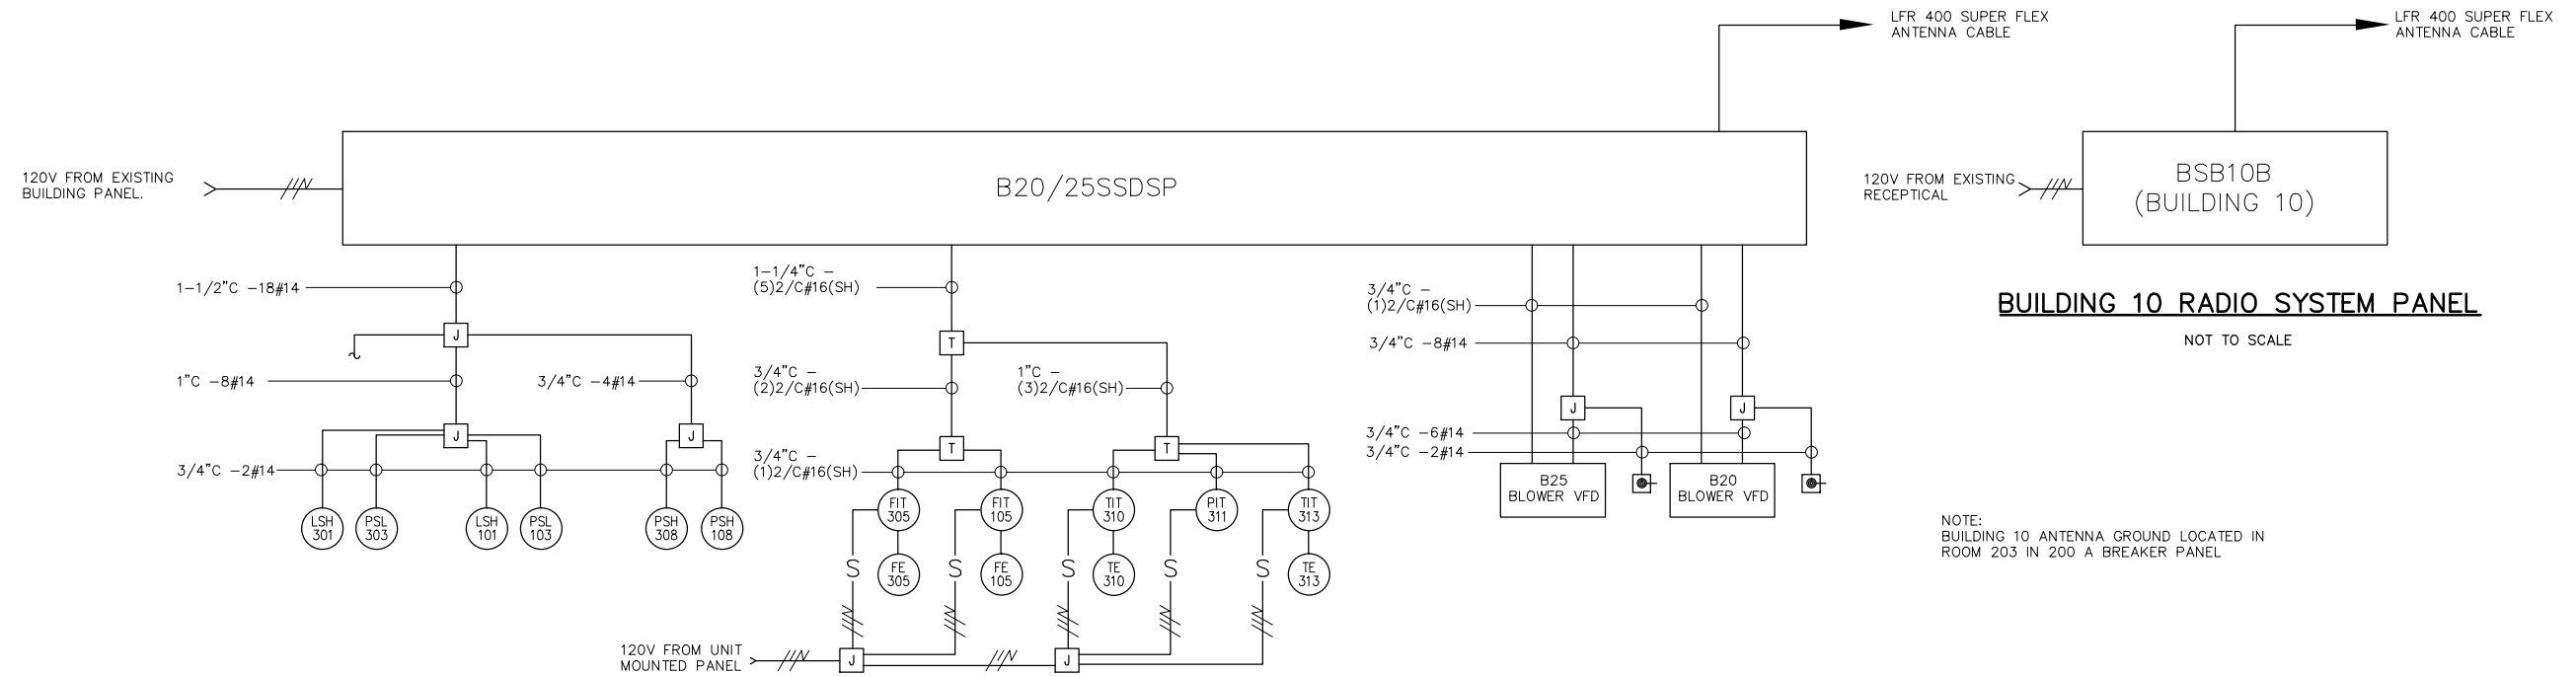
TYPE B SSDS SYSTEM BLOCK DIAGRAM

As indicated in Sections 3.2 and 3.3, the Type A and Type B SSDSs are controlled by PLCs. Each system has a touch-screen display monitor that provides system status and real-time system pressure and flow data. As shown in the As-built drawings, the control panels for the Type A SSDS are remote-mounted. The control panel for the Building 21 system is located in the basement of the building. The control panel for the Building 114 system is located on the east wall in Room 102. The As-built drawings show that a single display panel for the Building 20/25 Type B SSDS is located in the electrical room of the system enclosure.

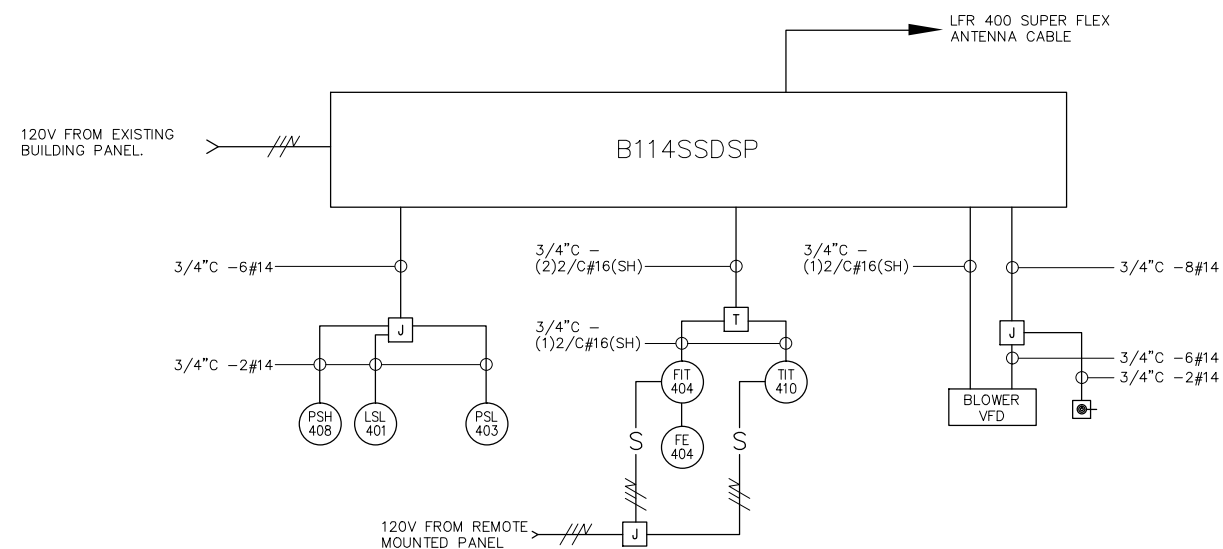
TYPE A SSDS SYSTEM BLOCK DIAGRAM

NOTE:
SSDS-B114-1 TYPE "A" SYSTEM SHOWN IS TYPICAL FOR
SSDS-B123-1, SSDS-B21-1 AND SSDS-B15-1 SYSTEMS.

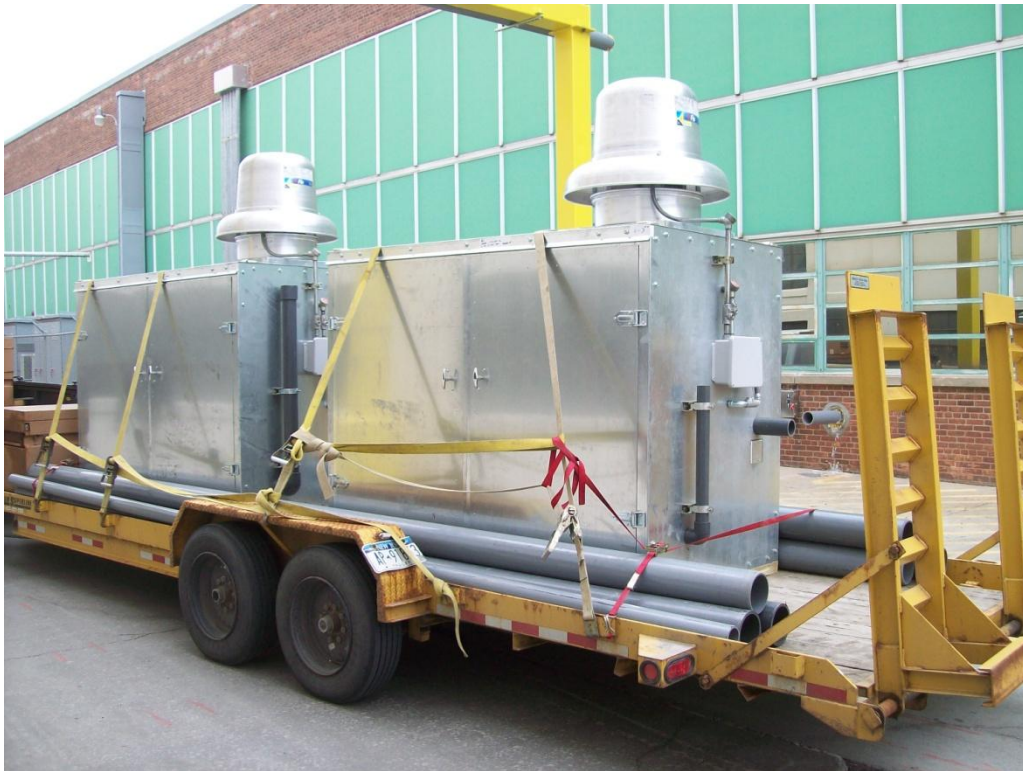
Photograph 1. Type A SSDSs being delivered to site.

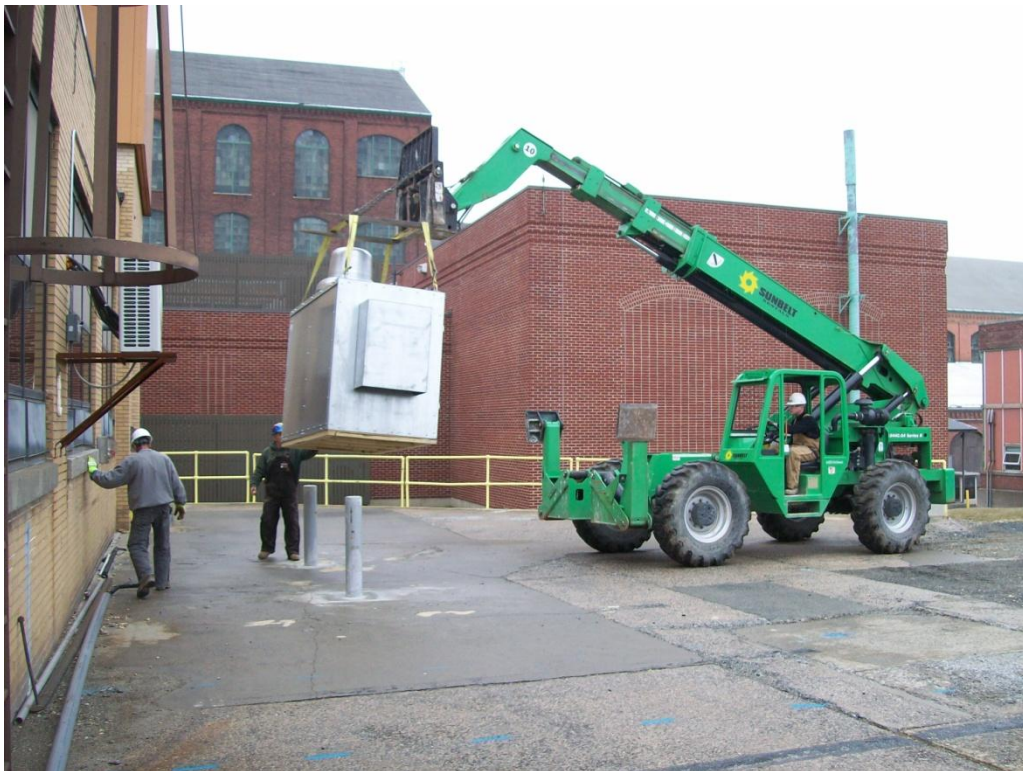
Photograph 2. Positioning Type A SSDS enclosure at Building 114.

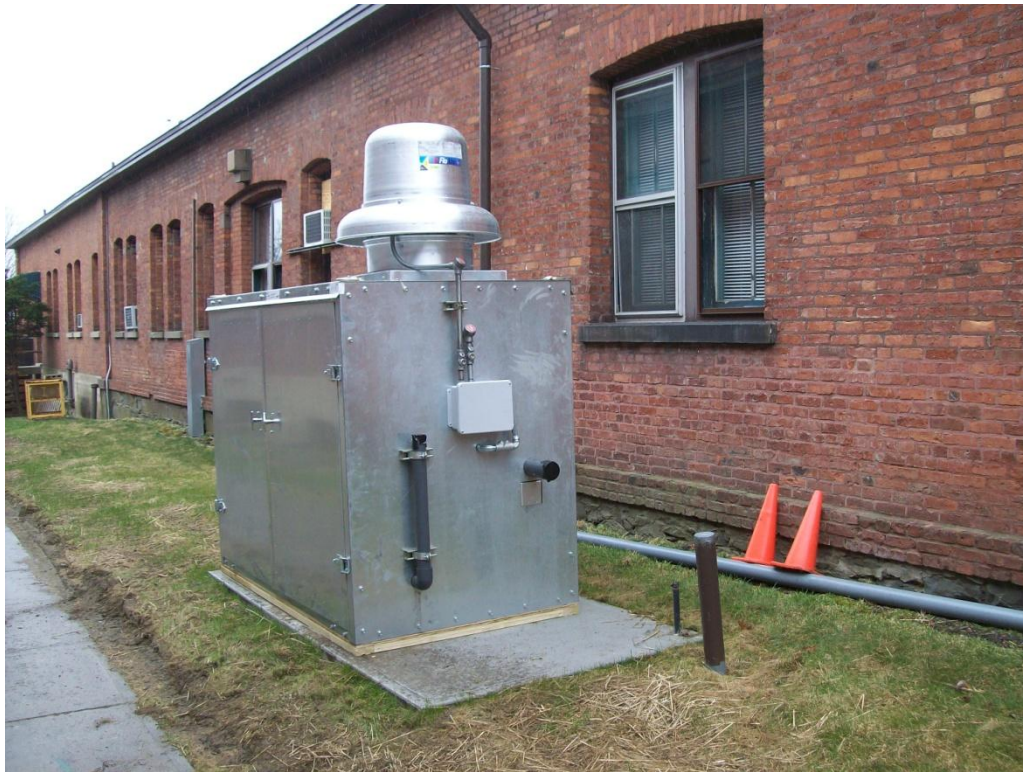
Photograph 3. Initial placement of Type A SSDS at Building 21.

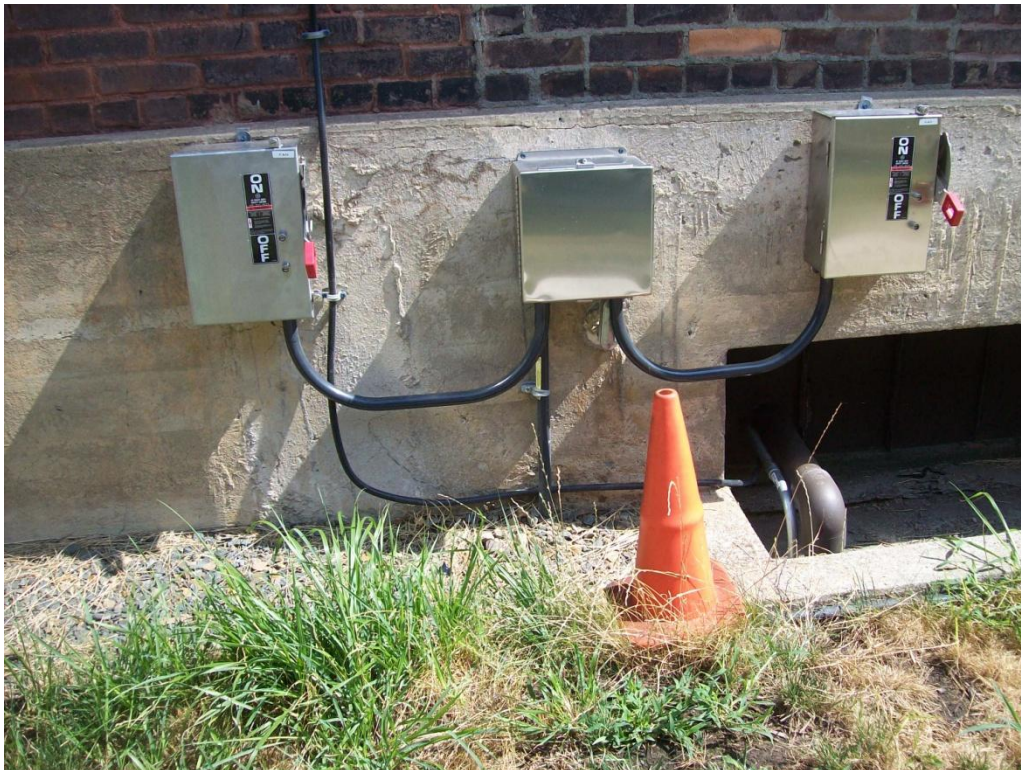
Photograph 4. Disconnect switches for Building 21 Type A SSDS.

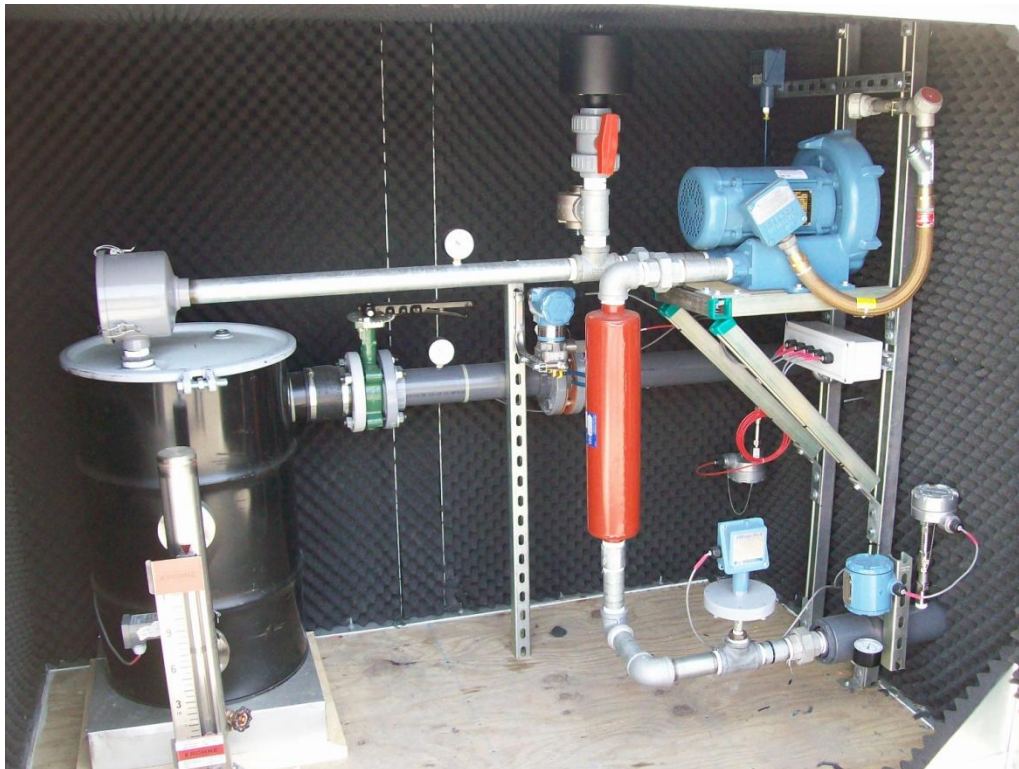
Photograph 3. Type A SSDS enclosure contents (Building 114).

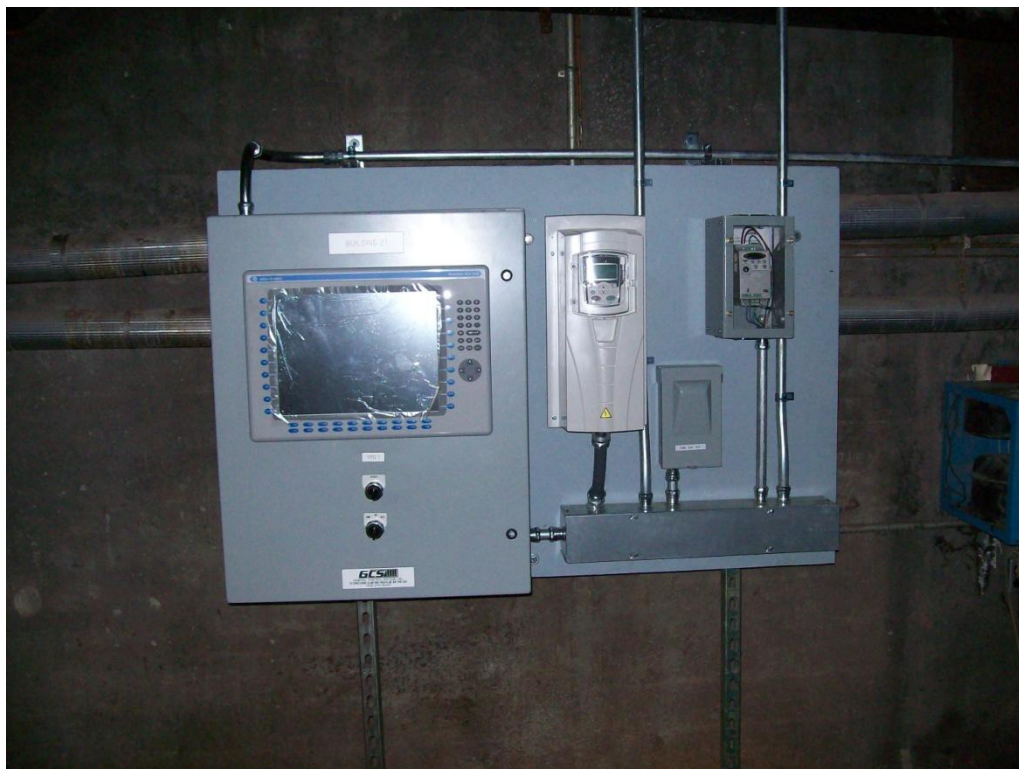
Photograph 4. Remote-mount control panel for Type A SSDS (Building 21 installation shown).

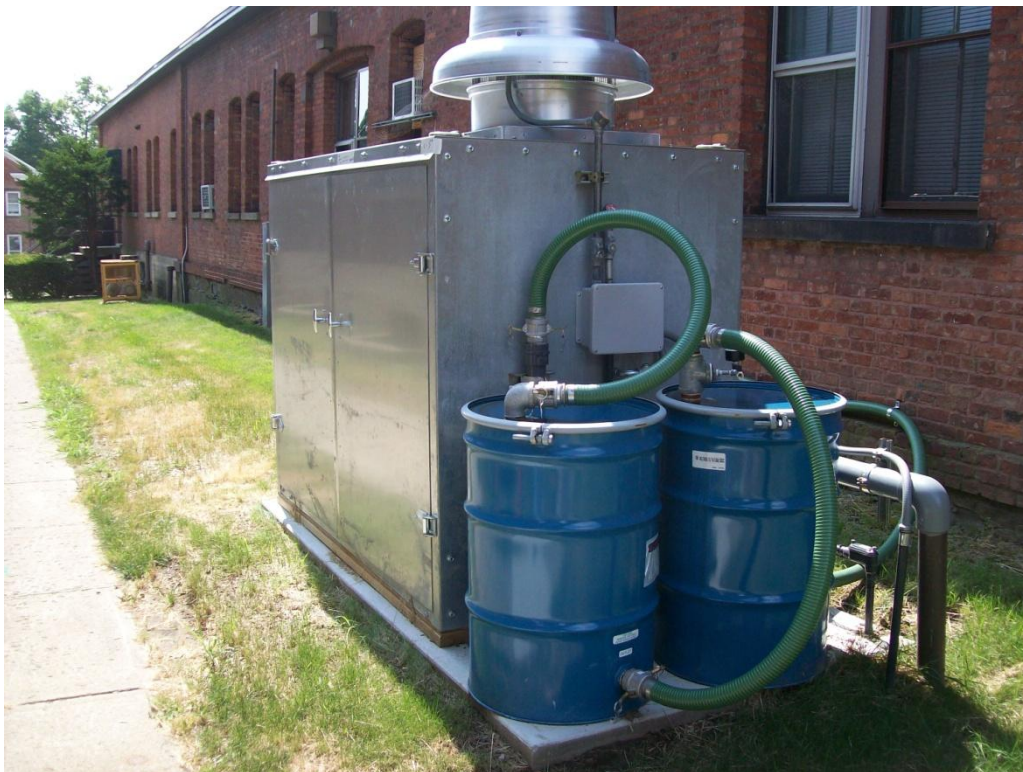
Photograph 5. Completed Building 21 Type A SSDS.

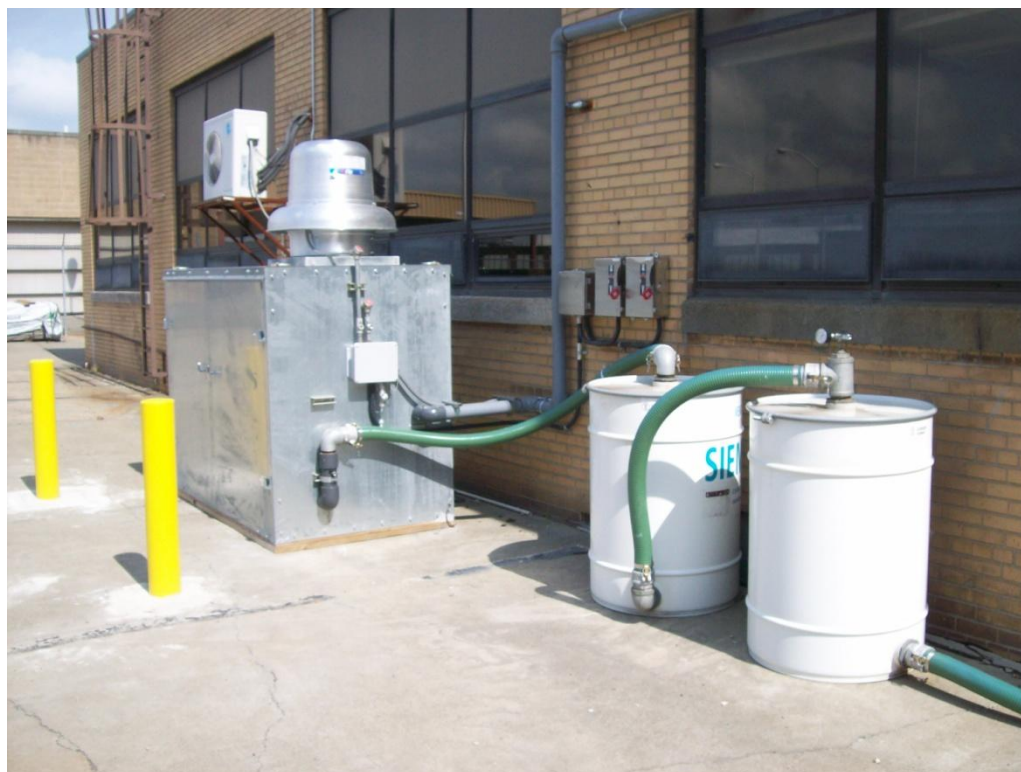
Photograph 6. Completed Building 114 Type A SSDS.

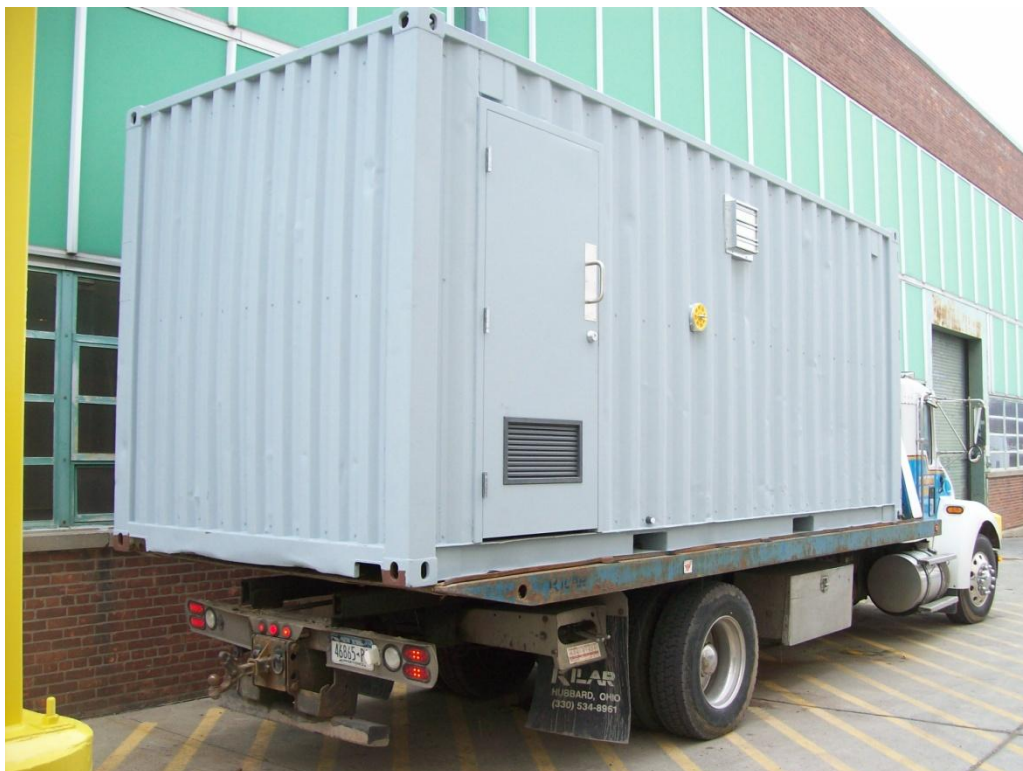
Photograph 7. Delivery truck with Type B SSDS.

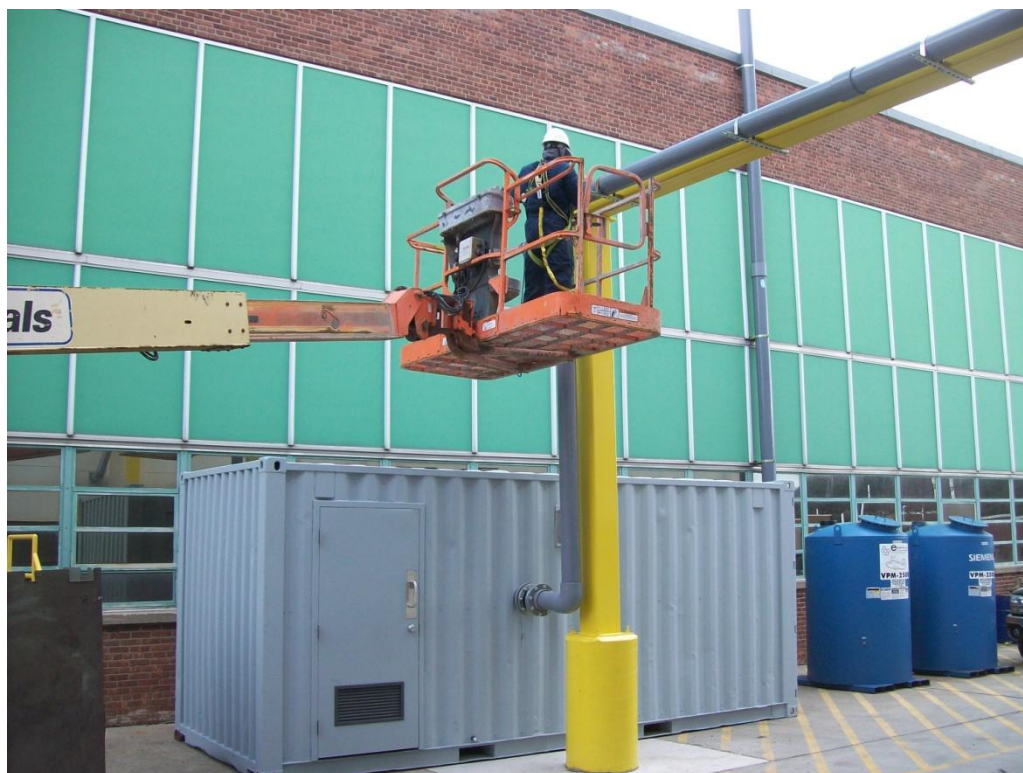
Photograph 8. Securing Building 25 suction line to pipe bridge. Type B SSDS and carbon vessels in background.

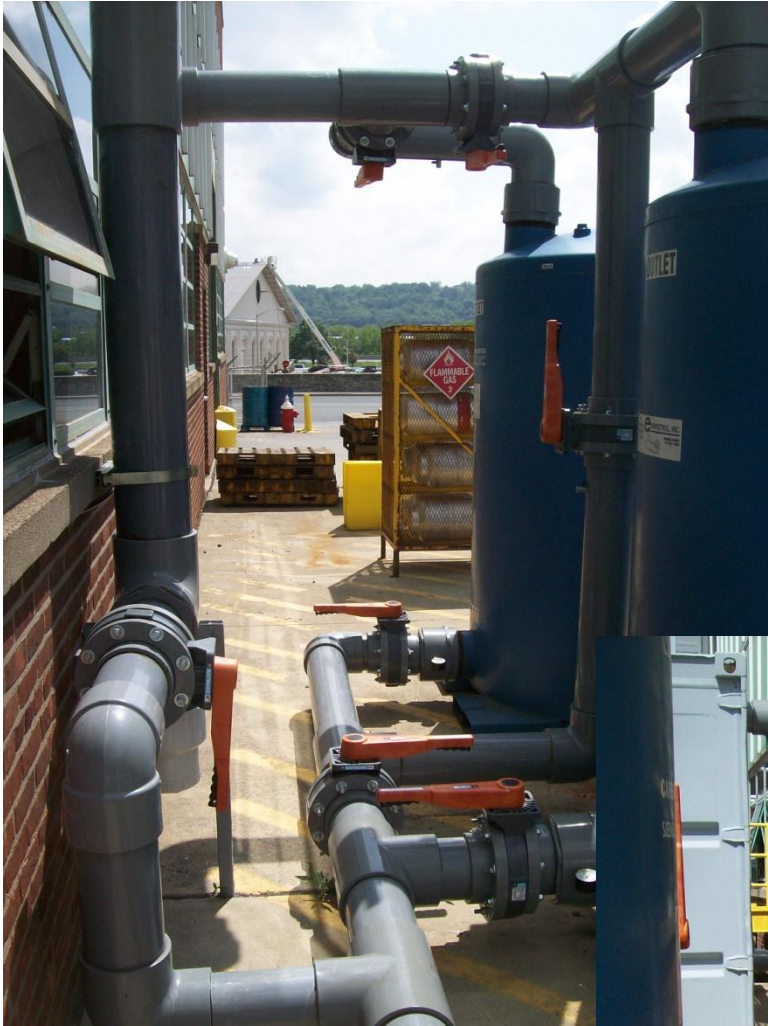
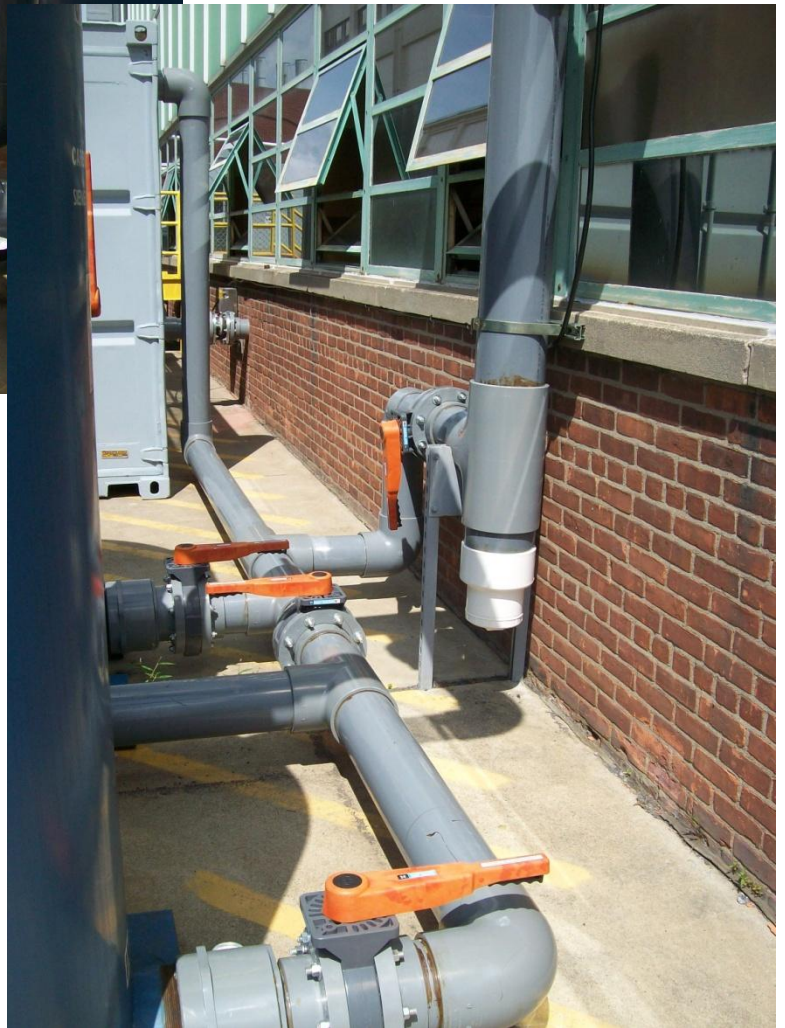
Photographs 9 and 10. Building 20/25 Type B SSDS discharge piping.

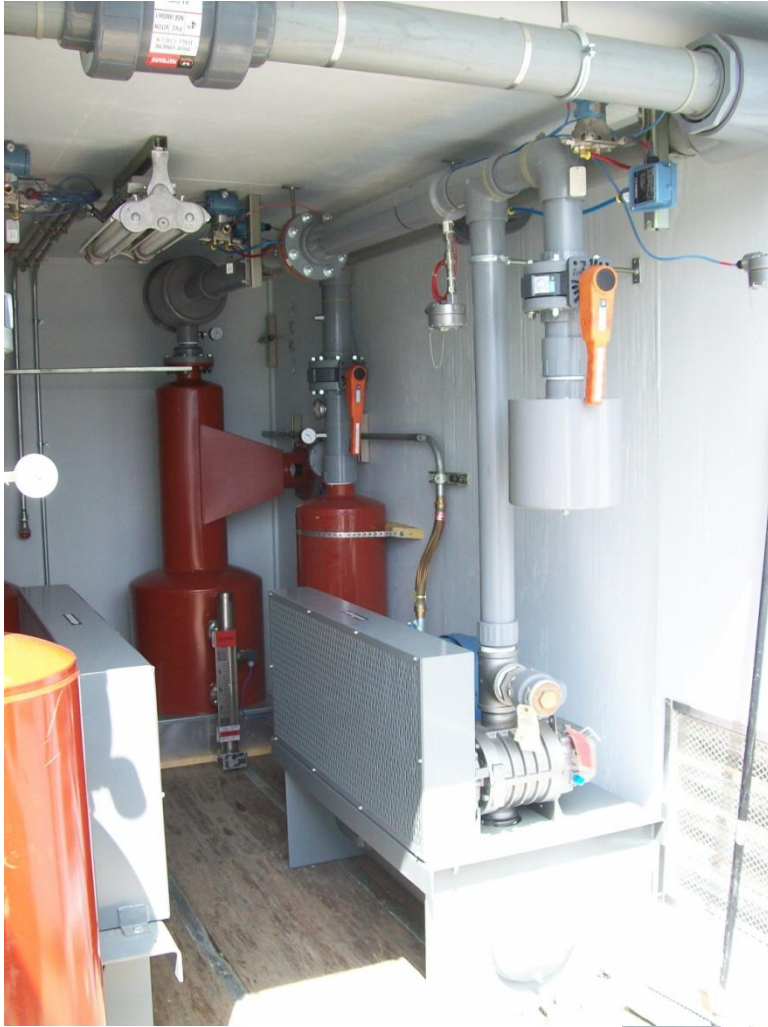
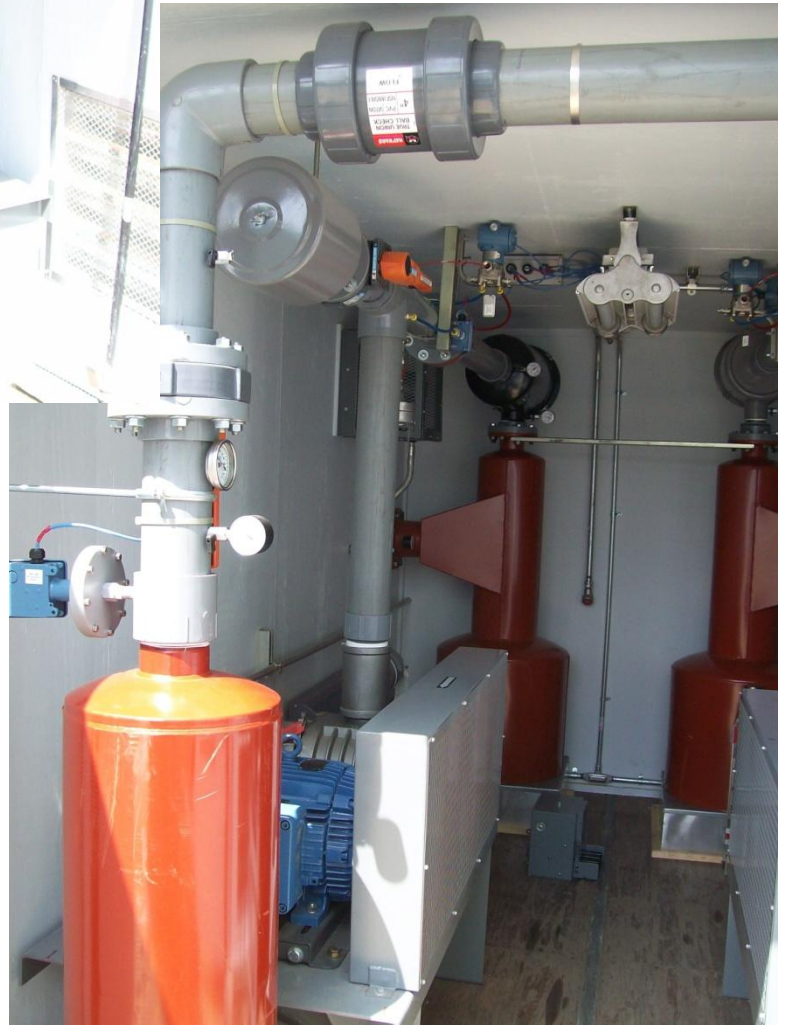
Photographs 11 and 12. Building 20/25 Type B SSDS mechanical room enclosure contents.

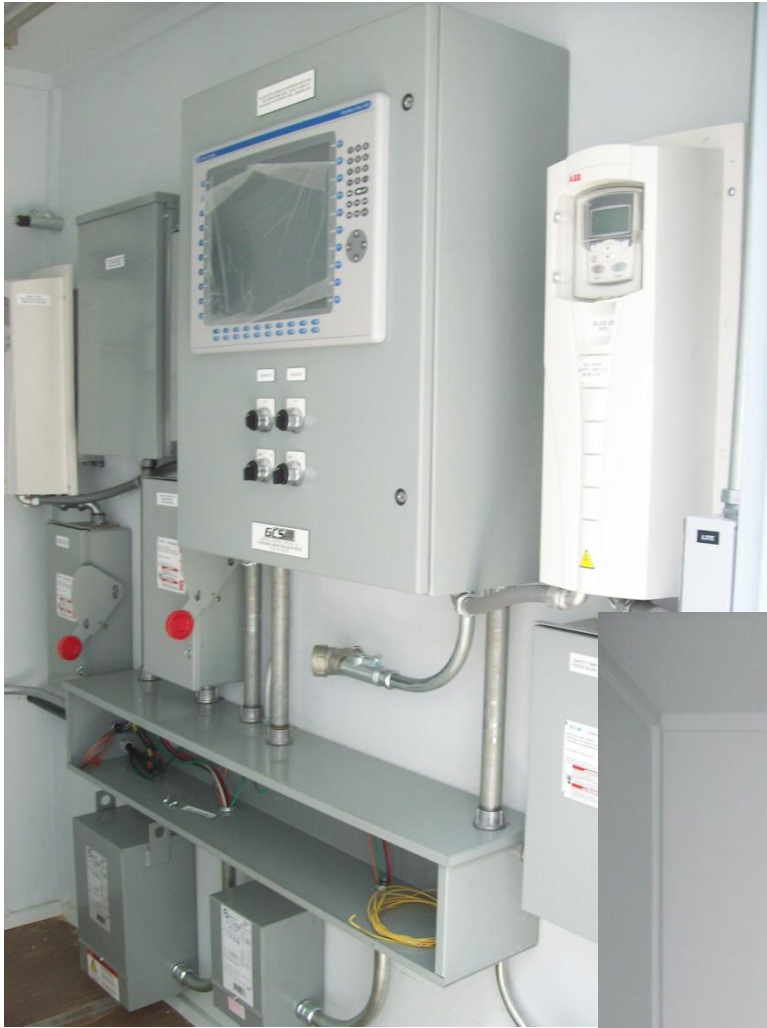
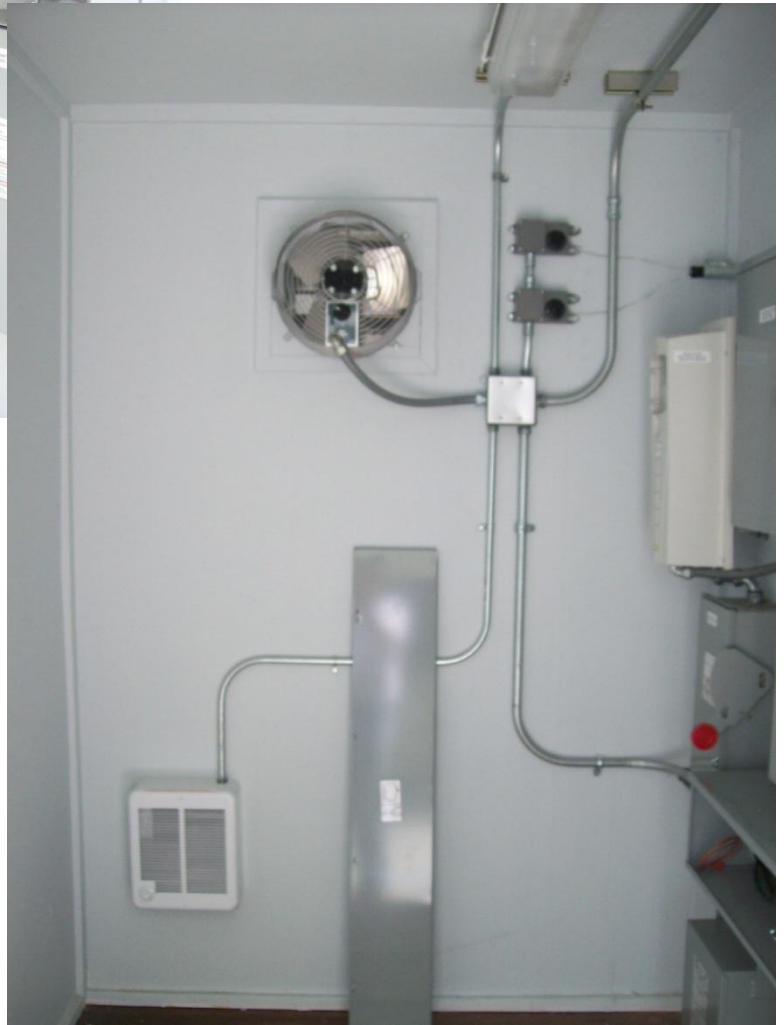
Photographs 13 and 14. Building 20/25 Type B SSDS electrical room enclosure contents.
