# **PLATING AREA SITE INVESTIGATION WORK PLAN**

**Watervliet Arsenal  
Watervliet, New York**

Contract: W912DR-18-D-0004  
WO: W912DR-17-F-0736  
NYSDEC Spill #: 1804728

July 2019

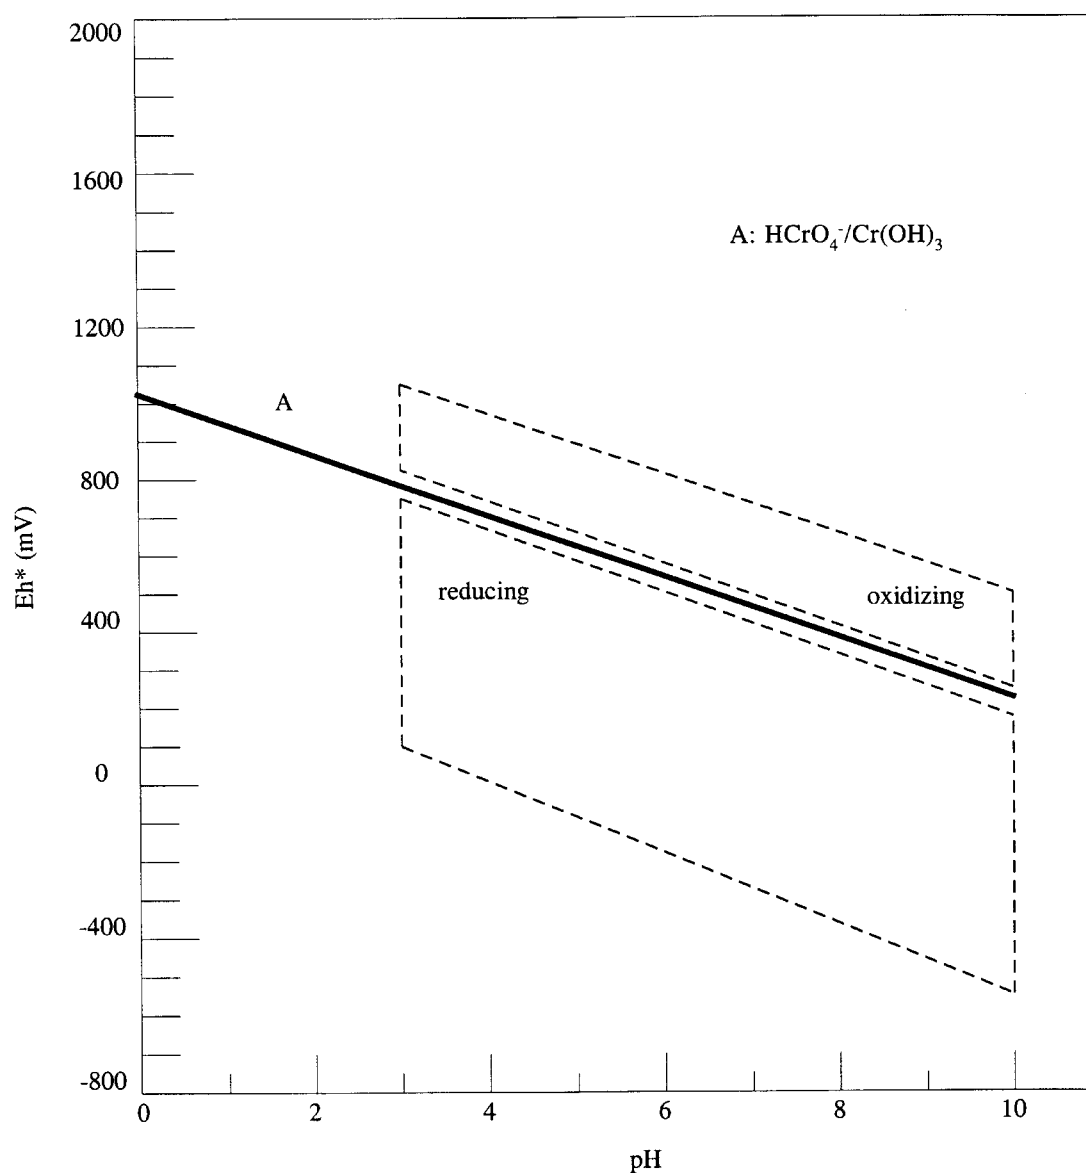
FIGURE 2  
Eh/pH PHASE DIAGRAM

The dashed lines define Eh-pH boundaries commonly encountered in soils and sediments.

\* Note the Eh values plotted on this diagram are corrected for the reference electrode voltage: 244 mV units must be added to the measured value when a separate calomel electrode is used, or 199 mV units must be added if a combination platinum electrode is used.

A value of Eh-pH below the bold diagonal line on Fig. 2 indicates a reducing soil for Cr(VI). The downward slope to the right indicates that the Eh value, at which Cr(VI) is expected to be reduced, decreases with increasing pH. The solubility and quantity of organic constituents influence reduction of Cr(VI). The presence of H<sub>2</sub>S or other strong odors indicates a reducing environment for Cr(VI). In general, acidic conditions accelerate reduction of Cr(VI) in soils, and alkaline conditions tend to stabilize Cr(VI) against reduction. If pre-digestion matrix spike recovery is not within the recovery limits, the reductive nature of the sample must be documented. This is done by plotting the Eh and pH data on the Eh-pH diagram (Fig. 2) to see if spike recovery is or is not expected in the soil. If the data point falls below the Cr(VI)-Cr(III) line on the diagram, then the data is not qualified or rejected. The sample is reducing for Cr(VI). If the data point falls above the line, then the sample is capable of supporting Cr(VI). In this case, technical error may be responsible for the poor spike recovery, and the extraction should be repeated, along with the Eh and pH measurements. If re-extraction results in a poor spike recovery again, then the data is qualified. At this point, review of other soil characteristics, such as levels of pH, Eh, TOC, sulfides, Fe(II), is appropriate to understand why poor spike recovery occurred. This extra review of these soil properties is only necessary if the unspiked sample contains detectable Cr(VI).

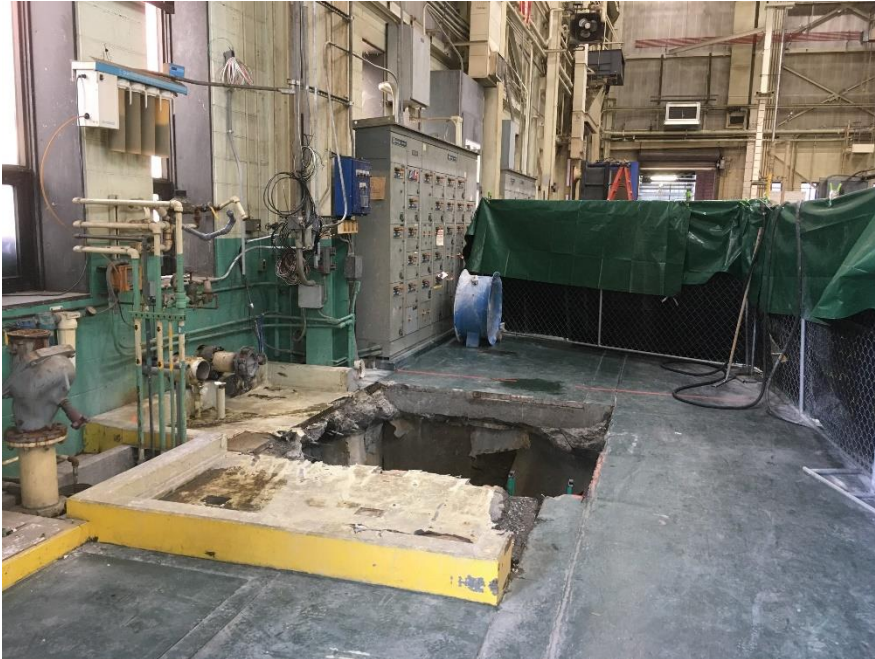
**Photo: 1**

**Description:**  
Westward view of interior  
portion of excavation

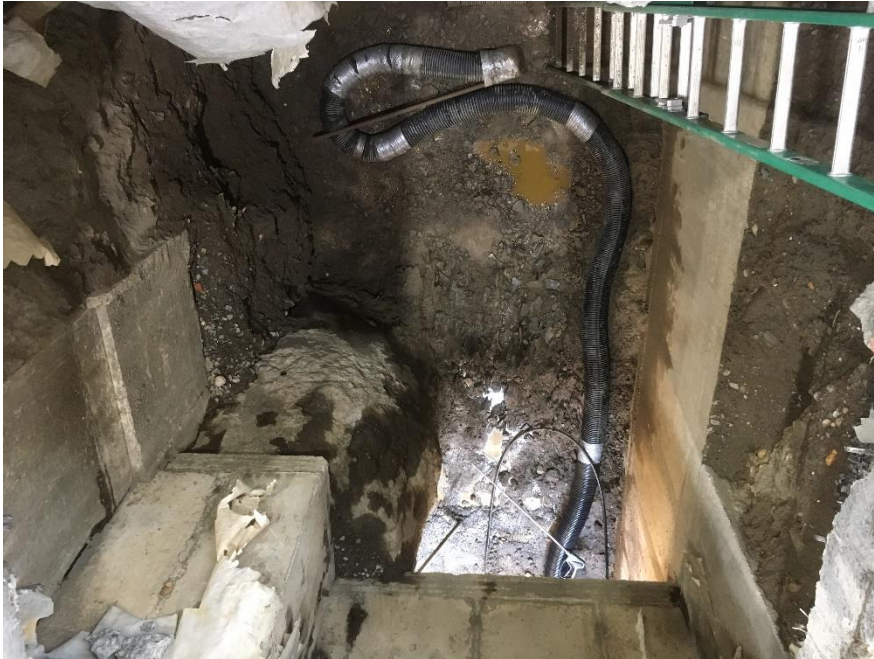
**Photo: 3**

**Description:**  
Northward/downward view  
of interior portion of  
excavation and location of IW  
and IE sidewall samples and IB  
bottom sample
