Basis of Design Report Perfection Plating Site (401037) Watervliet, Albany County, New York

October 2020
Version: REVISED FINAL
EA Project No. 16025.08

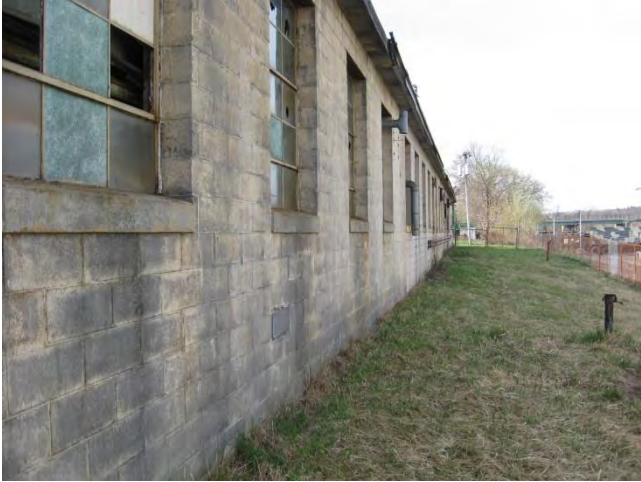
Photo: 1 Date: 5 April 2010	Former plating building west side exterior wall looking south

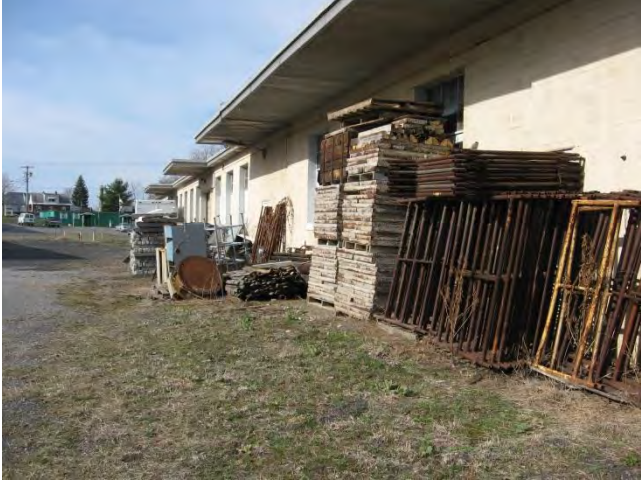
Photo: 2 Date: 5 April 2010	Former plating building east side exterior wall looking south

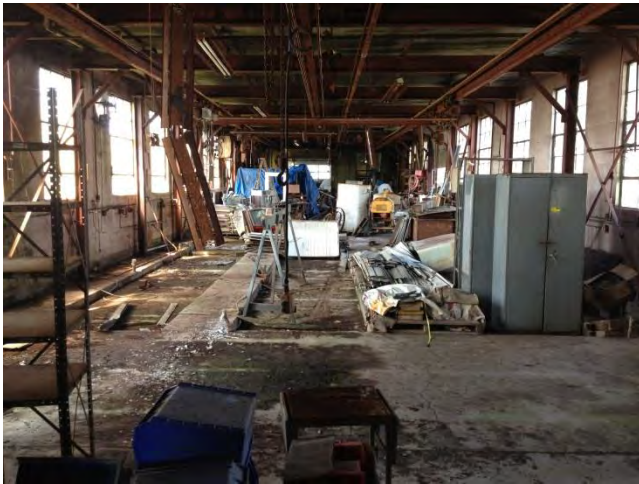
Plating process room
looking north (grid
locations A/B 8 to 3)

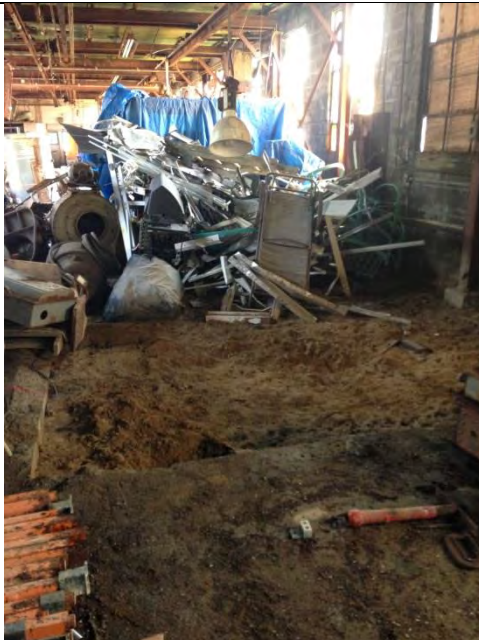
Plating process room
excavation area looking
south (grid location
A4/A3)

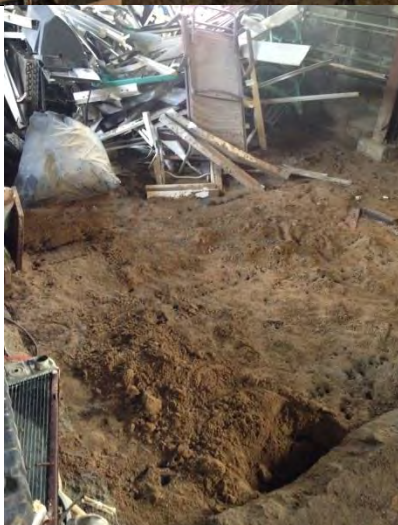
Plating process room
excavation area (grid
location A4/A3)

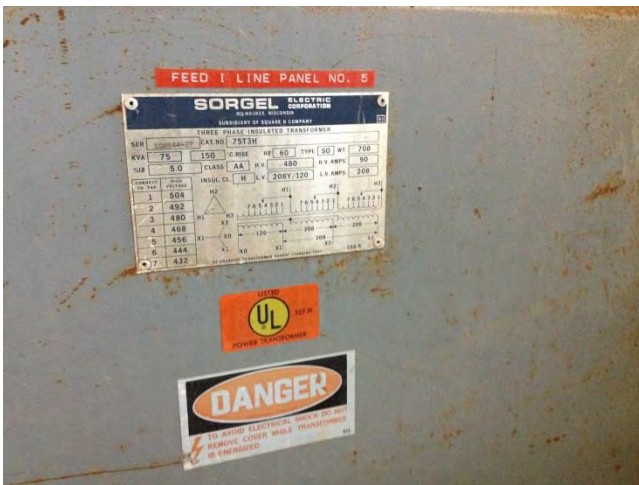
Electric panel, front
office (Grid location B2)

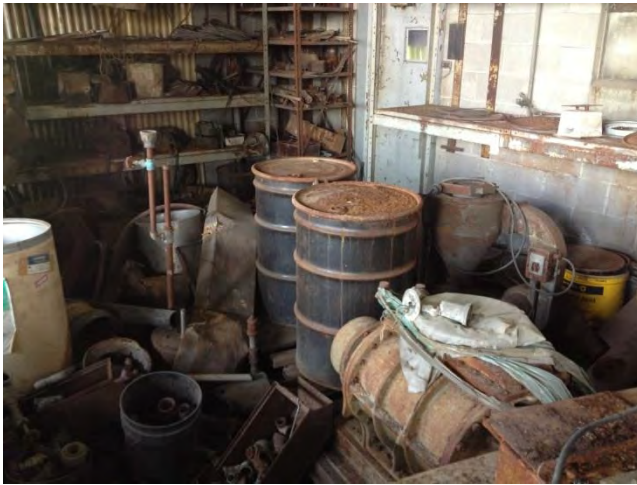
Front office empty chromium drums (Grid location B2)

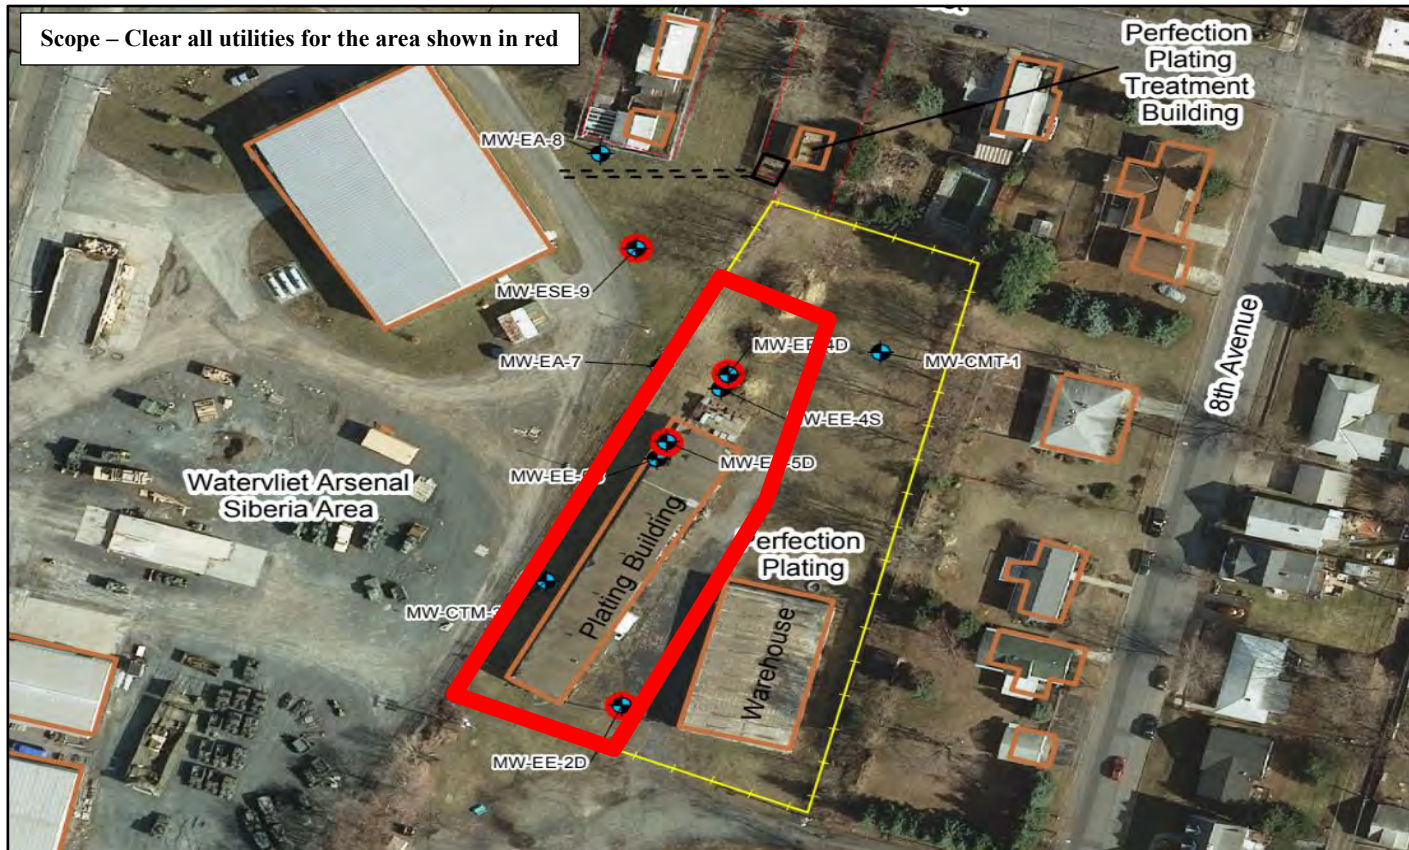
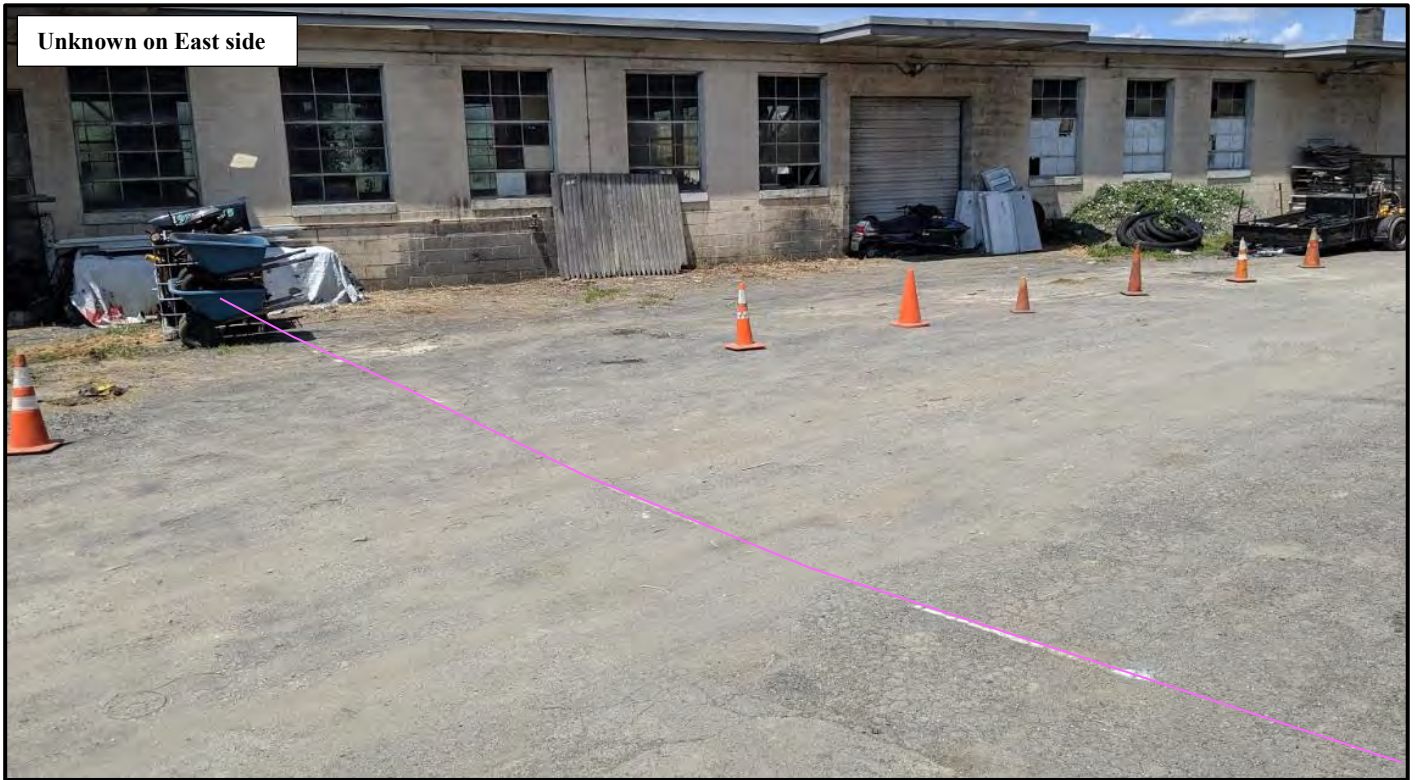
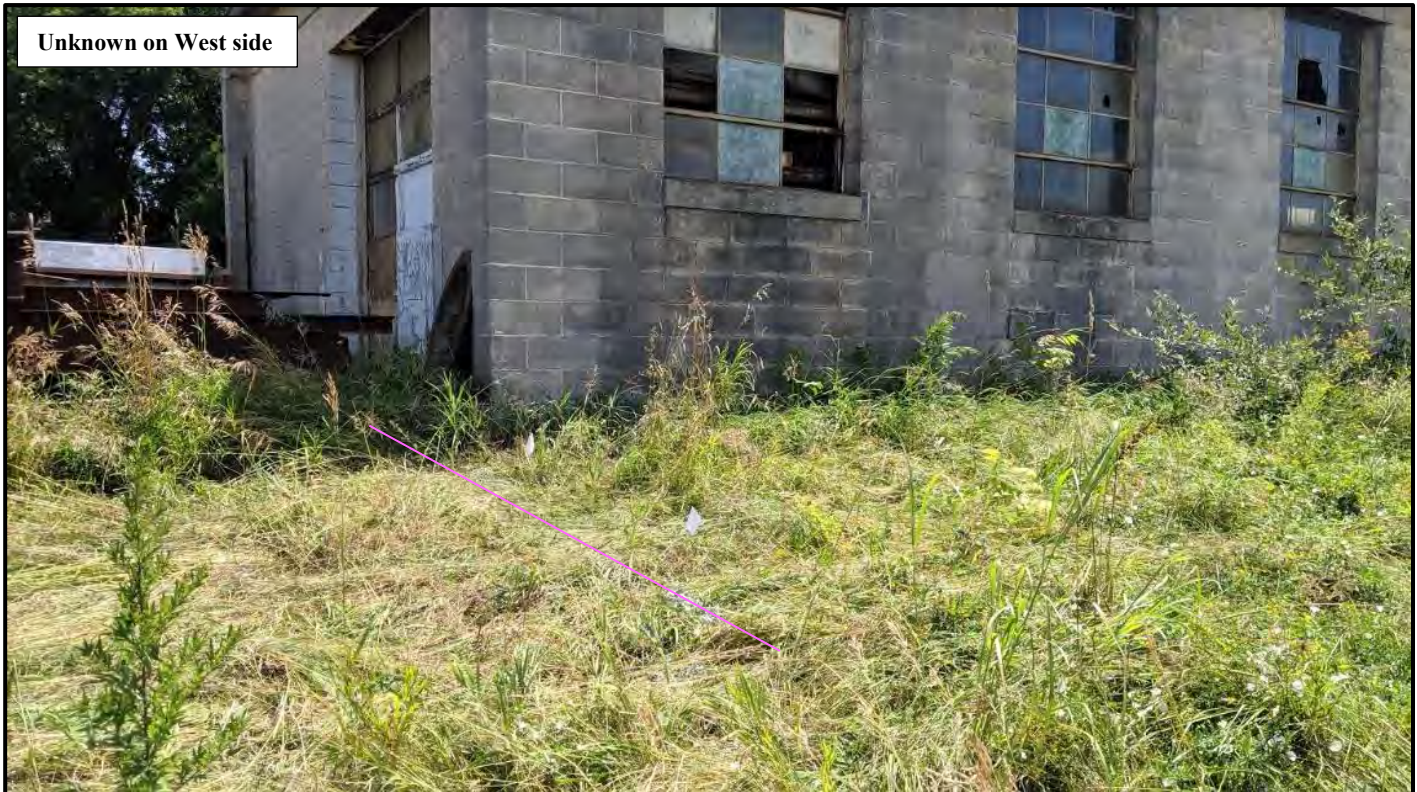
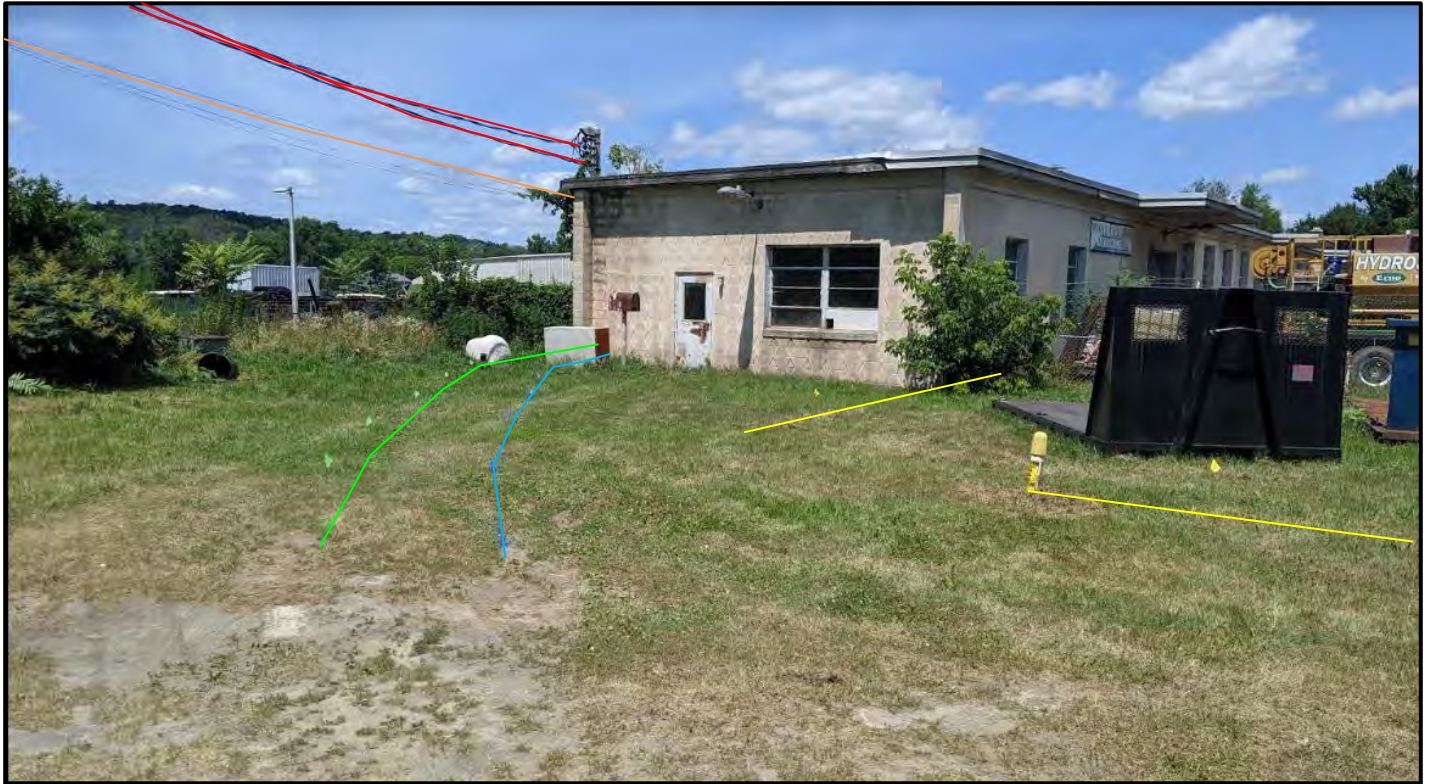
A visual inspection was performed in the area of concern to assess for utility structures. Utilizing the RD8000 in conductive, inductive, and power/radio modes, located and marked out utilities as shown in the area below. Sonde/Locatable Rodder was used within applicable utilities. Additional confirmation performed with the Noggin using the 250 and/or 500 MHz antenna. GPR signal reception varies depending upon soil conditions. Therefore, it is utilized in combination with various other geophysical tools for the most accurate verification of known/unknown utilities and/or structures. High voltage and communication ran overhead from utility pole. Utilities were painted in appropriate color, marked with flags and paint.

On 15 July 2019, a subsurface geophysical survey was completed by New York Leak Detection of Jamesville, New York. The complete geophysical survey report is included as **Appendix E**. The survey was completed to identify potential subsurface utilities, structures, or other anomalies in the area that would present hazards during a building demolition and site excavation. A visual inspection was performed in the area of concern to assess for utility structures. Following the visual inspection, geophysical equipment, including an RD8000 cable locator, a sonde locatable rod, and a Noggin ground penetrating radar were used to evaluate subsurface conditions. The equipment was used in combination with various other geophysical tools for the most accurate verification of known/unknown utilities and/or structures. High voltage and communication lines ran overhead from the existing utility pole. Utilities observed were painted in appropriate color and marked with flags and paint.
