New York State Department of Environmental Conservation

Final Engineering Report, C and F Plating

LOCATION: 406 N PEARL STREET, ALBANY
NEW YORK 12207
SITE NUMBER: 401057

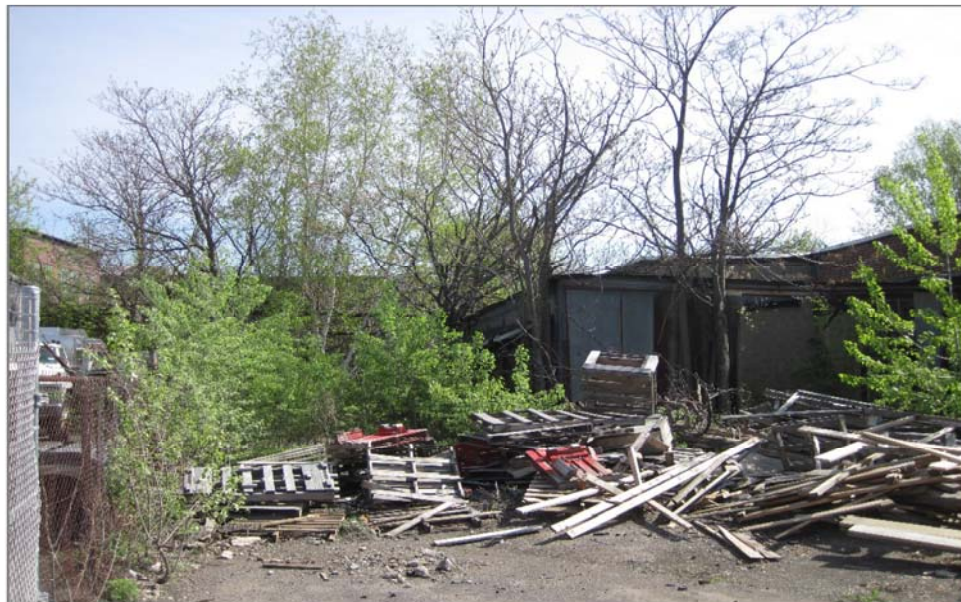
The existing buildings at the site were dilapidated and deemed structurally unsafe for entry and/or interior work. Upon PES's initial mobilization to the site, it was documented that much of ground surface within and outside of the building was covered with solid waste, trash and debris that appeared to have been dumped at the site or left by previous owners.

Land surfaces were 90 to 95% covered with concrete or asphalt. Land surfaces at the site are generally flat with slight slope to the east towards North Pearl Street.

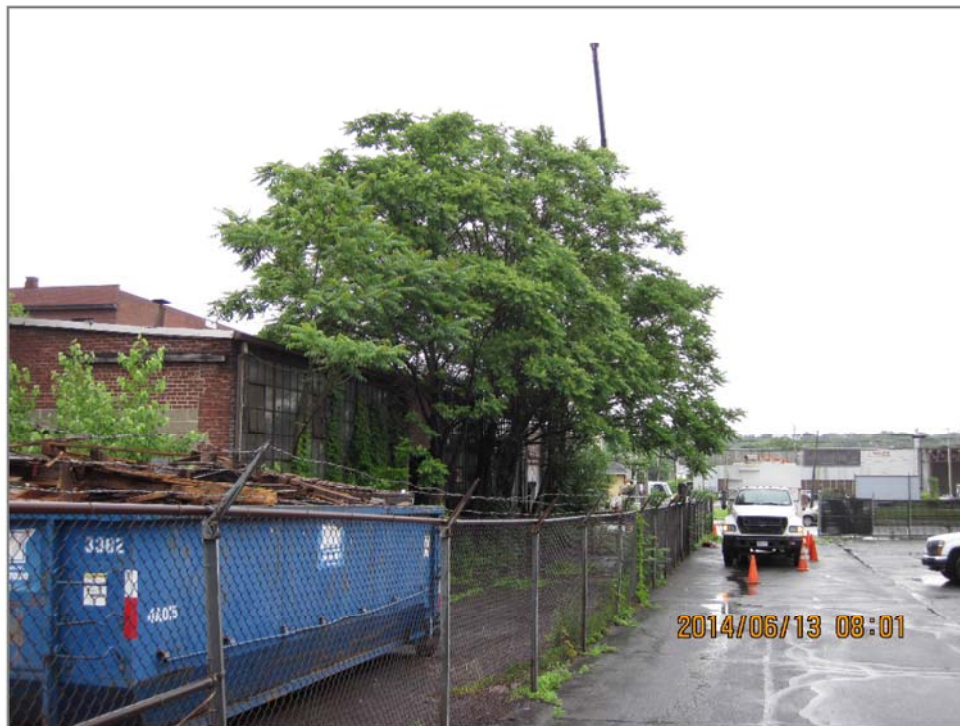
On June 13, 2014 PES and subcontractor The Davey Tree Expert Company of Latham, NY (Davey) performed site clearing work including cutting down and removing trees and woody vegetation. Davey removed and chipped all accessible trees within the site boundary to allow for access to the building by the demolition contractor. All trees were cut off above grade and stumps were left in place for removal by PES during the excavation work. All cuttings, chipping waste and woody debris and vegetation was hauled off site and recycled or composted By Davey.

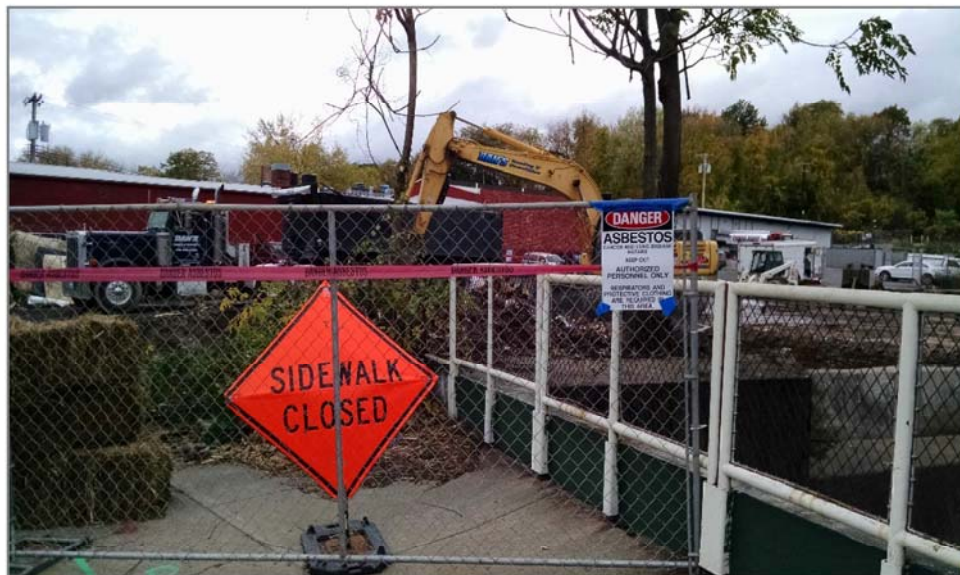
Dan's Demolition and Hauling Inc., of Troy, NY (Dan's) performed the subsequent ACM abatement and demolition work from 10/6/2014 to 10/17/2014. Dan's utilized wet methods to control dust and prevent air borne release of ACM. The building was systematically razed and all debris and building materials were either disposed of as ACM or were cleaned and recycled (non-porous steel). A total of 448.88 tons of ACM was disposed at City of Albany landfill (AL).

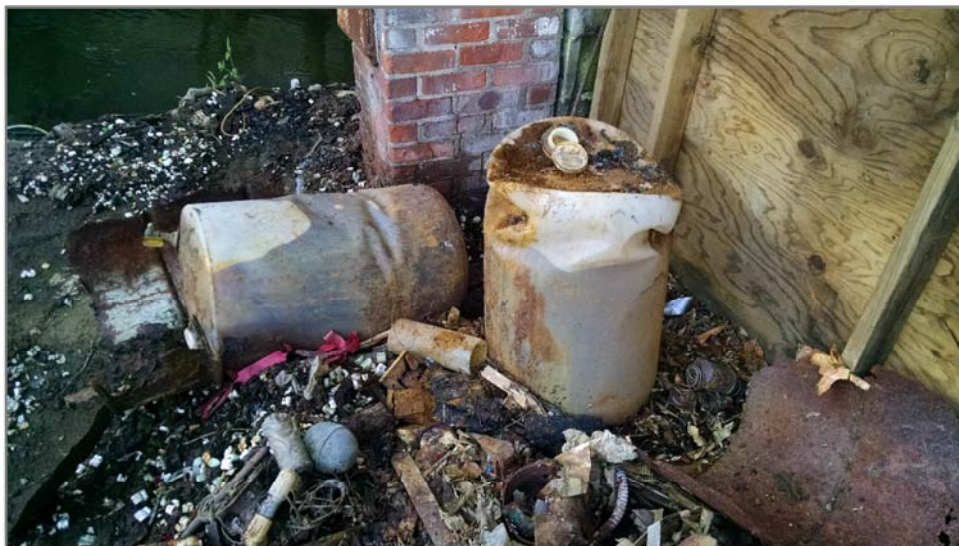
During the demolition work two (2) 30-gallon plastic drums of liquid were discovered beneath debris at the rear of the main building. The drums were in fair condition in original containers with partial labels still intact. The manufacturer of the drums (Luster-On Products, Inc. of Springfield, MA) was

contacted and samples from each drum were sent to them for testing to confirm product identification.

Through correspondence from October 29, 2014 (see Attachment D for detail) Luster On Products, Inc. confirmed that the liquid within the drums was their chromic and formic acid solutions referred to as Luster-On 66A and Luster-On 66B.

Both plastic drums were placed into 60-gallon plastic over pack drums by PES and were disposed of as D001 and D002 hazardous waste liquid and D002 and D007 hazardous waste liquid, respectively. Precision Industrial Maintenance, Inc., of Schenectady, NY (Precision) transported and disposed of the drums at Cycle Chem, Inc. of Elizabeth, NJ on December 3, 2014. Disposal documentation for the waste shipment has been provided in Attachment E.

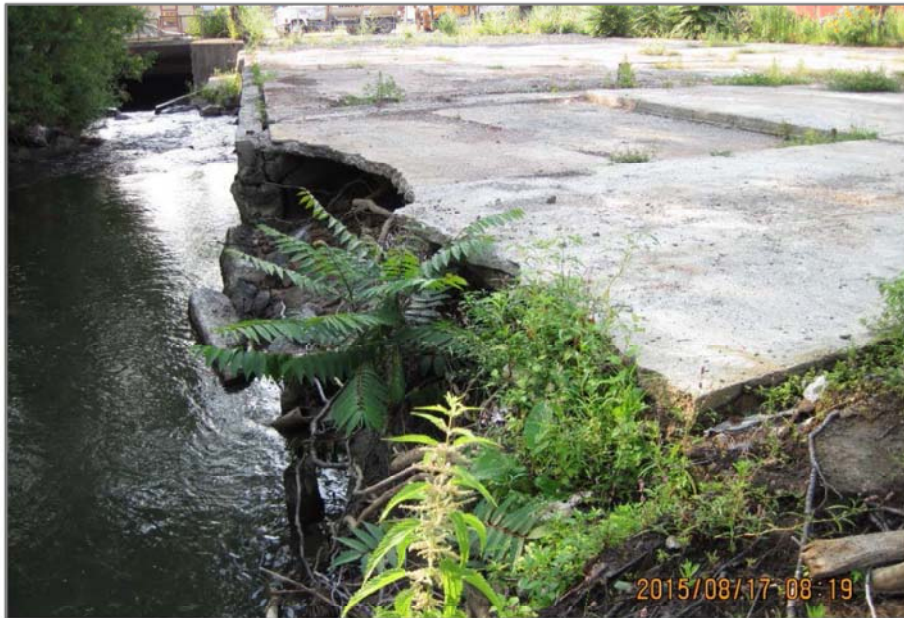
Prior to excavation process, engineering controls were required to facilitate safe and sound excavation and backfill activities occurring immediately adjacent to the Patroon Creek as the water body borders the property to the north-northeast. The existing creek bank and foundation of the removed building were visibly eroded and deemed unstable. Engineering controls consisted of:

- The installation of a permanent retaining wall along approximately 50-60 linear feet of creek bank and
- repair and replacement of a portion of concrete foundation and associated footer for the former building. The building foundation served the purpose of structural support as well as an integral component of the creek embankment and bridge abutment (where North Pearl Street overpasses the Creek).

PES contracted the services of Dente Engineering (Dente) of Watervliet, NY to design and provide specification for the construction of the retaining wall (see Attachment H). In general, the specification produced by Dente included the installation of geogrid reinforced shoring whereby no. 1 and no. 2 washed crushed stone was placed and retained within fabricated geogrid baskets.

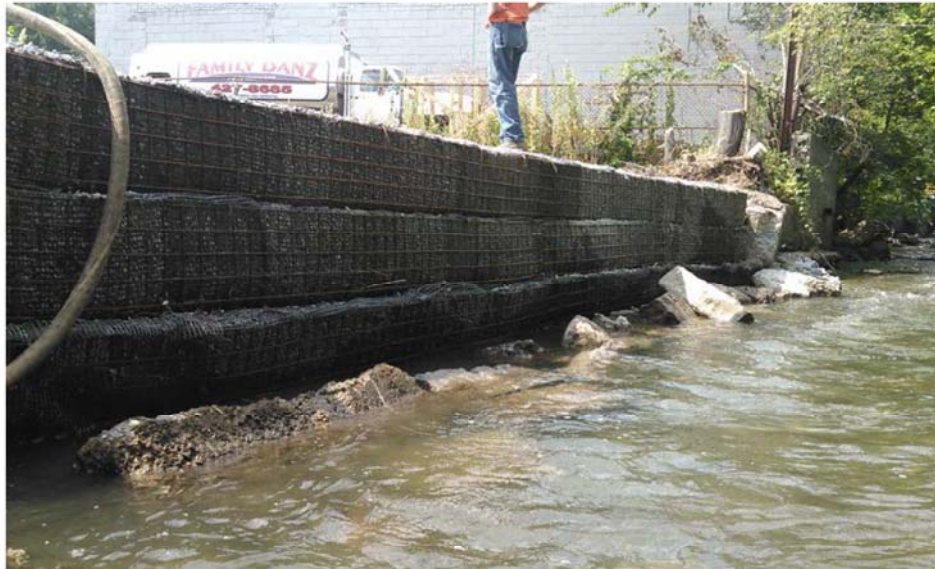
During the installation phase, large capacity sand bags were strategically placed in Patroon Creek to prevent sediment erosion and loading within the stream. The hydro barriers were left in place until a construction elevation was reached that exceeded the surface elevation of the stream.

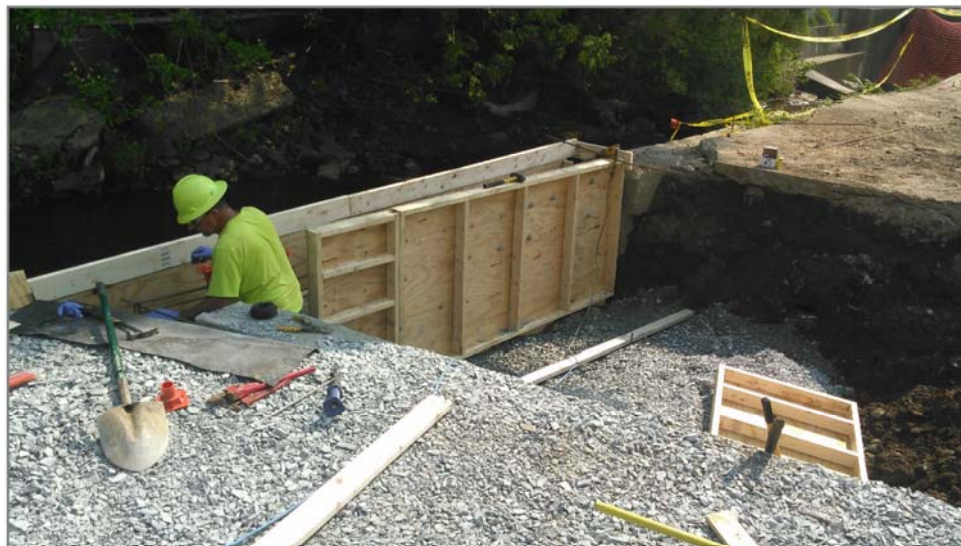
The required retaining wall was completed using PES equipment and personnel. Upon completion, the Department requested that PES perform additional bank stabilizing steps at the north and south ends of the newly installed retaining wall.

The additional work was performed to tie the new stabilizing feature into remaining foundation elements. This was accomplished by the construction of reinforced concrete forms and a monolithic pour of high strength concrete. All materials removed during the retaining wall work were staged on site and encapsulated in poly sheeting pending characterization and proper disposal. Subsequent to this phase, the site was scheduled for the soil excavation activities.

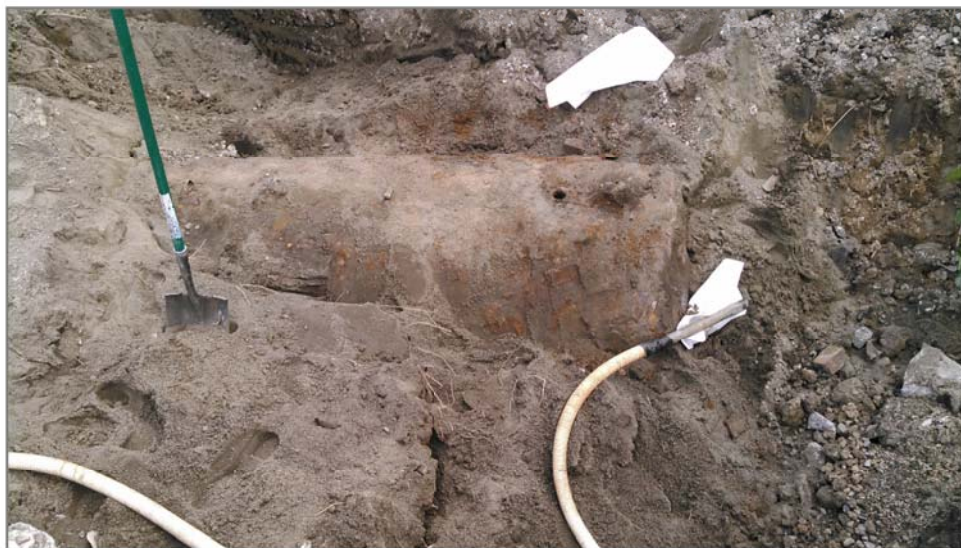
During installation of the retaining wall a 1,000-gallon underground storage tank (UST) was encountered. The UST was located within the footprint of Zone 2. Upon discovery of the vessel, the cover material was removed to expose piping access points for the purpose of assessing the volume and type of fluid content.

The assessment revealed a mixture of water and No. 2 fuel oil. A total of 850 gallons of mixed groundwater/fuel were removed (see Attachment I). The contents of the UST were removed by MacSon of Selkirk, NY under manifest. MacSon performed proper disposal of the processed fluids at Industrial Tank Services, Inc. in Oriskany, NY.

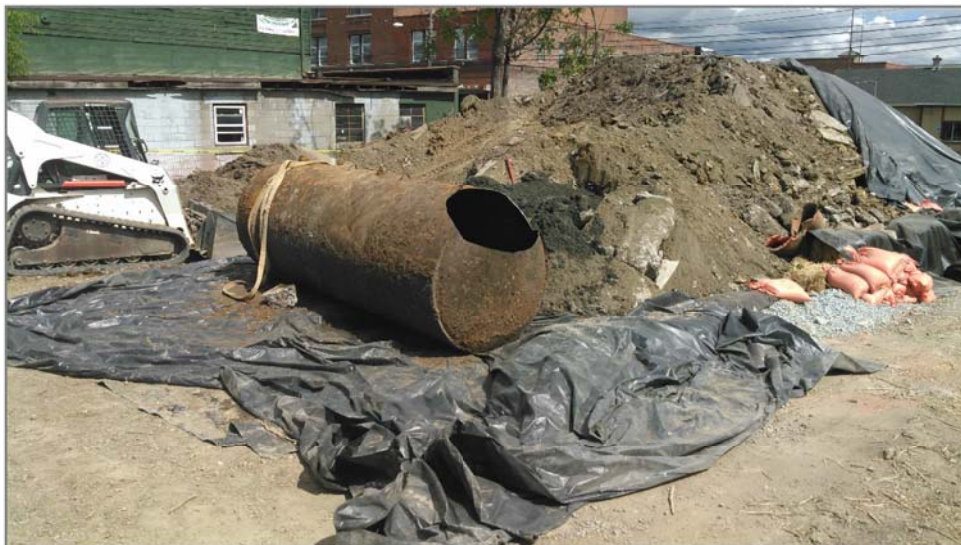
PES construction crew extracted the UST from its grave and placed it above grade on poly sheeting for cleaning.

A PES representative examined the outer surfaces for evidence of product leakage, holes, pitting, or areas of weakness. The single wall, bare steel, UST was recorded as being in fair condition. Surficial rust and minor pitting was observed; however, the vessel did not contain any visible holes or perforations.

Following cutting and cleaning of the undocumented UST, the tank was loaded for transport to Upstate Shredding Albany, located in the Port of Albany for recycling. A copy of the scrap steel receipt provided by the recycling facility is included in Attachment I.

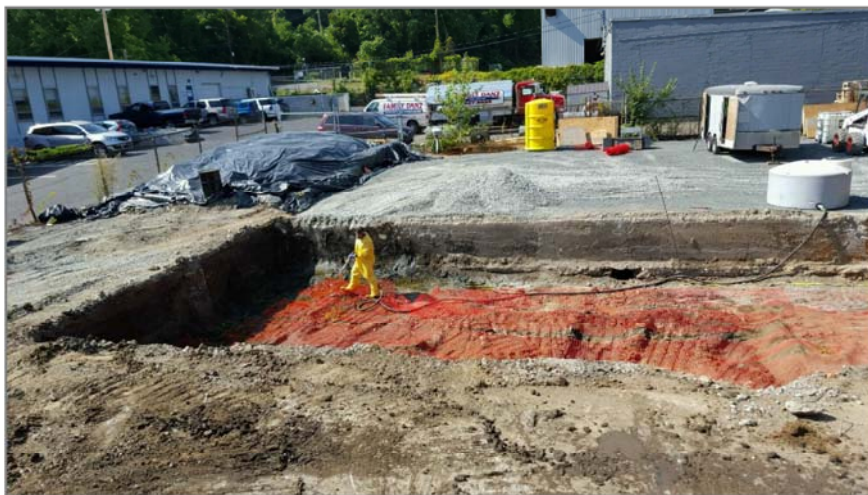
Post excavation soil existing in the phreatic zone (below the water table interface) within the footprint of the most contaminated area (beneath floor drain network- Zone 3) were further remediated with in-situ chemical reduction (ISCR). A Calcium Polysulfide (CaSx) solution was applied to the floor the excavation to treat metals in soil and groundwater. CaSx is intended to create conditions that cause the metals to precipitate out of solution such that they bind with soil particles rather than migrate with the localized groundwater flow. The byproducts of the ISCR process are non-toxic.

250 gallons of liquid CaSx were mixed with 250 gallons of potable water to provide a concentration of 15% CaSx placement mixture. Once mixed the compound was spread along the floor of the excavation via gravity flow.

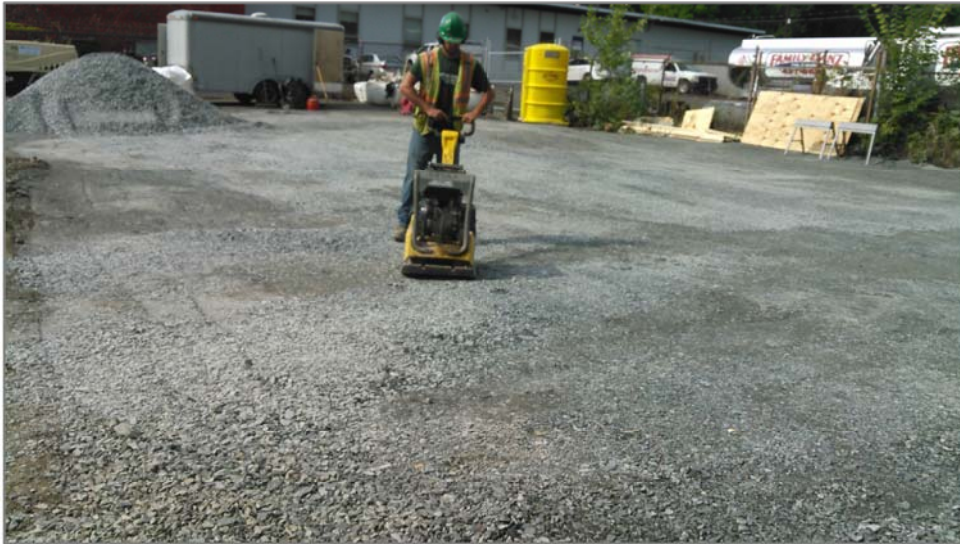
Pursuant to the ROD, PES imported clean select fill for application as cover over the upper 1-foot surface of all excavations (Zones 1-5). The imported material consisted of clean crushed stone and was supplied by Larned & Sons, of Rotterdam, NY. The material was sourced from their Rotterdam, NY location. In general, the material was placed in a maximum of 6" vertical lifts and compacted using walk behind vibratory equipment.

In general, the surface completion was performed in accordance with the minimum of one-foot placement of material as set forth in 6 NYCRR Part 375-6.7(d).

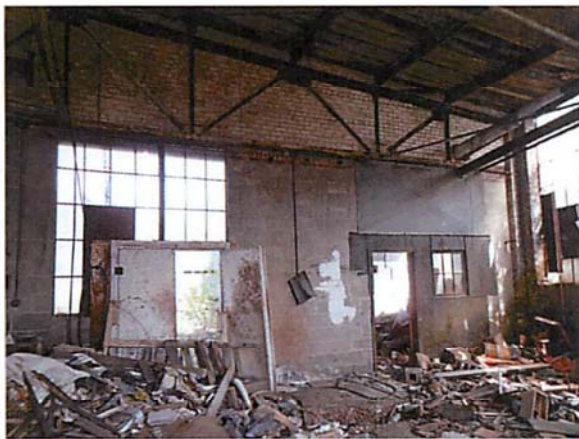
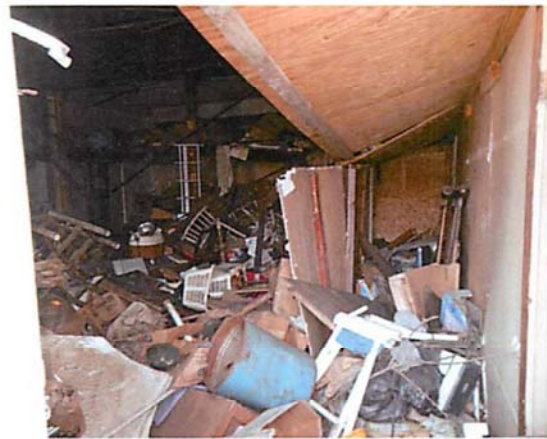
Interior of building

The structure was observed to exhibit significant structural, weather and/or water damage. Vertical and horizontal members are not structurally sound due to this damage. Walls, ceilings and floors were damaged such that partial collapse has occurred and additional collapse is possible.
