**PHASE 1  
ENVIRONMENTAL SITE ASSESSMENT  
STAR PLAZA  
NYS ROUTES 20 & 155  
ALBANY, N.Y. 12084**

Tax Map No.51.02-2-5.1, 5.1/1, 5.1/2 & 5.2  
NETC Project No. 96.080024

**NORTHEASTERN ENVIRONMENTAL  
TECHNOLOGIES CORPORATION**

**Date:** October 1996

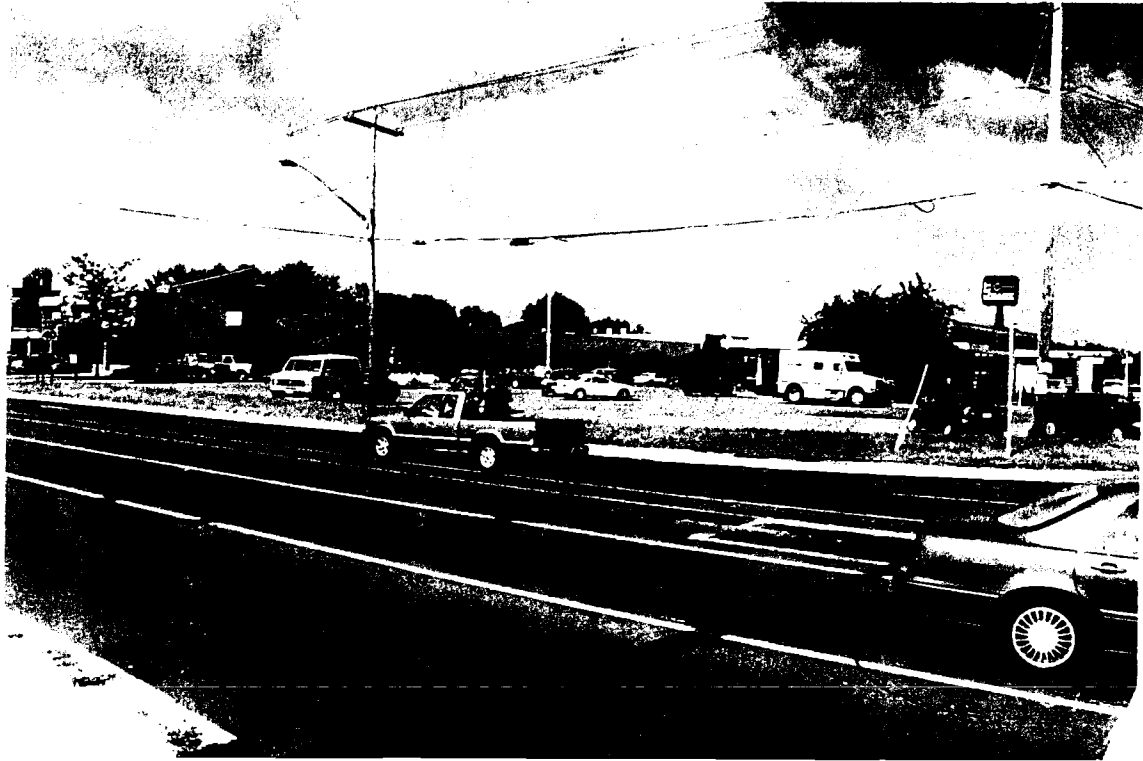
Figures 1 & 2: Subject Star Plaza site facing southwest from the intersection of NYS Routes 20 & 155 and from NYS Route 20 facing south respectively.

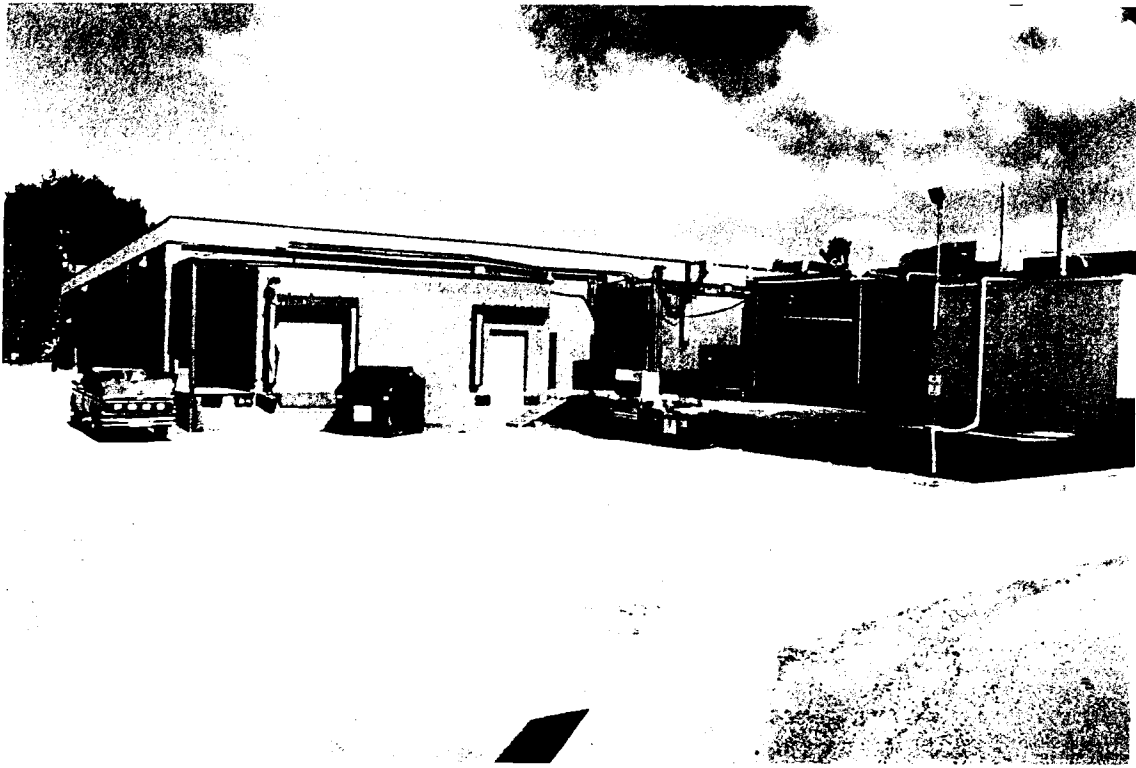
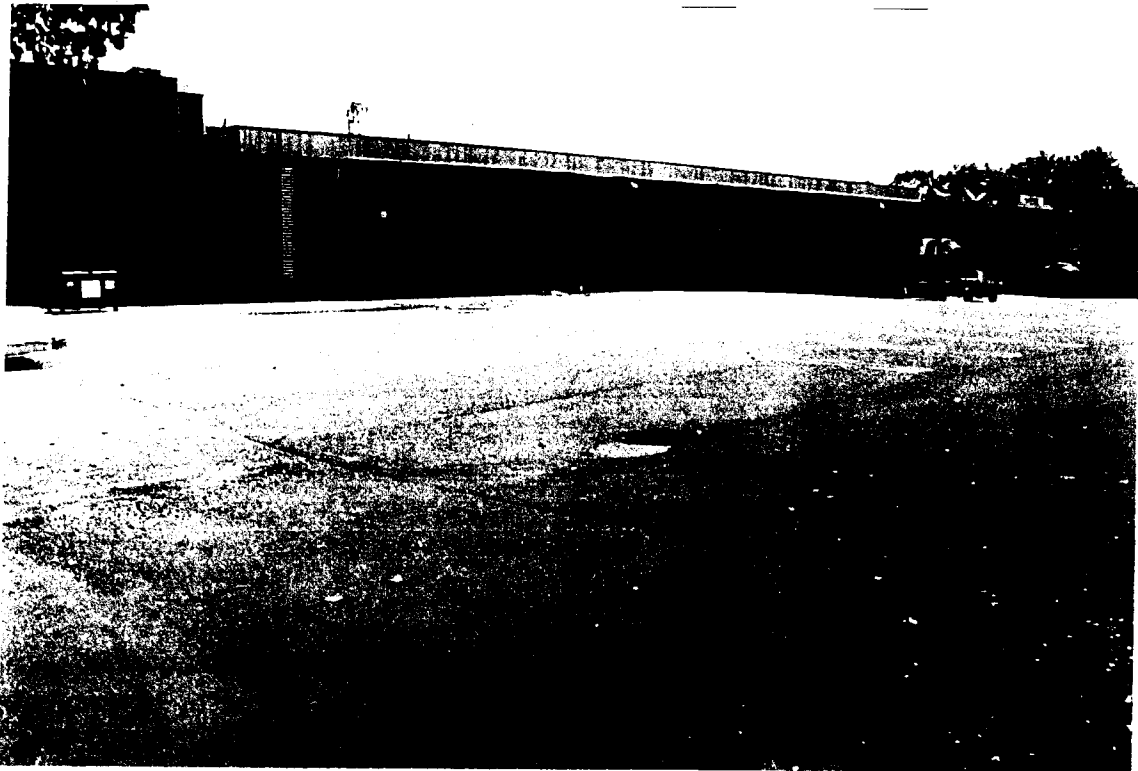
Figures 3 & 4: Rear service loading dock portion of the subject Star Plaza site and the site's southern parking lot facing northeast from the site's southwestern property line respectively.

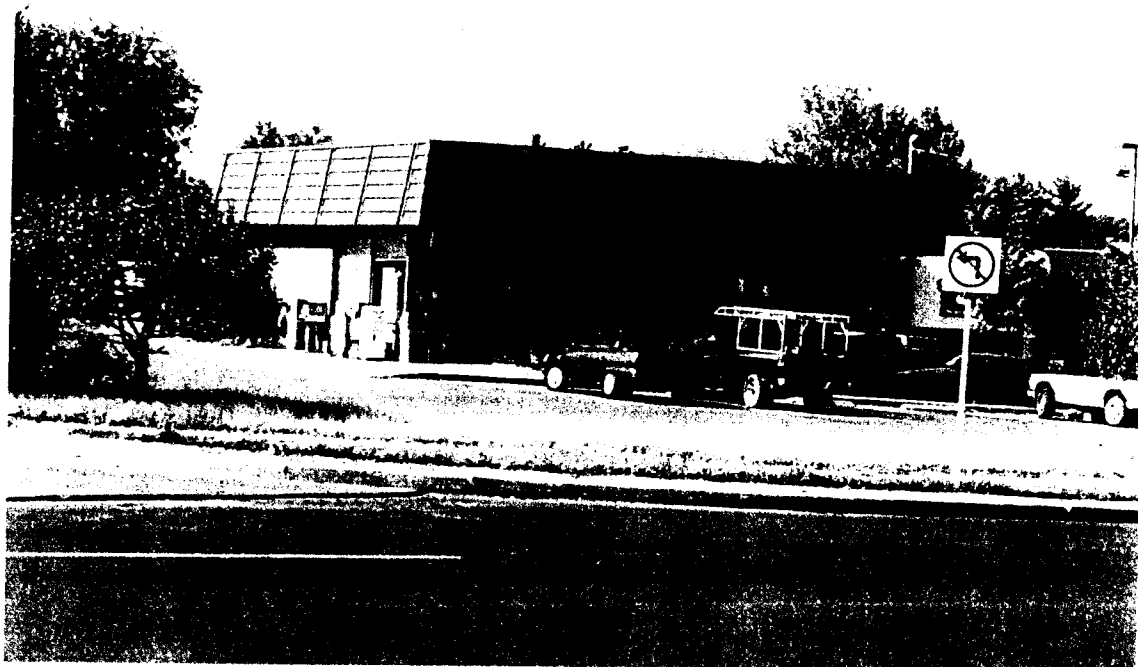
Figures 5 & 6: Key Bank and Dunkin Donuts structures located along the northern portion of the subject site respectively.
