# 2024-2025 PERIODIC REVIEW REPORT

**Port of Albany**  
700 Smith Boulevard  
Albany, New York

**NYSDEC Site # 401080**  
CHA Project Number: 028952.000

**July 2025**

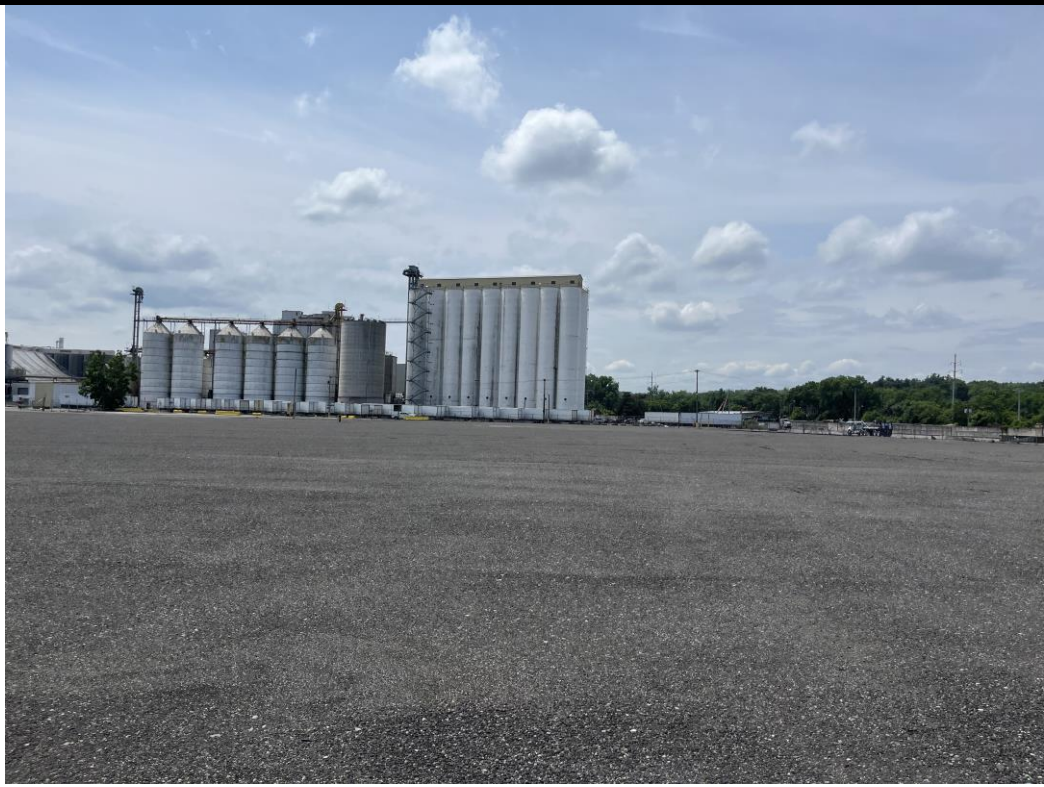
**Photograph 1.** General overview of the Site, looking south.

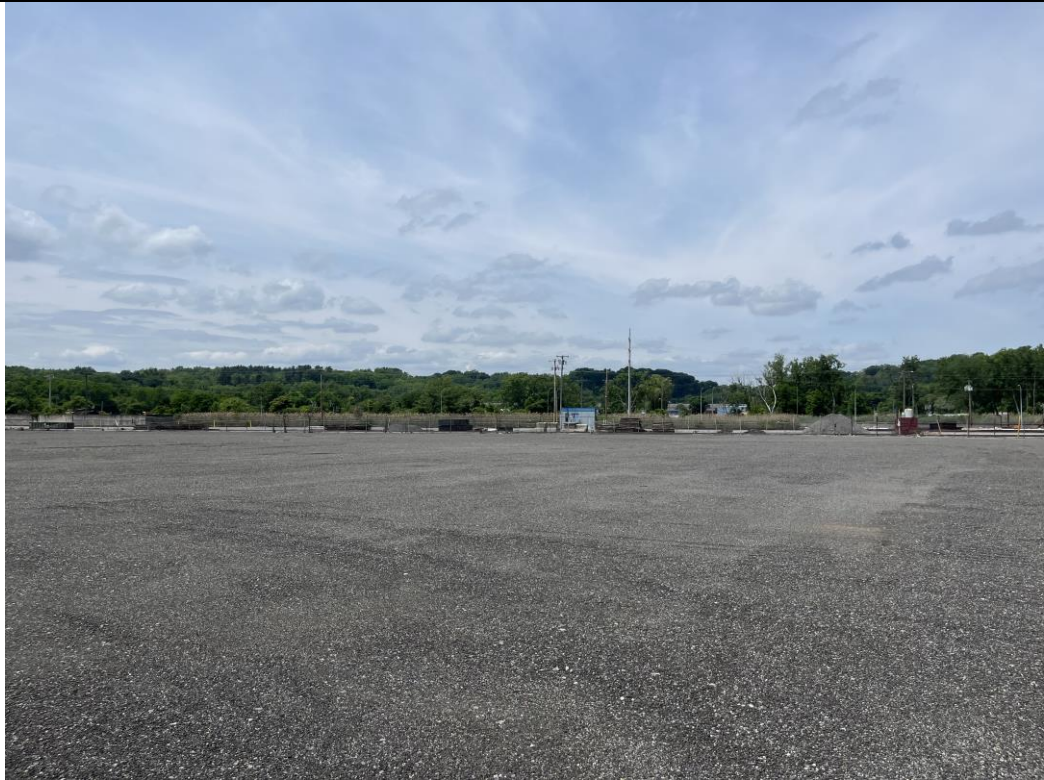
**Photograph 2.** General overview of the Site, looking west.

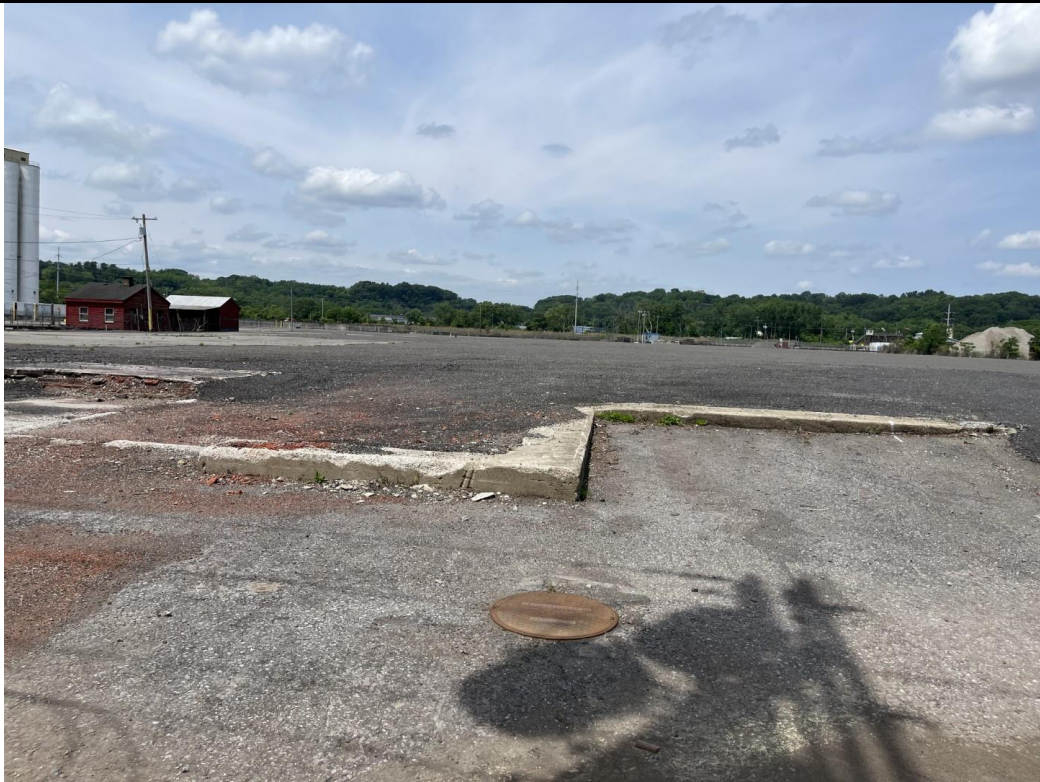
**Photograph 3.** Former location of the office building and the concrete foundation acting as a site cap.

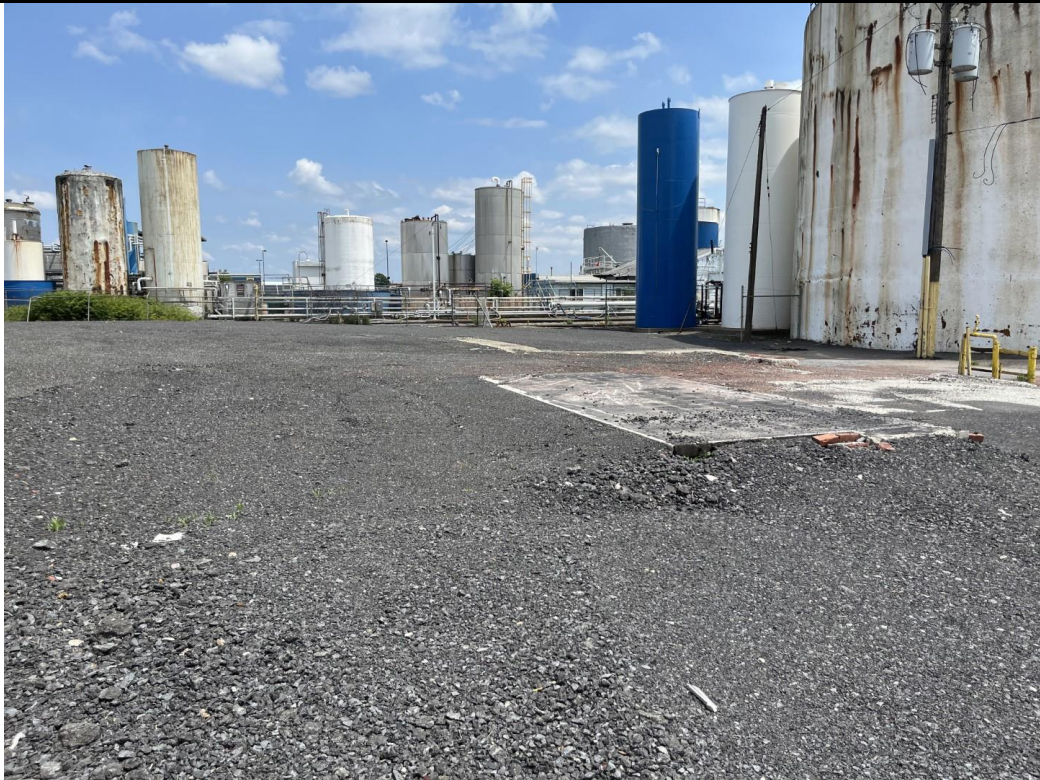
**Photograph 4.** Overview of the former office building and garage building location. Site cap consisting of concrete and reclaimed asphalt pavement.

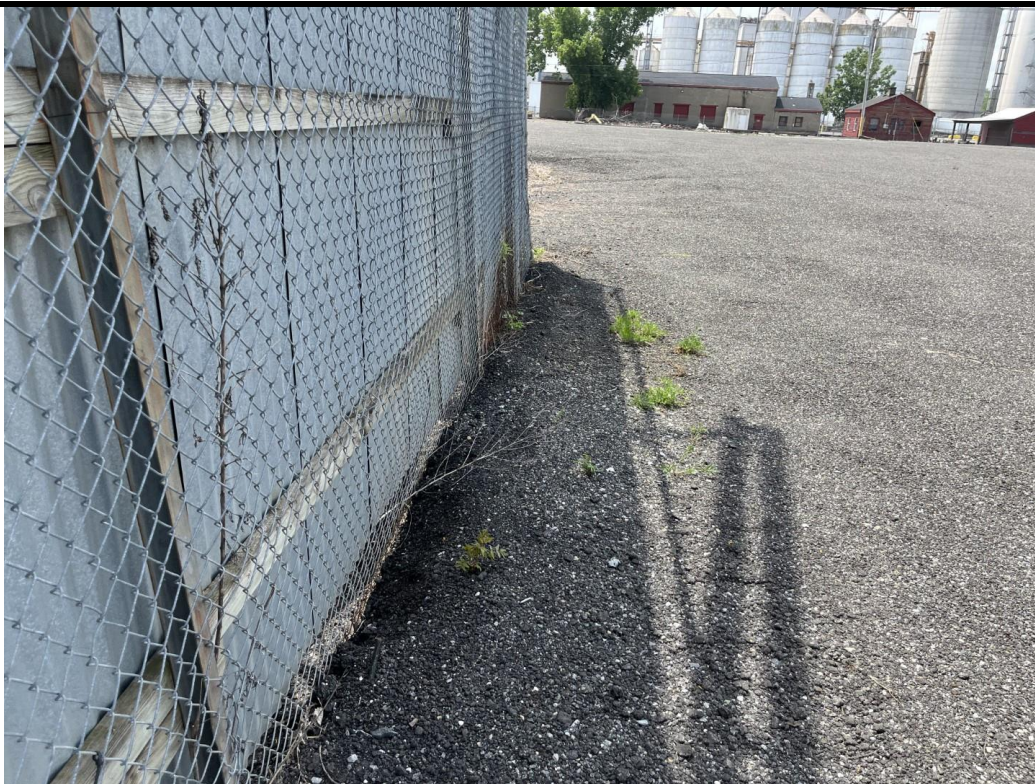
At the time of the annual Site-wide inspection conducted by CHA on June 16, 2025, the Site cap was observed to be in good condition. The two buildings previously on the Site have been razed and compliant Site capping systems were installed or left in place, as discussed further in Section 2.3. The RAP Site cap that covers the majority of the Site is intact and stable. No excessive vegetation was noted, no scour or erosion was noted, and the area previously identified as an area of concern along the fence separating the process tanks and the Site appeared to be in good condition with no significant erosion or scour.

**Photograph 5.** Location of historical RAP erosion from steam blowdown. Significantly less scour compared to previous site inspections. No repair necessary.

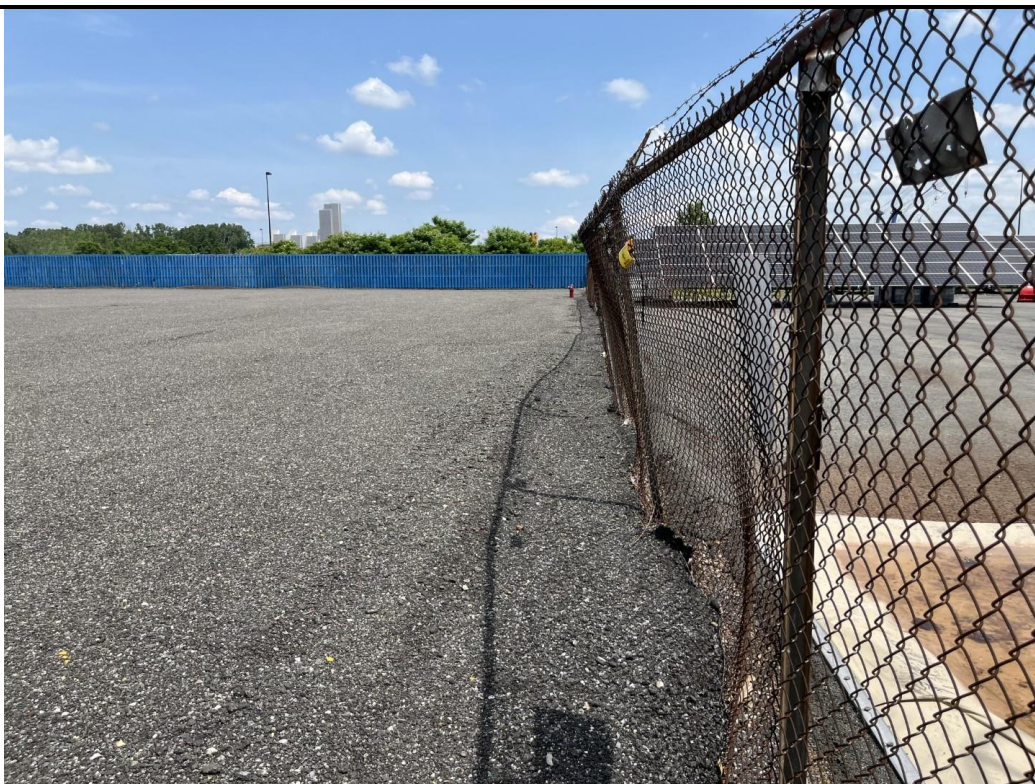
The Site-wide inspection conducted by CHA on June 16, 2025, largely involved the inspection of the Site protective capping system, as detailed above, and the perimeter fencing on the Site. The perimeter fencing was observed to be intact. Some areas of fencing on the west side of the Site are damaged, but no breaches were noted. During proposed Site redevelopment, the fence will be replaced; therefore, repairing the fence at this time is not deemed necessary.

**Photograph 6.** Fence in acceptable condition.
