Subject: [EXTERNAL] Hudson (Water St.) MGP Site, 411005, Final Engineering Report for OU1, Arcadis 2008

Final Engineering Report

Remedial Action Implementation
for Operable Unit 1
Hudson (Water Street) Site
Hudson, New York

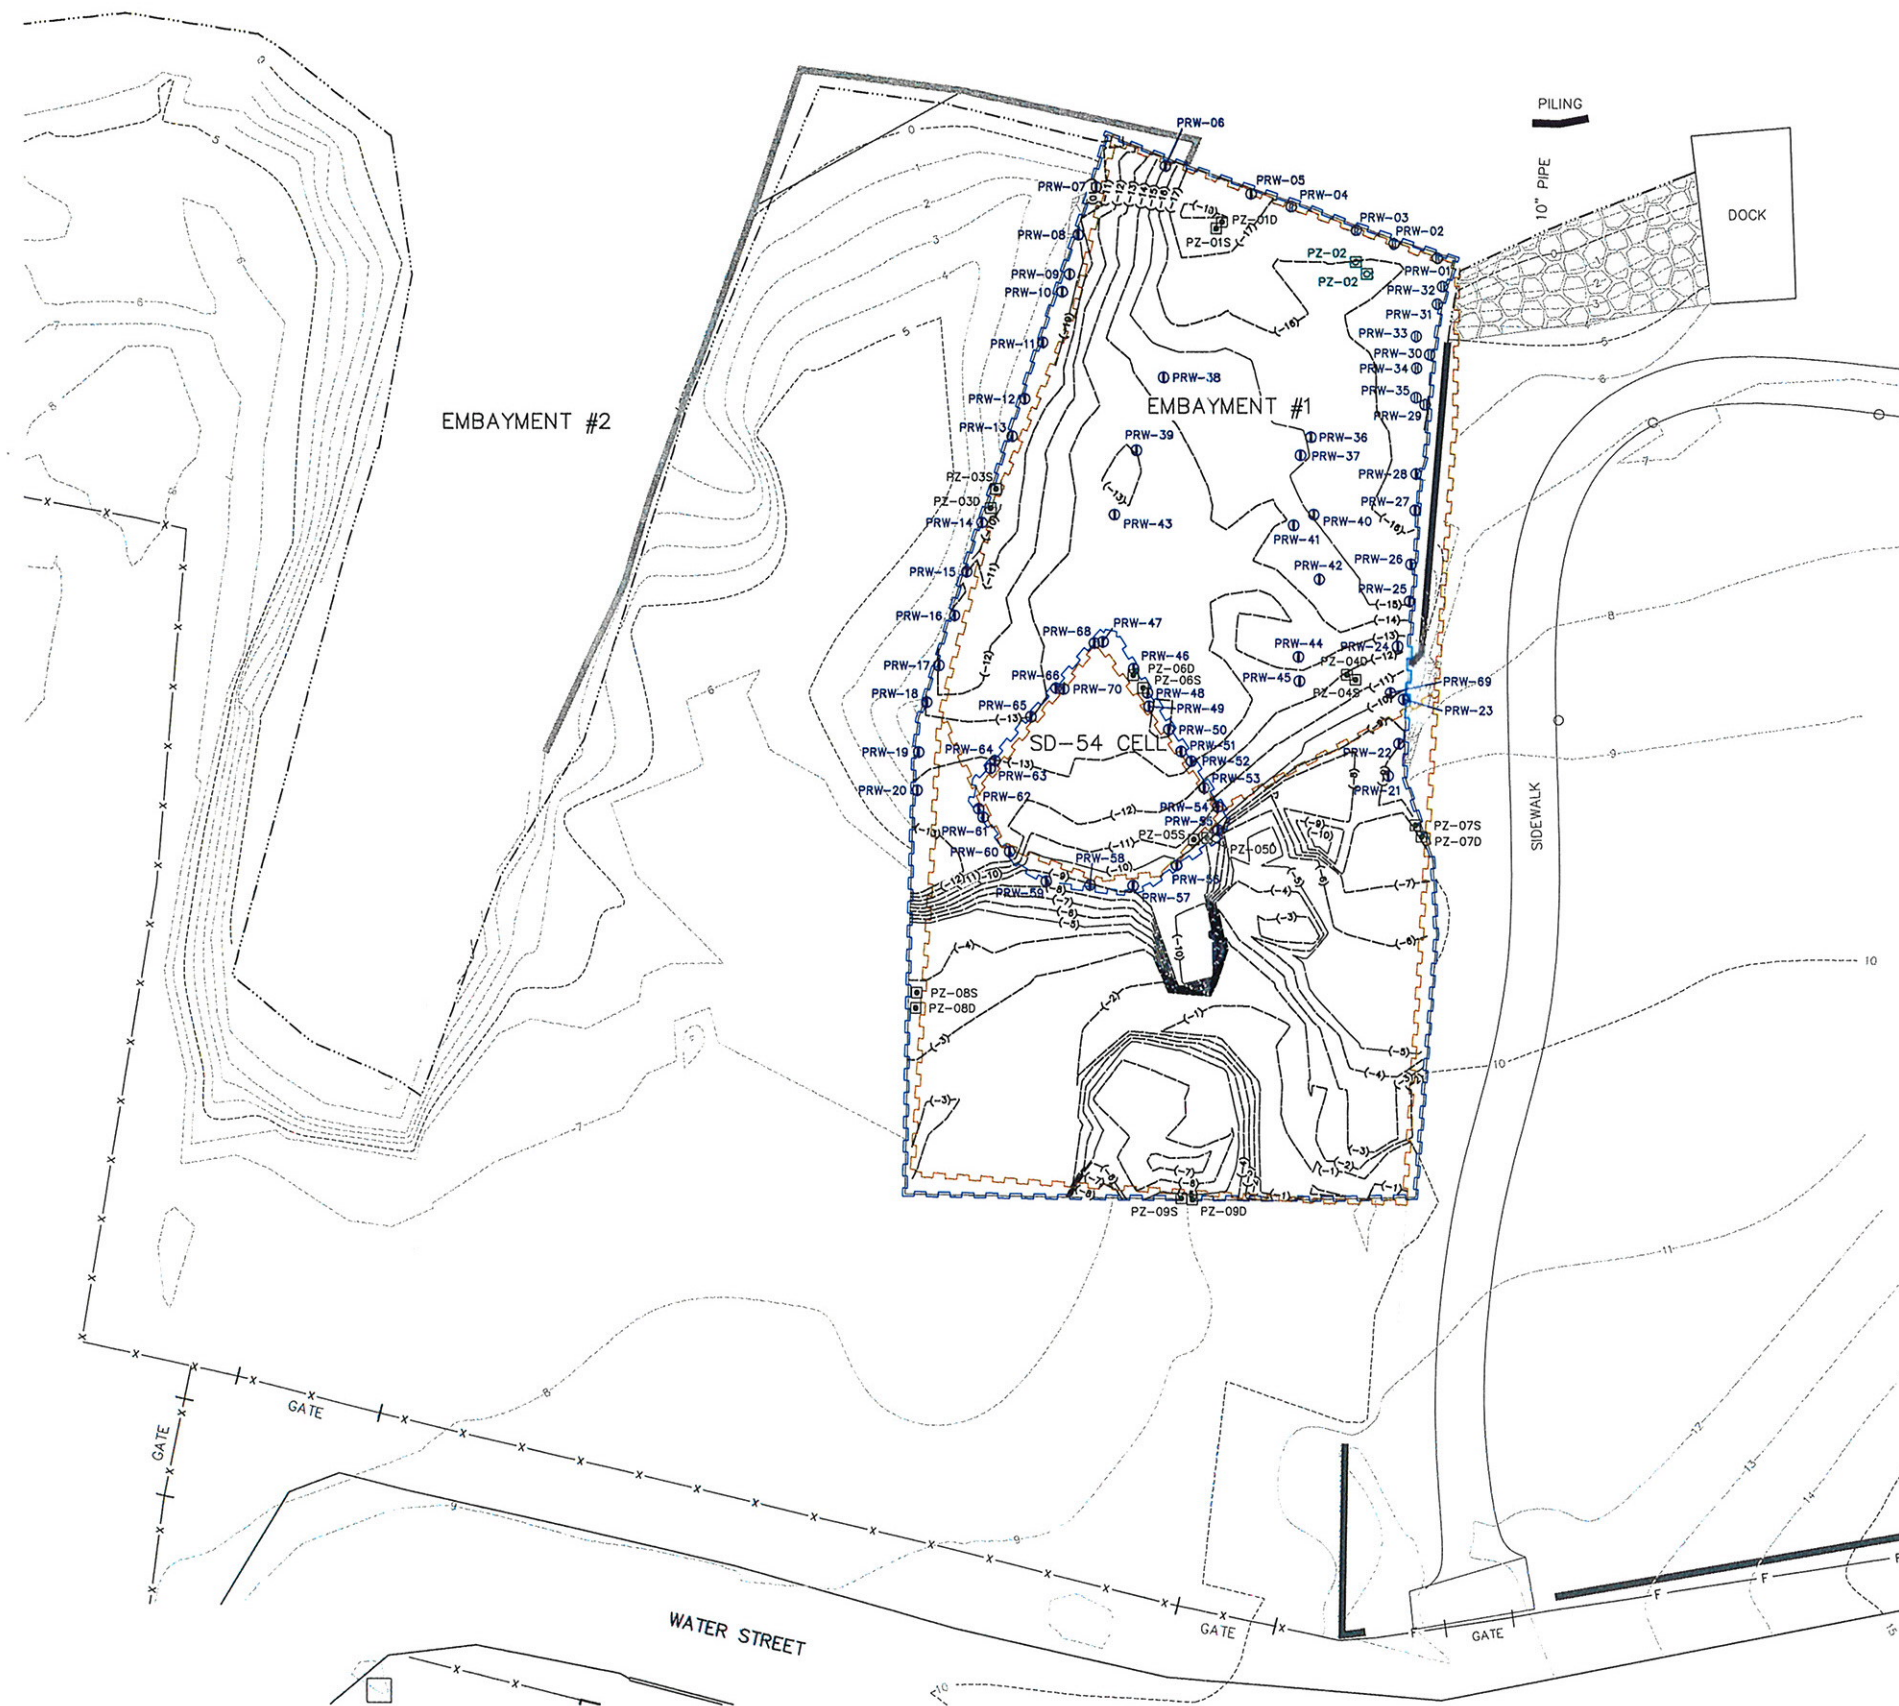
FIGURE
3

- 1 Site Location Map
- 2 Pre-Remediation Site Conditions
- 3 Embayment #1 and East Bank Soil Excavation Area – Final Excavation Limits
- 4 Embayment #1 Excavation Area – Sand Layer and Engineered Containment Systems
- 5 Embayment #1 Excavation Area – Isolation Layer
- 6 Former Gas Holder Soil Excavation Area – Final (As-Built) Excavation Limits
- 7 Restoration Site Plan
- 8 Embayment #1 Cross Section A-A'
- 9 Additional Excavation Embayment #1
- 10 Additional Excavation Former Gas Holder Area

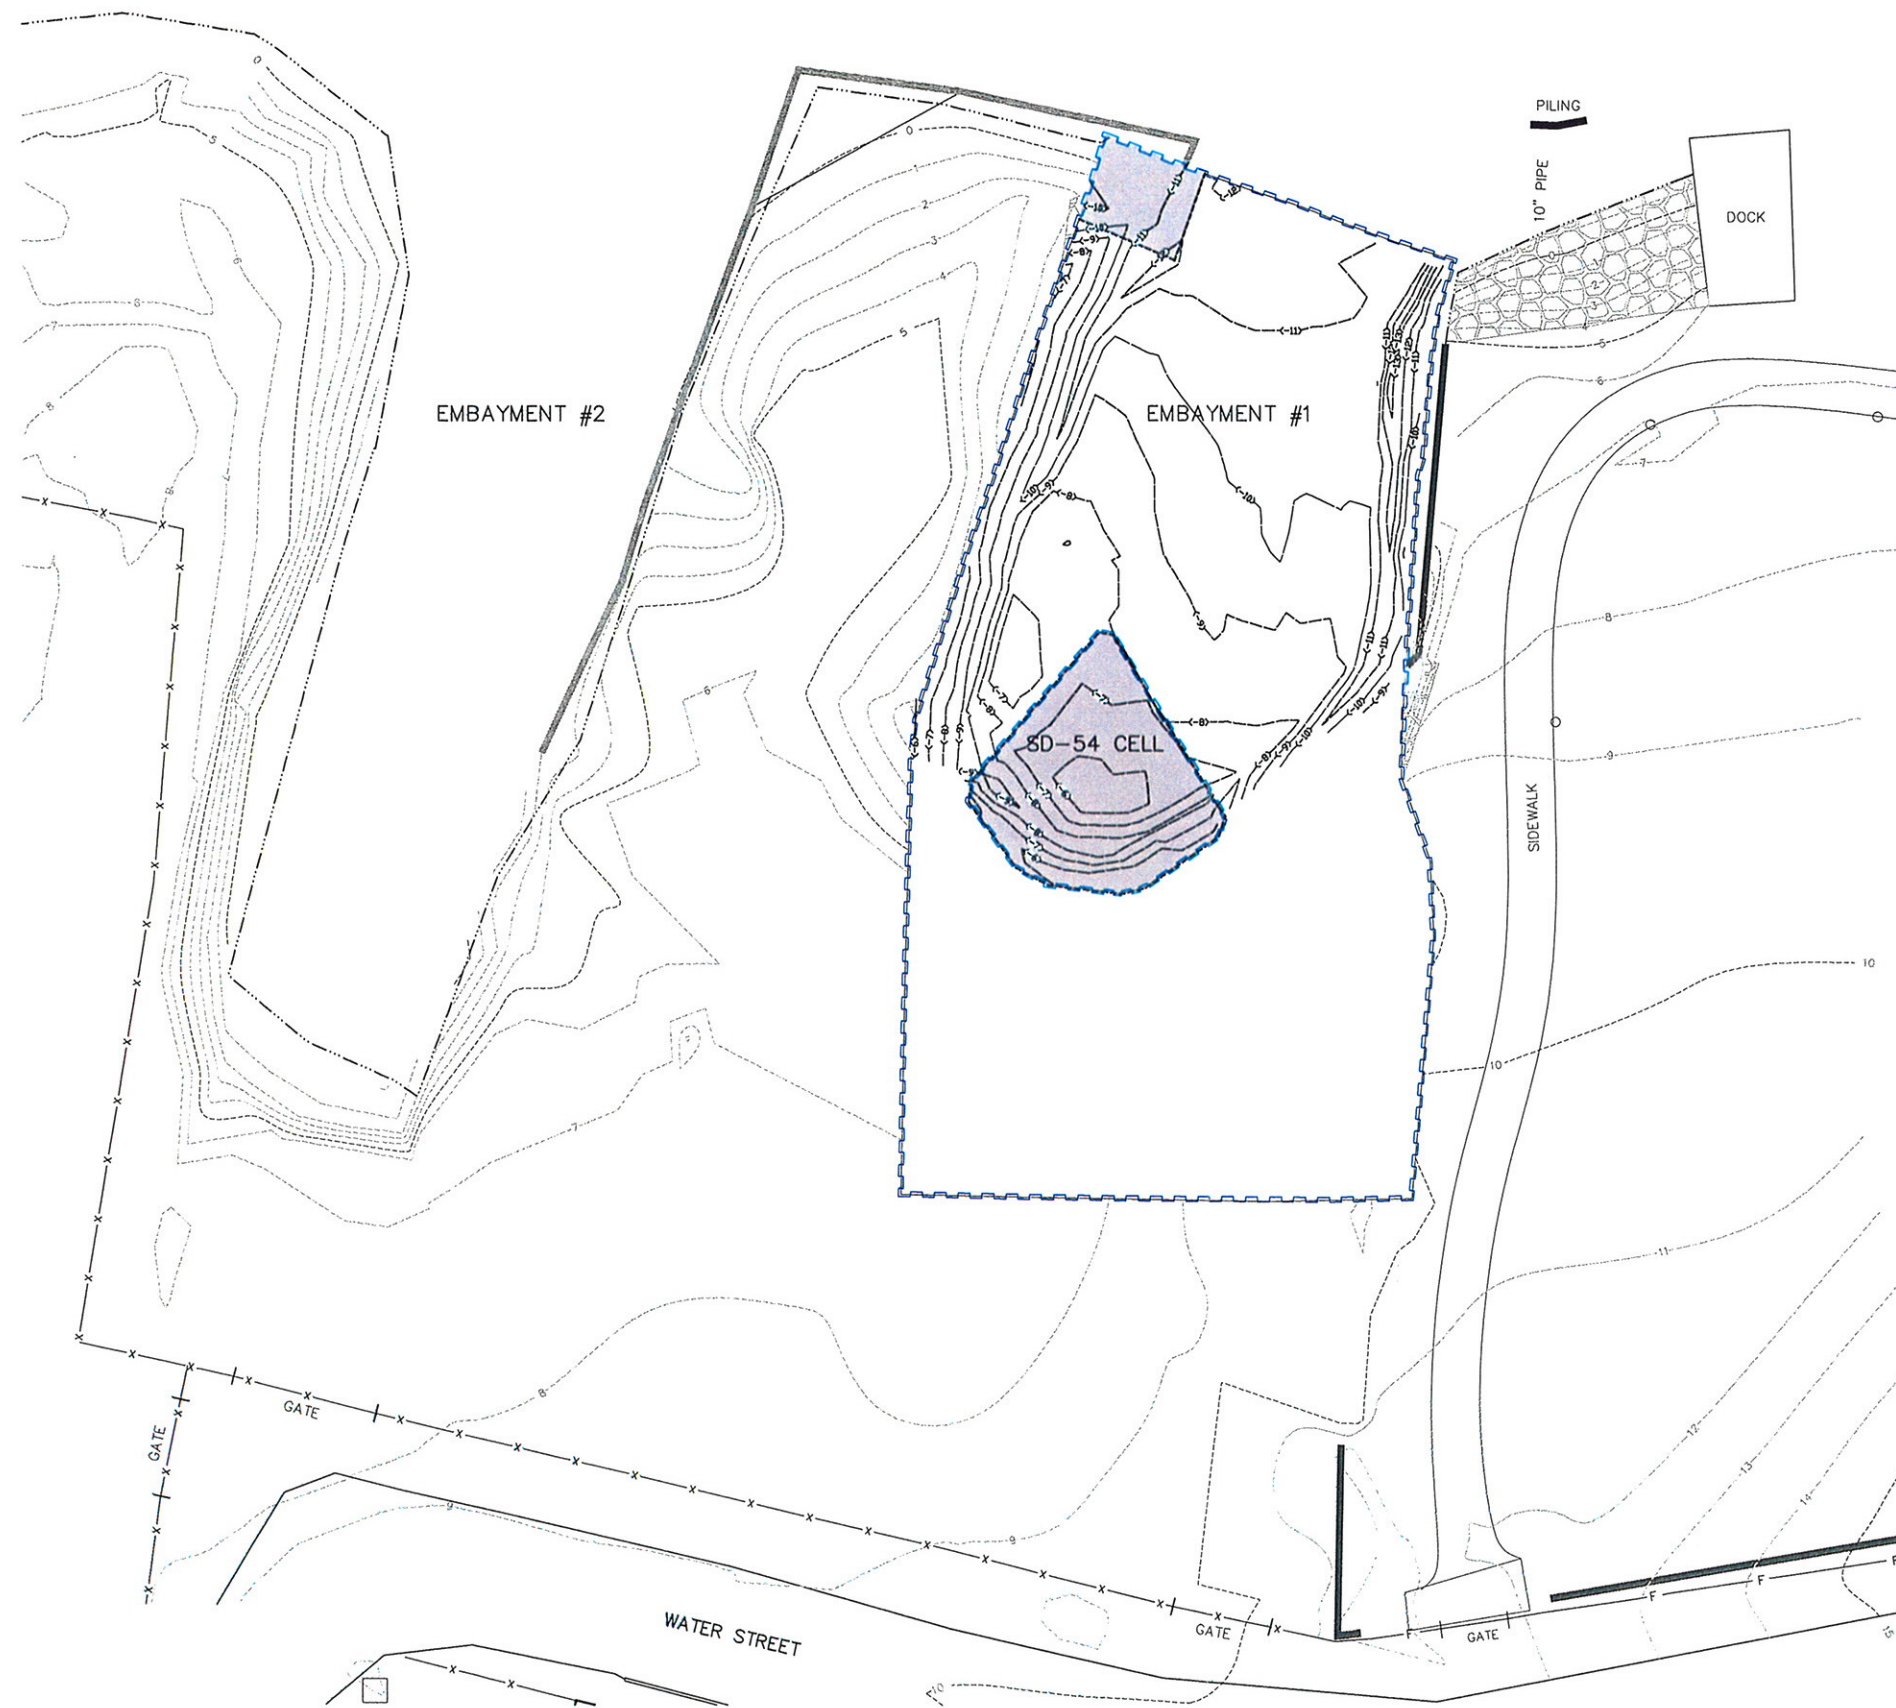
<p>NATIONAL GRID HUDSON (WATER STREET) SITE HUDSON, NEW YORK FINAL ENGINEERING REPORT EMBAYMENT #1 EXCAVATION AREA - SAND LAYER AND ENGINEERED CONTAINMENT SYSTEMS</p>	
<p>BBL BLASLAND, BOUCK & LEE, INC. engineers, scientists, economists</p>	<p>FIGURE 4</p>

On January 12 and 13, 2005, Earth Tech installed an engineered containment system within the southwest corner of Embayment #1 to encapsulate an isolated area of impacted material that remained in-place (below the designed excavation depth of 10 feet bgs) following excavation activities. Impacted material was removed to a depth of 12 feet bgs; however, excavation below 12 feet bgs within the southwest corner of Embayment #1 was determined to be unsafe due to the proximity and depth of the impacted material to the sheetpile wall. As such, a containment system was installed consistent with Section 4.6.2 of the Final BOD. The containment system covered approximately 400 square feet (20 feet by 20 feet), and consisted of a 60-mil LLDPE geomembrane, covered by a non-woven geotextile fabric and a 1-foot-thick layer of clean sand. Along the south and west side of the containment system (adjacent to the southern and western sheetpile walls) wooden forms (1 foot high by 2 feet wide) were installed and filled with bentonite to create a seal between the sheetpile wall and the containment system. Trenches (1 foot high by 2 feet wide) were excavated along the north and east side of the containment system. The edge of the 60-mil LLDPE geomembrane was placed in the trench, and the trench was backfilled with bentonite to form a bentonite seal, and key the containment system into native soil.
