**Re:    *National Grid Hudson Water Street Site  
Hudson, New York  
2013 Ground Water Monitoring Report***

Subject: 2012-2013 Groundwater Monitoring Report  
Hudson (Water Street) Site, Hudson, New York

**Site Inspection  
Hudson-Water Street  
Operable Unit 1  
Hudson, New York**

## National Grid Hudson Water Street Site Photographic Log

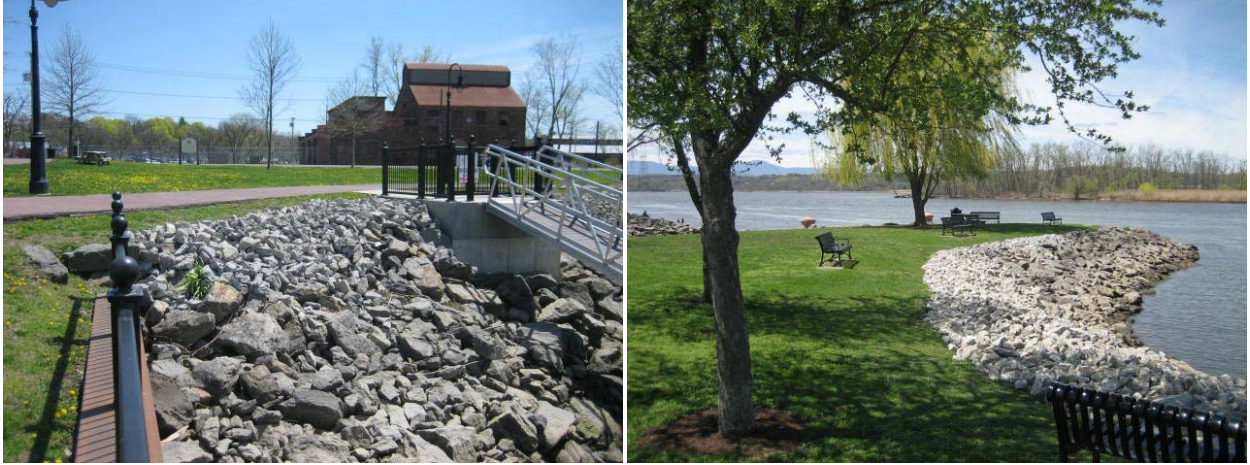
Rip Rap/Stone Riverbank Protection Improvements.  
Photos Taken: 4/20/13

Minor settlement and erosion along the riverbank continues to be an issue. CDM Smith continues to monitor the rip rap/stone riverbank protection and recommends material placement as needed. In April 2013, approximately 65 tons of rip rap/stone was placed along the riverbank to restore adequate protection by Abscope Environmental, Inc.

- On April 29-30, 2013, Abcope Environmental, Inc. installed approximately 65 tons of rip rap/stone along the riverbank to restore adequate protection.

Installed 65tons of small rip rap stone with Abscope on 4/29-4/30.

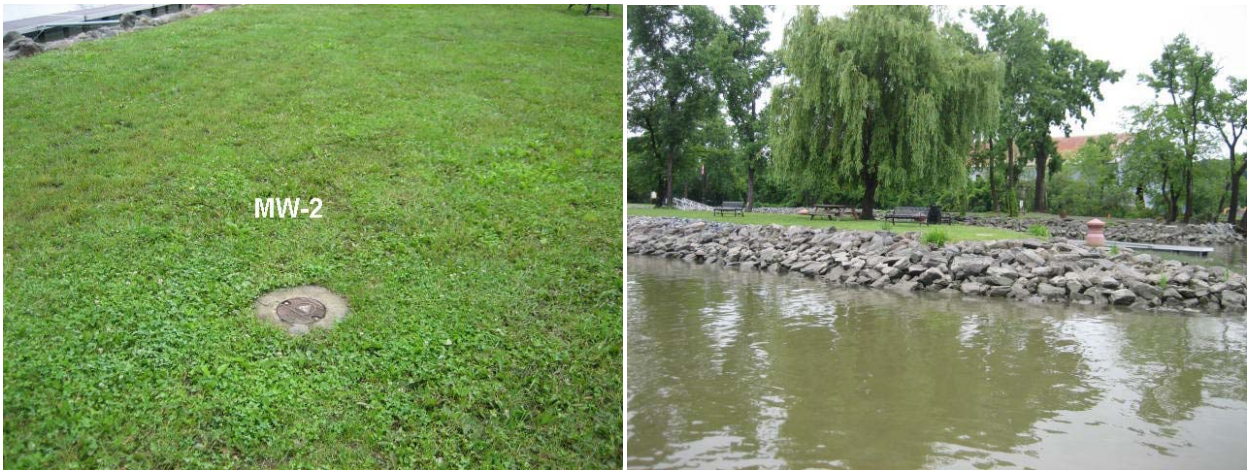
Well Cover Replacement and Rip Rap/Stone Riverbank Protection  
Photos Taken: 6/10/13

The site is in good shape. Some minor rip rap/stone repairs were made to the riverbank protection. A few of the monitoring well covers were replaced.
