**Re: National Grid Hudson Water Street Site  
Hudson, New York  
2021 Groundwater Monitoring Report**

# 2021 Groundwater Monitoring Report

National Grid Hudson Water Street Site  
Water Street between Ferry Street and Broad Street  
Hudson, NY 12534

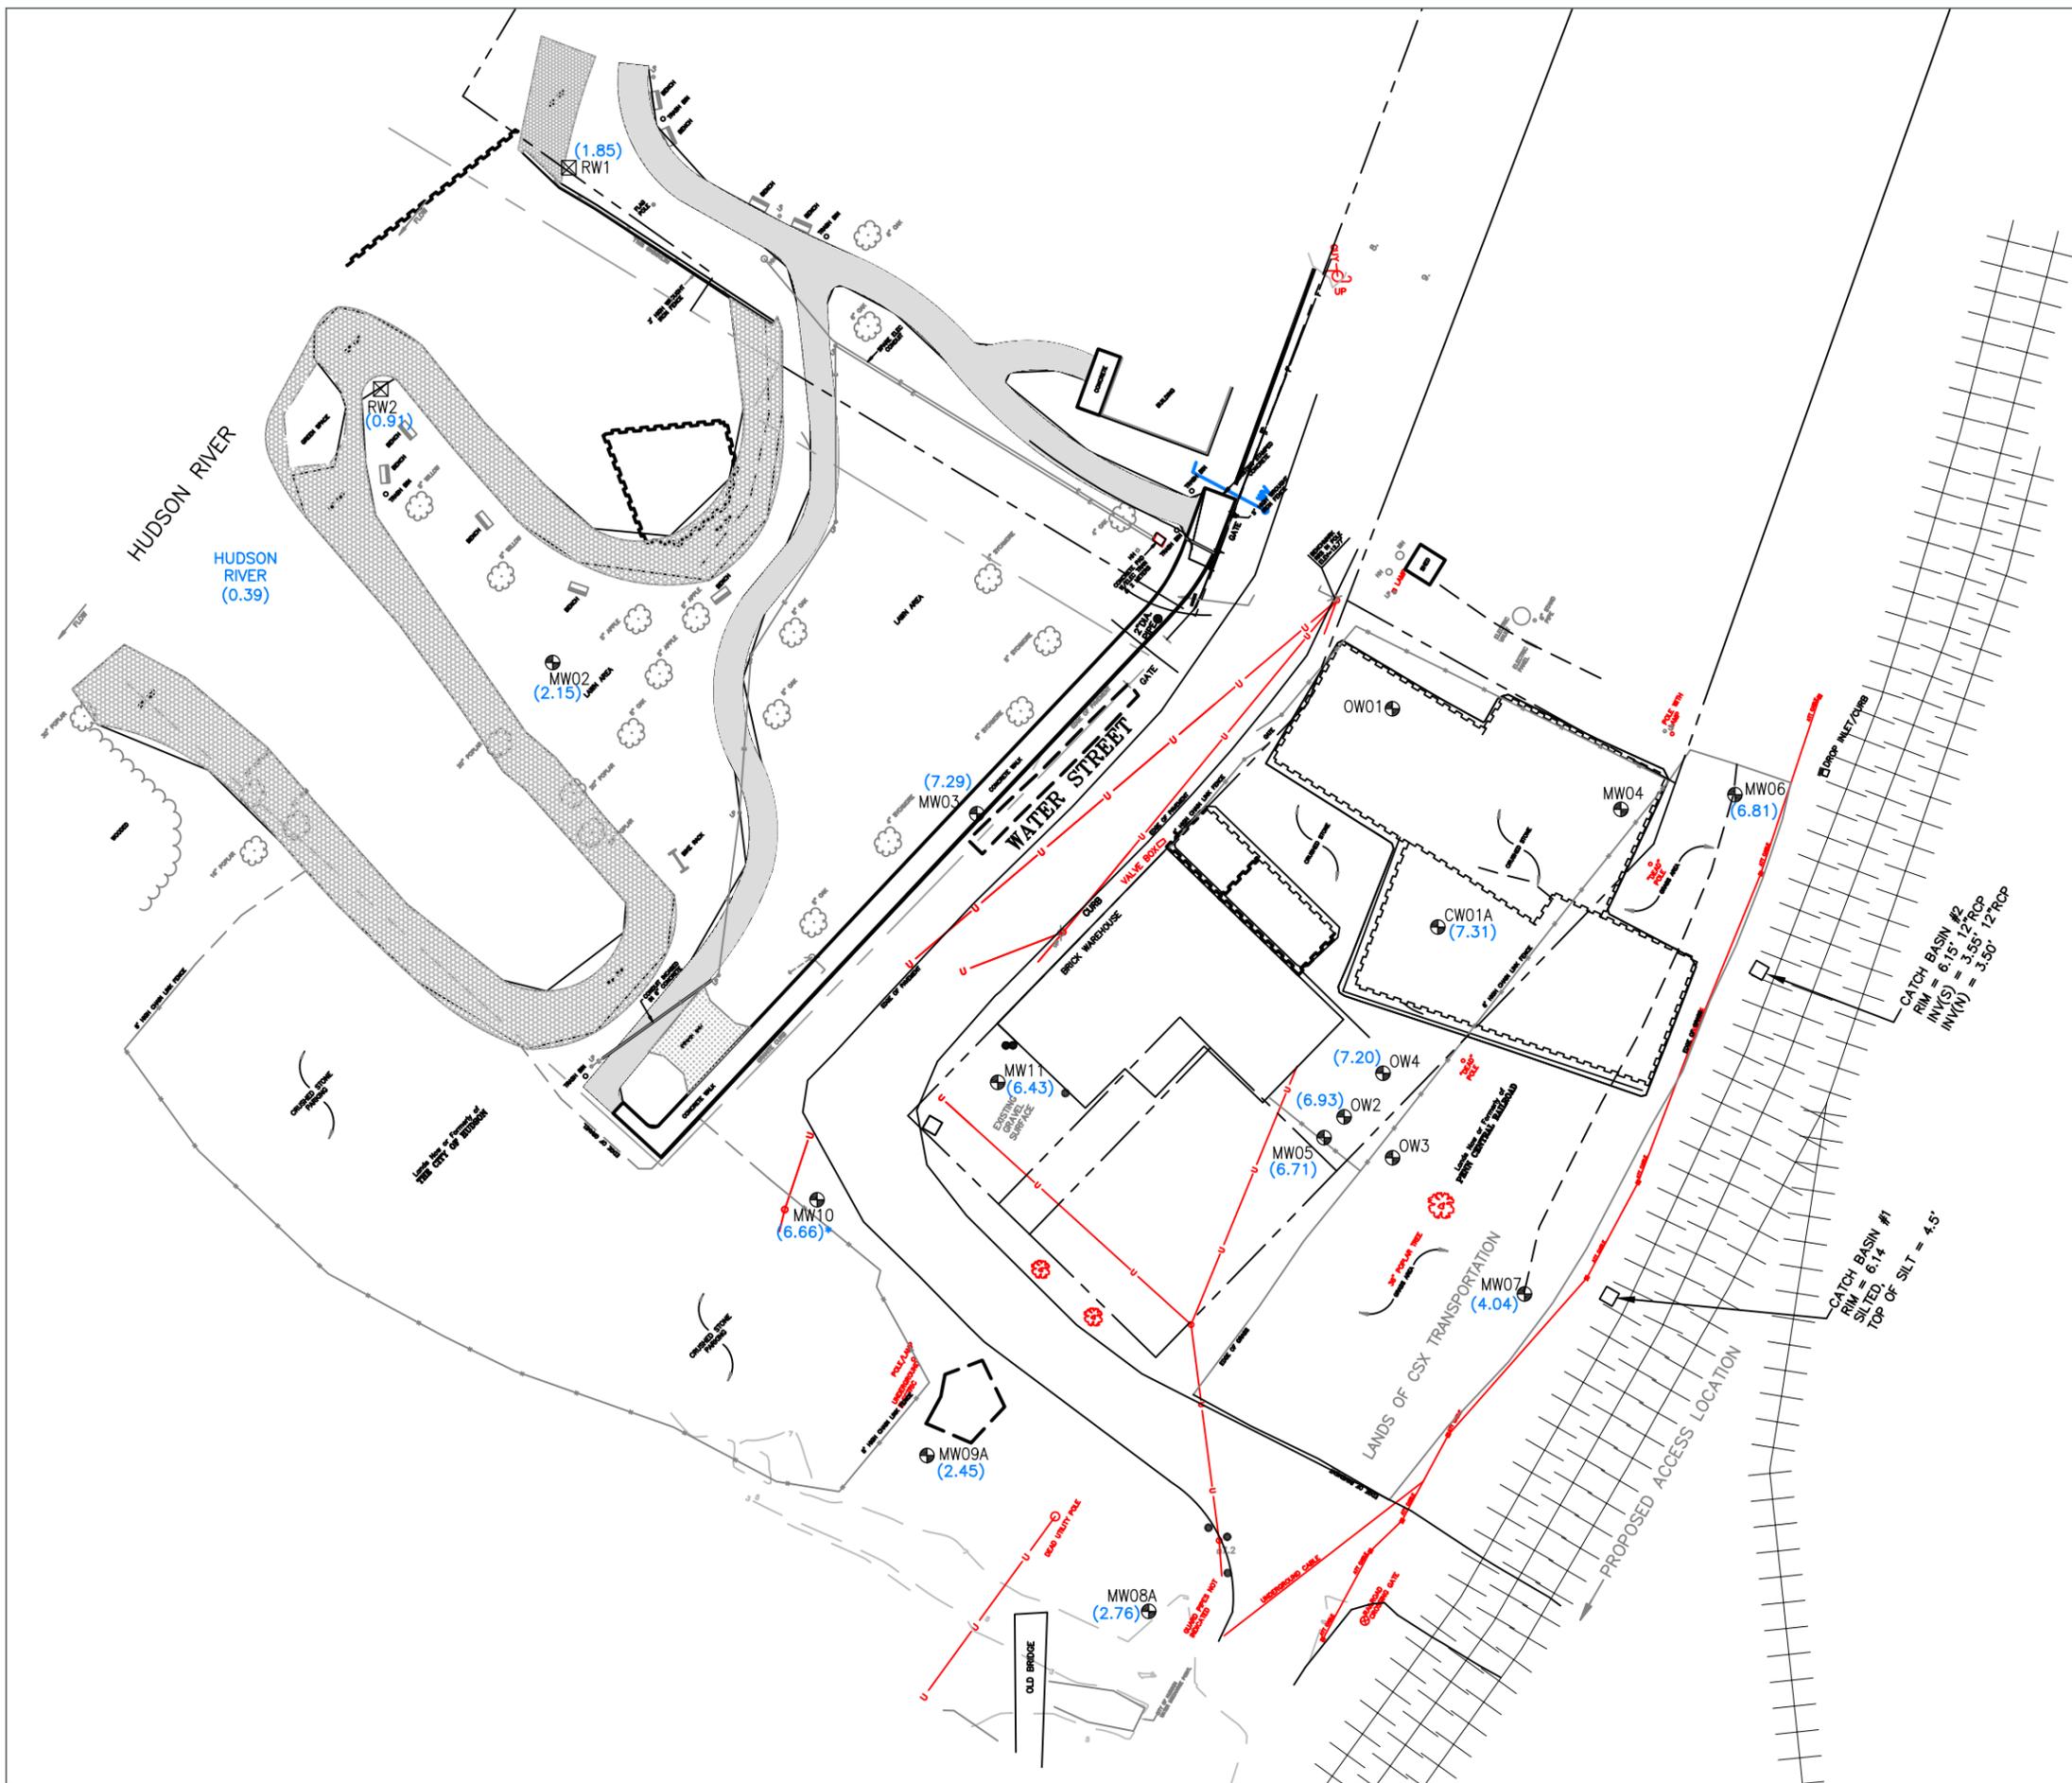
Groundwater Elevation Map June 17, 2021	
National Grid Water Street Hudson, New York	
Drawn W.G.S. Designed	Date 6/25/21 Figure 1
Approved

Annual gauging field data is presented in **Table 2**. In general, site groundwater flows radially outward from the former gas holder area toward the Hudson River, consistent with past groundwater elevation data.

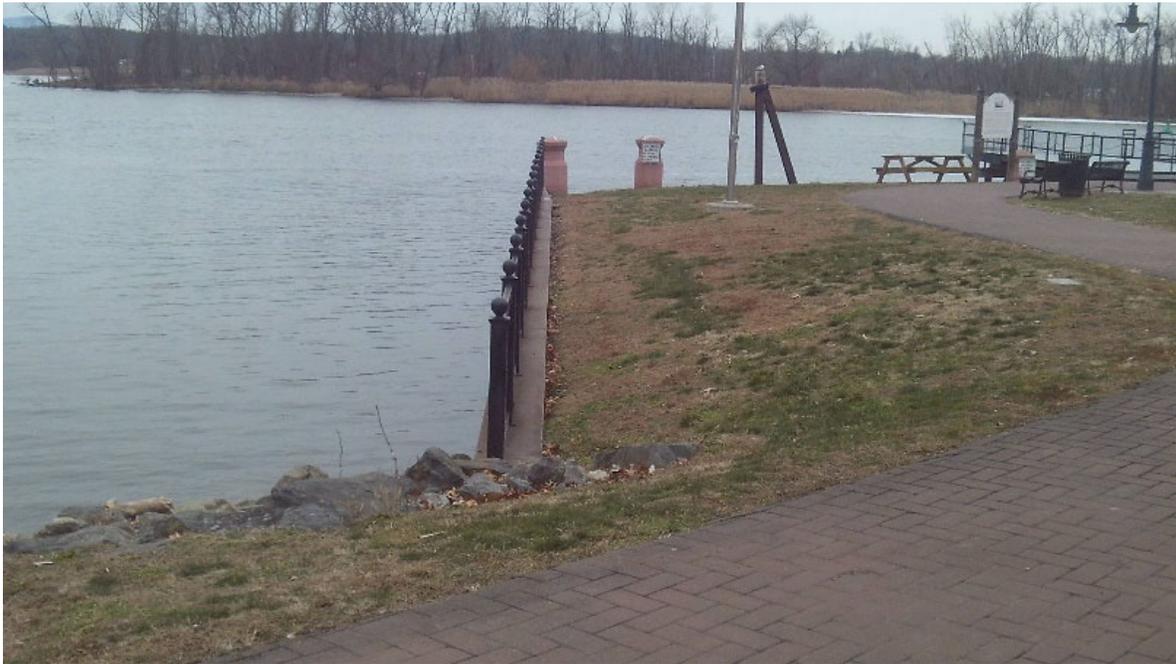
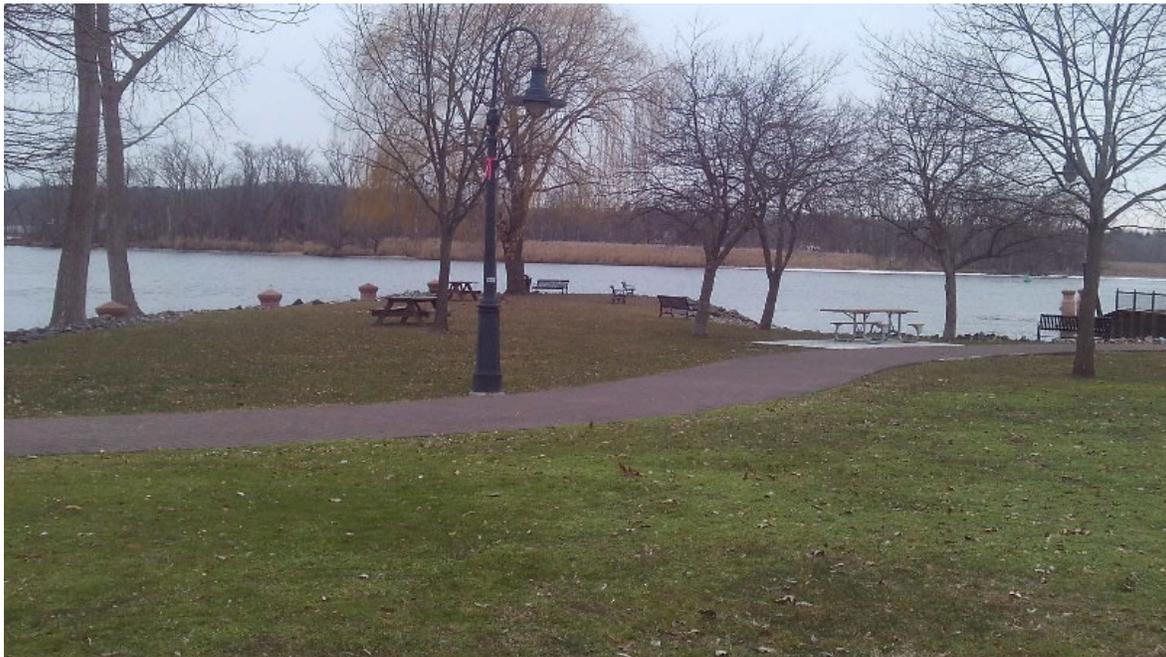
Site Photo – December 2020

In general, the Site is in good condition and in compliance.

Site inspections during this reporting period indicated no maintenance was required on site. Photographs from quarterly site visits are included in **Attachment D**.
