**Re: National Grid Hudson Water Street Site  
Hudson, New York  
2024 Groundwater Monitoring Report**

# 2024 Groundwater Monitoring Report

National Grid Hudson Water Street Site  
Water Street between Ferry Street and Broad Street  
Hudson, NY 12534

GES Project:  
0603340.125340.221

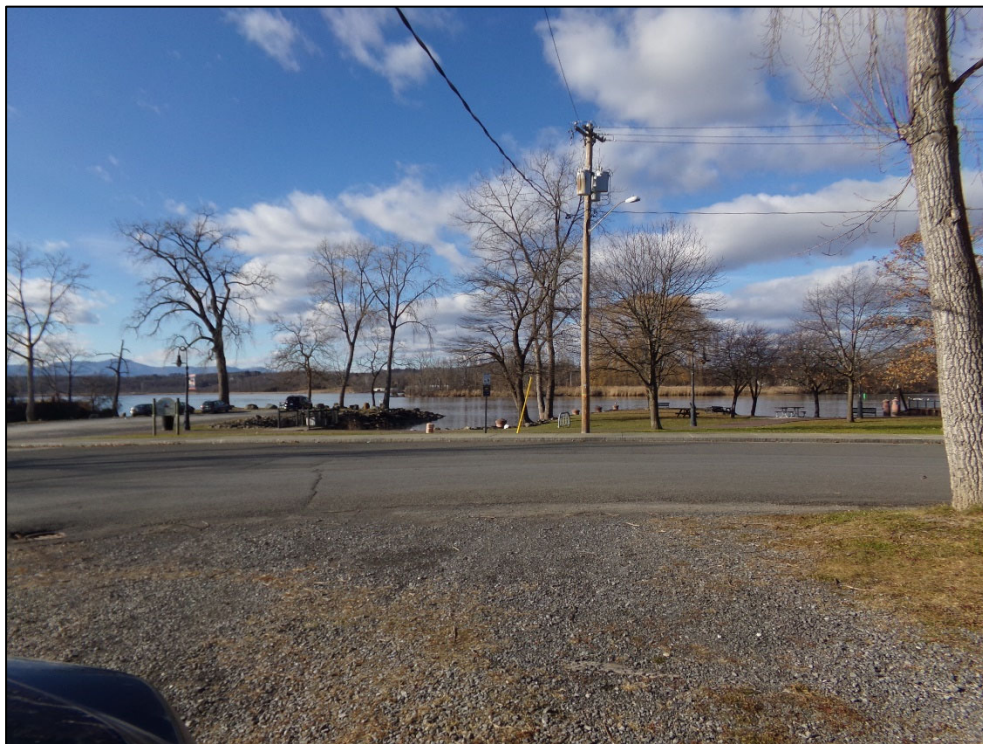
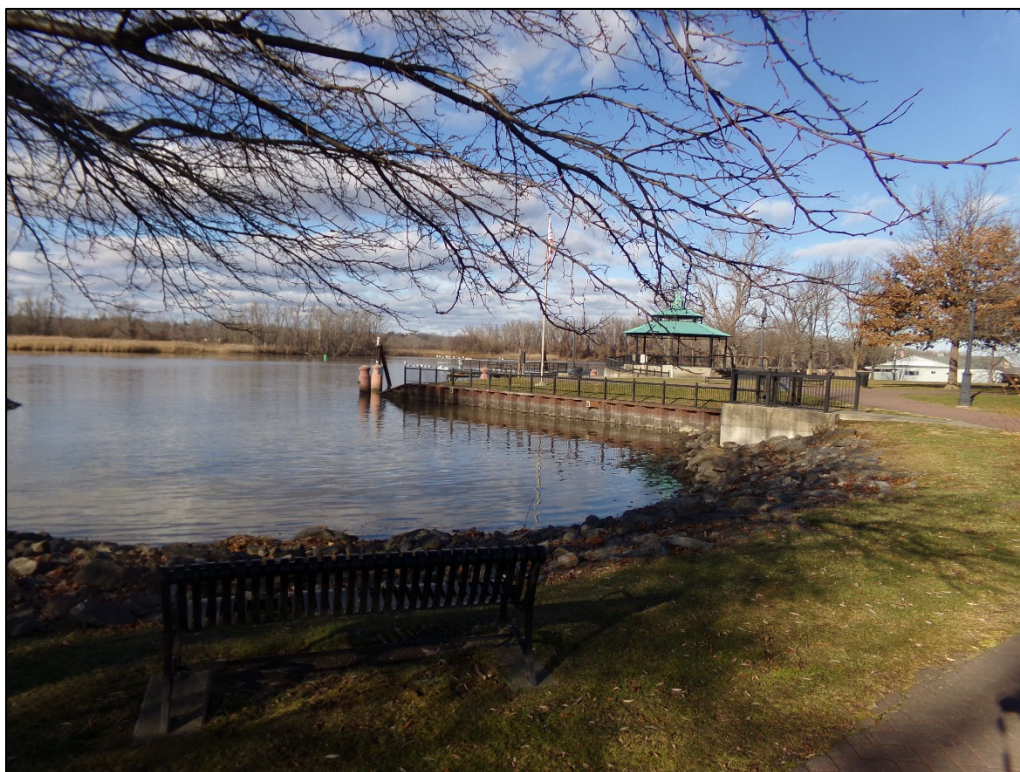
Site Conditions – December 2023

In general, the Site is in good condition and in compliance.

Site inspections during this reporting period indicated no maintenance was required on site. Photographs from quarterly site visits are included in **Attachment D**.
