Re: Former Bouchard Junkyard Site (Site No. 4-11-014)
Wetland Pre-Excavation Characterization
D&B No. 2605

Dvirka and Bartilucci Consulting Engineers (D&B) was retained by the New York State Department of Environmental Conservation (NYSDEC) to perform wetland pre-excavation characterization monitoring and sampling at the Former Bouchard Junkyard Site located in New Lebanon, New York (see Figure 1 in Attachment A). The work was completed to define the existing hydrology, soil and vegetation conditions that currently exist within the wetlands area. The data collected will be used to define the conditions by which the post-excavation wetland restoration will be compared to gauge the success of the restoration. The following sections discuss the sampling and monitoring activities that were completed and present the results from each activity.

Baseline Vegetation Survey

Former Bouchard Junkyard Site
Town of New Lebanon
Columbia County, New York
(Site Registry NO. 4-11-014)

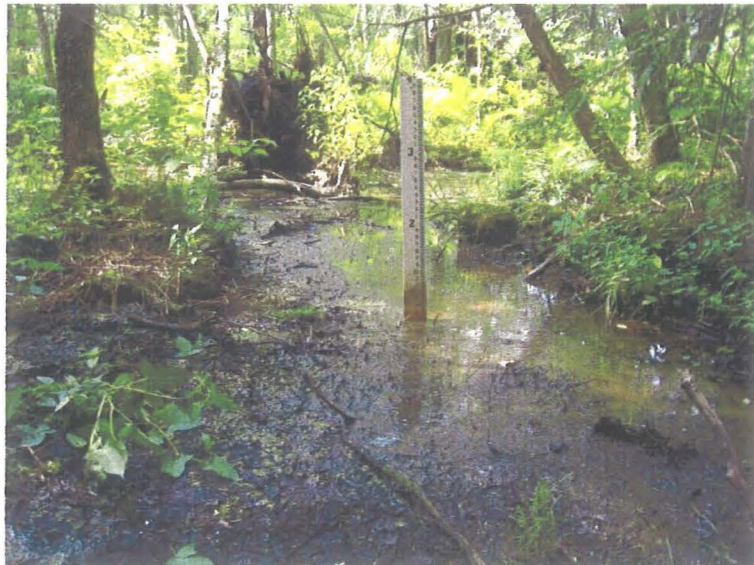
Staff Gauge Location 6.

This location, which will serve as an undisturbed control, was on east side of site. The staff gauge was located in the intermittent stream identified on site plans. Immediately surrounding the gauge was an open space of mud and standing water. Around this area were raised hummocks supporting trees and other vegetative growth. The canopy was fairly closed over this location. Shrubs were abundant, but were not so dense as to prevent walking through the area. Herbaceous vegetation was distributed predominantly on hummocks, although aquatic vegetation such as duckweed and tearthumb were observed in the hollows. For additional photographs, see [Appendix 1](#).

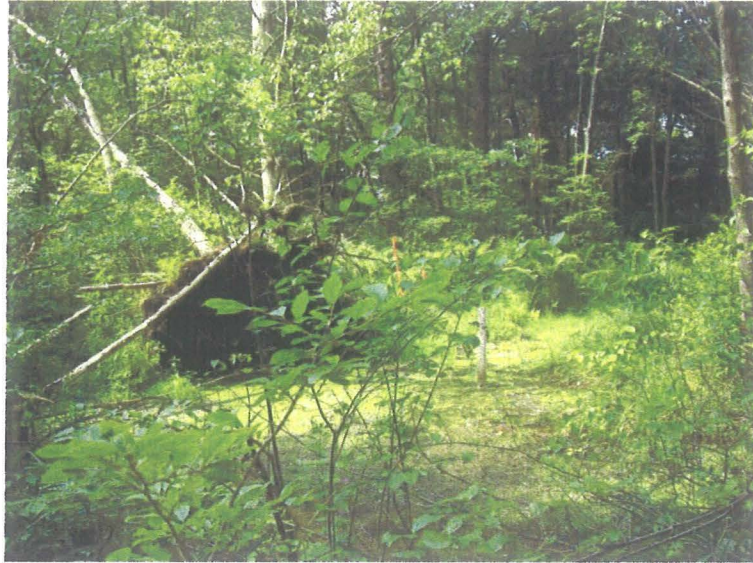
Staff Gauge Location 4.

Located on the eastern side of the site at its lowest elevation, this location was the wettest vegetation sampling point and the area will be excavated during remediation. This area was characterized by multiple tree blow-downs and a shrubby understory. Vegetative growth was predominantly clustered on raised hummocks, while some herbaceous vegetation tolerant of wetter conditions were observed in the lower areas. The canopy was relatively open due to the number of blowdowns in the area. For additional photographs, see [Appendix 1](#).

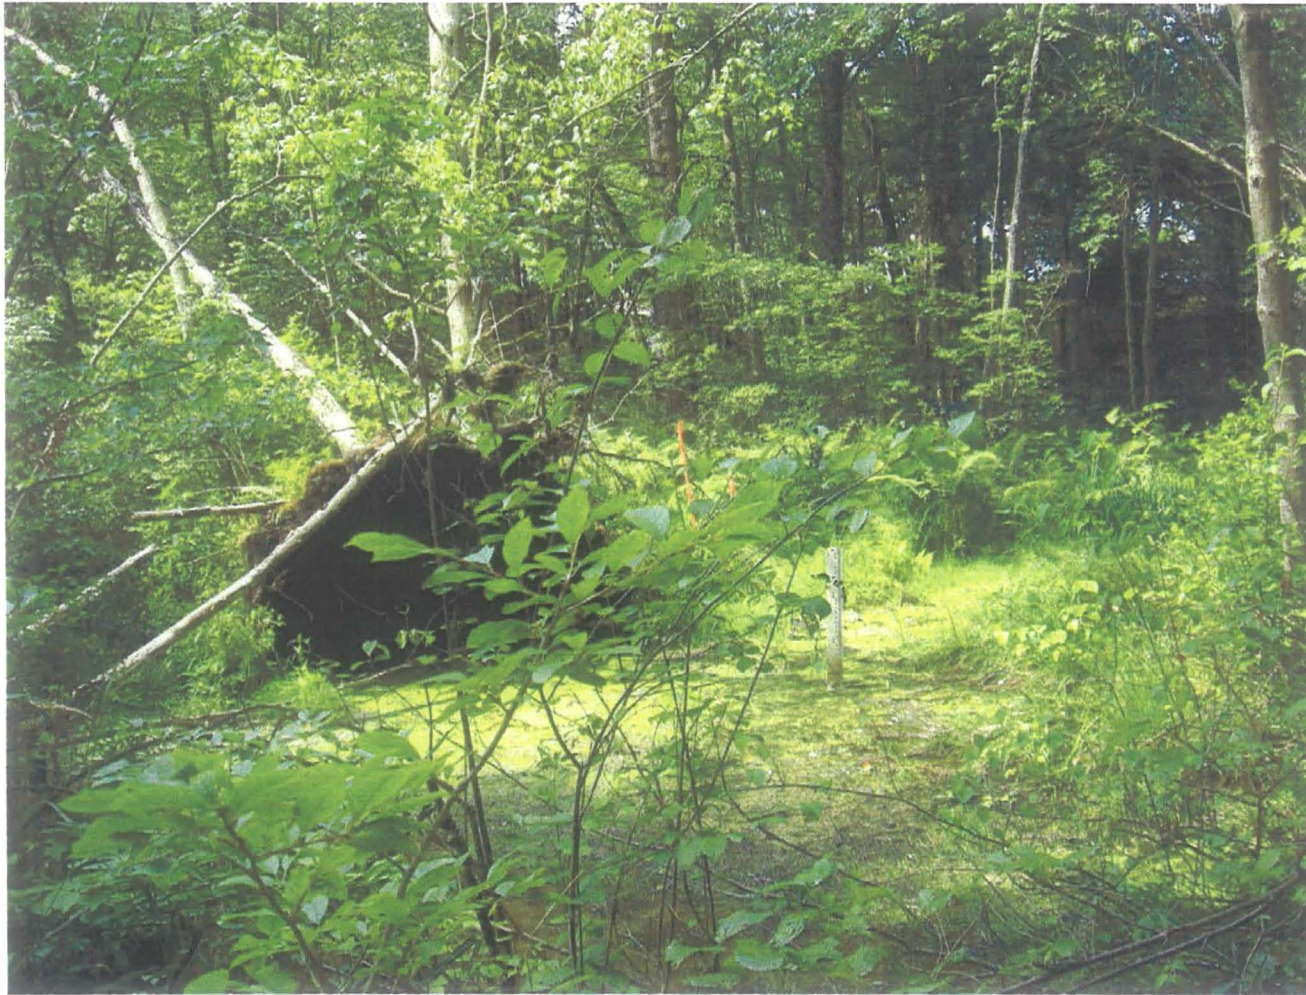
Staff Gauge Location 4. View from hummock east of gauge facing west. Red maple dominates the canopy, multiple “blow-downs” in the vicinity. Shrub layer includes green ash, meadowsweet, highbush blueberry and arrow wood. Herbaceous layer includes sensitive fern, jewelweed, mosses, and sedges.

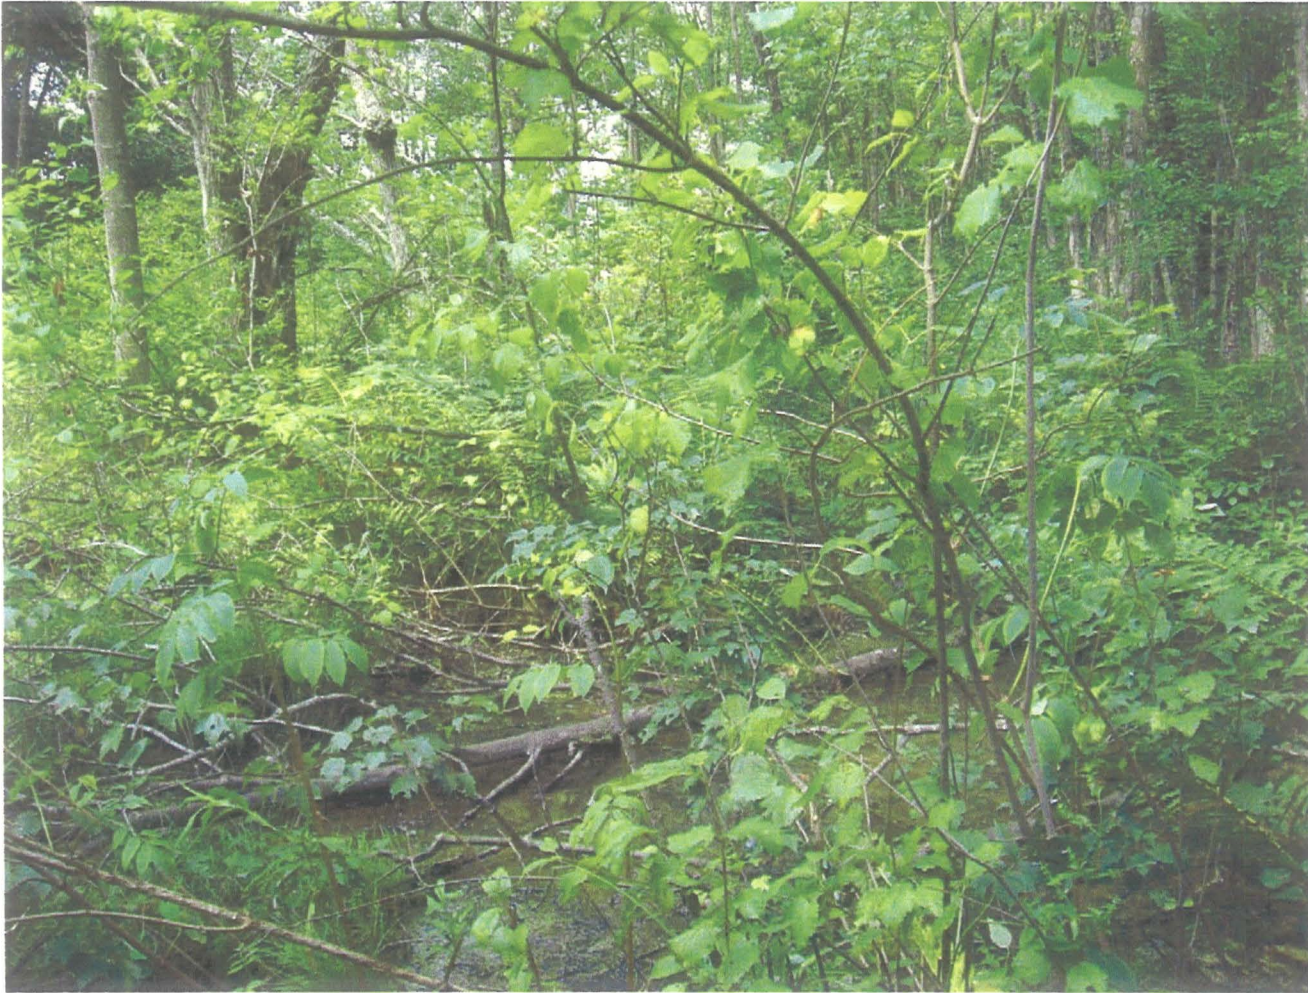
Staff Gauge Location 4. View from hummock east of gauge facing northwest. Vegetation occurring north of the gauge (gauge is out of the image to the left). Water was present at the surface, and soils were saturated. Plants were growing on raised hummocks.

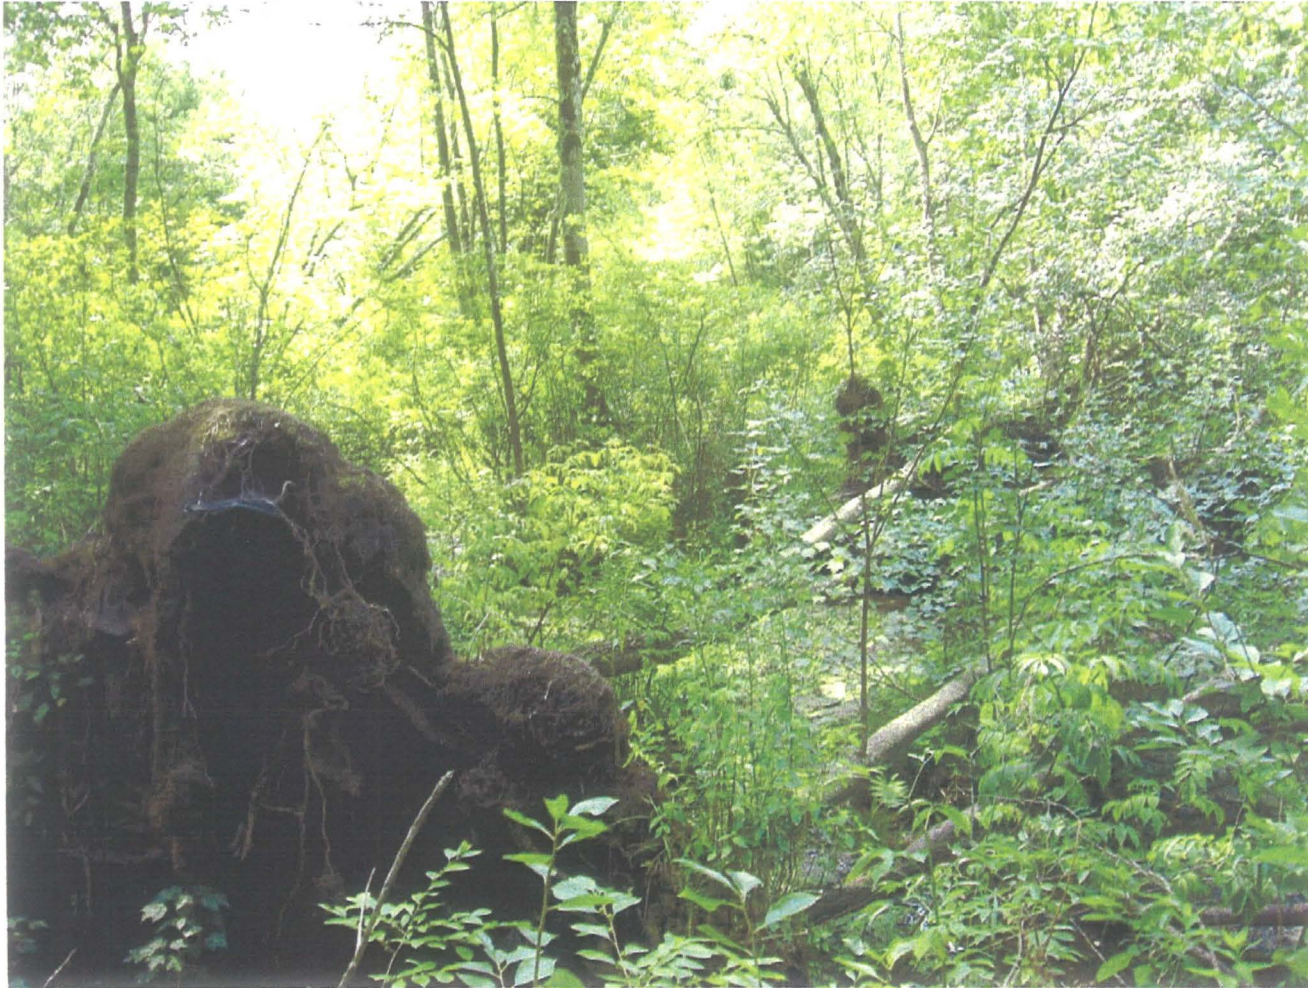
Staff Gauge Location 4. View from hummock east of gauge facing south. Multiple blow-downs have occurred in this area; one in foreground and two in background of this image. Gauge is outside of this image to the right, adjacent to another blowdown. There is another blowdown behind the photographer. Approximately eight blowdowns were noted in this area.

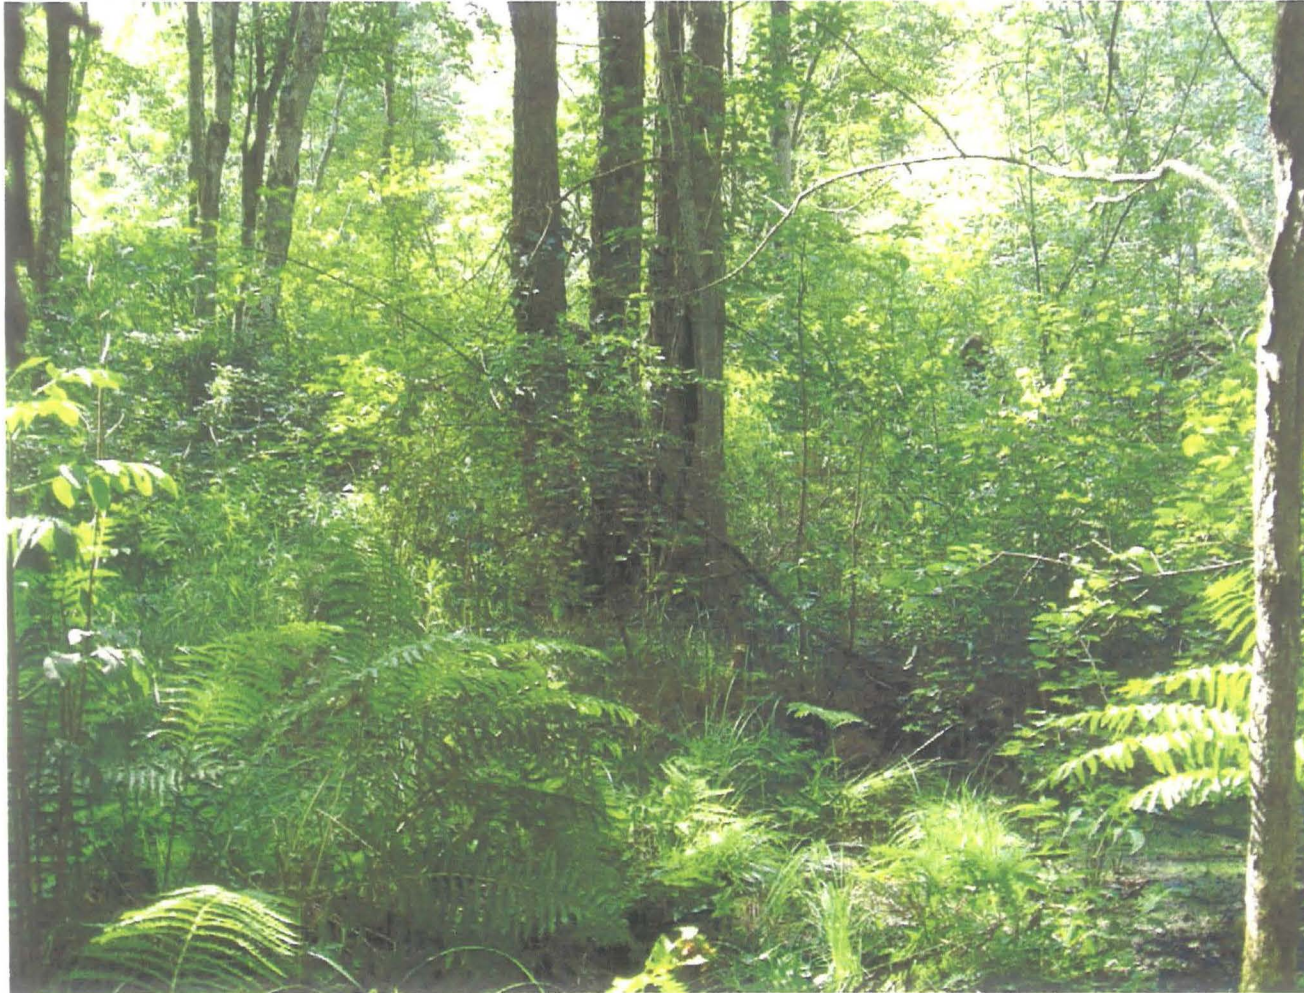
Staff Gauge Location 4. View of the four-tree hummock (center) east of Gauge Location 4, facing south. Image was taken from a hummock about half-way between Gauge Location 4 and Gauge Location 6. Gauge 4 is outside of the image to the right and is not visible from this vantage point.

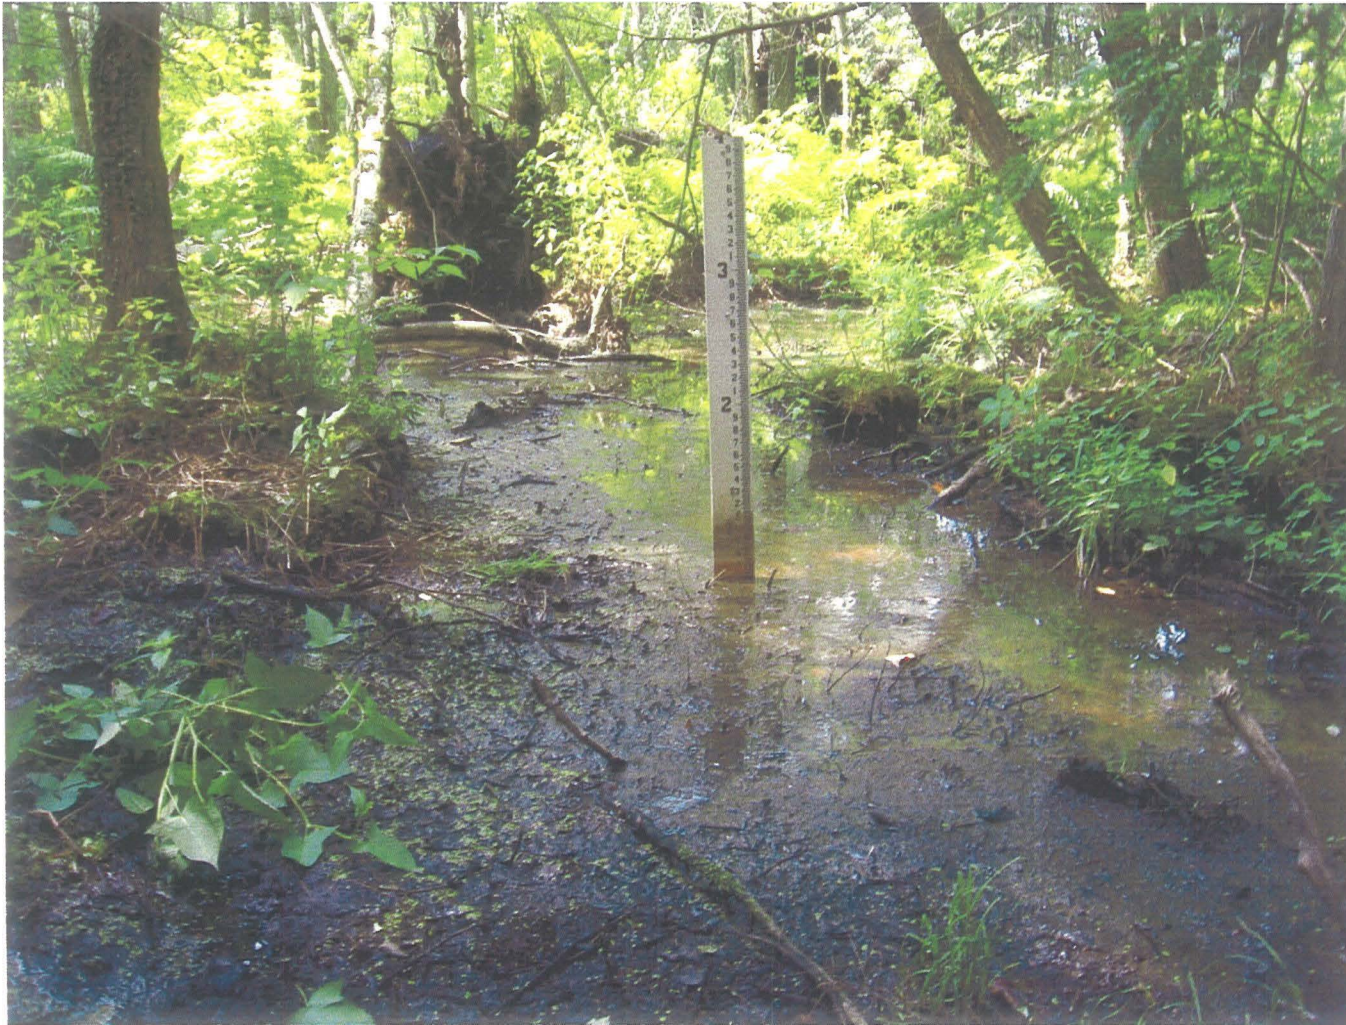
Staff Gauge Location 6. View from hummock north of gauge facing south. Herbaceous vegetation visible includes Halberd-leaved tearthumb, jewelweed, duckweed, sedges and mosses. Canopy dominated by red maple with eastern hemlock. Shrub layer dominated by common elder.

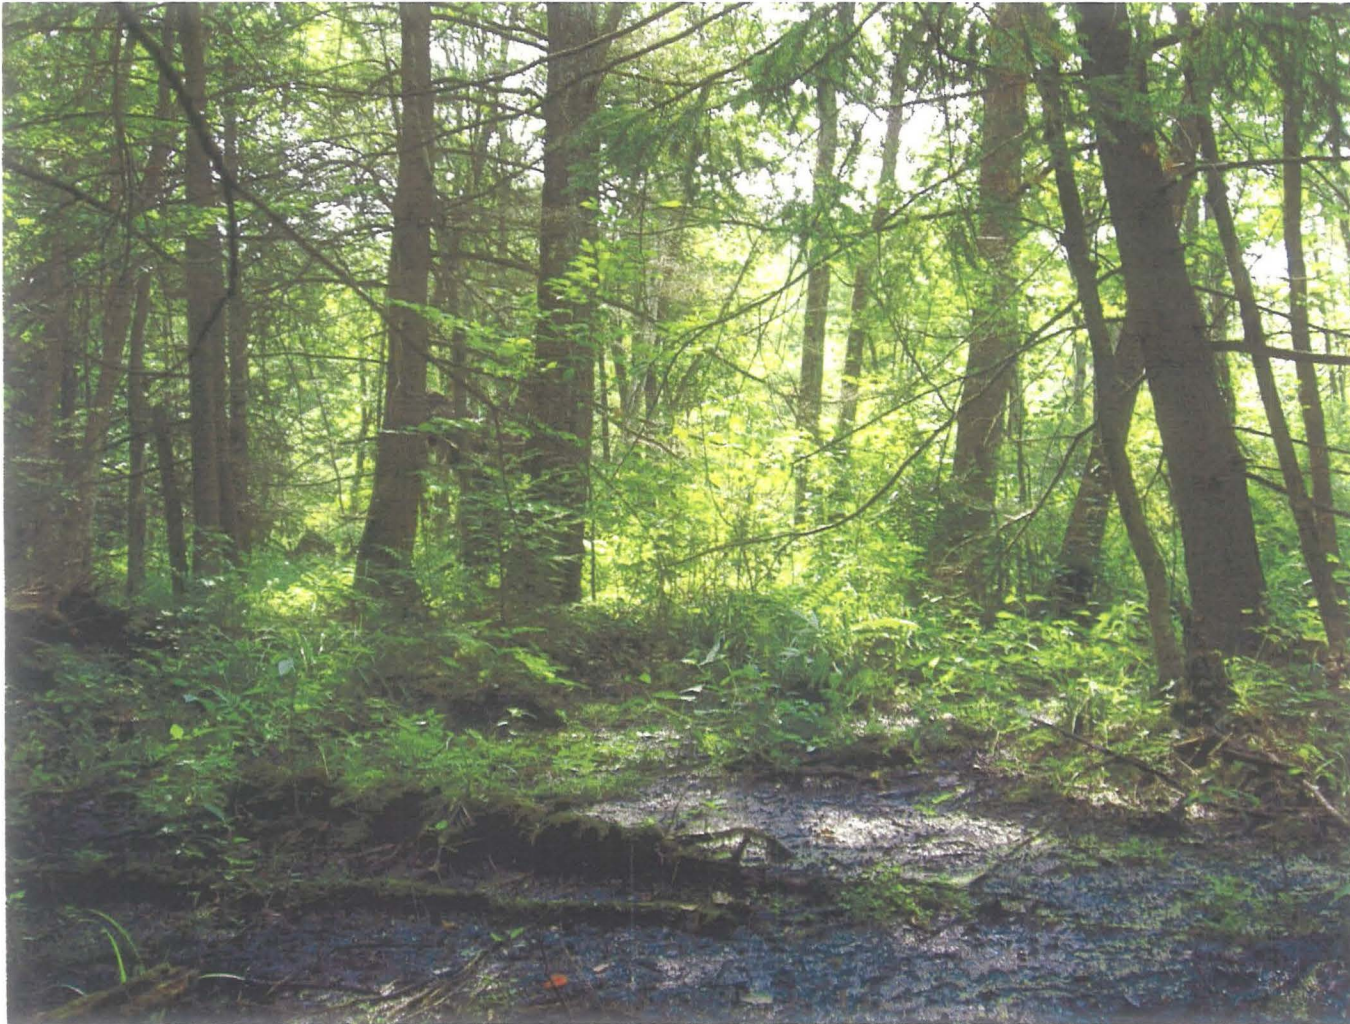
Staff Gauge Location 6. View from hummock north of gauge facing east of gauge (gauge is out of the image to the right). Most of the vegetation grows on hummocks that rise a foot or two above the saturated elevation. Between hummocks, saturated conditions seem to limit most plant growth.

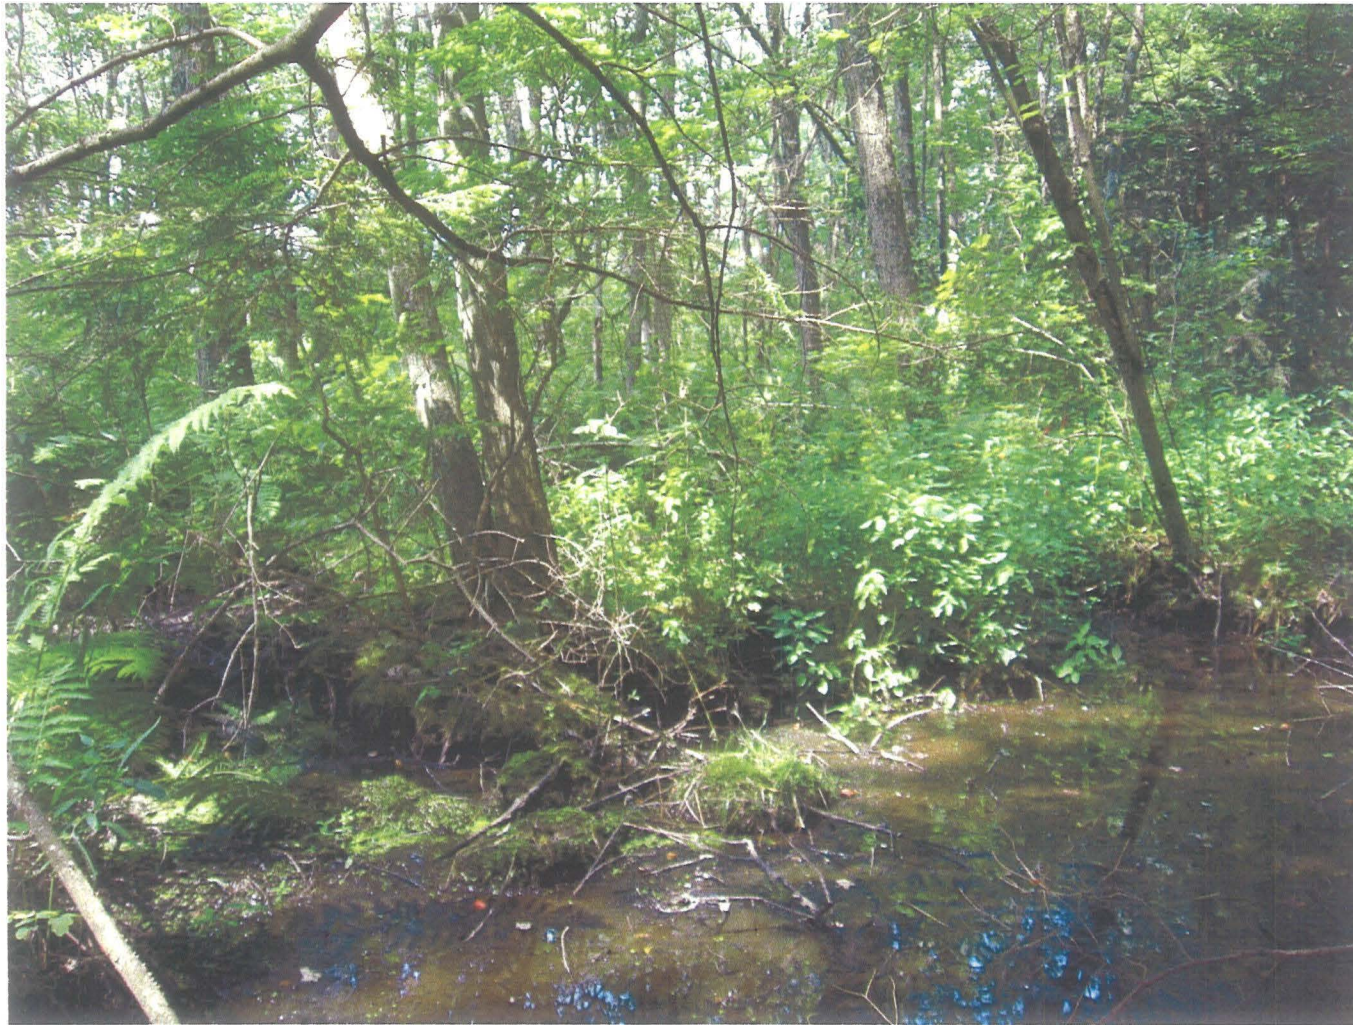
Staff Gauge Location 6. View from hummock north of gauge facing west of gauge (gauge is out of the image to the left). Standing water was present with saturated soils in the foreground. Plants including jewelweed and mosses grow on elevated hummocks; duckweed was observed in the water.

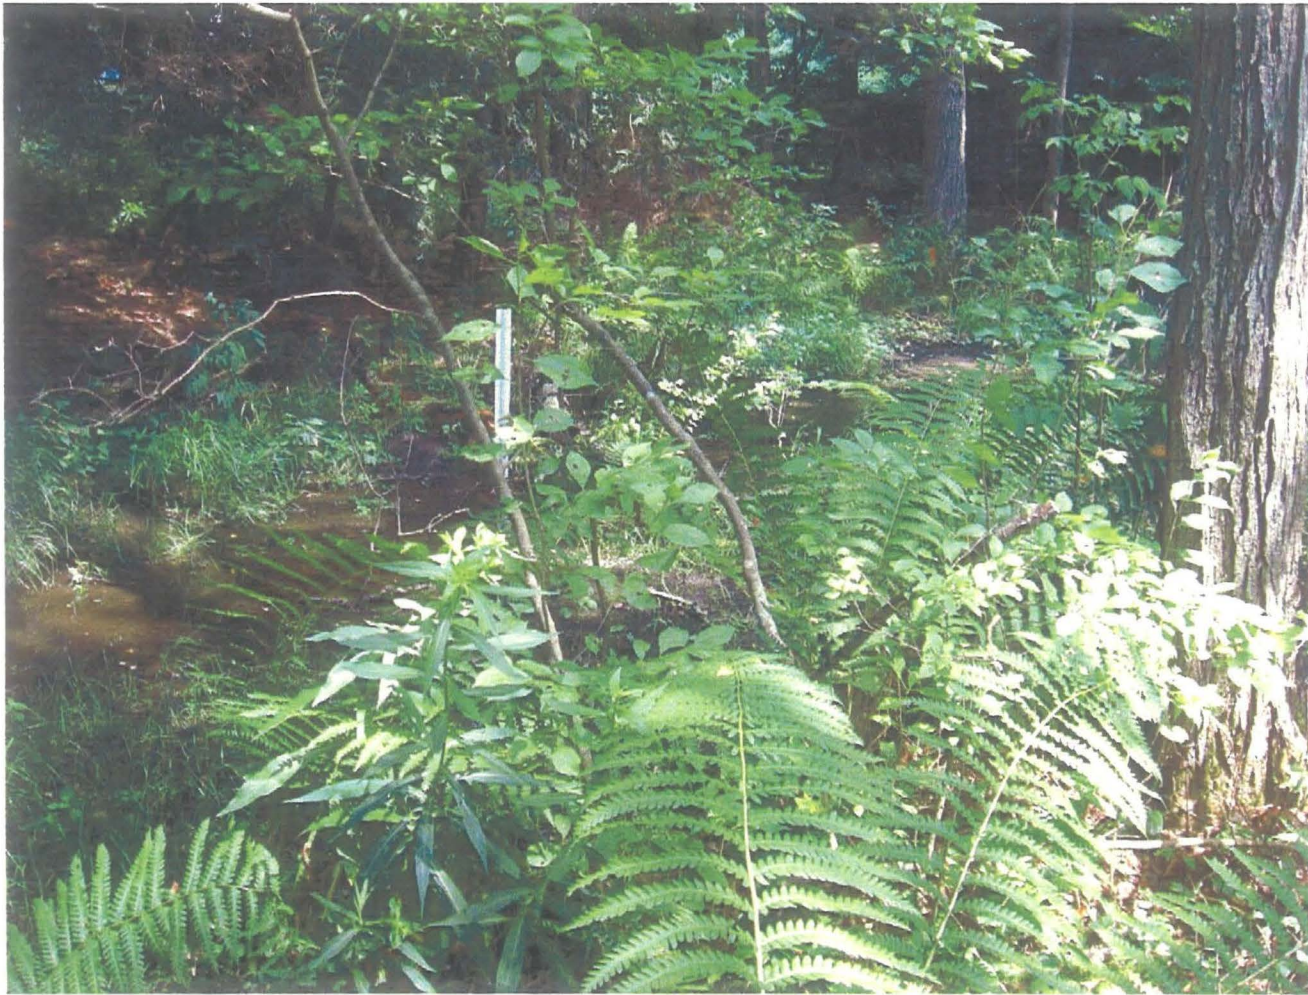
Staff Gauge Location 5. View from hummock in wetland southwest of gauge facing northeast toward upland. Wetland area is to the south of the gauge; north of the gauge becomes upland. Red maple and dogwood dominate the wetland side; eastern hemlock and common elder dominate the upland side in canopy and shrub layers, respectively.

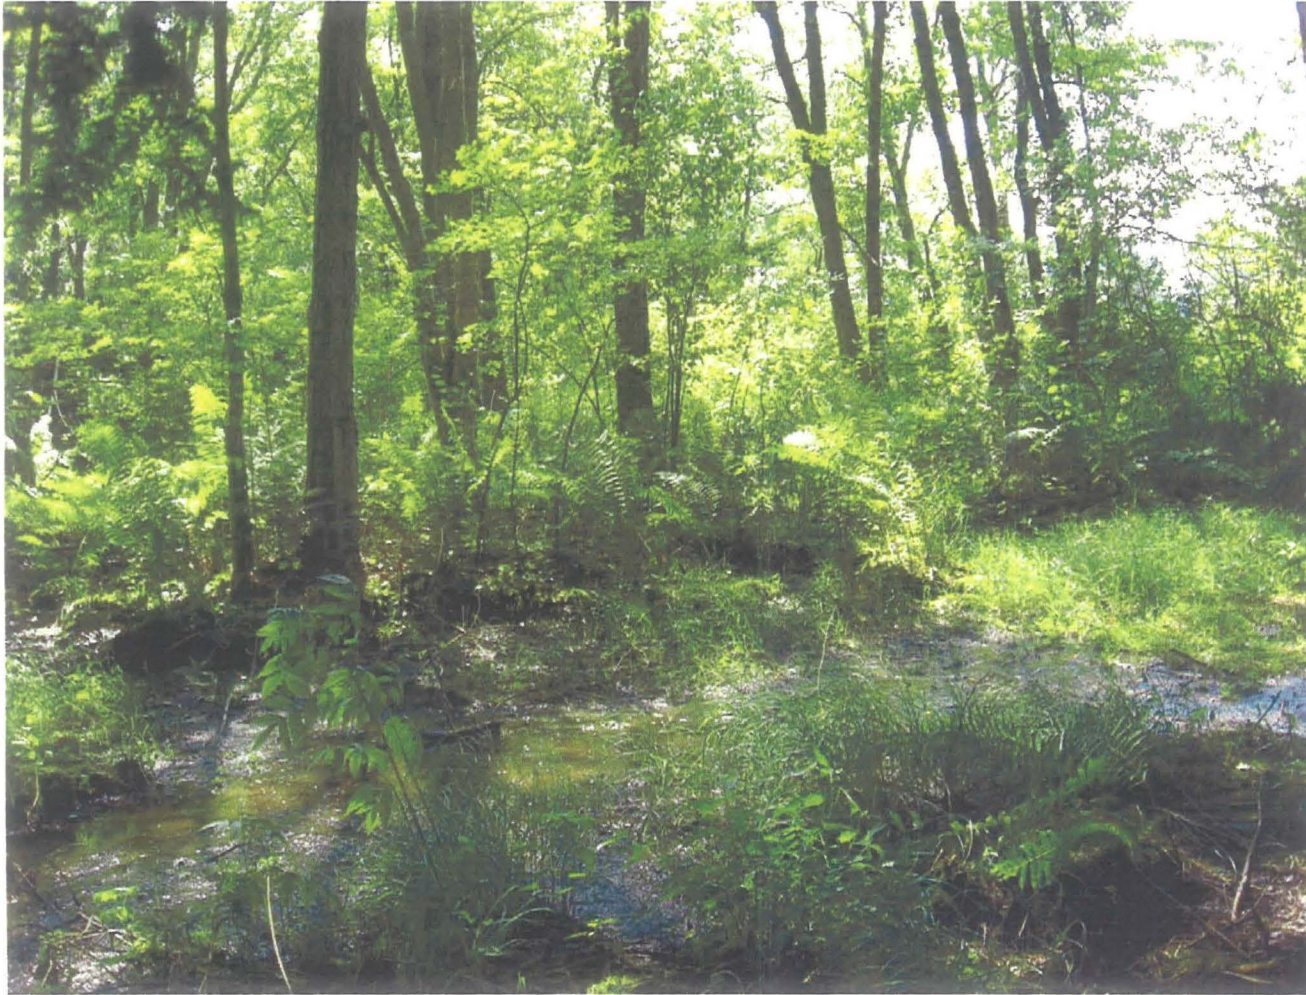
Staff Gauge Location 5. View from edge of wetland north of gauge facing southwest into wetland. Upland is behind the photographer. Gauge is outside of the image, to the left.

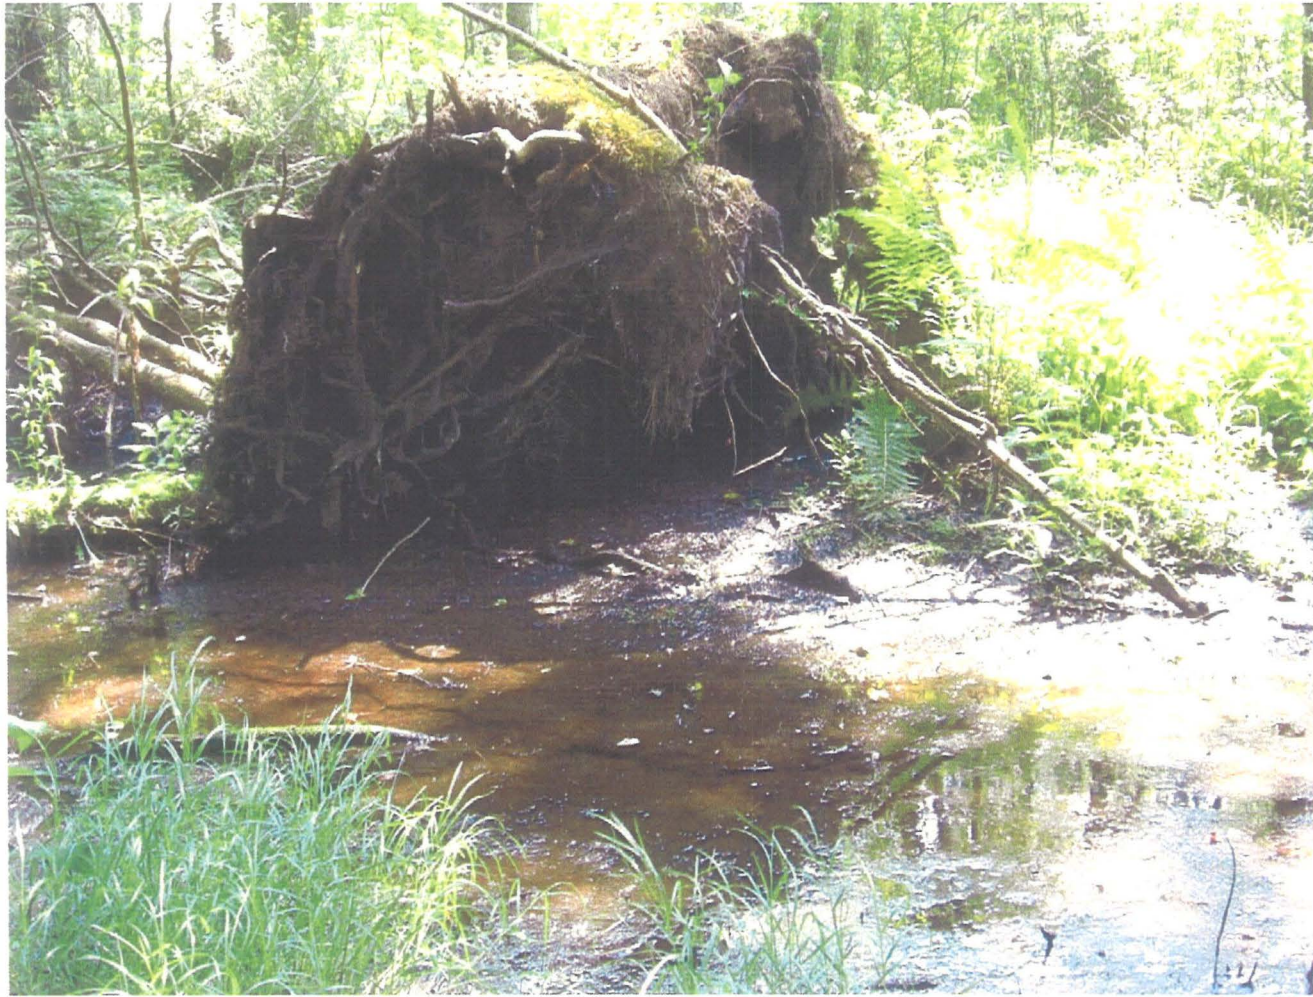
Staff Gauge Location 5. View from edge of wetland north of gauge facing east into wetland. Upland is behind the photographer. Gauge is outside of the image, to the right. This image is an example of a blowdown, located just east of the gauge.

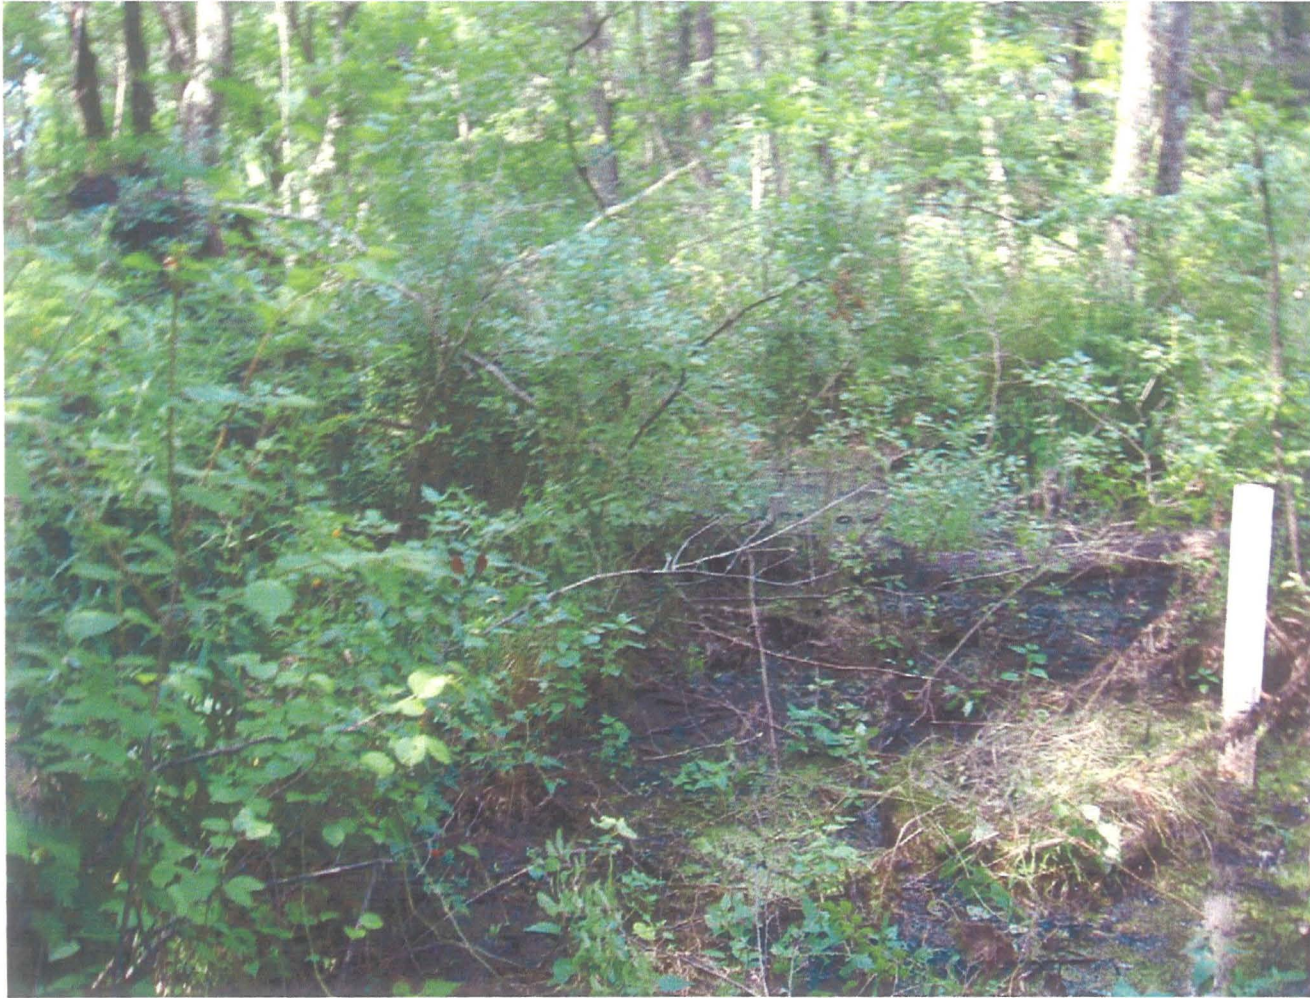
Staff Gauge Location 3. View from edge of wetland south of gauge facing north-northwest into wetland. The canopy is generally open due to nearby blowdown. Soils were saturated with standing water. One of the grassy areas near the gauge in this image is an island formed by a tire.

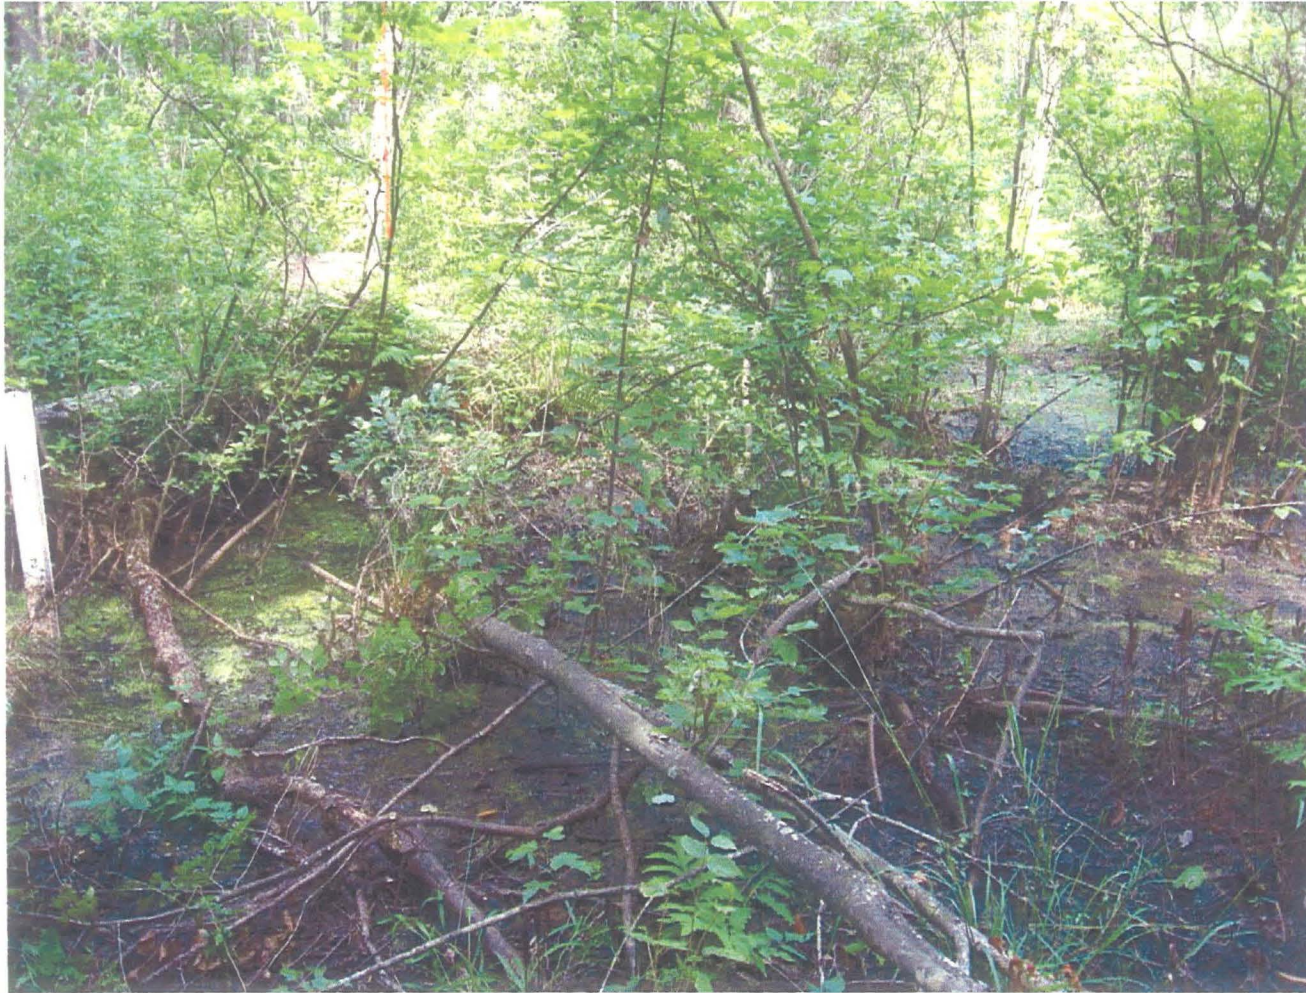
Staff Gauge Location 3. View from edge of wetland south of gauge facing north-northeast into wetland. Saturated soils conditions observed.

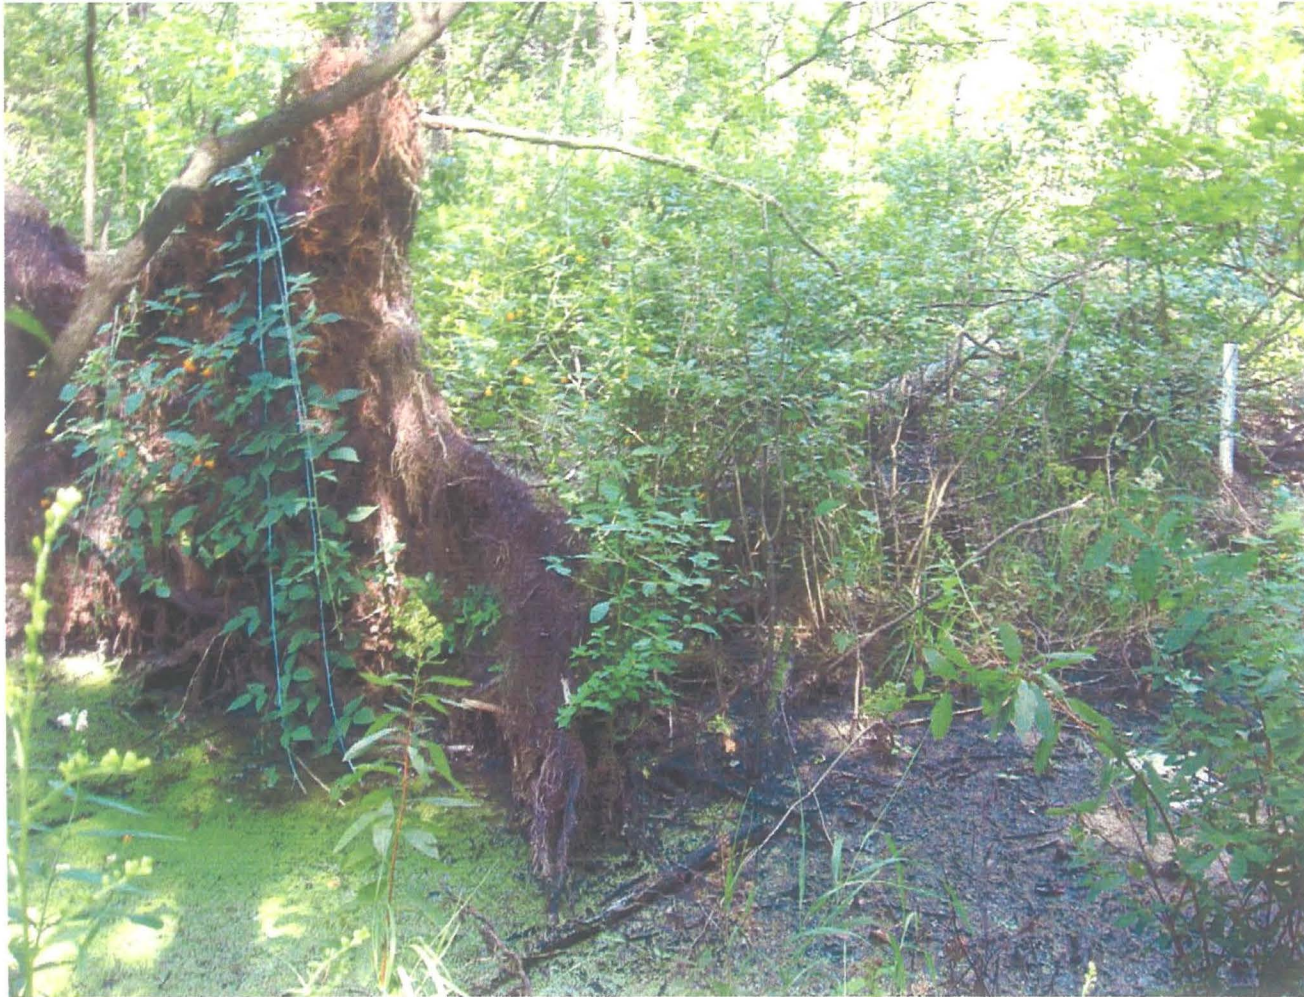
Staff Gauge Location 3. View from edge of wetland west of gauge facing east-northeast into wetland. Saturated soils conditions and standing water observed. Duckweed and jewelweed were present.

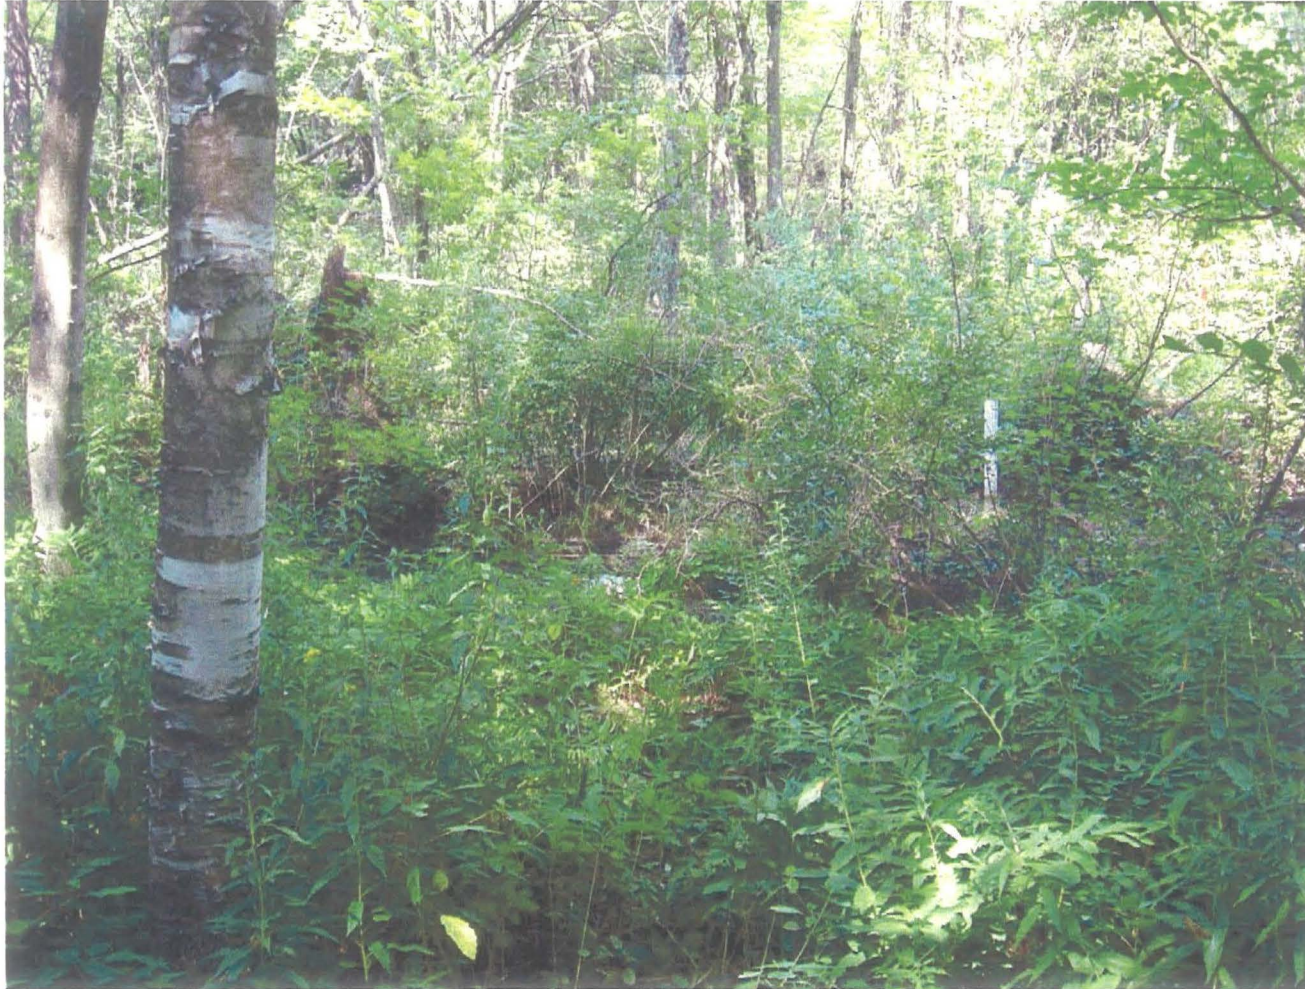
Staff Gauge Location 3. View from upland southwest of gauge facing northeast toward wetland.
