## DAILY FIELD ACTIVITY REPORT

| PROJECT | Former Bouchard Junkyard | WEATHER | TIME | TEMP. | PRECIP. | WIND (MPH) | WIND (DIR) |
| LOCATION | Town of New Lebanon, NY | P. Cloudy | 0715 | 71 F | None | Calm | N/A |

**PHOTOGRAPHIC LOG**  
**July 25, 2008**  
**D&B JOB NO. 2605**  
**FORMER BOUCHARD JUNKYARD SITE**  
**TOWN OF NEW LEBANON, NEW YORK**

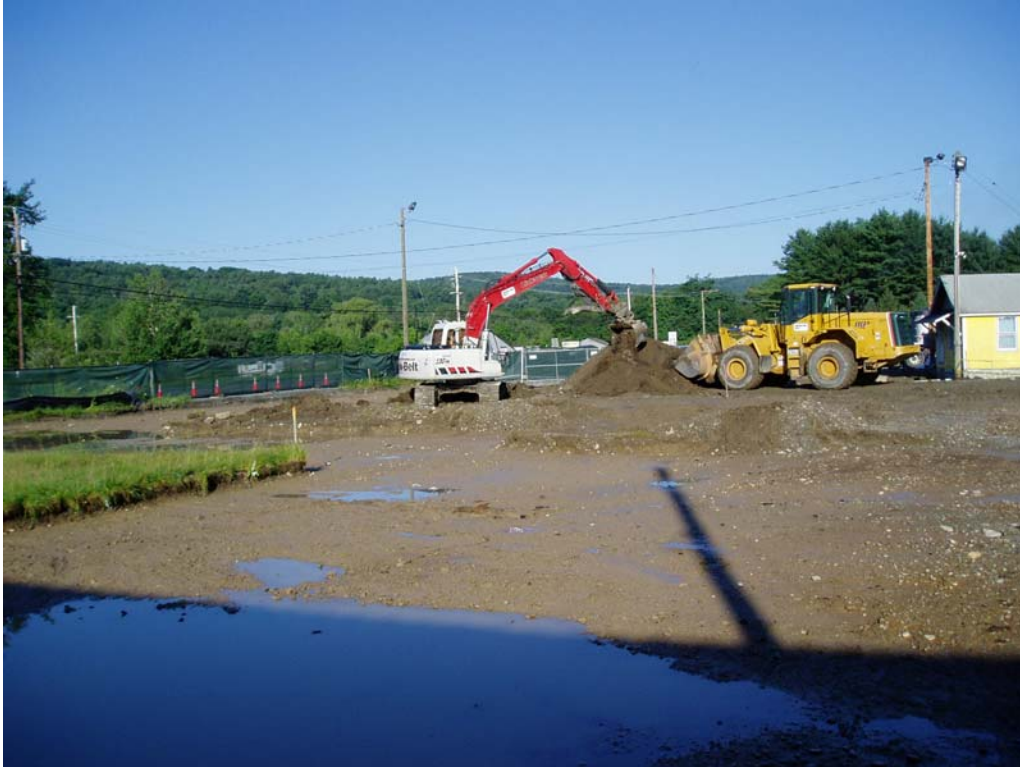
P7250001.JPG

| PHOTO | DATE | TIME | DESCRIPTION |
|---|---|---|---|
| P7 250001 | 7/25/2008 | 7:35 | View to southwest showing remedial excavation at south side of Area 9 (grid station K-1) |

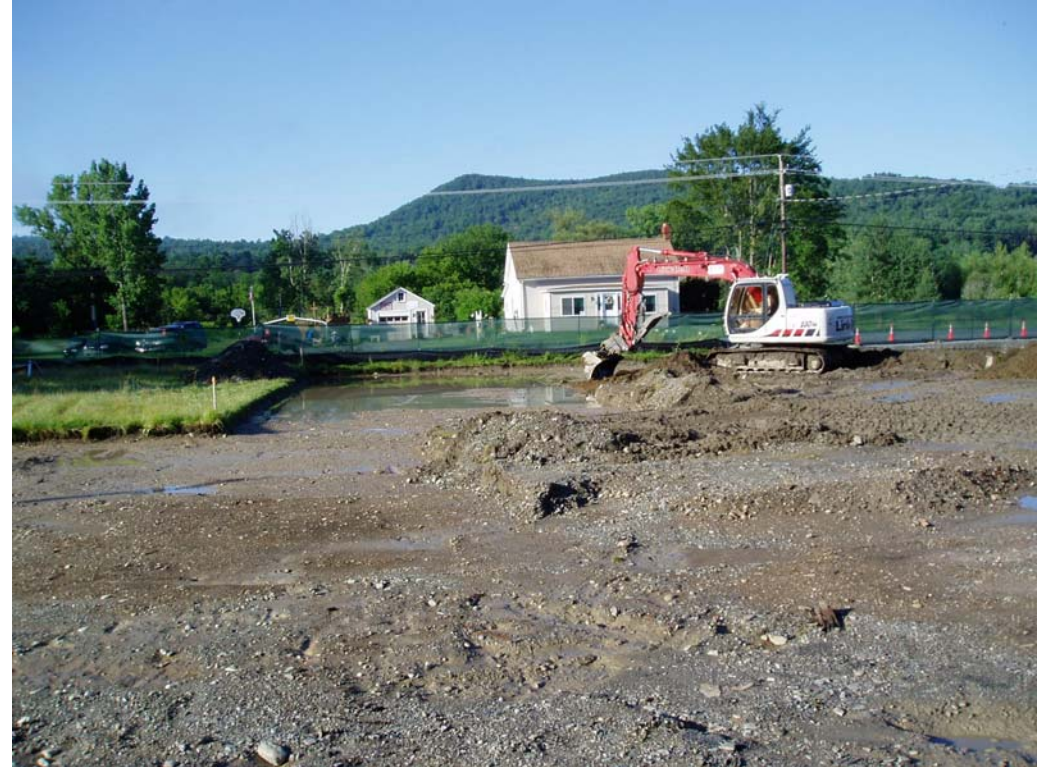
P7250002.JPG

| PHOTO | DATE | TIME | DESCRIPTION |
|---|---|---|---|
| P7 250002 | 7/25/2008 | 7:36 | View to south showing remedial excavation at south side of Area 9 (grid station K-1) |

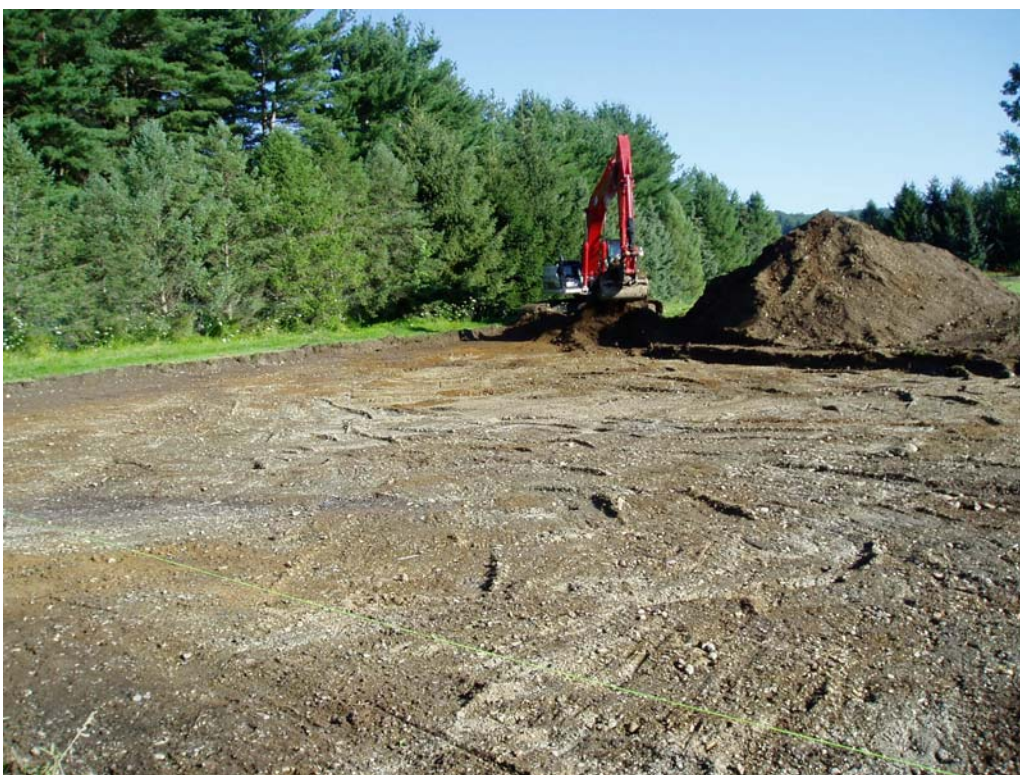
P7250003.JPG

| PHOTO | DATE | TIME | DESCRIPTION |
|---|---|---|---|
| P7 250003 | 7/25/2008 | 7:55 | View to northwest showing remedial excavation at southwest corner of Area 4 (grid station B-4) |

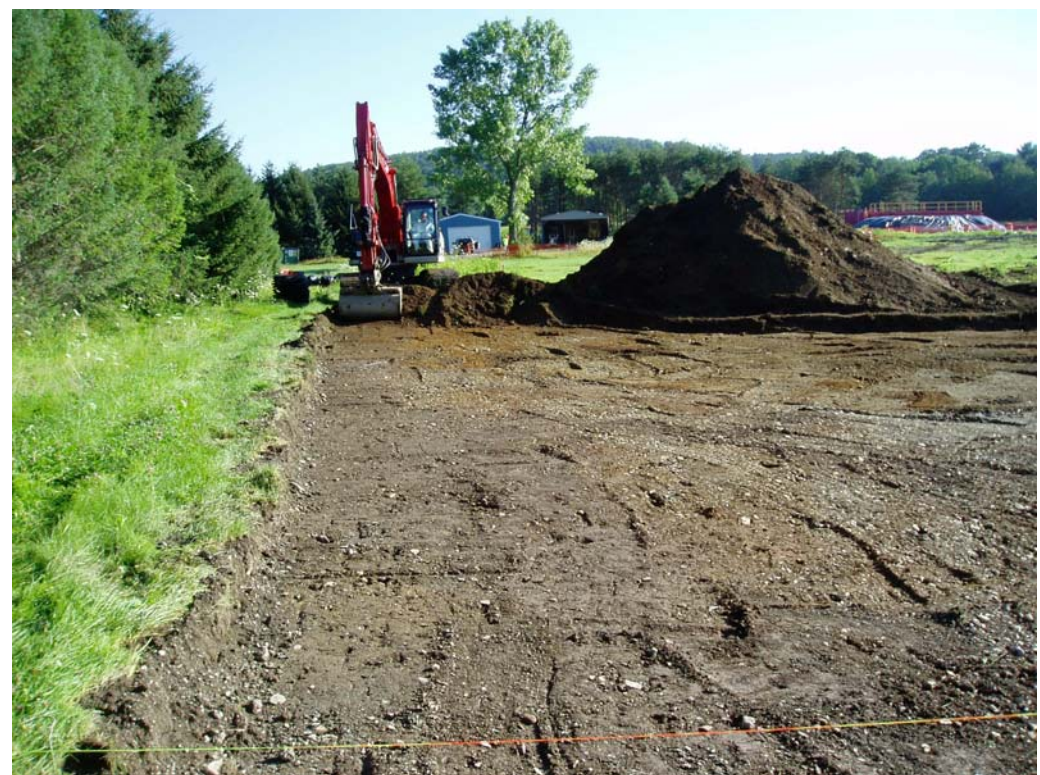
P7250004.JPG

| PHOTO | DATE | TIME | DESCRIPTION |
|---|---|---|---|
| P7 250004 | 7/25/2008 | 7:55 | View to north showing remedial excavation at southwest corner of Area 4 (grid station B-4) |

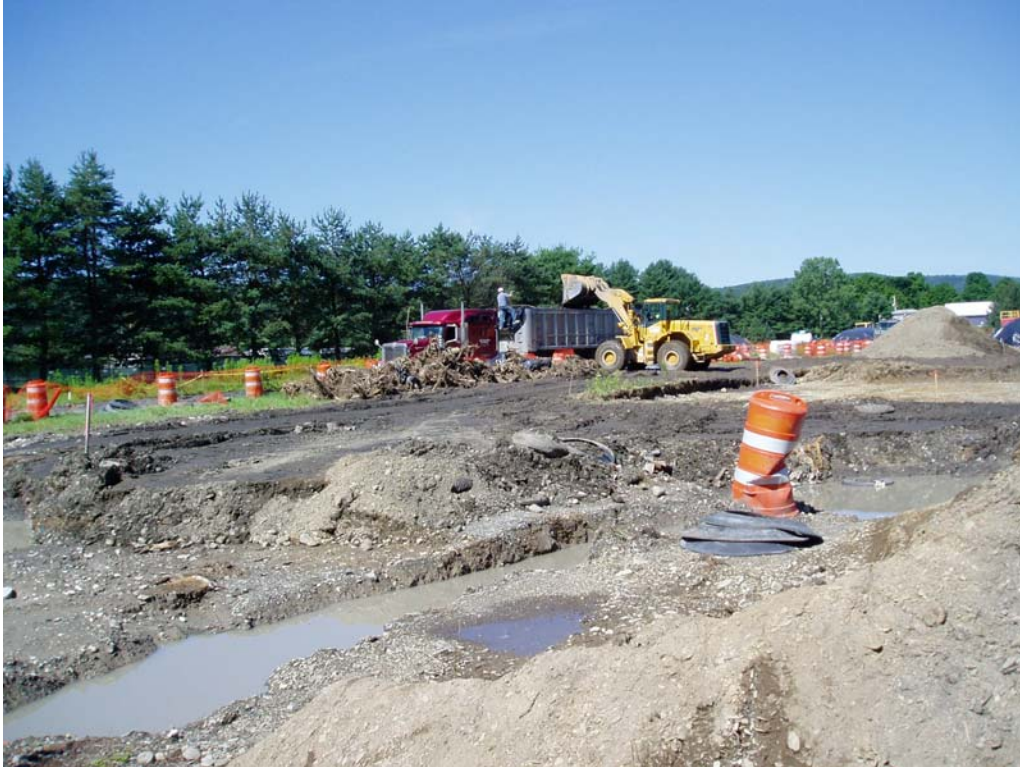
P7250005.JPG

| PHOTO | DATE | TIME | DESCRIPTION |
|---|---|---|---|
| P7 250005 | 7/25/2008 | 9:56 | View to southwest showing front end loader loading TSCA PCB contaminated soil into truck at southeast corner of Area 3 for off-site disposal |

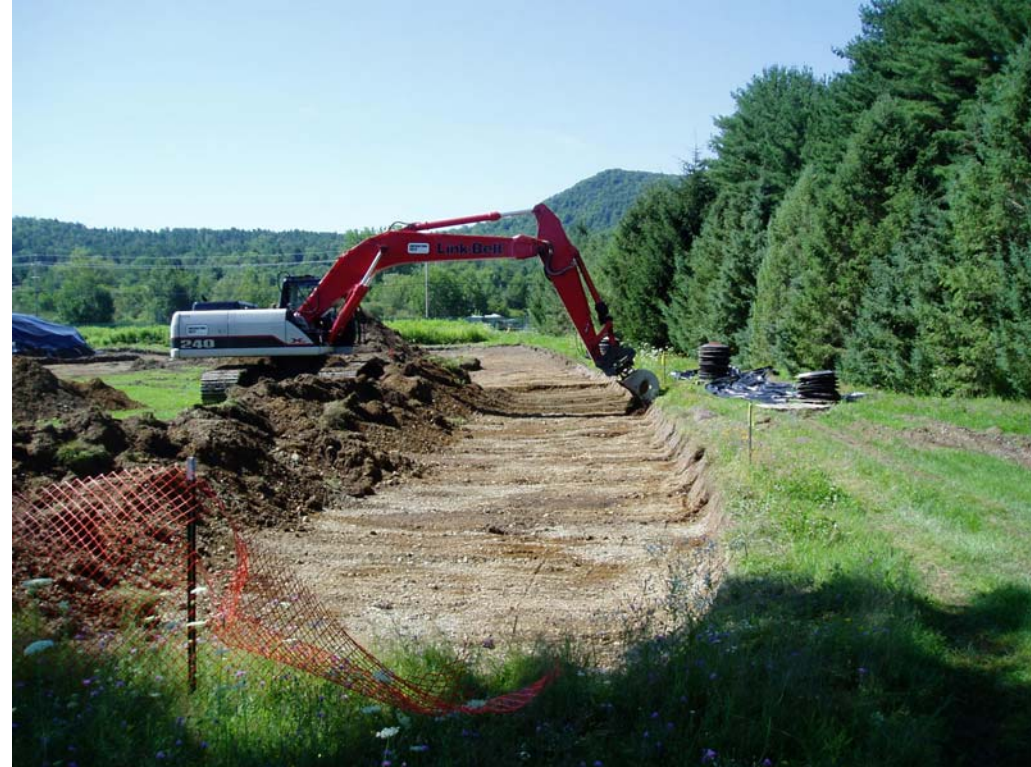
P7250006.JPG

| PHOTO | DATE | TIME | DESCRIPTION |
|---|---|---|---|
| P7 250006 | 7/25/2008 | 10:17 | View to south showing remedial excavation at southwest corner of Area 4 (grid station B-6) |

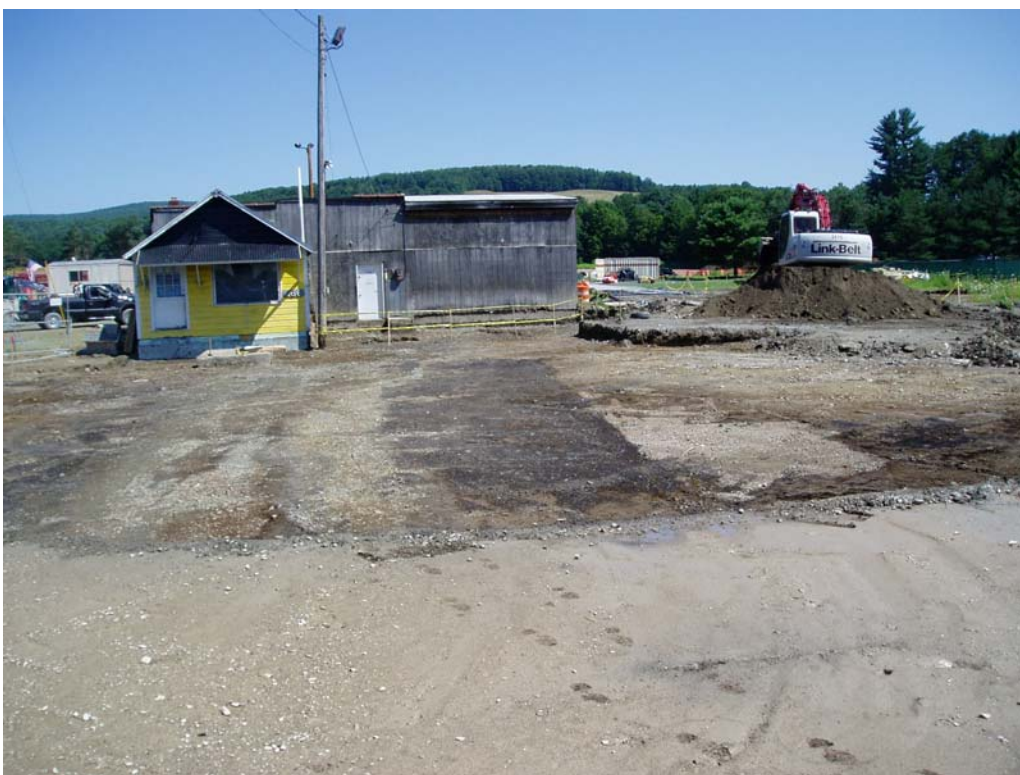
P7250007.JPG

| PHOTO | DATE | TIME | DESCRIPTION |
|---|---|---|---|
| P7 250007 | 7/25/2008 | 10:48 | View to north showing black stained soil area along surface in grid station J-2 (south side Area 9) after remedial excavation completed |

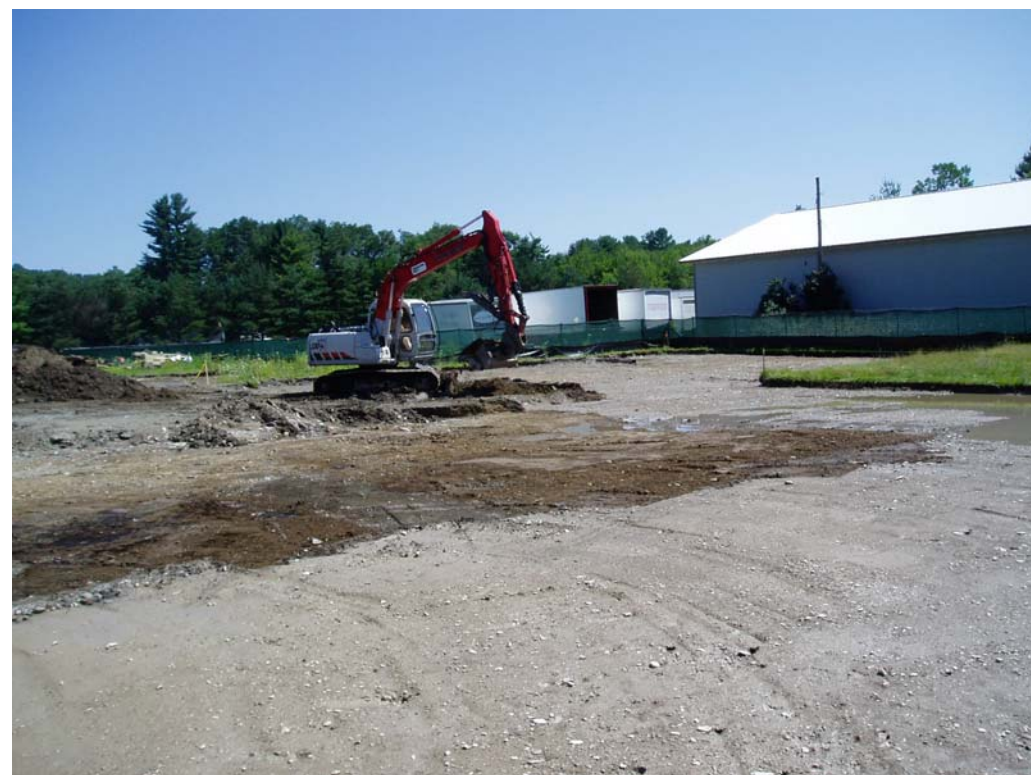
P7250008.JPG

| PHOTO | DATE | TIME | DESCRIPTION |
|---|---|---|---|
| P7 250008 | 7/25/2008 | 11:01 | View to northeast showing remedial excavation at south side of Area 9 (grid station K-2) |

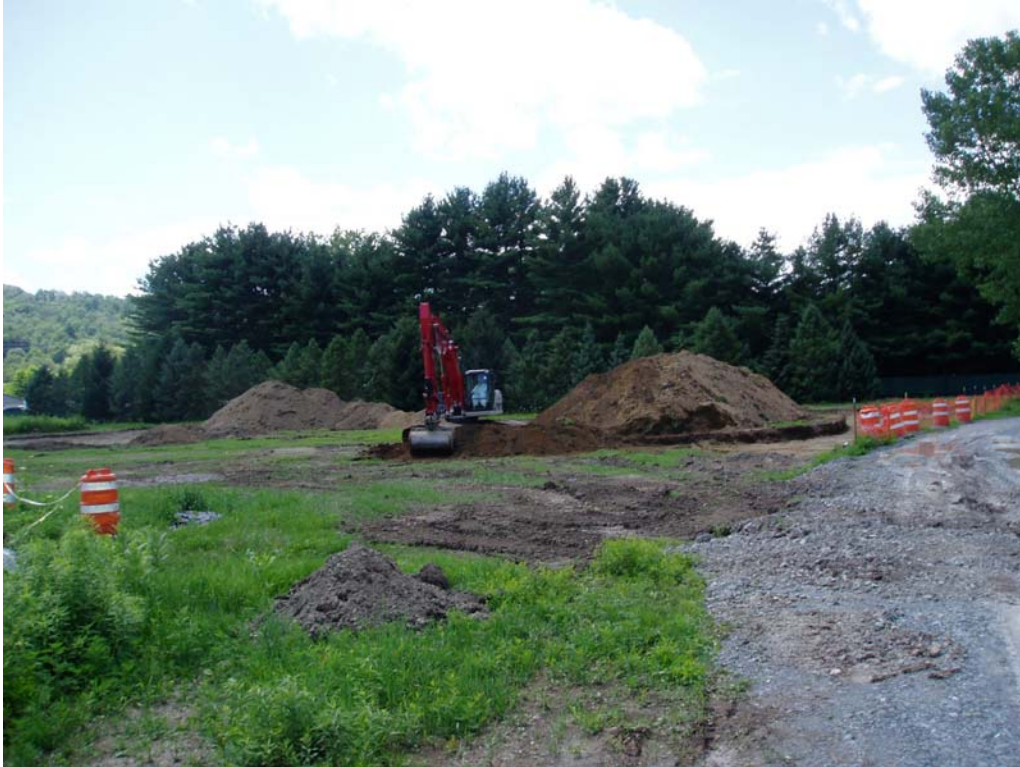
P7250009.JPG

| PHOTO | DATE | TIME | DESCRIPTION |
|---|---|---|---|
| P7 250009 | 7/25/2008 | 13:20 | View to southwest showing remedial excavation at Area 4 (grid stations D-7, D-8) |

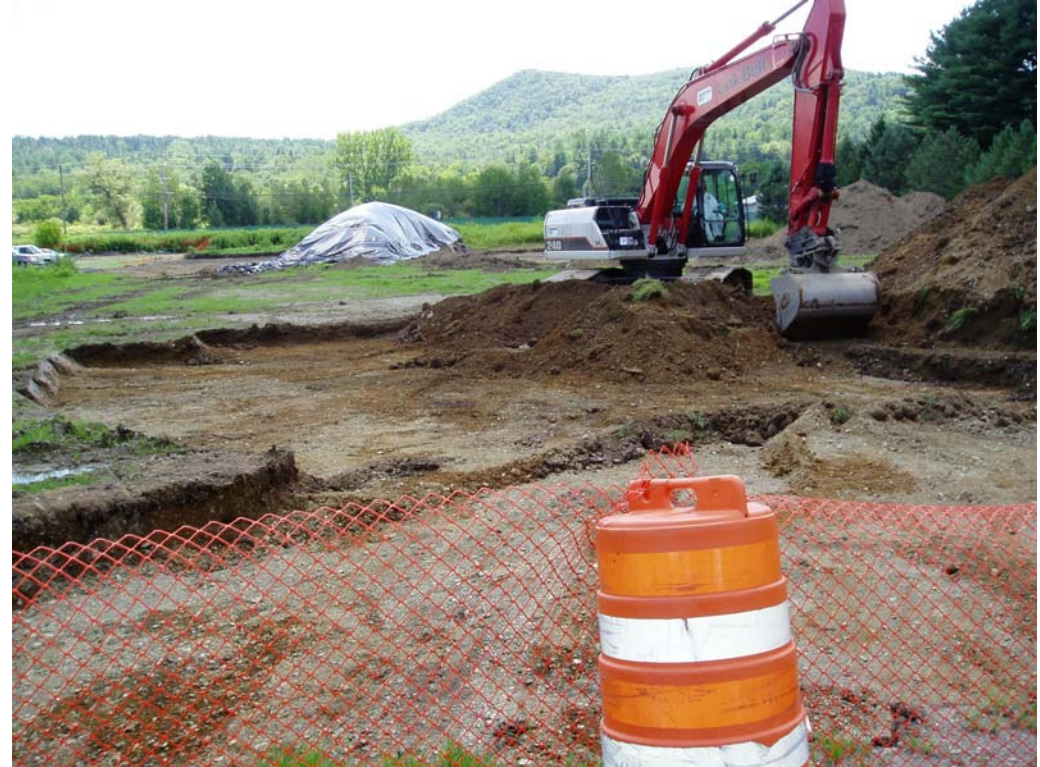
P7250010.JPG

| PHOTO | DATE | TIME | DESCRIPTION |
|---|---|---|---|
| P7 250010 | 7/25/2008 | 13:22 | View to south showing remedial excavation at Area 4 (grid stations D-7, D-8) |

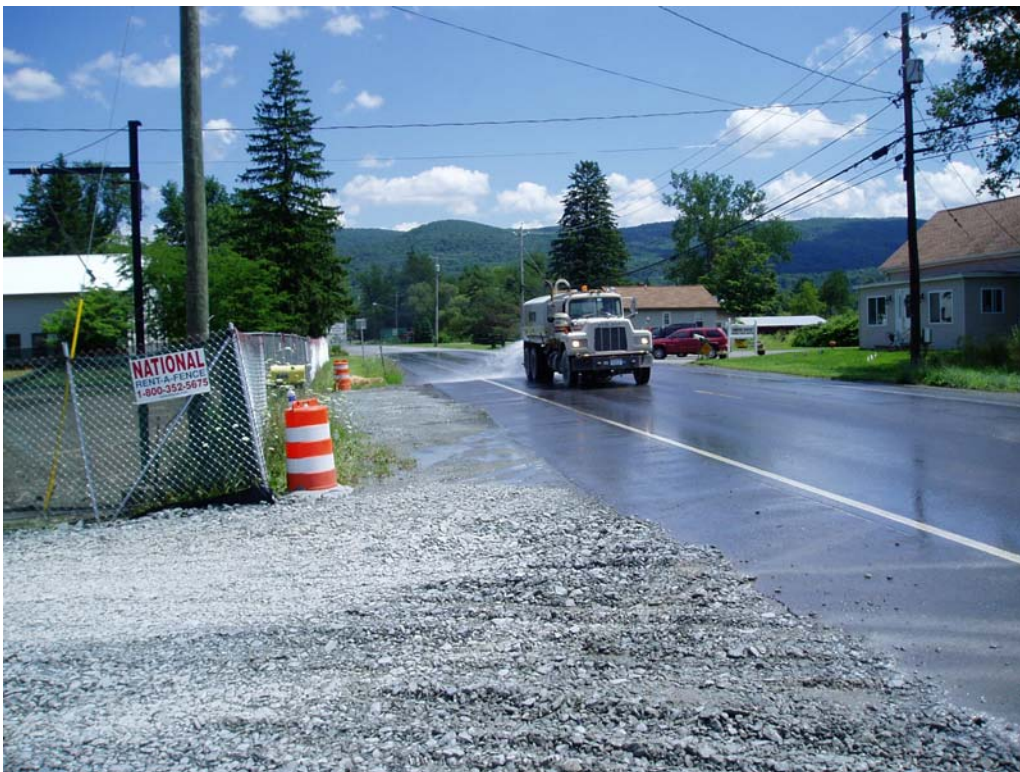
P7250011.JPG

| PHOTO | DATE | TIME | DESCRIPTION |
|---|---|---|---|
| P7 250011 | 7/25/2008 | 13:26 | View to east showing water truck spraying water along Rt. 20 for dust control |

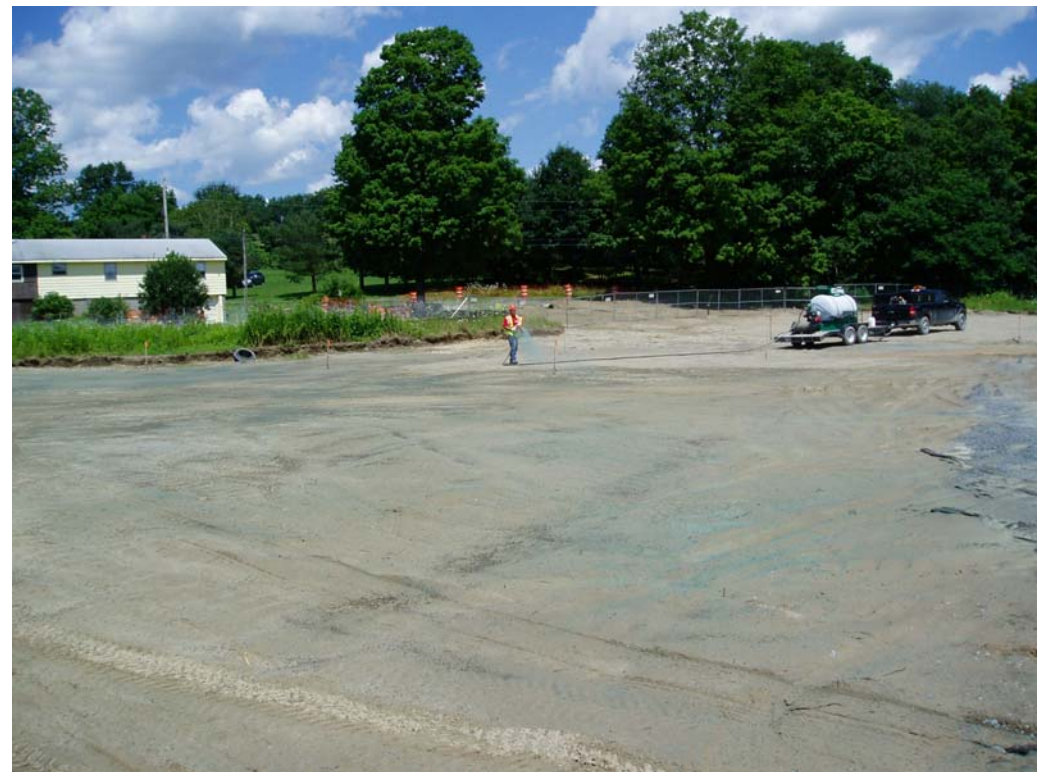
P7250012.JPG

| PHOTO | DATE | TIME | DESCRIPTION |
|---|---|---|---|
| P7 250012 | 7/25/2008 | 13:55 | View to northeast showing D. A. Collins installing hydromulch and tackifier over approved backfill material at northwest corner of Area 1 |

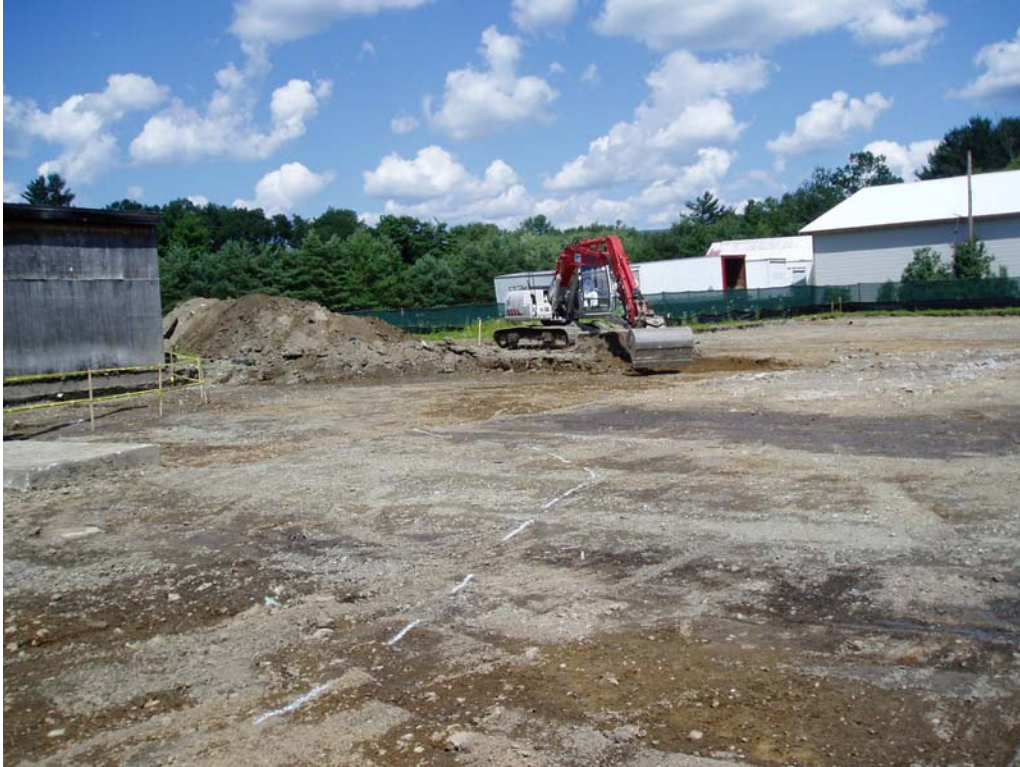
P7250013.JPG

| PHOTO | DATE | TIME | DESCRIPTION |
|---|---|---|---|
| P7 250013 | 7/25/2008 | 14:52 | View to northeast showing remedial excavation at south side of Area 9 (grid station K-3) |

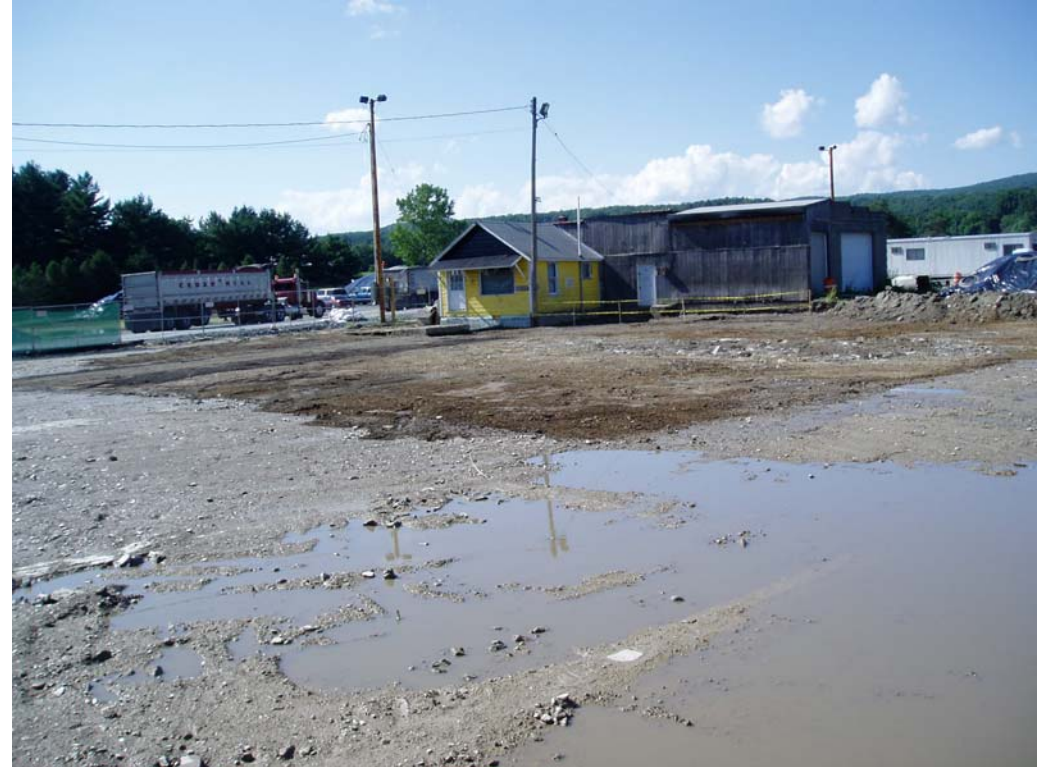
P7250014.JPG

| PHOTO | DATE | TIME | DESCRIPTION |
|---|---|---|---|
| P7 250014 | 7/25/2008 | 16:15 | View to northwest showing south side of Area 9 after remedial excavation completed for the day (grid stations J-2/3, K-2/3, L-2/3) |

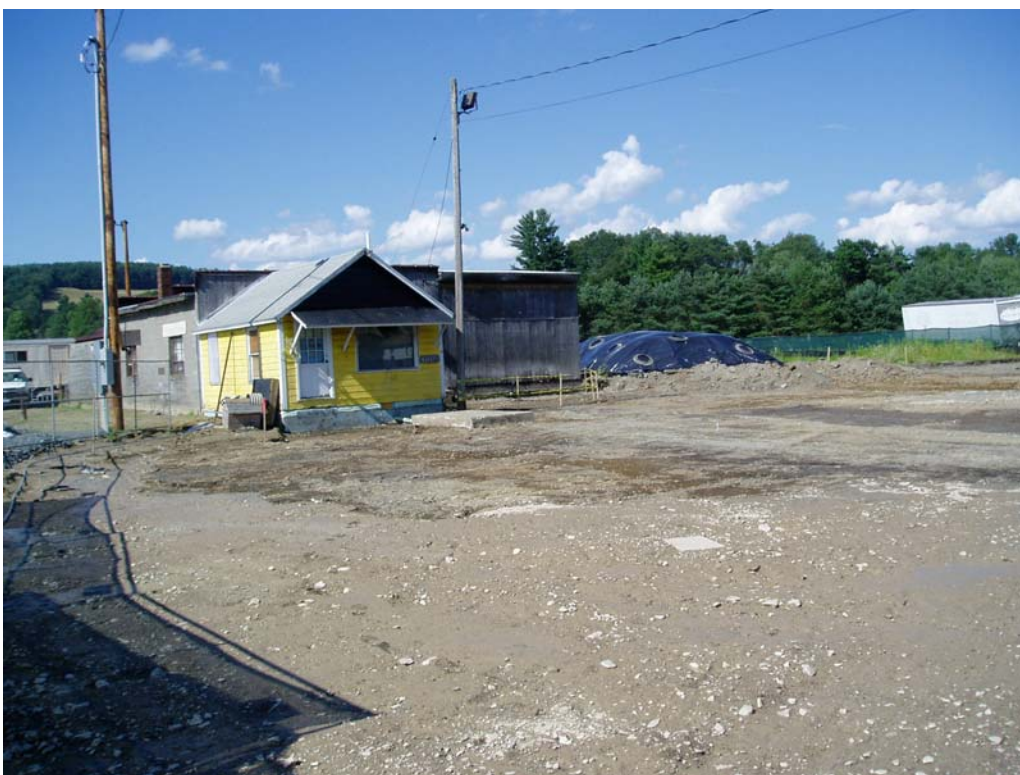
P7250015.JPG

| PHOTO | DATE | TIME | DESCRIPTION |
|---|---|---|---|
| P7 250015 | 7/25/2008 | 16:16 | View to northeast showing south side of Area 9 after remedial excavation completed for the day (grid stations J-2, J-3) |

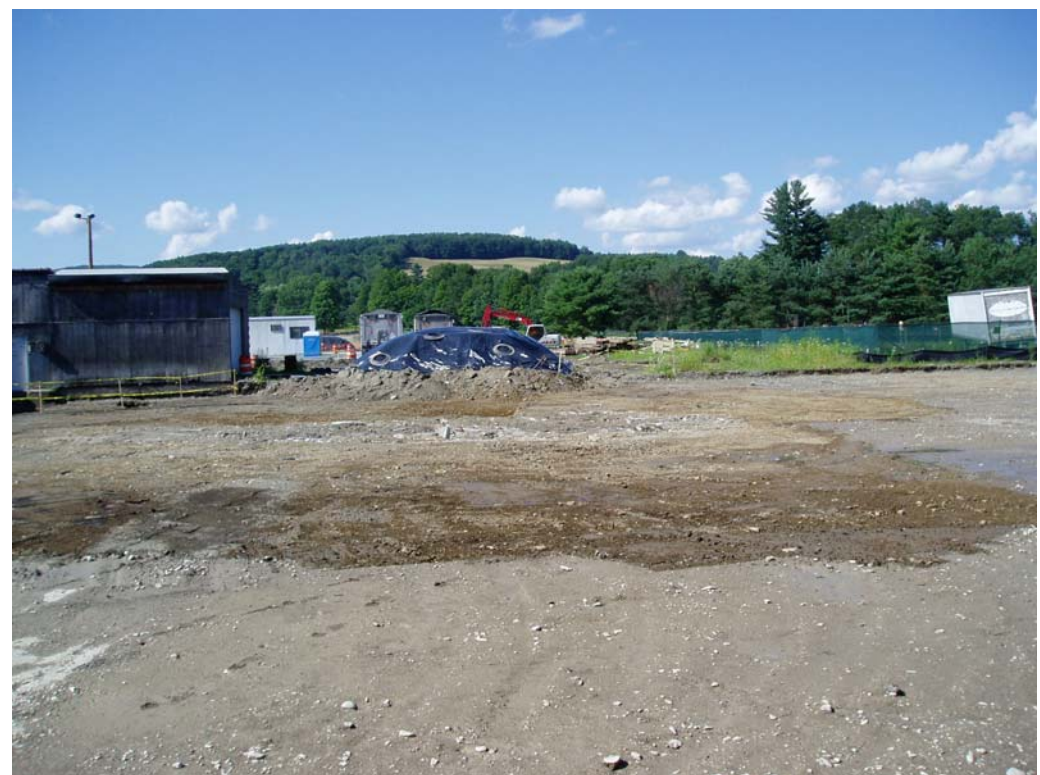
P7250016.JPG

| PHOTO | DATE | TIME | DESCRIPTION |
|---|---|---|---|
| P7 250016 | 7/25/2008 | 16:17 | View to north showing south side of Area 9 after remedial excavation completed for the day (grid stations K-2, K-3, L-2, L-3) |

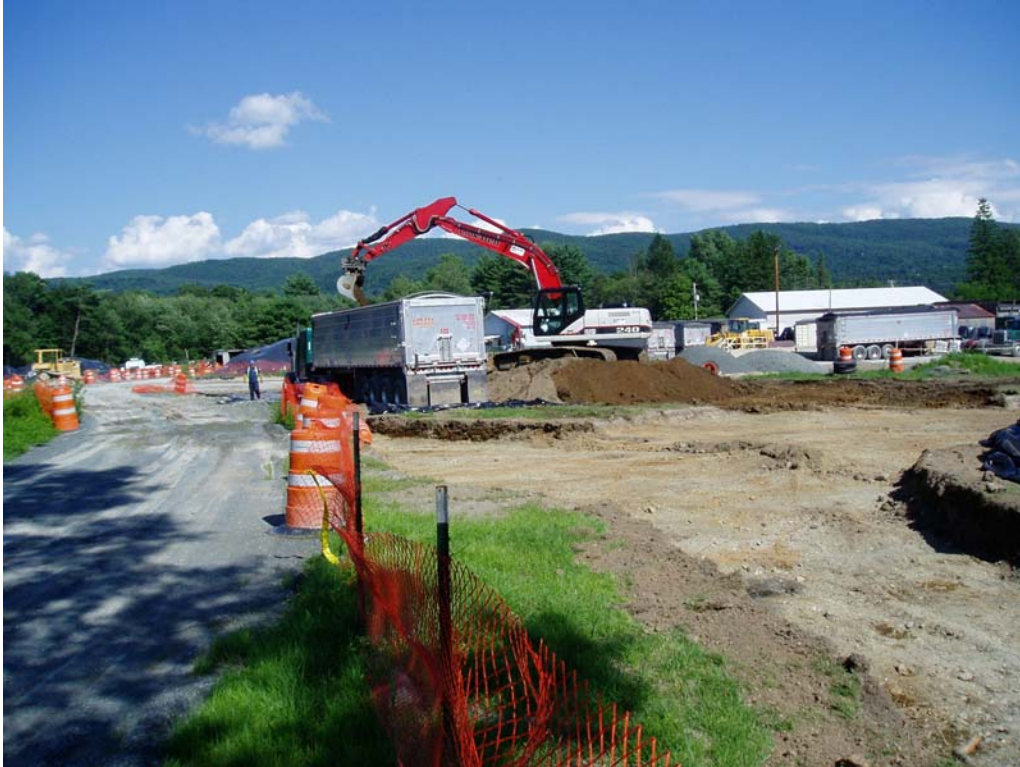
P7250017.JPG

| PHOTO | DATE | TIME | DESCRIPTION |
|---|---|---|---|
| P7 250017 | 7/25/2008 | 16:21 | View to east showing excavator loading non-TSCA PCB contaminated soil into truck at Area 4 for off-site disposal (grid station F-8) |

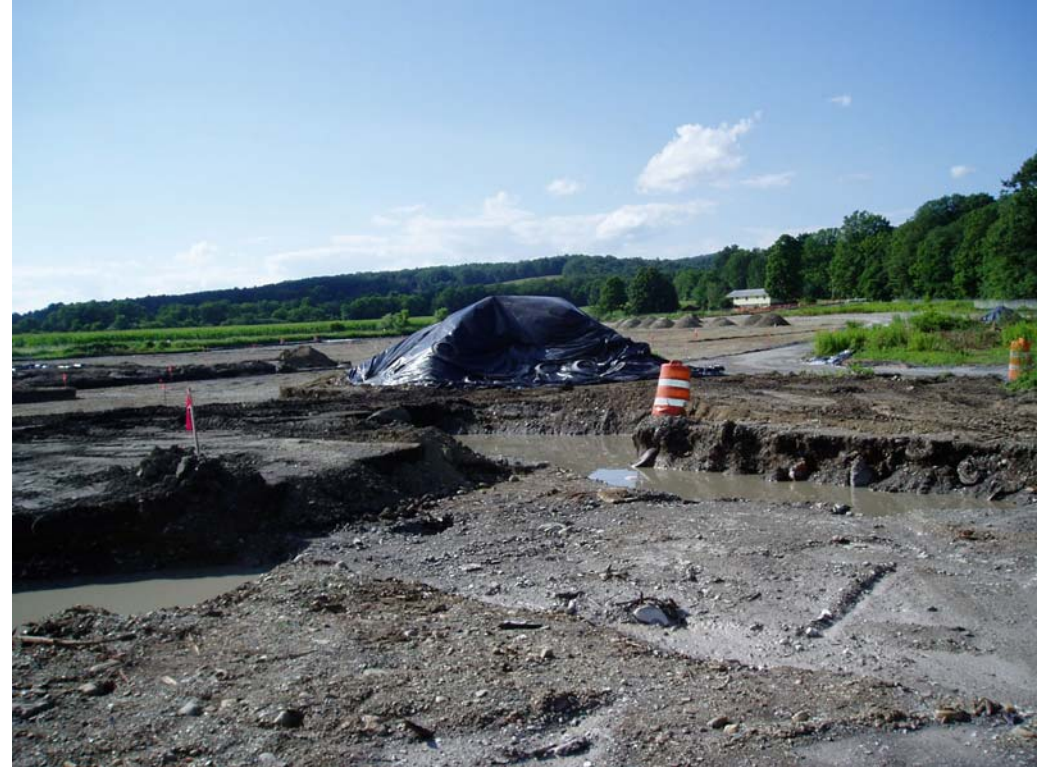
P7250018.JPG

| PHOTO | DATE | TIME | DESCRIPTION |
|---|---|---|---|
| P7 250018 | 7/25/2008 | 17:00 | View to northwest showing TSCA excavated soil pile covered with poly sheeting after work completed for the day (west side Area 8) |

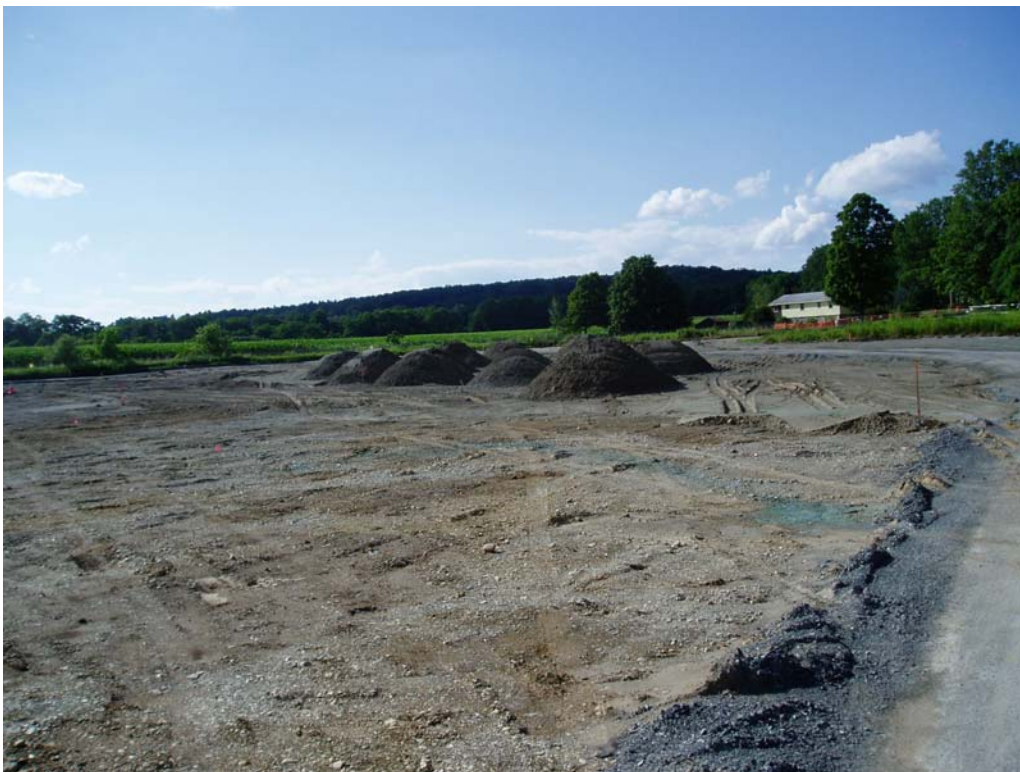
P7250019.JPG

| PHOTO | DATE | TIME | DESCRIPTION |
|---|---|---|---|
| P7 250019 | 7/25/2008 | 17:03 | View to northwest showing stockpiles of backfill material (common fill sand) staged at Area 1 |

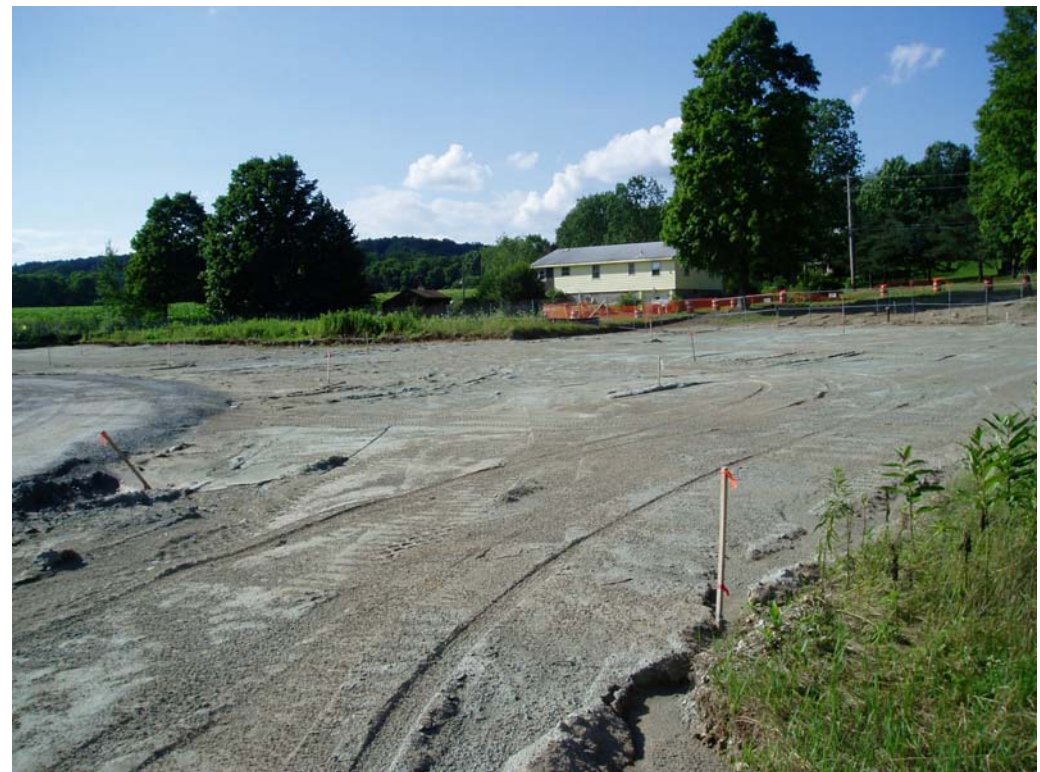
P7250020.JPG

| PHOTO | DATE | TIME | DESCRIPTION |
|---|---|---|---|
| P7 250020 | 7/25/2008 | 17:05 | View to northwest showing hydromulch and tackifier installed over backfill material at north side of Area 1 |

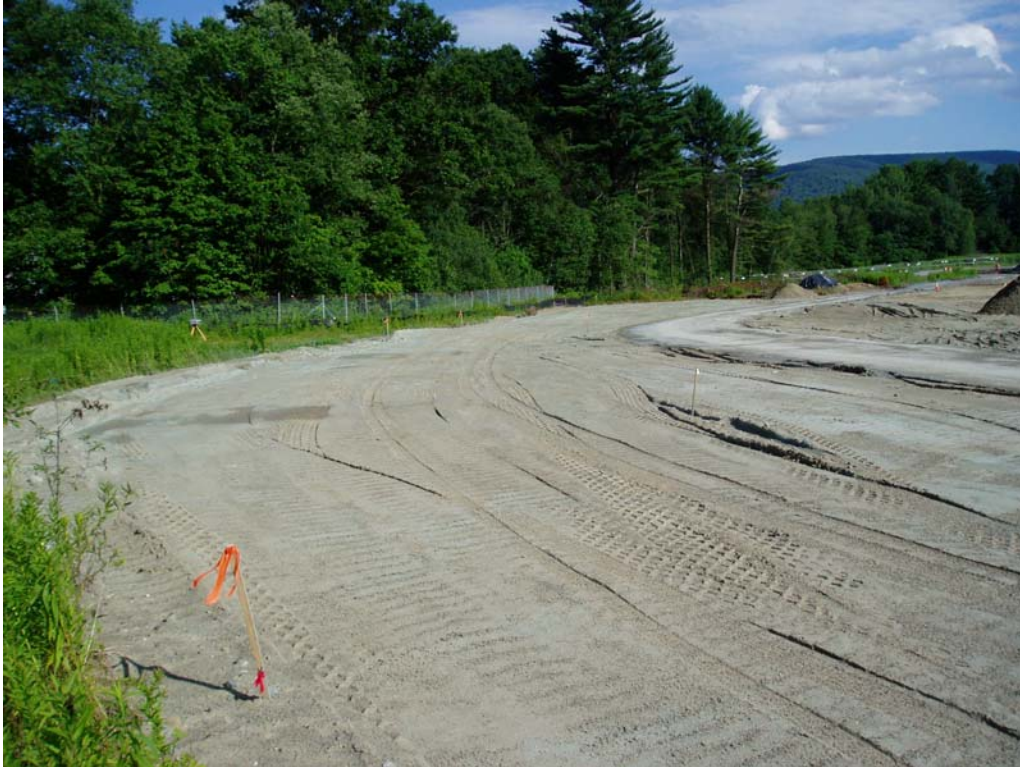
P7250021.JPG

| PHOTO | DATE | TIME | DESCRIPTION |
|---|---|---|---|
| P7 250021 | 7/25/2008 | 17:05 | View to southeast showing hydromulch and tackifier installed over backfill material at east side of Area 1 |

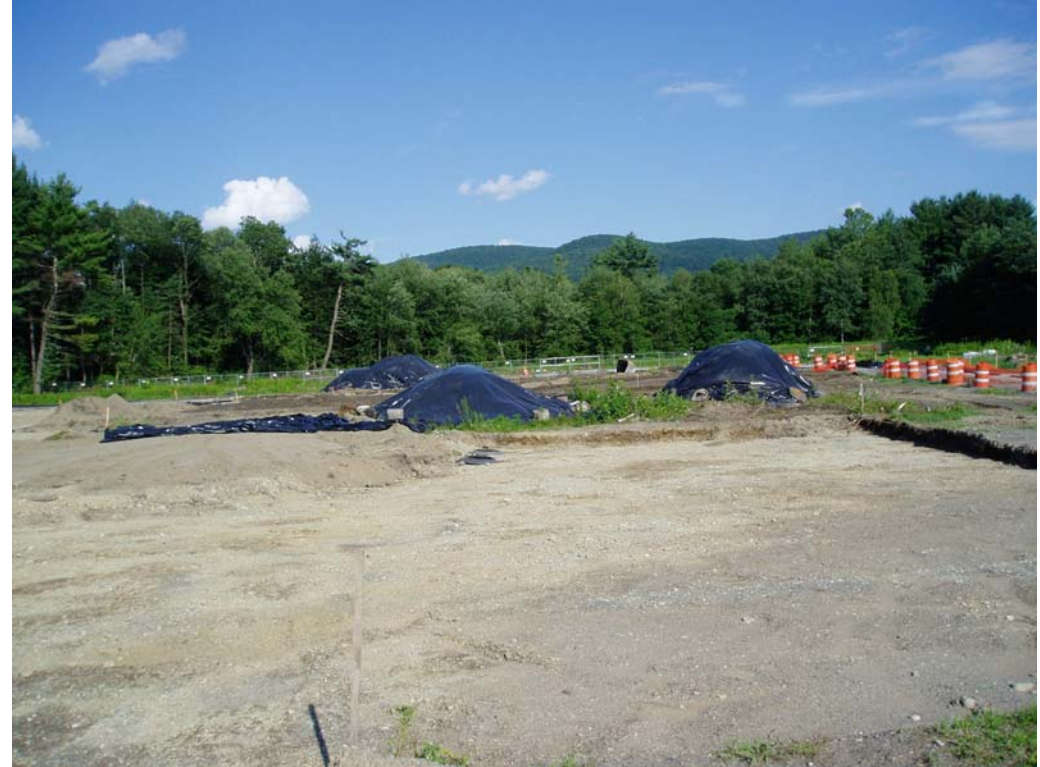
P7250022.JPG

| PHOTO | DATE | TIME | DESCRIPTION |
|---|---|---|---|
| P7 250022 | 7/25/2008 | 17:09 | View to east showing excavated soil piles covered with poly sheeting after work completed for the day (south side Area 3) |

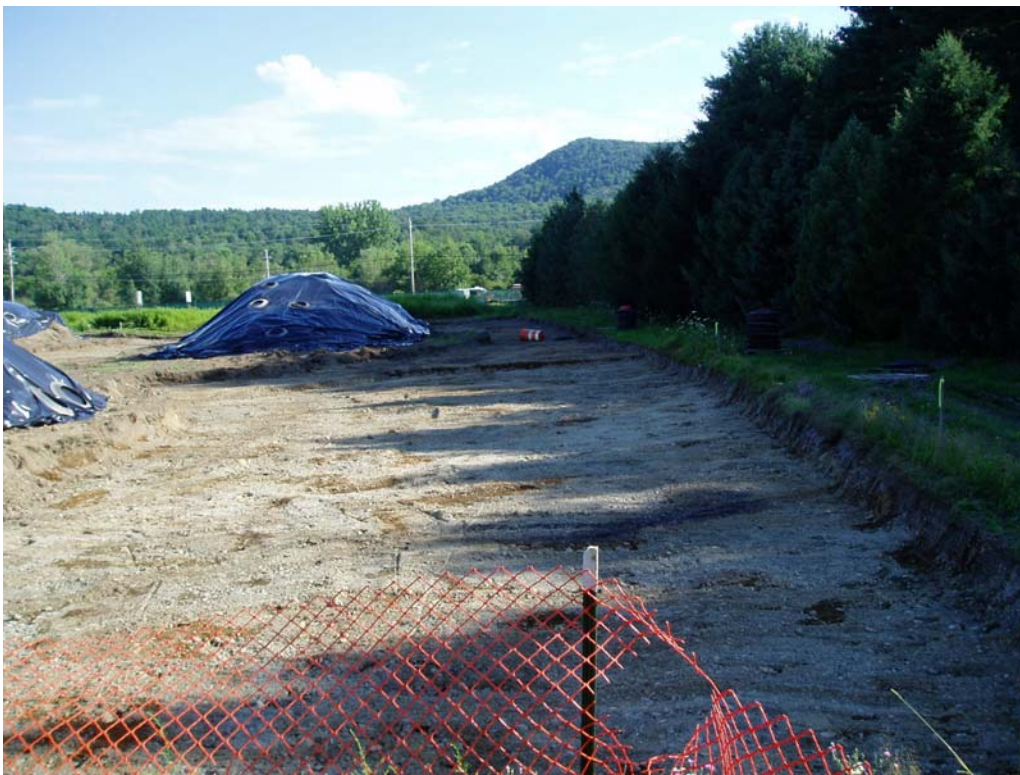
P7250023.JPG

| PHOTO | DATE | TIME | DESCRIPTION |
|---|---|---|---|
| P7 250023 | 7/25/2008 | 17:35 | View to south showing west side of Area 4 after remedial excavation completed for the day (grid stations B-4 through B-8) |

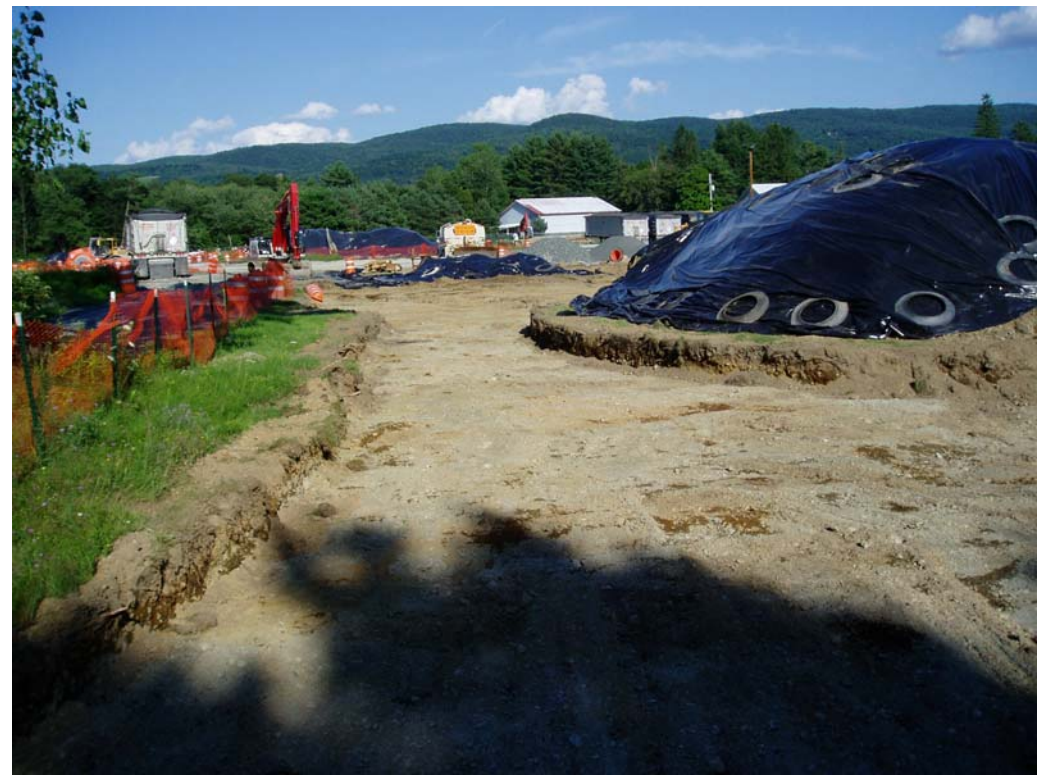
P7250024.JPG

| PHOTO | DATE | TIME | DESCRIPTION |
|---|---|---|---|
| P7 250024 | 7/25/2008 | 17:35 | View to east showing Area 4 after remedial excavation completed for the day (grid stations B-8, C-8, D-8, E-8, F-8) |

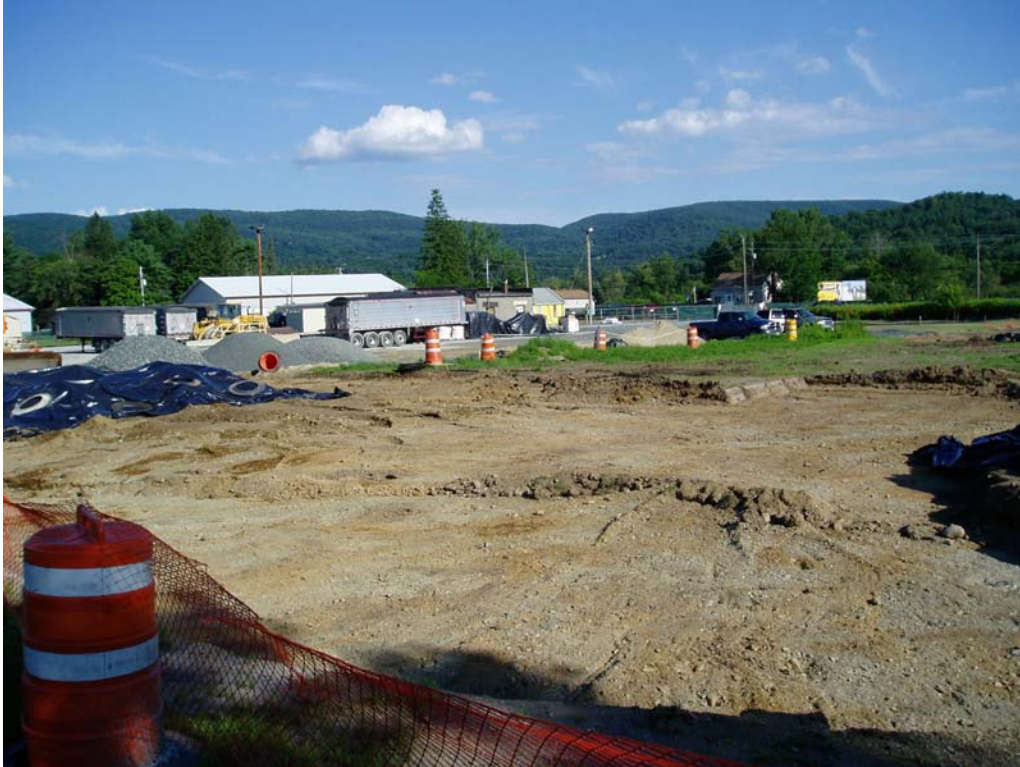
P7250025.JPG

| PHOTO | DATE | TIME | DESCRIPTION |
|---|---|---|---|
| P7 250025 | 7/25/2008 | 17:36 | View to southeast showing Area 4 after remedial excavation completed for the day (grid stations D-7, D-8, E-7, E-8, F-8) |

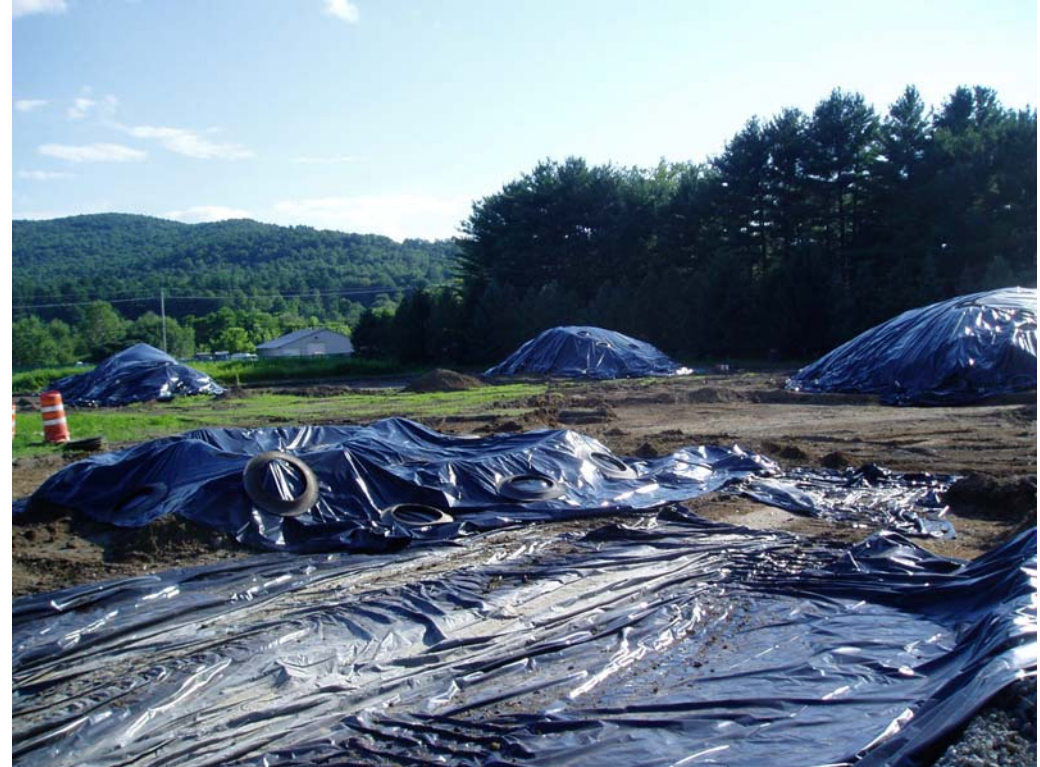
P7250026.JPG

| PHOTO | DATE | TIME | DESCRIPTION |
|---|---|---|---|
| P7 250026 | 7/25/2008 | 17:37 | View to southwest showing excavated soil piles covered with poly sheeting after work completed for the day (Area 4) |
