**SUBJECT: FINAL REMOVAL ACTION REPORT, REVISION 1 – READBURN
WOOD TAR SITE, HANCOCK, DELAWARE COUNTY, NEW YORK**

FINAL REMOVAL ACTION REPORT, REVISION 1

**READBURN WOOD TAR SITE
2222 READBURN ROAD, HANCOCK,
DELAWARE COUNTY, NEW YORK**

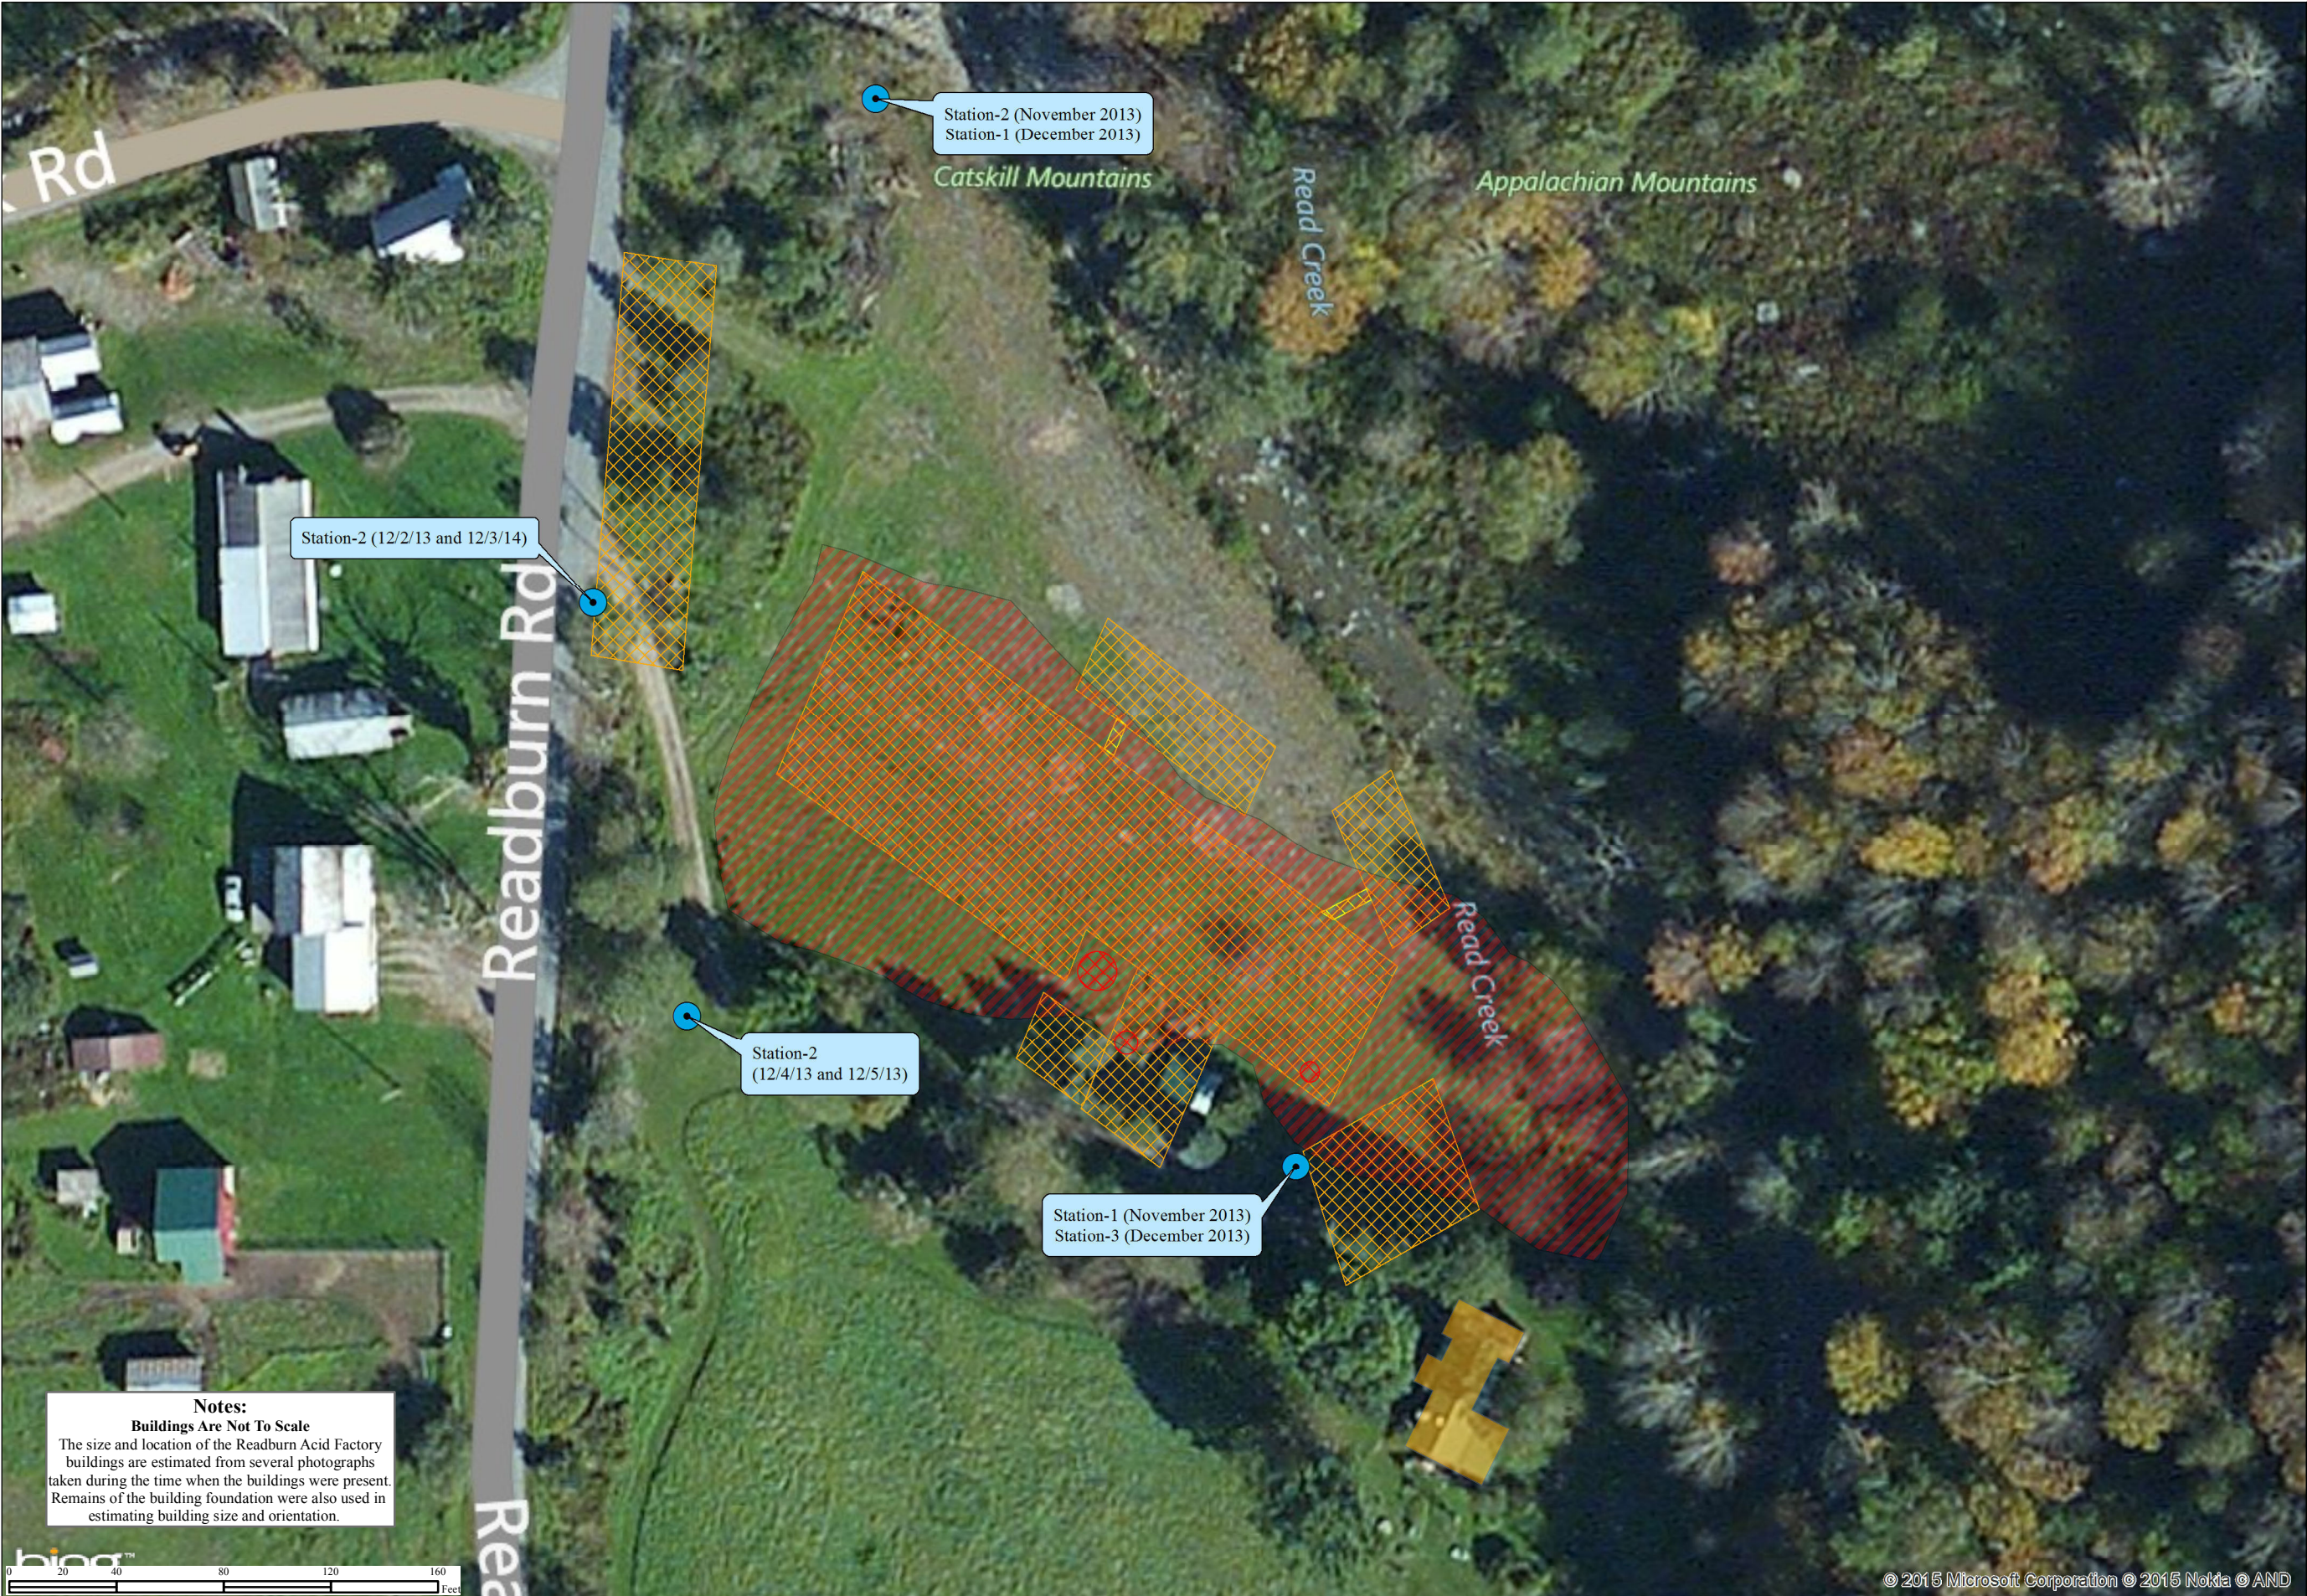
Figure 2: Site Overview Map

- Excavation Area
- Air Monitoring Station
- Readburn Building Location Structure**
- Smoke Stack
- Building Foundation
- Chute
- On-Site Residence

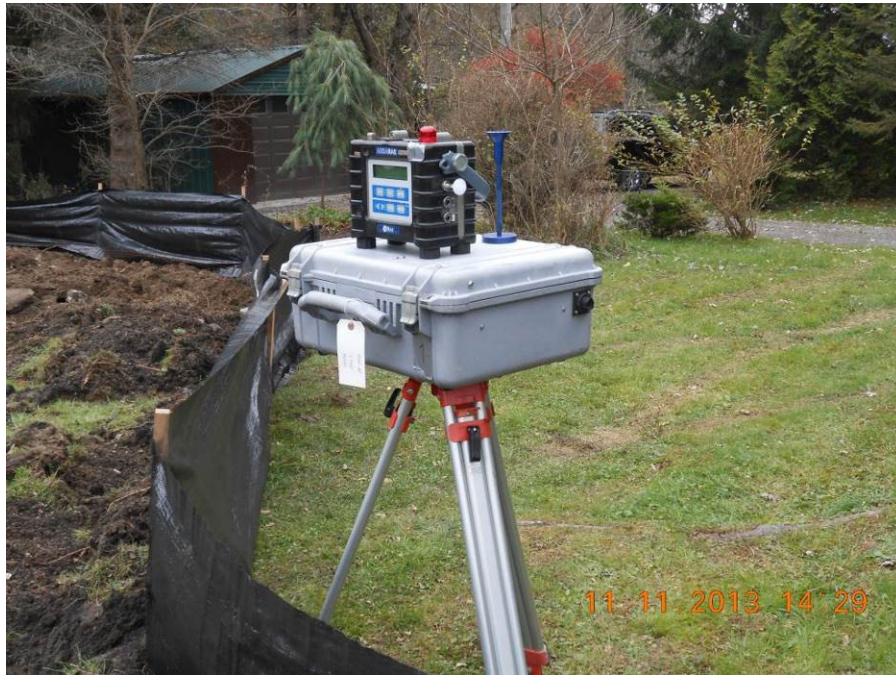
Photo 1: RST 2 deployed three air monitoring stations during Removal Action activities at the Site. Each station comprised of one DustTrack II and one AreaRae air monitoring unit.

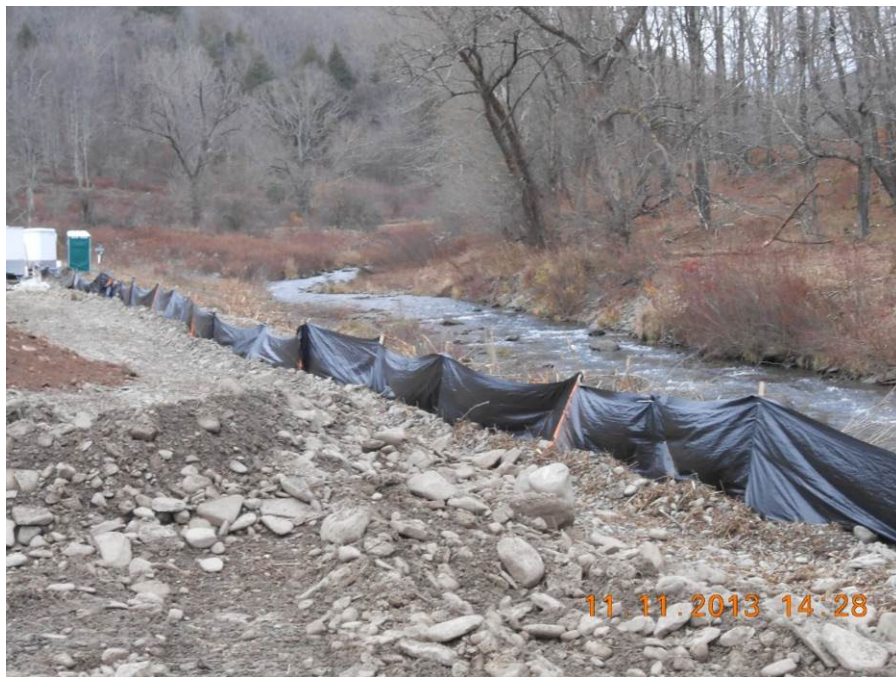
Photo 2: EPA's ERRS contractor established work zones and delineated the active work areas by installed silt fences along the proposed excavation boundaries of the Site. From this southeast portion of the Site, Read Creek can be seen east of the silt fence.

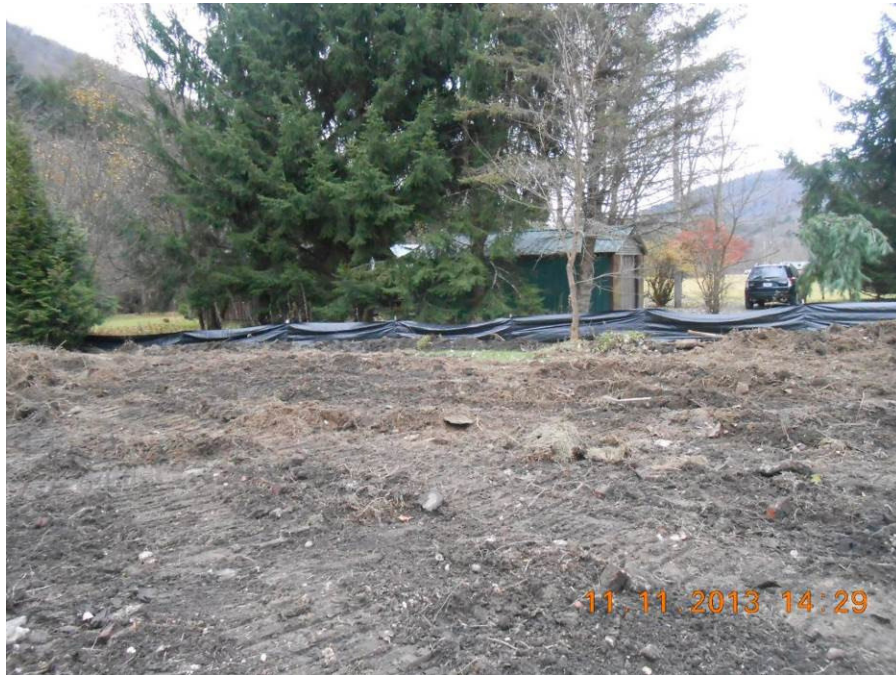
Photo 3: A view of the southern portion of the Site before ERRS began excavation of contaminated soils. An occupied residence is located on-site.

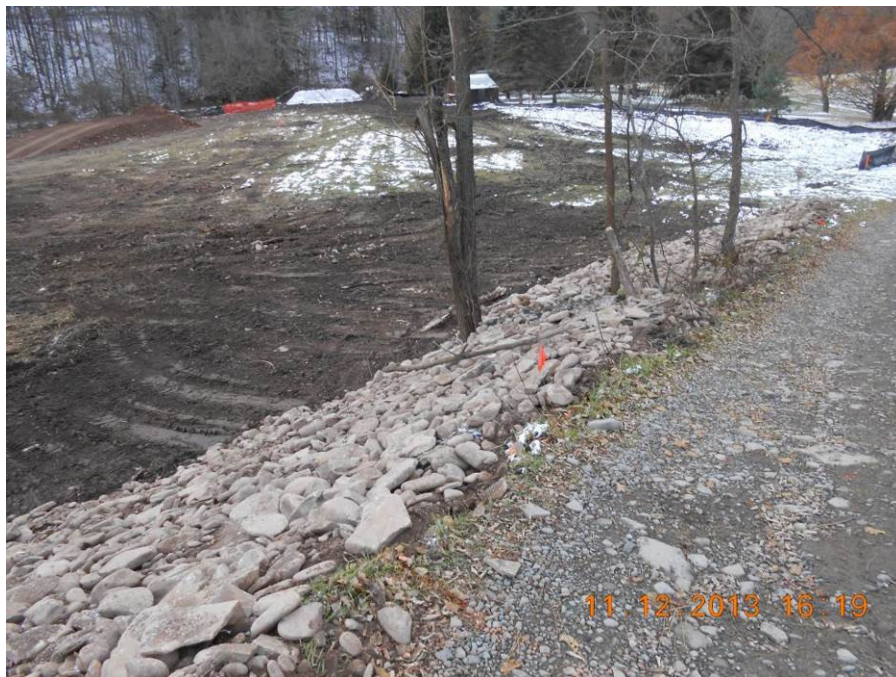
Photo 4: A northwest view of the Site looking south, before excavation activities commenced. ERRS placed large rocks and cobble stones along the sloped northwest area along Readburn Road to prevent erosion.

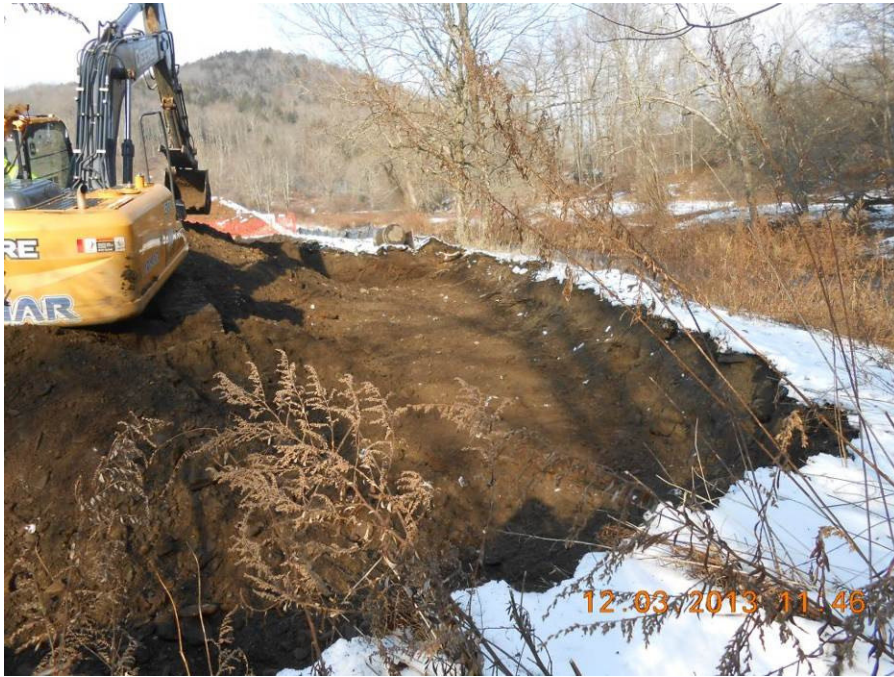
Photo 5: Excavation of wood tar-contaminated soils started from the southeast portion of the Site. The southeast sidewall was later removed completely. No sidewall sample was collected from this portion (grid AA2) of the excavation.

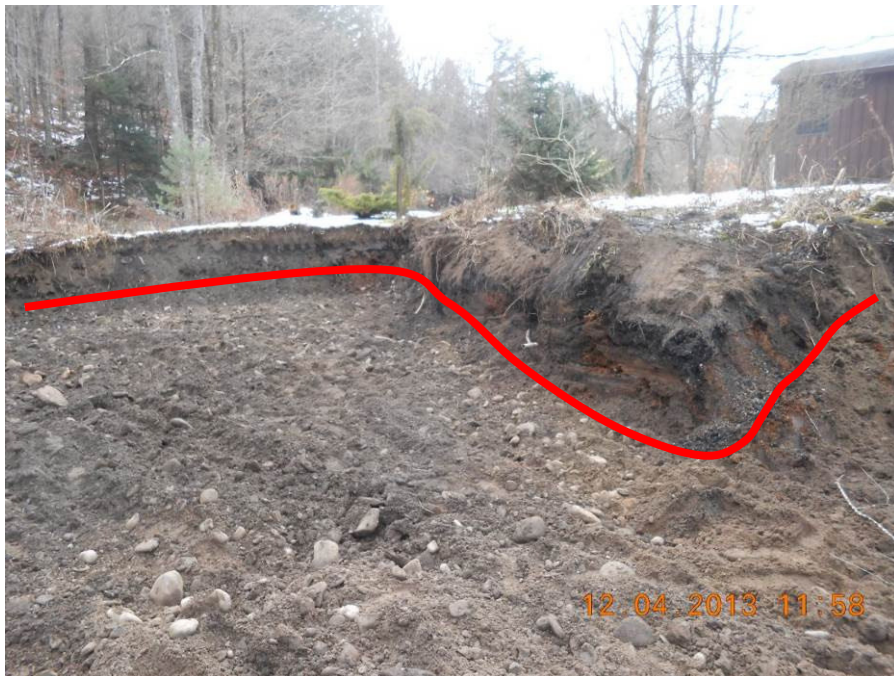
Photo 6: The red line indicates the depth, approximately 2 to 3 feet bgs, where material suspected to be wood tar was observed. This area was excavated southward to 4 feet bgs and eastward to 3 feet bgs.

As the Removal Action activities progressed, a continuous lens of wood tar was observed at approximately 2 to 3 feet bgs along approximately 100 feet of sidewall at the south side of the excavation. This excavation sidewall was approximately 30 feet from the resident's house and approximately 10 feet from a large storage building. The lens of contamination, which measured approximately 1 foot thick, appeared to continue horizontally toward the residence and storage building. The property owner requested that EPA stop advancing the excavation along this sidewall because of his concerns with the structural stability of his house and storage shed. The OSC agreed to stop excavating the lens of contamination in the sidewall at this location. Pursuant to the OSC's direction, RST 2 collected three post excavation sidewall samples from what appeared to be uncontaminated soil below the lens of the wood tar. Samples RW2-81-AA1-03W, RW2-81-AA2-04W, and RW2-81-AA3-04W were collected at depths ranging from 3 to 4 feet bgs along the south sidewall where visible wood tar contamination was present. The analytical results of these three samples were all below the EPA's Site-Specific Cleanup Goals for the Site. However, since available information (refer to Section 1.1 – Site Location and Description) indicates that the residence was built sometime in the 1980s, it is not known if the structure was built on contamination found in the sidewall. Because the excavation in the direction of the residence was stopped, EPA did not fully complete the work proposed in the Action Memorandum in this area of the Site (Refer to Attachment B for Photographic Documentation of Site Activities).

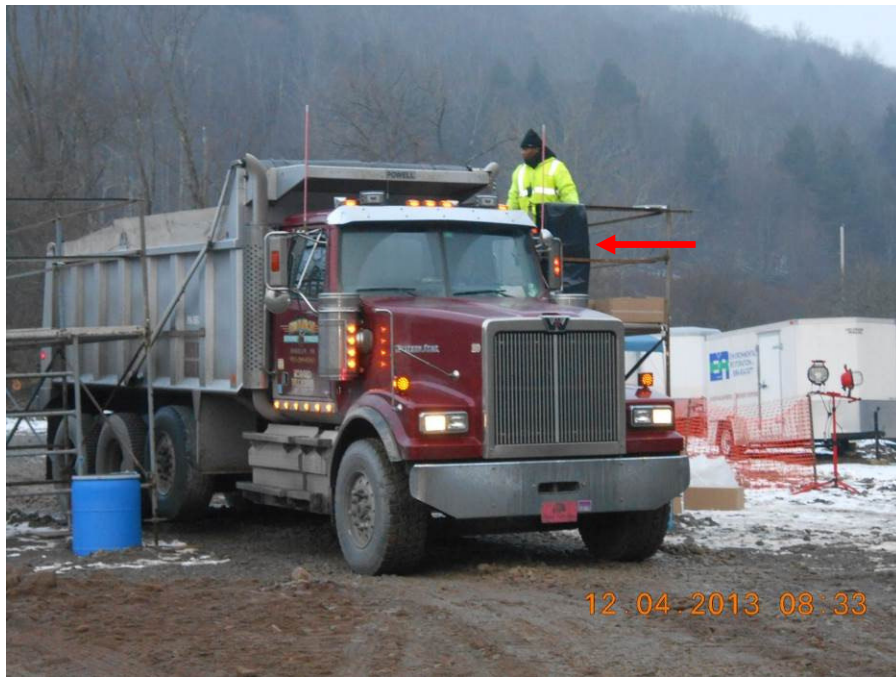
Photo 7: Trucks were lined with poly sheets (red arrow) before they were loaded with contaminated soils for off-site disposal.

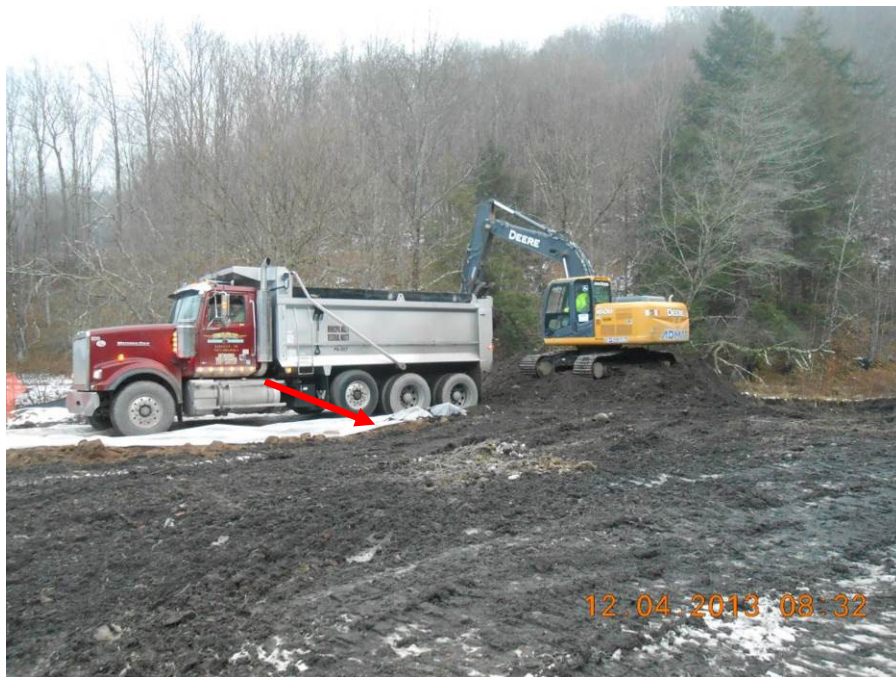
Photo 8: Poly sheets (red arrow) were placed along the truck access path to the soil loading area to prevent the vehicles from tracking contaminated soils offsite when exiting the Site.

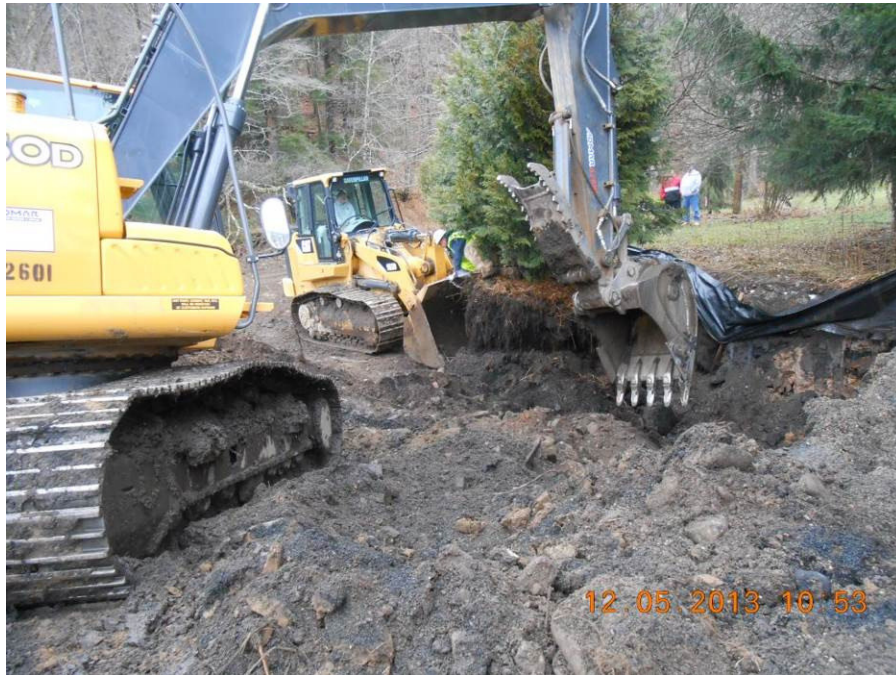
Photo 9: Trees that were in the way of the excavation area were removed and replanted at a different location within the Site.

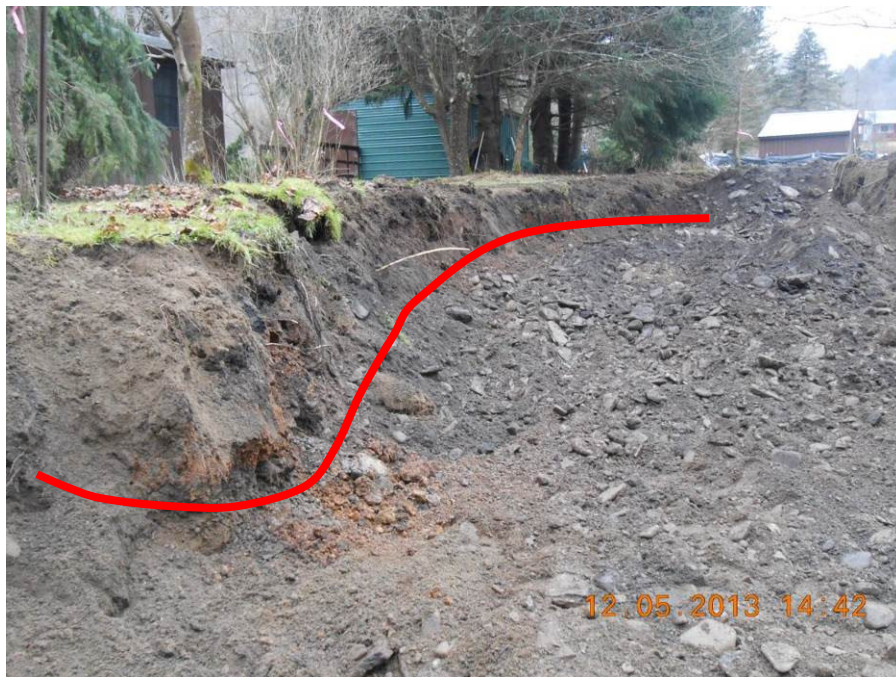
Photo 10: This southern portion of the Site encompassing all of grid-A1 and portions of grid-B1 was excavated to a depth of 4 feet bgs. The red line indicates the location where a layer of material suspected to be wood tar was observed to be progressing towards the foundation of on-site residential property.

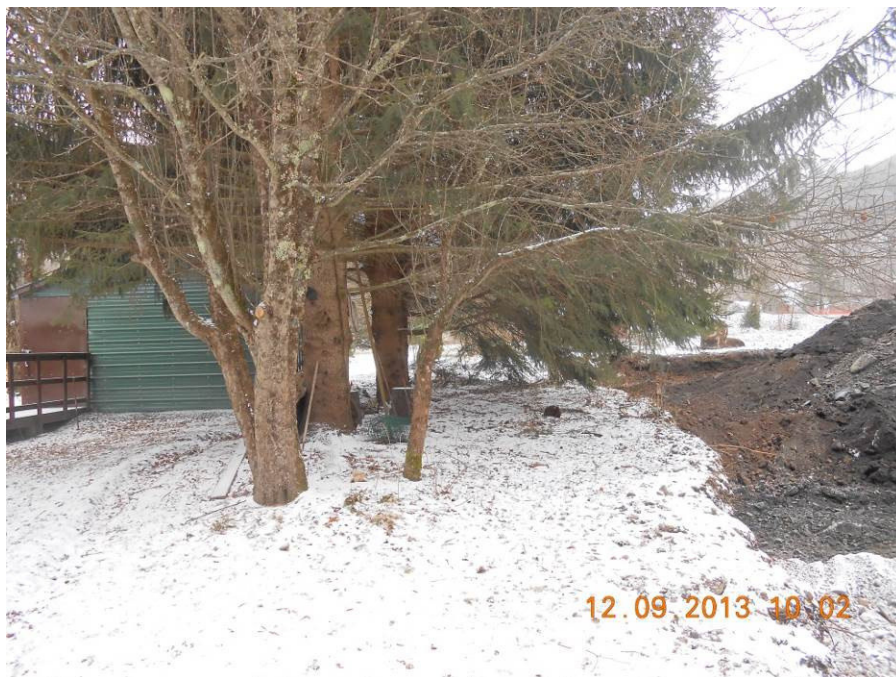
Photo 11: The southern extent of the excavation was approximately 29 feet from the foundation of the on-site residential property. The property owner requested that the excavation should be stopped from encroaching further in the direction of the residence.

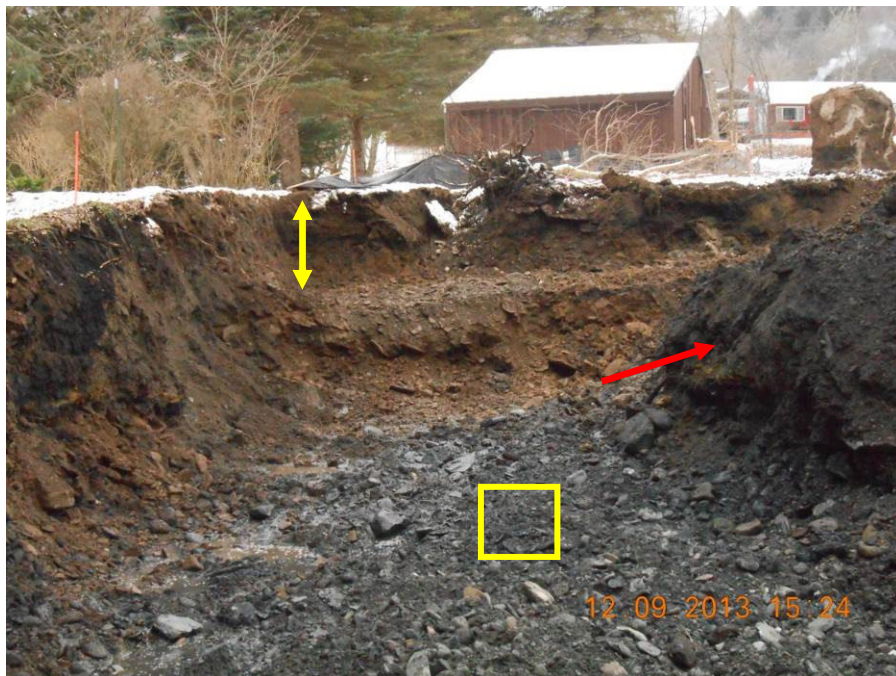
Photo 12: Large chunks of wood tar (red arrow) were excavated from grid-B1. Grid-C1 was excavated to 3 feet bgs (yellow arrow). The yellow square indicates the location where post excavation soil sample RW2-81-B1-08B was collected.

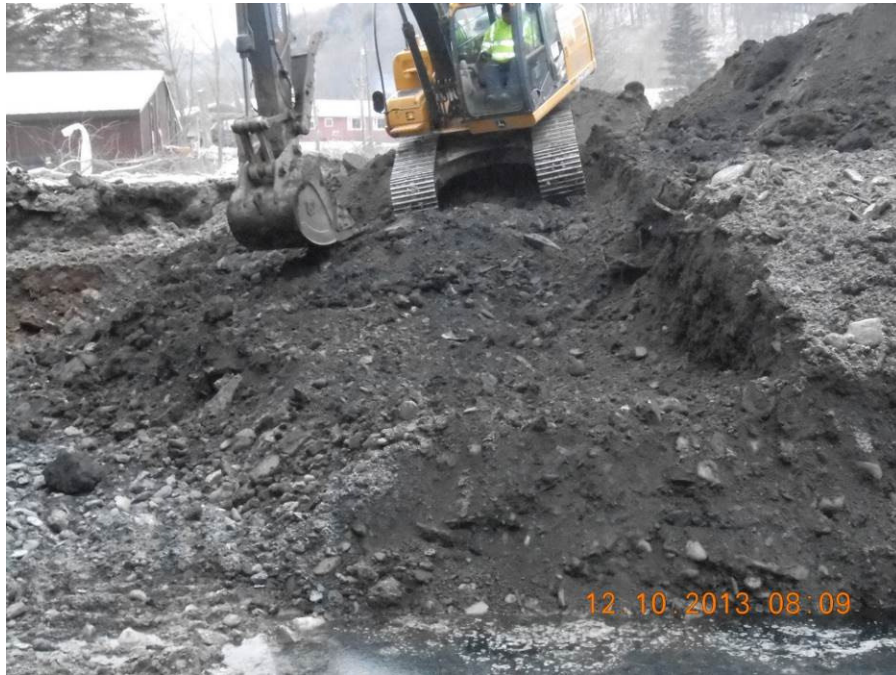
Photo 13: ERRS excavated portions of grid-B1 and all of grid-B2 to a depth of 8 feet bgs. Both grids were filled with large quantities of wood tar which were transferred directly to trucks for off-site disposal.

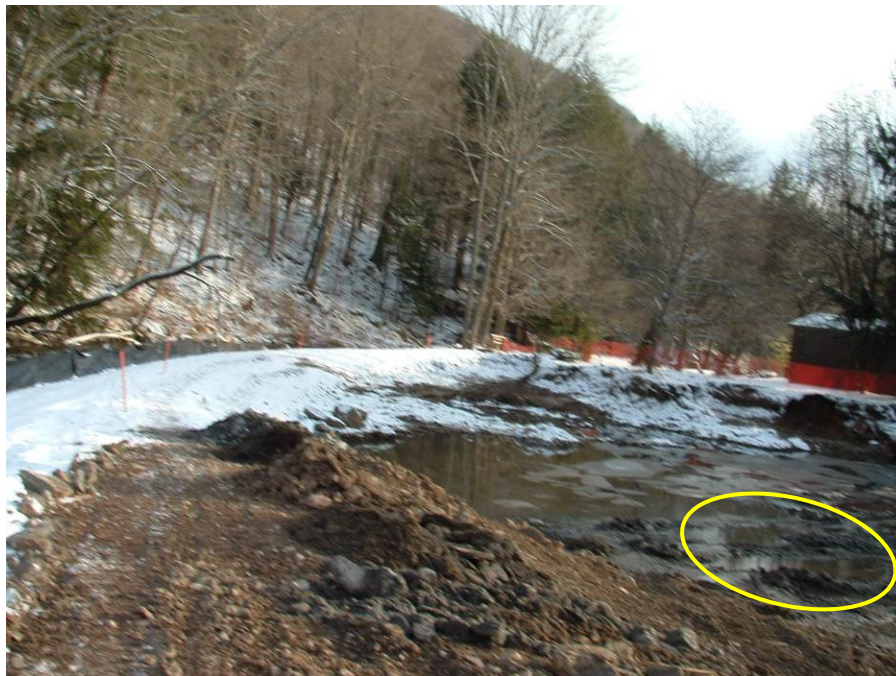
Photo 14: The yellow ellipse indicates the location within the excavation from where groundwater sample RW2-81GWAB was collected. This location encompassed groundwater that had seeped into grids A and B.

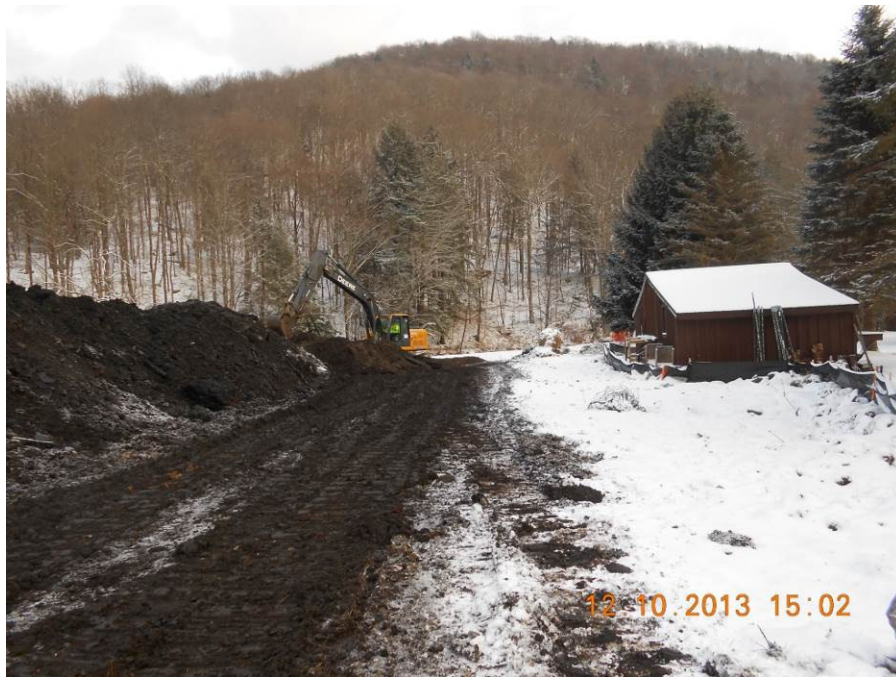
Photo 15: Wood tar-contaminated soils were staged onsite while waiting for trucks to arrive for loading and off-site disposal.

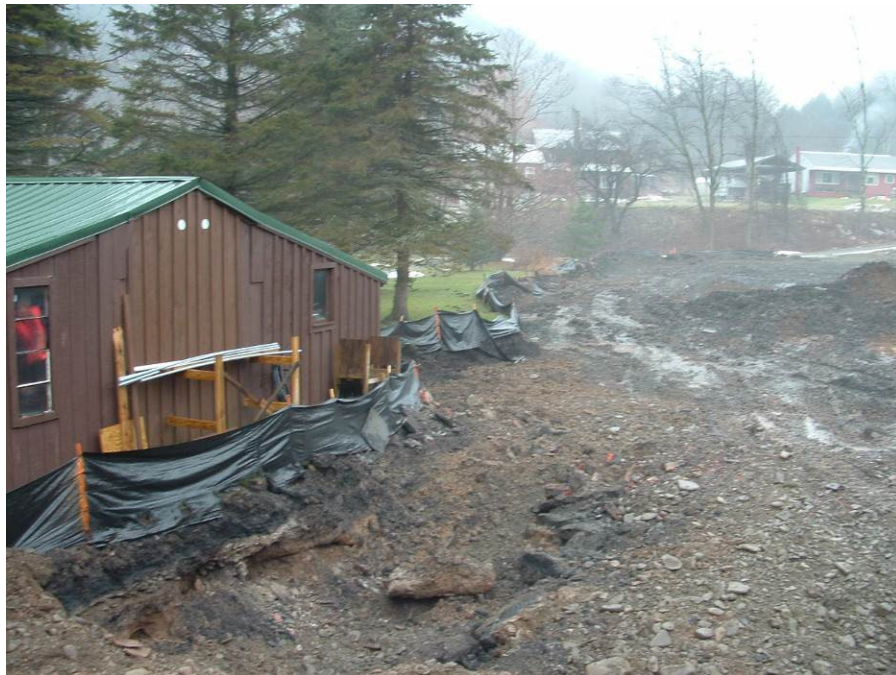
Photo 16: Grid-D1 along the southwest portion of the Site was excavated to approximately 24 inches bgs and tapered to the west and northwest direction to a depth of approximately 18 inches bgs at grid-J1. Although material suspected to be wood tar was observed to be progressing beneath the foundation of the property's garage, the excavation was terminated in this direction at the request of the property owner.

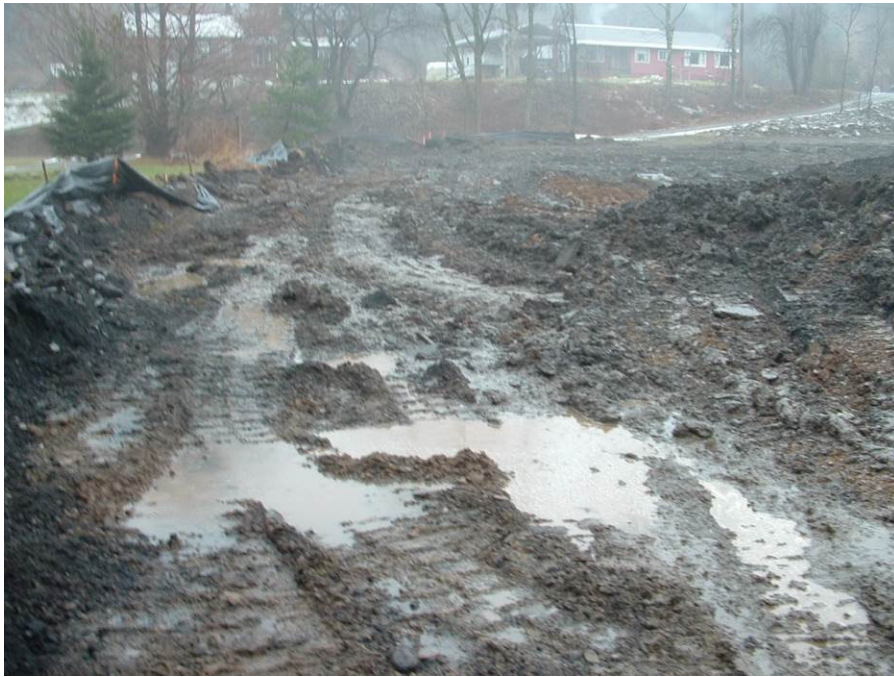
Photo 17: A view of the southwest portion of the Site after it was excavated to a depth of approximately 18 inches bgs along grid-F through grid-J.

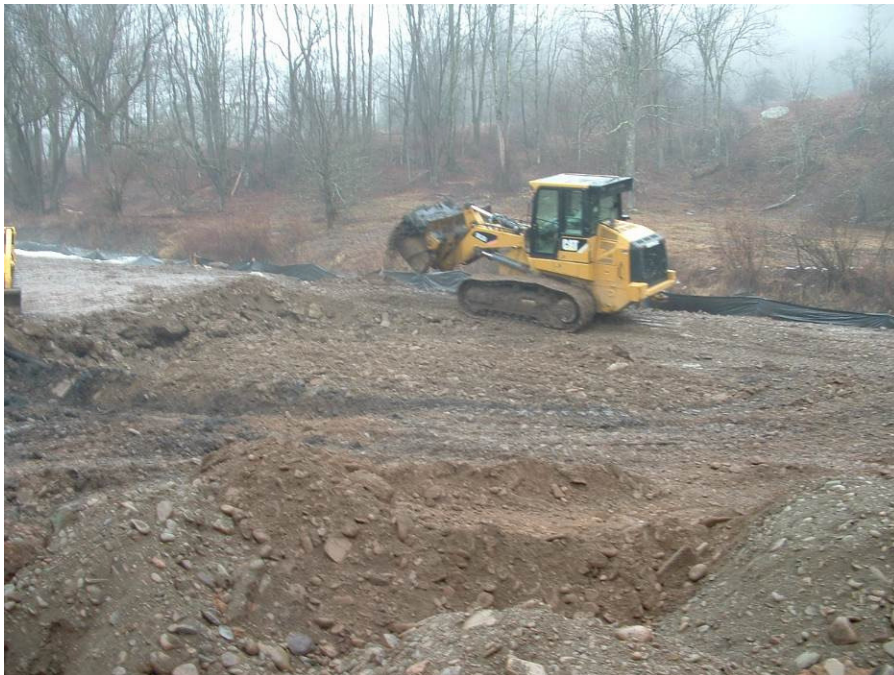
Photo 18: ERRS backfilled the excavation with imported pre-analyzed soil starting from the southeast portion of the Site.

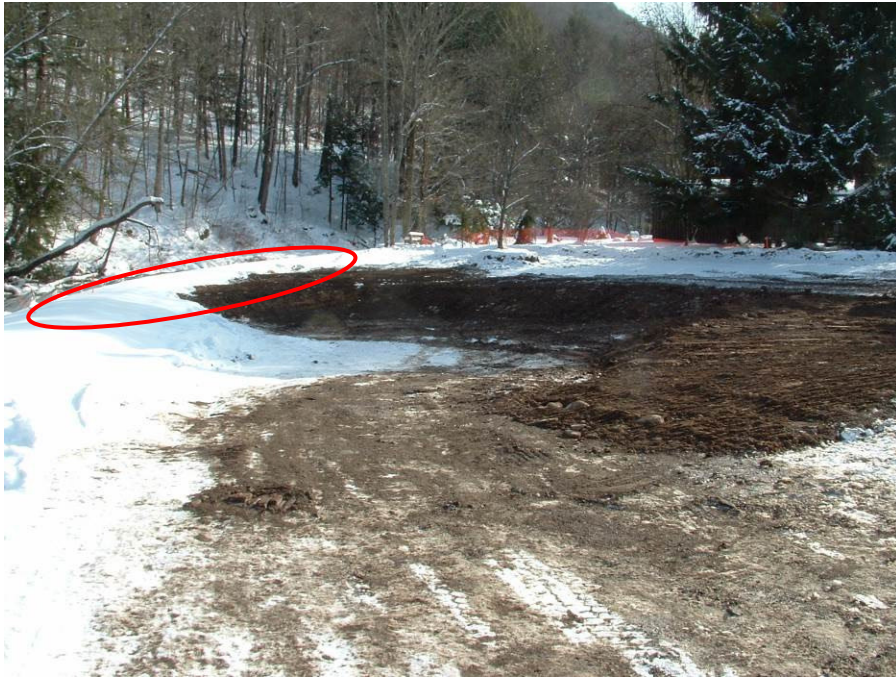
Photo 19: The west bank of the Creek which was completely removed during the excavation of the southeast portion of the Site was reconstructed with backfill material. The red ellipse shows portions of the west bank that was reconstructed.

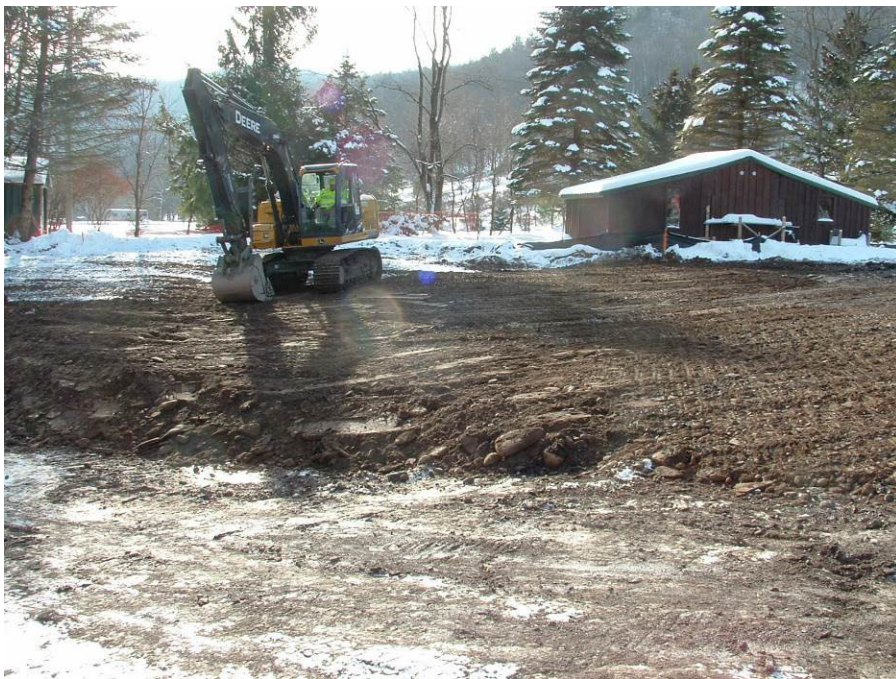
Photo 20: A view of the southern portion of the Site after the excavation was backfilled.

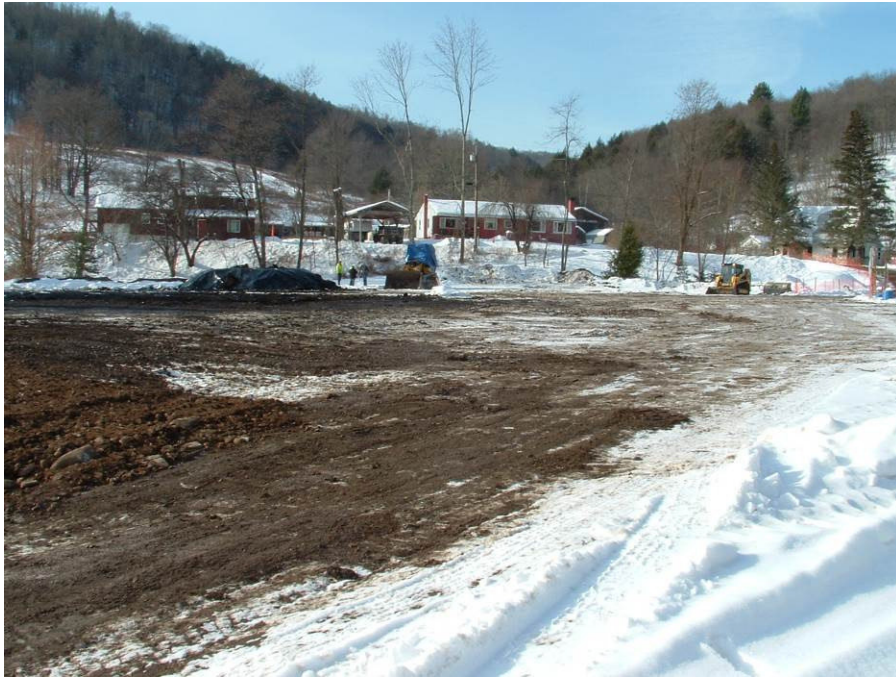
Photo 21: A view of the northwest portion of the Site after the excavation was backfilled.

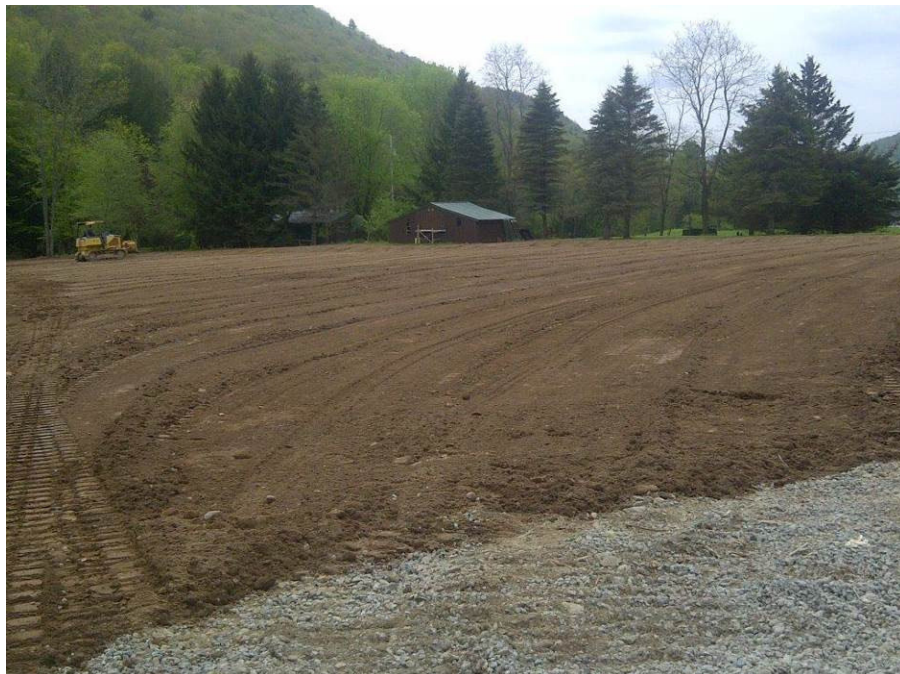
Photo 22: Approximately 900 tons of pre-analyzed top soil was placed throughout the approximately 65,000 ft² area of the Site, including the approximately 43,000 ft² excavation area, to a depth of 3 to 4 inches, thereby raising the ground surface to its original grade.

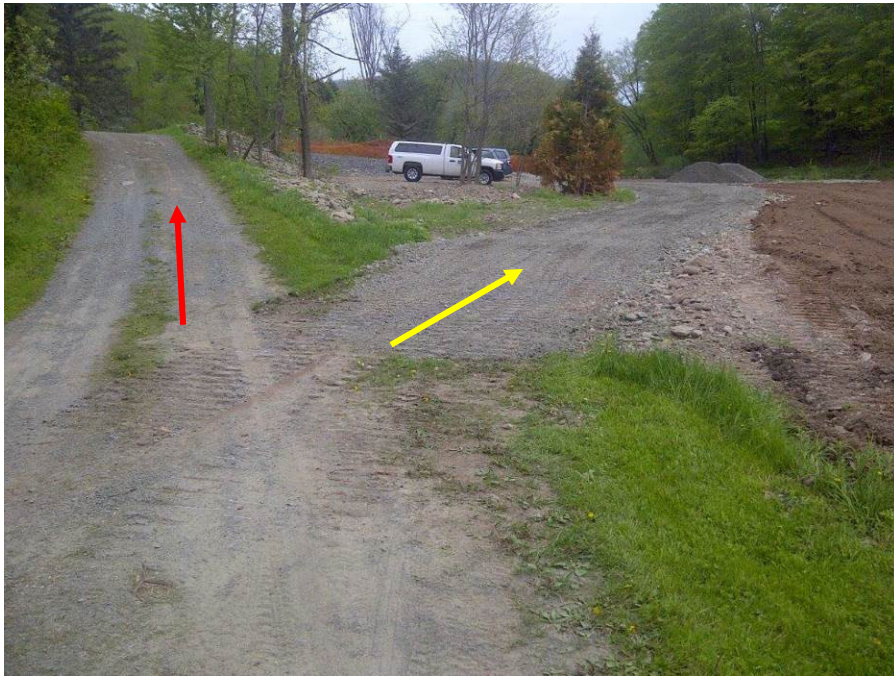
Photo 23: Approximately 66 tons of 2-inch crushed stones was repurposed from the Site's CRZ and trailer staging area and used in the construction of an alternative north driveway to the on-site residence. The red arrow indicates the old drive way and the yellow arrow indicates the new drive way.

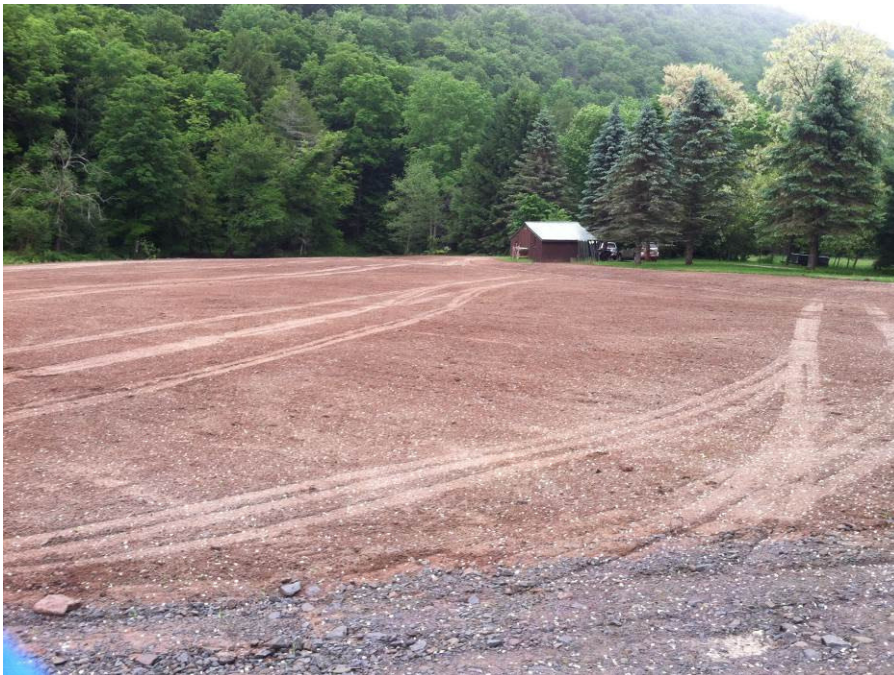
Photo 24: A mixture of red clover and pasture grass (contractors blend) was planted throughout the Site via hydroseeding.

The on-site property owner informed EPA that the site restoration which was completed in June 2014 caused poor stormwater drainage and requested for alteration. On August 18 and 19, 2014, EPA and ERRS remobilized to the Site and restored the impacted area to permit proper stormwater drainage. The material removed during the re-grading activities was utilized to re-grade the west bank of the Creek. During the re-grading of the property, an additional 125 tons of pre-analyzed topsoil was delivered and spread throughout the remediated areas. The areas that re-grading activities were completed were also re-seeded by the ERRS contractor. All
