REMEDIAL INVESTIGATION AND  
FEASIBILITY STUDY

BECKER ELECTRONICS SITE  
TOWN OF DURHAM  
GREENE COUNTY, NEW YORK  
SITE I.D. NO. 4-20-007

PHASE I REMEDIAL  
INVESTIGATION REPORT  
VOLUME 1

JUNE 1992

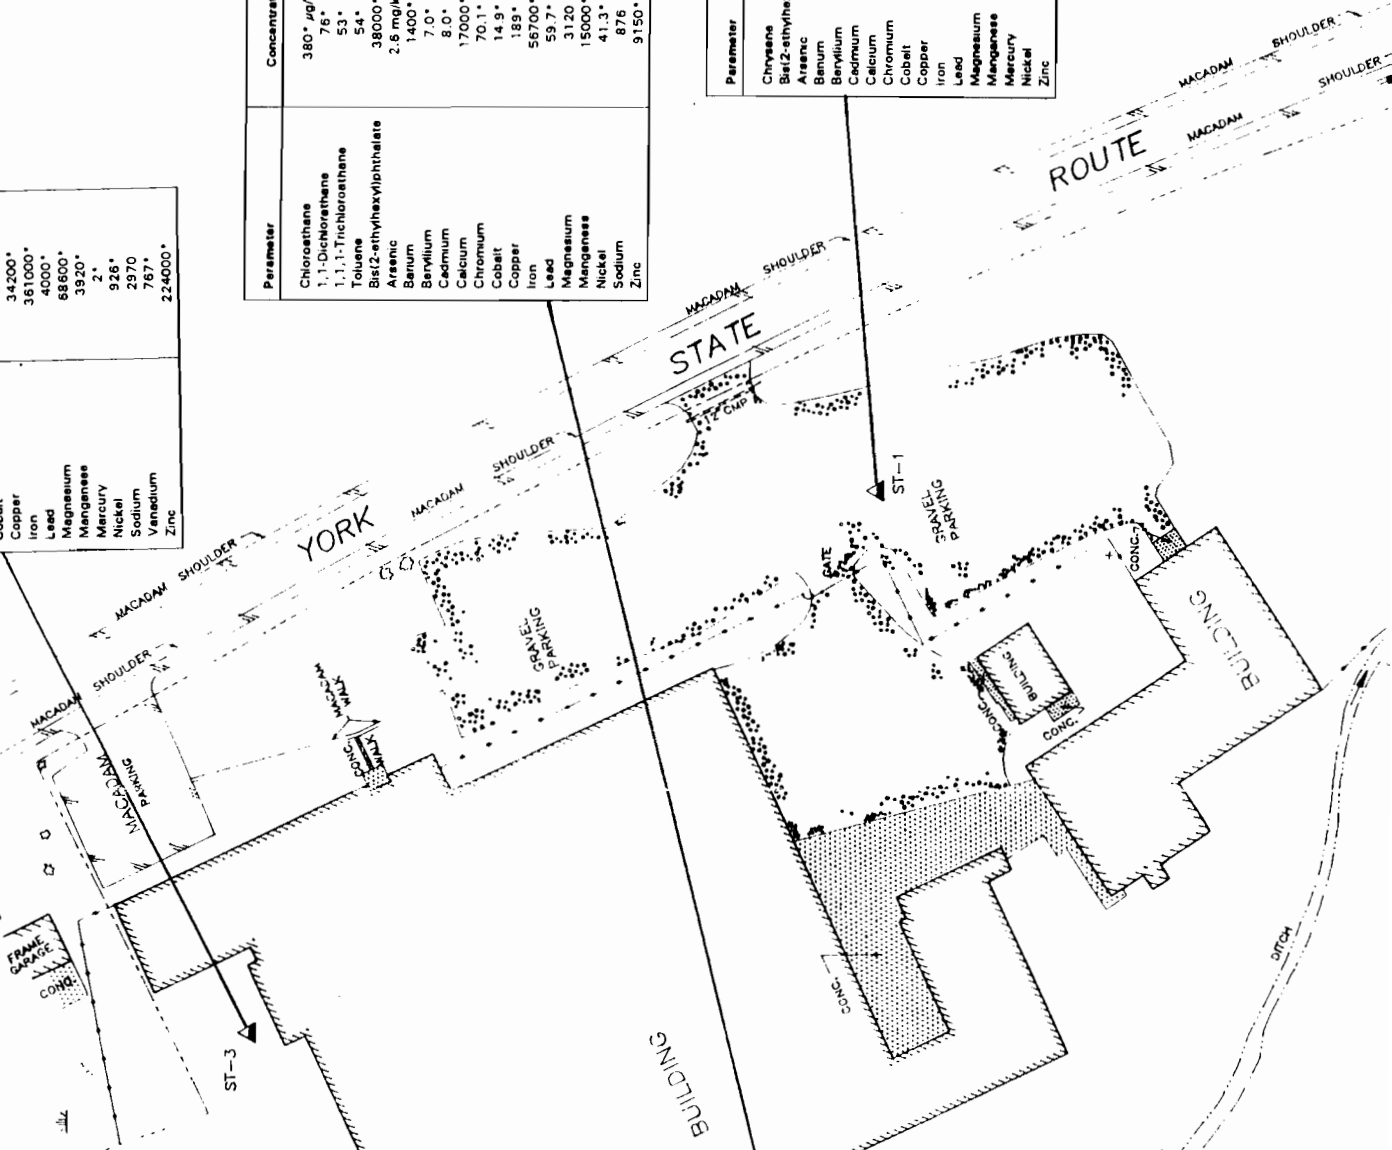
Parameter	Concentration
Chloroethane	380* $\mu\text{g}/\text{kg}$
1,1-Dichloroethane	76*
1,1,1-Trichloroethane	53*
Toluene	54*
Bis(2-ethylhexyl)phthalate	38000*
Arsenic	2.6 $\text{mg}/\text{kg}$
Barium	1400*
Beryllium	7.0*
Cadmium	8.0*
Calcium	17000*
Chromium	70.1*
Cobalt	14.9*
Copper	189*
Iron	56700*
Lead	59.7*
Magnesium	3120
Manganese	15000*
Nickel	41.3*
Sodium	876
Zinc	9150*

Parameter	Concentration
Chrysene	140* $\mu\text{g}/\text{kg}$
Bis(2-ethylhexyl)phthalate	6700
Arsenic	5.8 $\text{mg}/\text{kg}$
Barium	277
Beryllium	5.1*
Cadmium	3.9*
Calcium	28000*
Chromium	23.4
Cobalt	16.2*
Copper	117*
Iron	31800*
Lead	23.4*
Magnesium	3720
Manganese	411
Mercury	0.23*
Nickel	42.6*
Zinc	1580*

SC/NATURAL BACKGROUND LEVEL IN SOIL  
SEPTIC TANK TEST PIT SAMPLE LOCATION

- Notes: 1. Non-detect values for parameters are not shown on this figure.
- 2. Contaminant concentrations for volatile and semivolatiles compounds expressed in  $\mu\text{g}/\text{kg}$ ; Inorganic compounds expressed in  $\text{mg}/\text{kg}$  unless otherwise noted

- Investigate any septic tanks or distribution chambers which may have possibly been overlooked in the Phase I RI specifically, site records indicate that there may be septic tanks located in the northeast and east portions of the site property. In the event that additional septic tanks are uncovered, provision should be made to collect samples to be analyzed for the full TCL parameters.
- Define the Septic Tank #2 (ST-2) leaching field system, as well as leaching fields located in the eastern and southeastern portions of the site property. Soil gas analysis is the recommended
